Re: Report No. 2
FERC Independent Consultants Review Panel
Silver Lake Dam

REPORT NO. 2

SILVER LAKE DAM

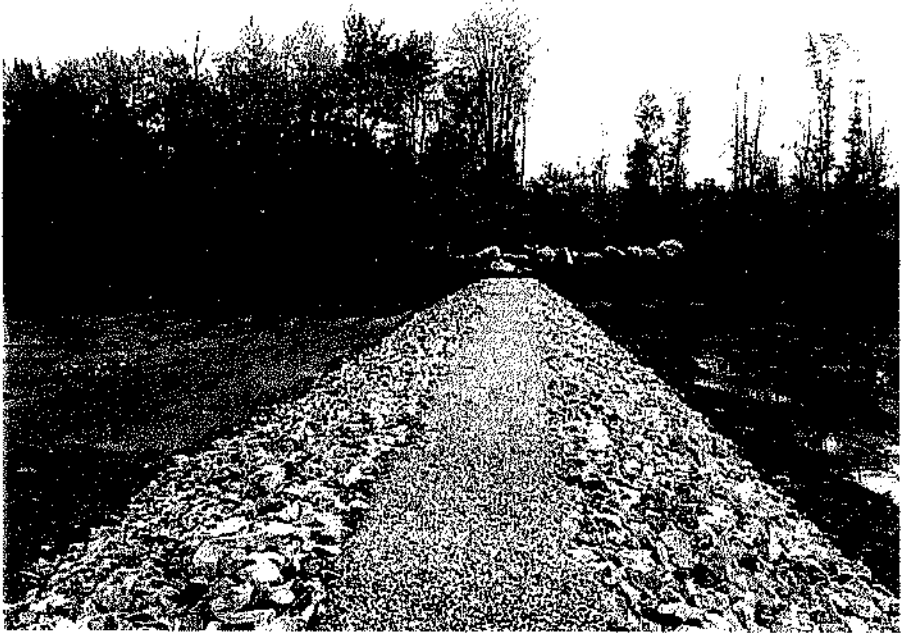
Figure 2.3.3-1 Fuse plug embankment during post-construction inspection

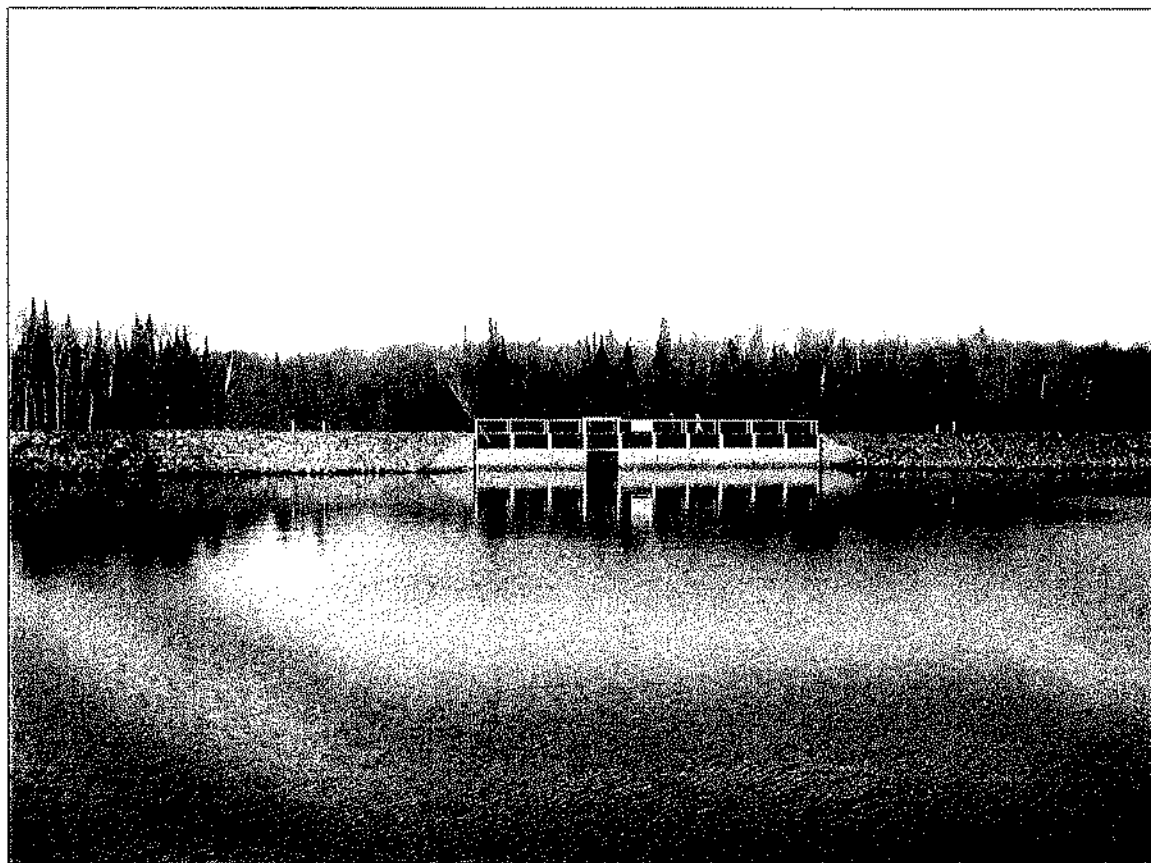
Figure 3.6.2-2 Upstream side of concrete spillway at about 8:30 PM, May 14, 2003

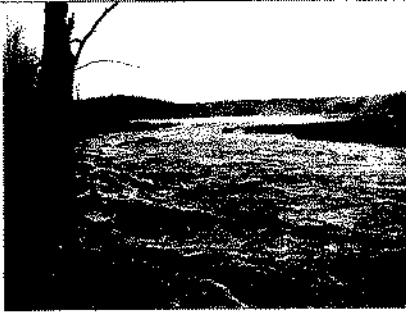
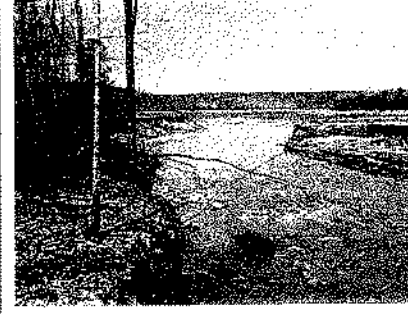
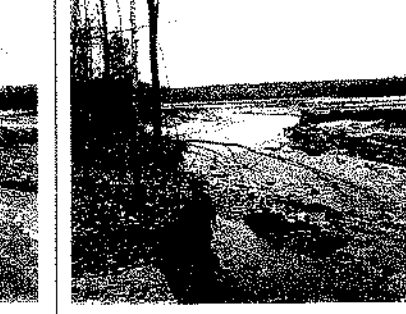
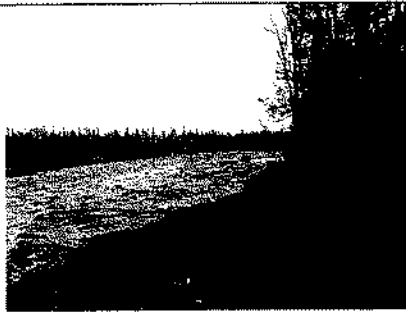
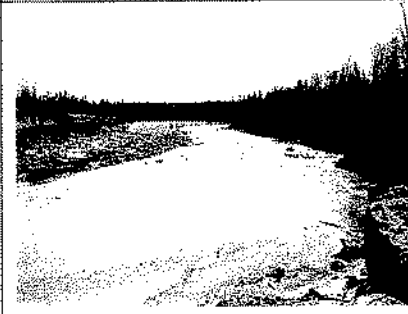
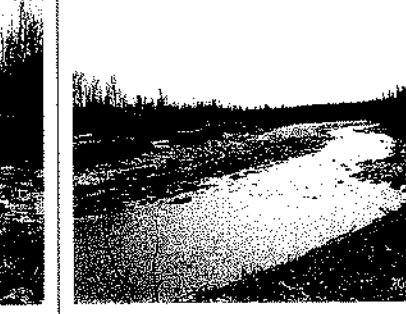
Figure 3.6.4-1 Photographs upstream and downstream from fuse plug embankment on October 8, 2002 at the end of construction, and on May 14; May 15; and May 16; 2003, showing progressively deepening erosion

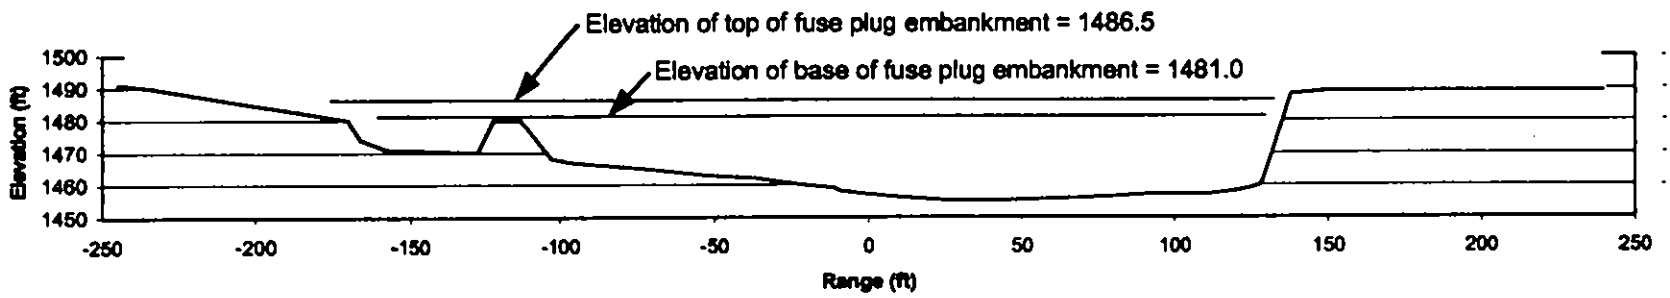
Figure 3.6.4-2 Cross section through eroded channel at STS Station 27+00, near fuse plug axis

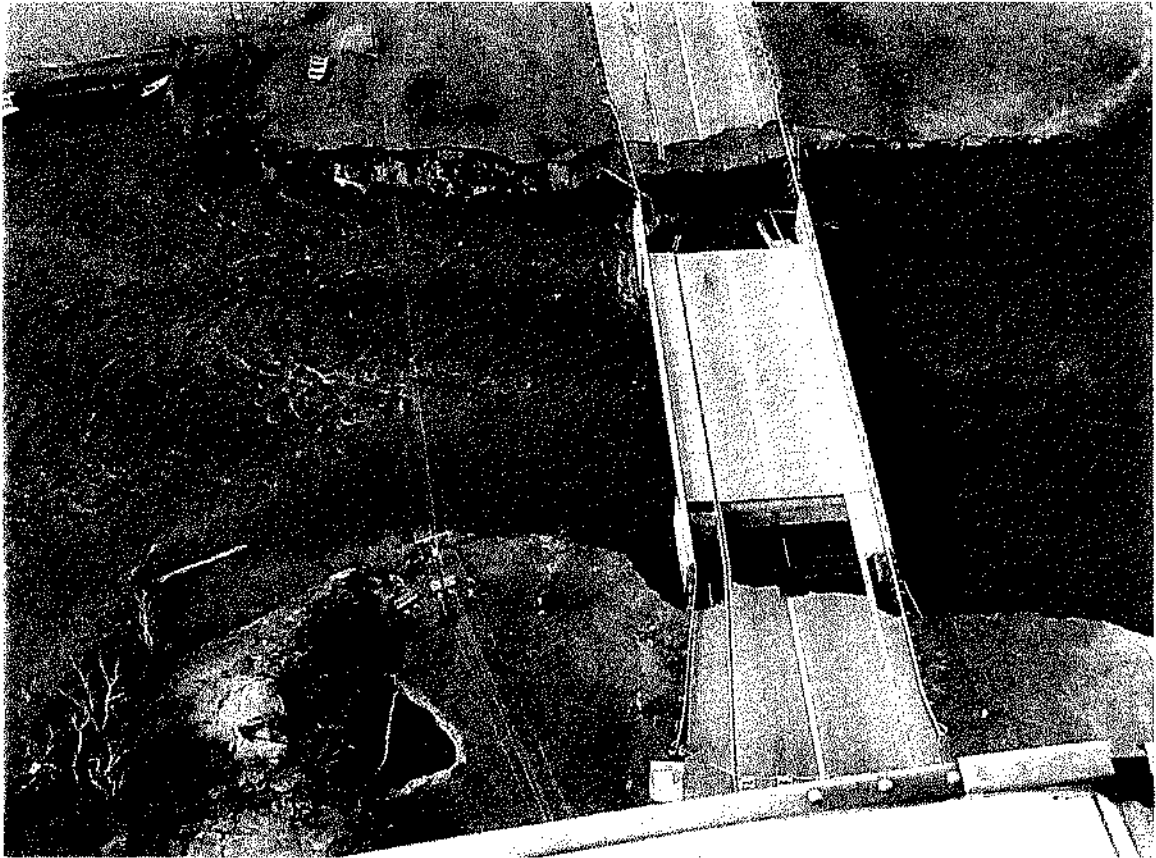
Several railroad and highway bridges suffered damage to foundations or abutments that rendered them unusable. One of the damaged highway bridges is shown in Figure 3.6.5-1. More than 1,700 people were evacuated from an area of about 485 acres (195 ha) in the city of Marquette from 8:45 AM on May 15 through 1:00 PM on May 16.

Figure 3.6.5-1 Bridge at mouth of Dead River after fuse plug breach
