A DAM MYSTERY: DEAD RIVER FLOOD

Marquette County, MI
May 14-16, 2003

Information contained herein is from the "Root Cause Report," submitted to UPPCO by the Washington Group, Inc., June 2003.

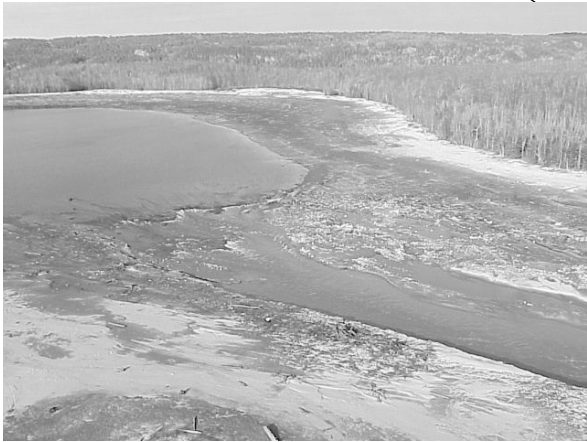
Silver Lake Basin Breach

- May 14, 2003
- Silver Lake Basin earthen dike bursts – approx. 5:00 p.m.
- 8:44 p.m. Flash Flood Warning Issued

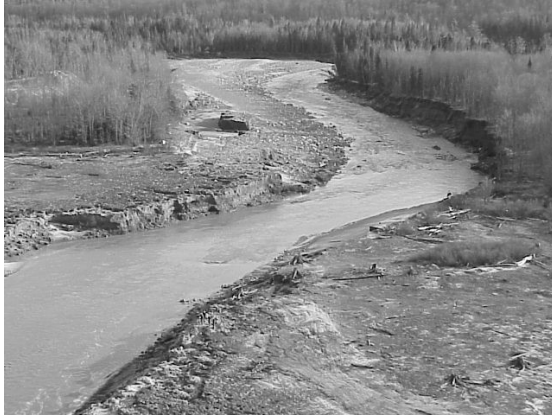
Downriver from Silver Lake

- Break unleashes an estimated 8 billion gallons of water downriver.
- Mqt. County Board Chair Gerald Corkin declares State of Emergency at 1:30 a.m., May 15.

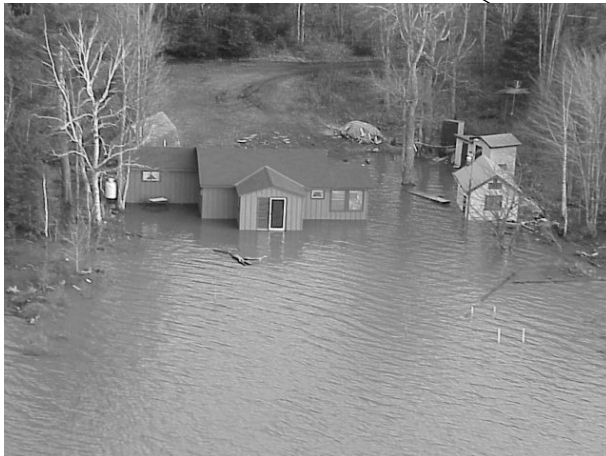
- Floodwaters reach Dead River Basin – damaging camps and homes

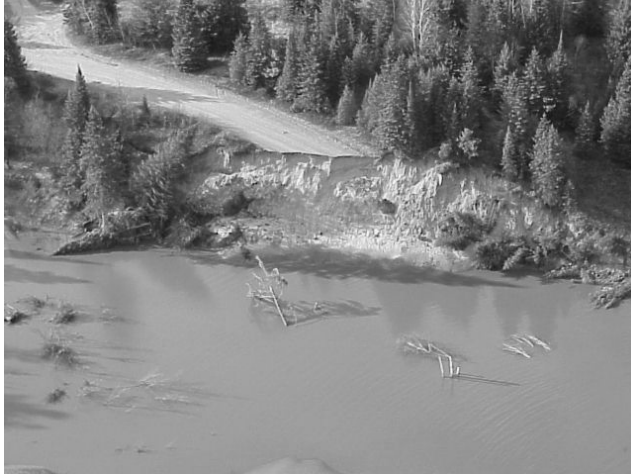
Dead River Basin

- The torrent of water also destroys roads along the way

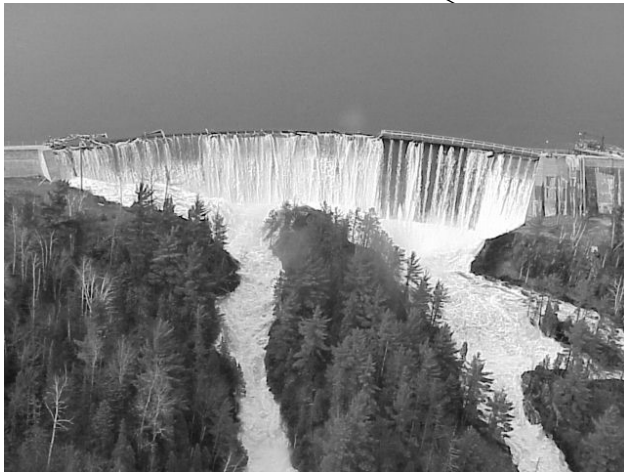
- Floodwaters crest the Hoist Dam and flow further downriver

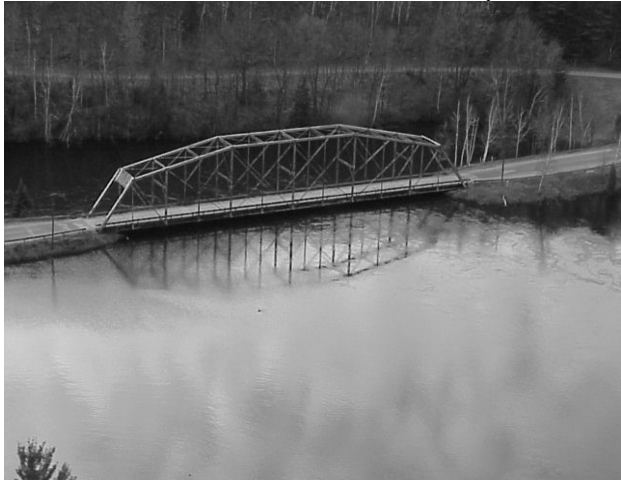
CR 510 Steel Bridge

- Water continues downstream – crossing CR 510 (Steel Bridge)

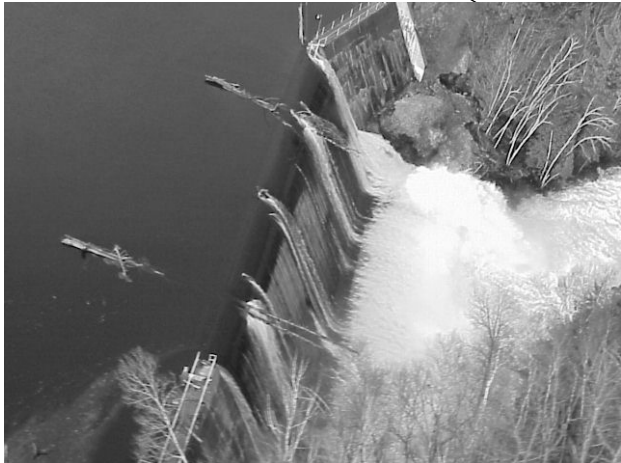
- Downriver, the floodwaters crest the McClure Dam

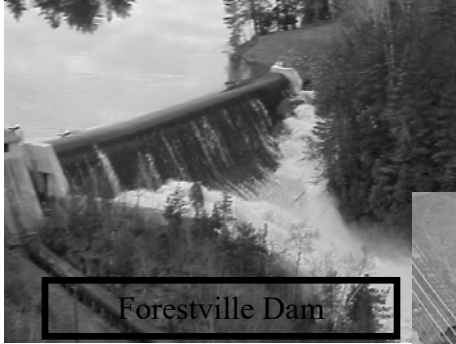
Forestville Dam

- Floodwaters reach Forestville Dam, destroy railroad grade.

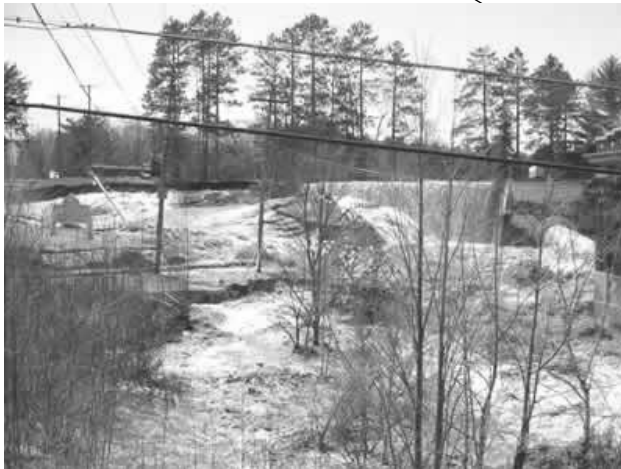
- Flood reaches Tourist Park and destroys the Dam

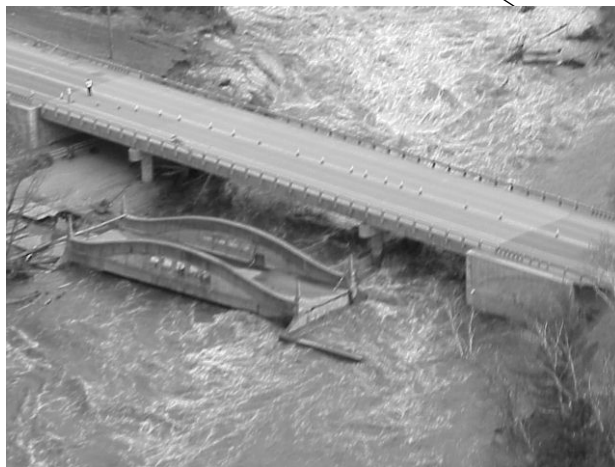
- Flood damages bridges on CR 550
- Utility service interrupted to Big Bay

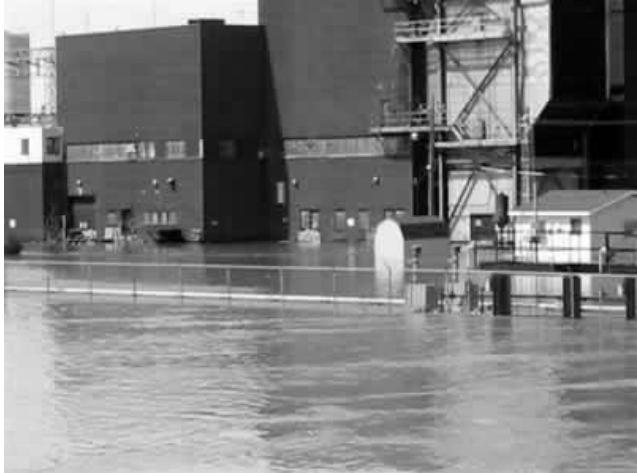
- Considerable damage to Presque Isle Power Plant

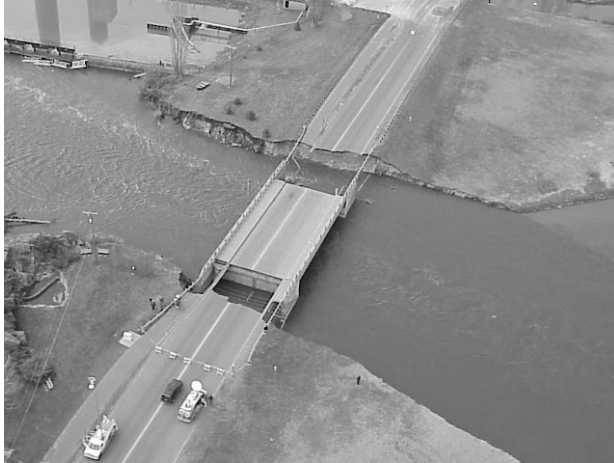
Lakeshore Blvd.

- Flood destroys bridge on Lakeshore Blvd
- Cuts power, gas, and telephone service to residences

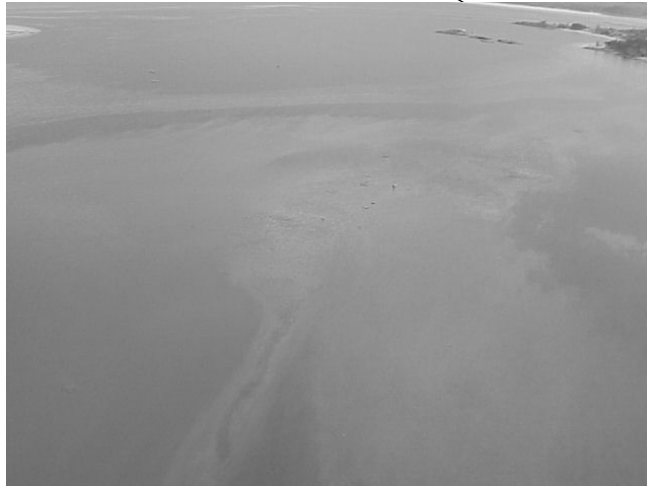
- Silt and debris flow into Lake Superior

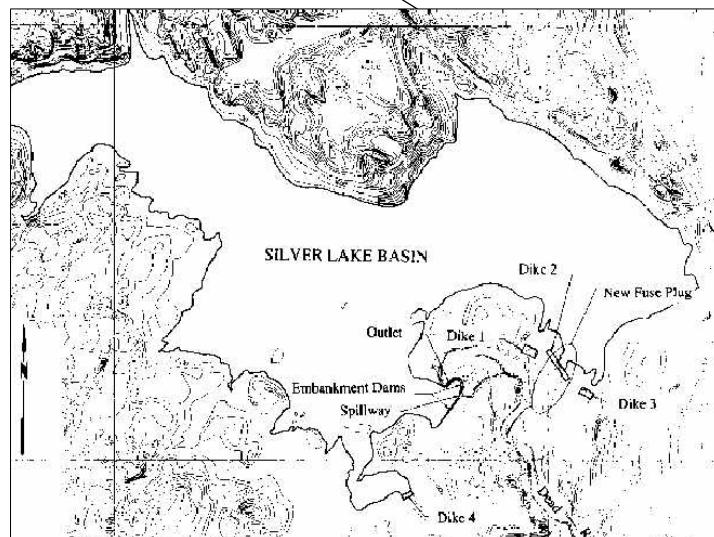
Fuse Plug Dam

- Constructed in Fall 2002.
- Earth dam, about 5 feet high.
- Designed to overtop and serve as an emergency spillway in the event of a very severe flood (approx. 500-yr flood).
- Required operational change – keeping lake level lower to maintain storage capacity for flood control.

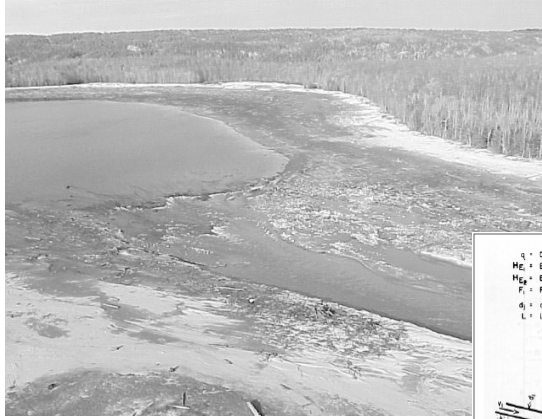
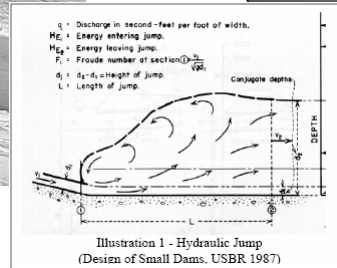
Headcutting

⁽¹⁾ A discharge of 4,900 cfs is comparable to the estimated May 14, 2003 discharge from Silver Lake immediately after the breach and washout of the fuse plug embankment.
