Initial Report of Findings

FERC Investigation of Activation of Fuse Plug Spillway  
May 14, 2003

Silver Lake Basin  
Dead River Project No. 10855  
Marquette County, MI  
Upper Peninsula Power Company

Draft: July 24, 2003

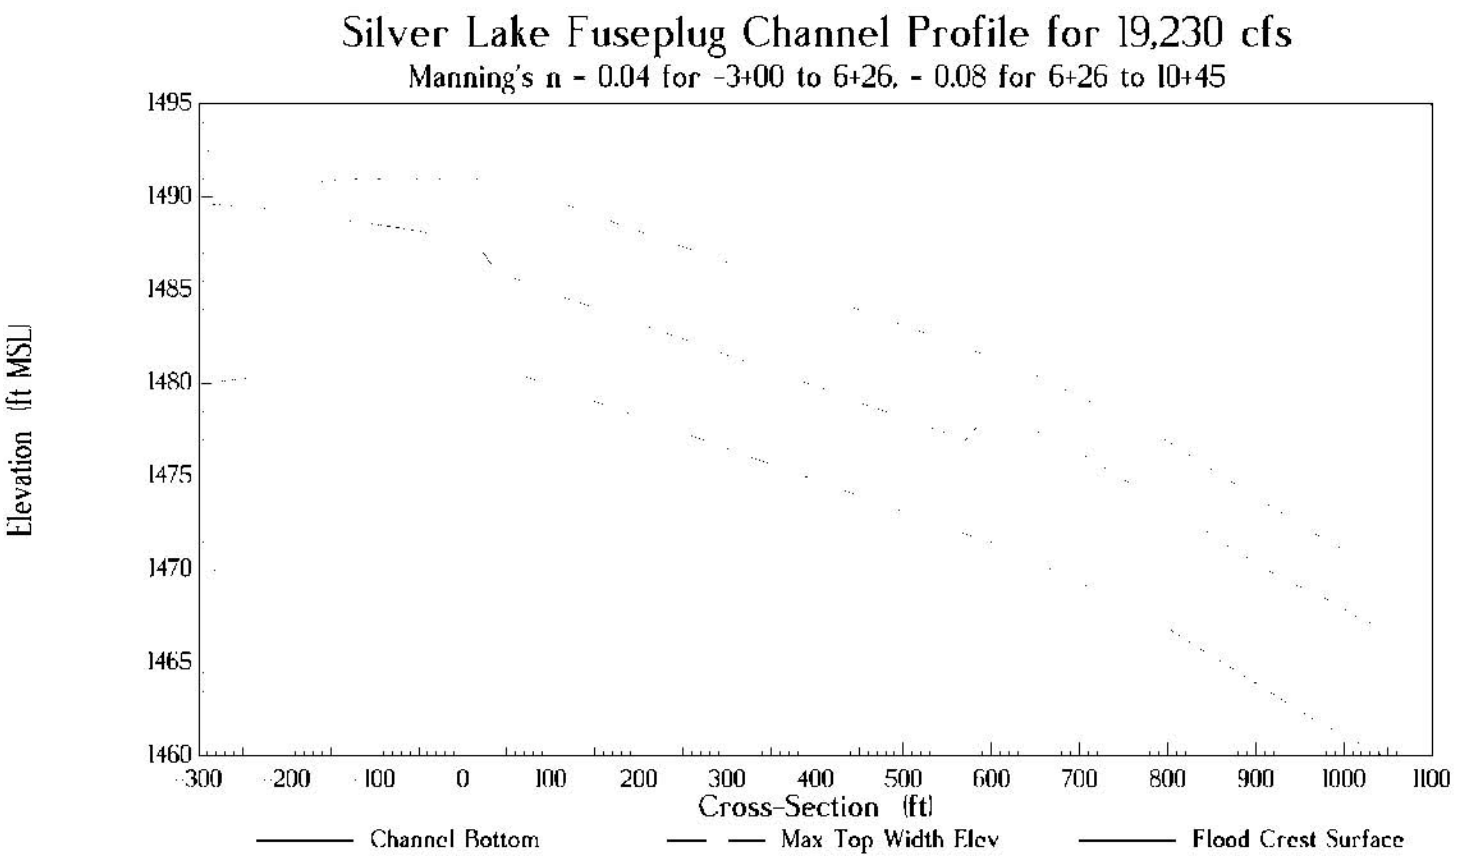
Figure 2. Slope Profile of the Fuseplug Channel during the PMF.

We also performed an open channel analysis using the same model to approximately match the water surface elevation at the entrance channel entrance to the high water mark of 1485.60 feet observed on the upstream side of the overflow spillway. Through trial and error, we determined that a flow of about 8,000 cfs was needed to match the water surface elevation at Station -3+00 to the high watermark. For this scenario, the velocity in the sloped section of the exit channel was computed to be equal to about 10 fps.

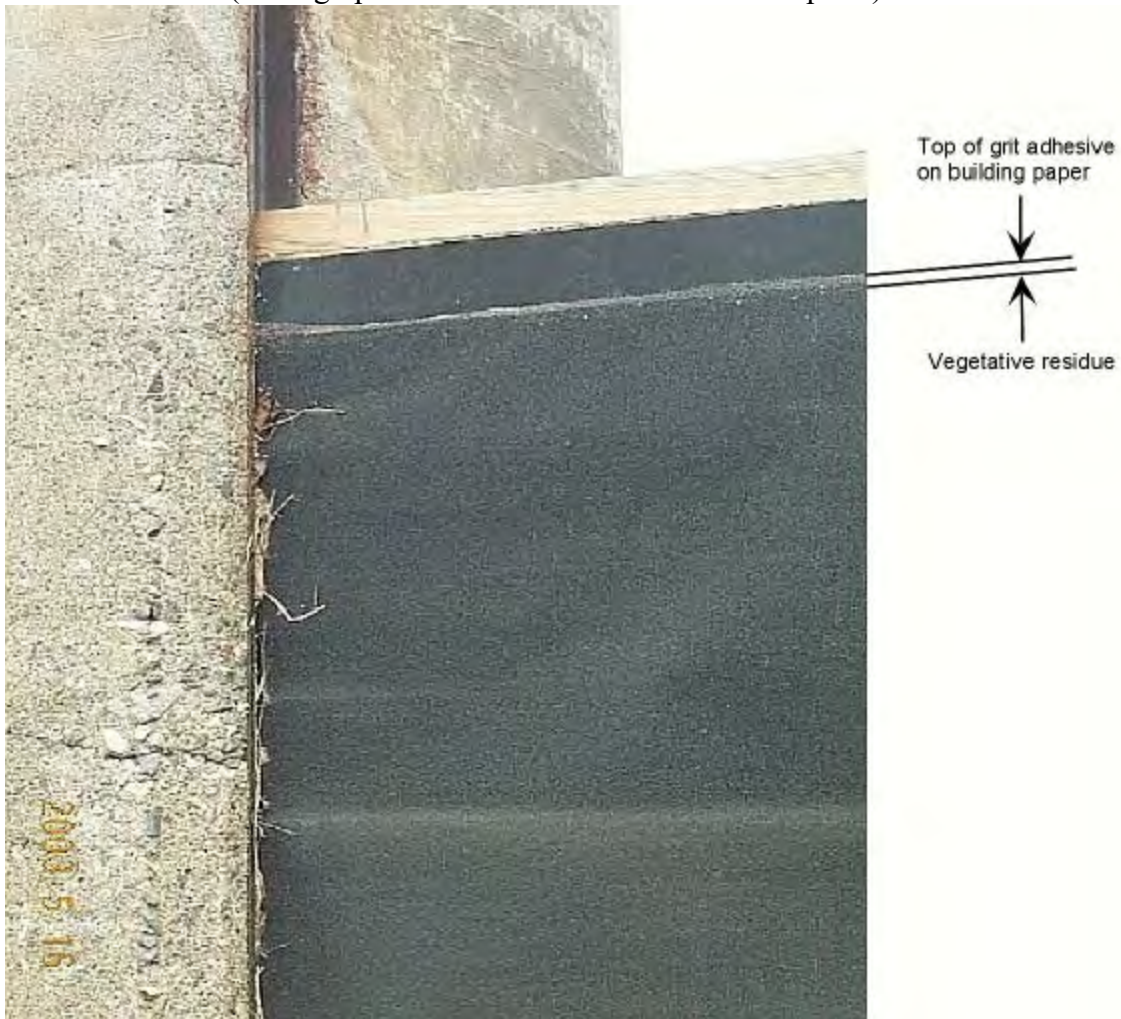
Photograph 1. Downstream right side of the stoplog bay of the overflow spillway at Silver Lake. Photograph taken on May 16, 2003. Note the vegetative debris in the slot and small debris on the felt paper indicative of a watermark near the top of the felt paper.

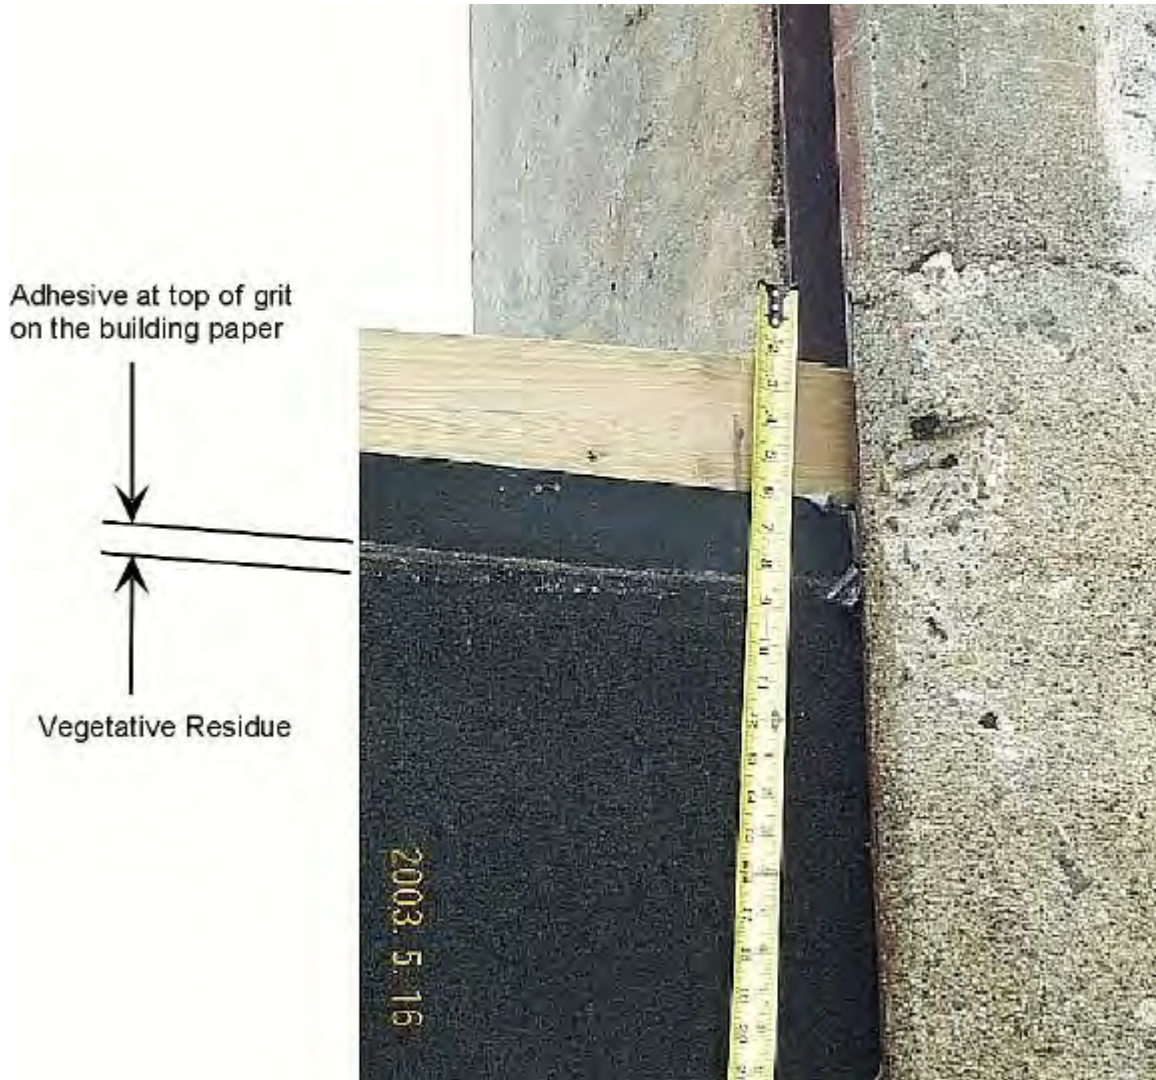
Photograph 2. Downstream left side of the stoplog bay of the overflow spillway at Silver Lake. Photograph taken on May 16, 2003. Note the small debris on the felt paper indicative of a watermark near the top of the felt paper.

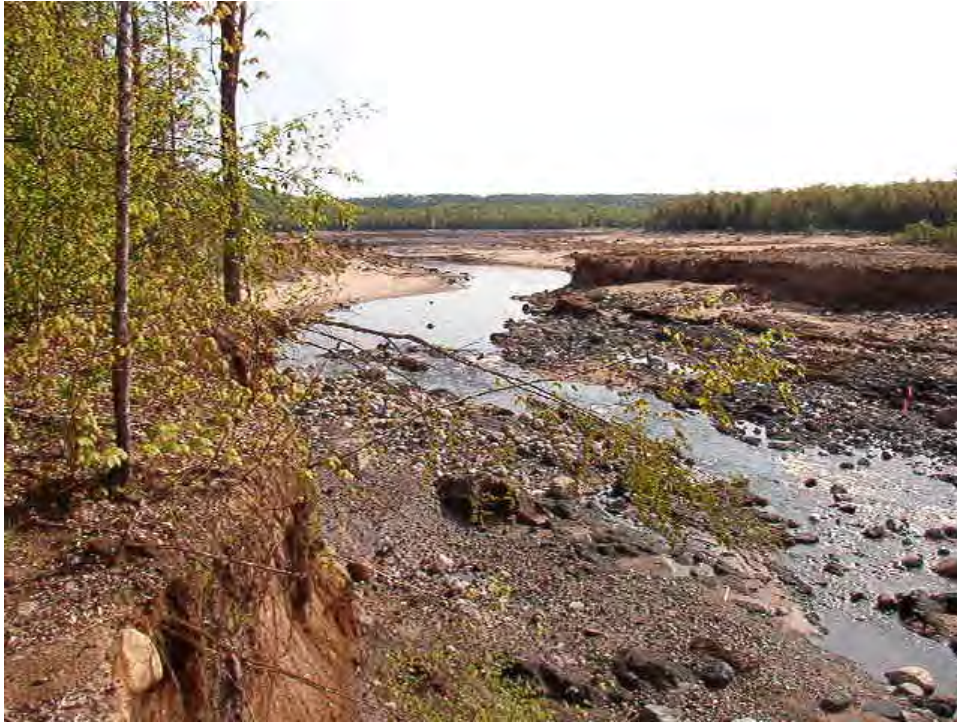
The licensee hired STS Consultants to survey the breached channel. Their results were included with the licensee's June 12, 2003 letter. Photographs 3-7 show the channel as observed during our June 3, 2003 site visit. The breach scoured the entire entrance and exit channels and further

Photograph 3. Silver Lake channel entrance as viewed from the right abutment near Station 0+35. Photograph taken on June 3, 2003.

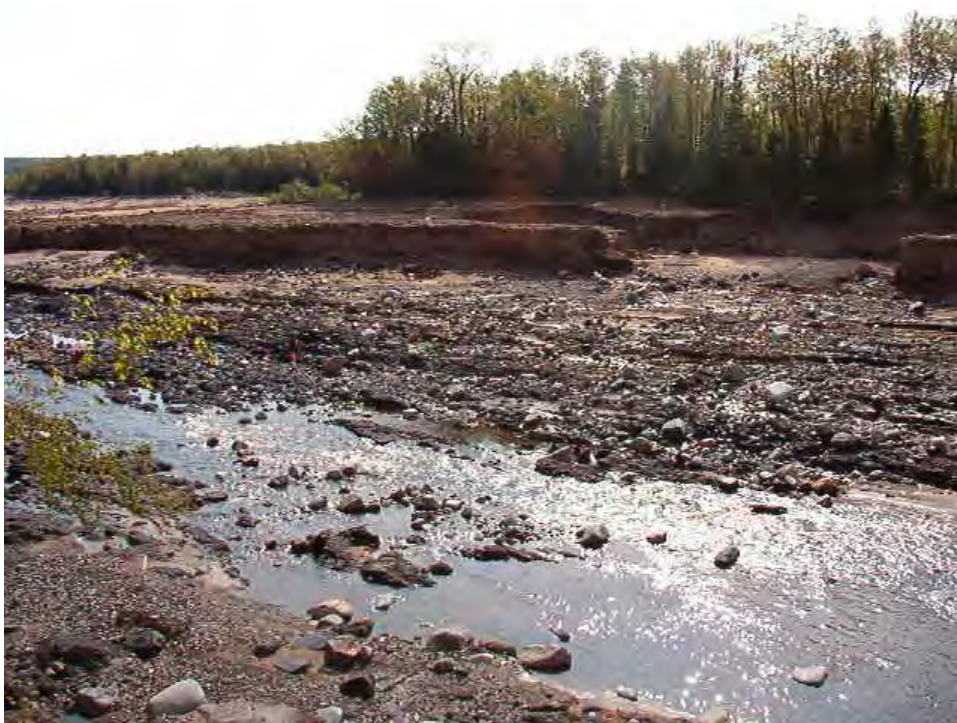
Photograph 4. View of the upstream portion of the channel as viewed from the right abutment near Station 0+35. Photograph taken on June 3, 2003.

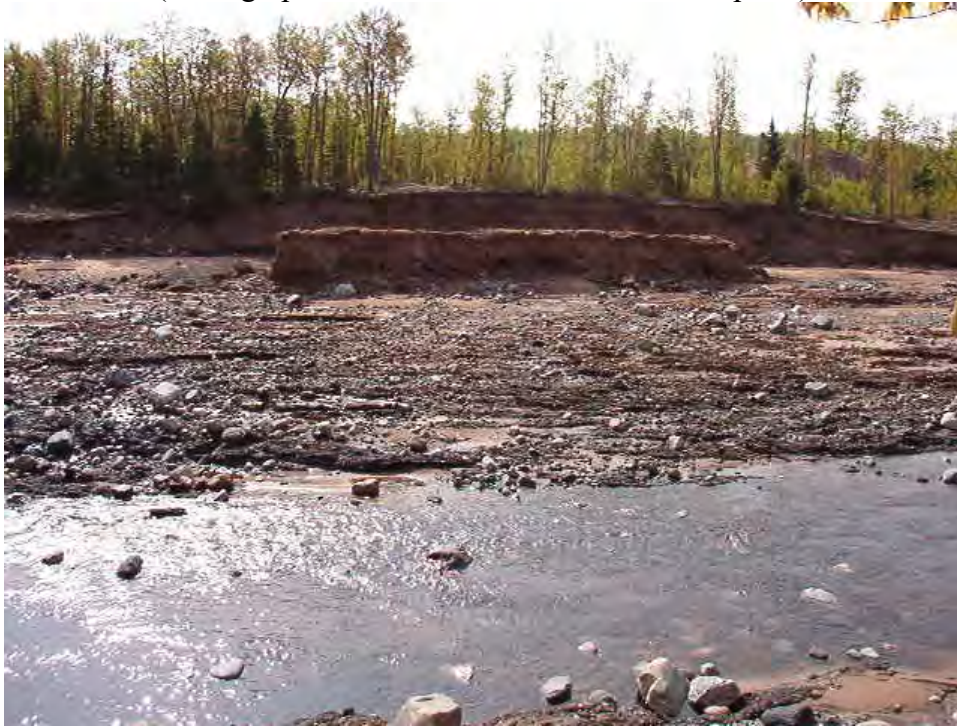
Photograph 5. The left abutment at Station 0+35 where the fuseplug dike was located. According to the STS survey, the top of the remnant section is at elevation 1481 feet. Photograph taken on June 3, 2003.

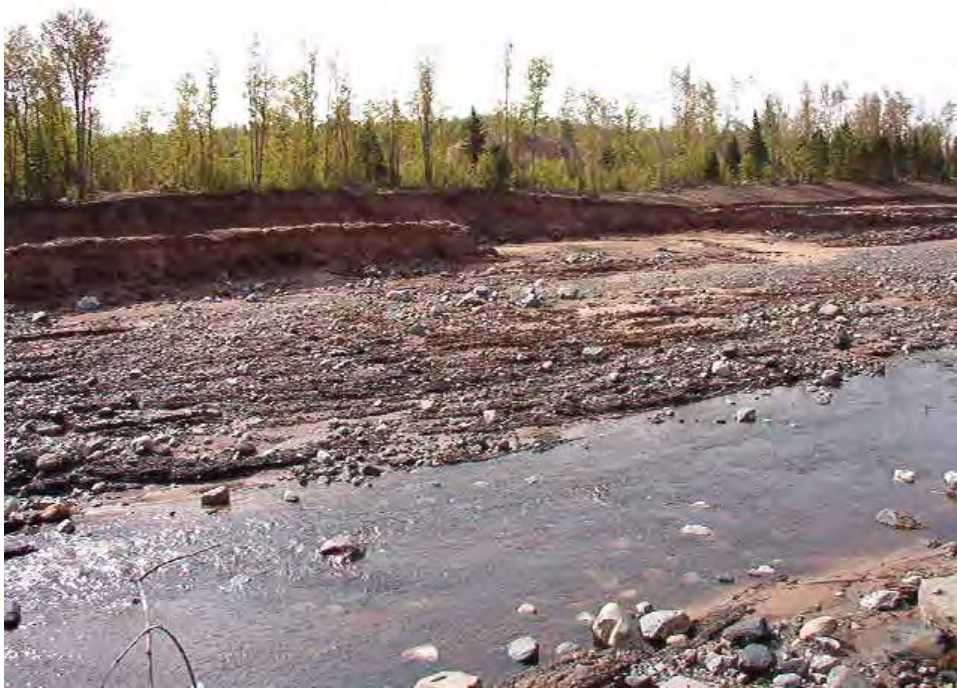
Photograph 6. Downstream portion of the channel as viewed from the right abutment near Station -0+60. Photograph taken on June 3, 2003.

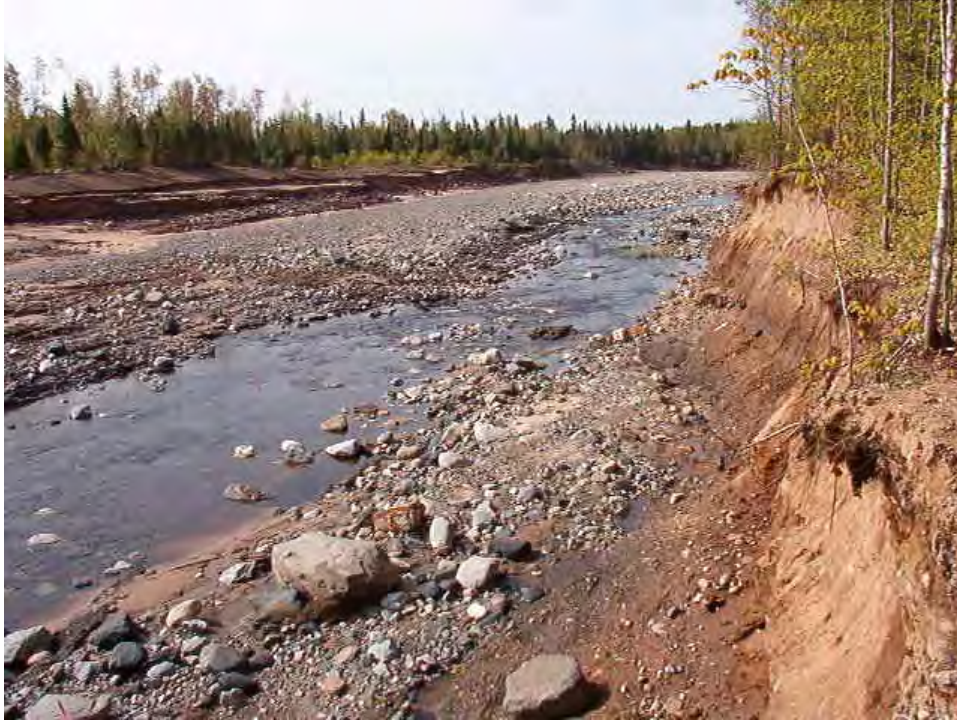
Photograph 7. Downstream channel as viewed from the right abutment near Station -0+60. Photograph taken on June 3, 2003.
