VIII. Fuse Plug Design, Construction and Activation

A. Fuse Plug Design.

B. Fuse Plug Construction.

a) Surficial Geology along the Silver Lake Fuse Plug (Dike No.2) Channel

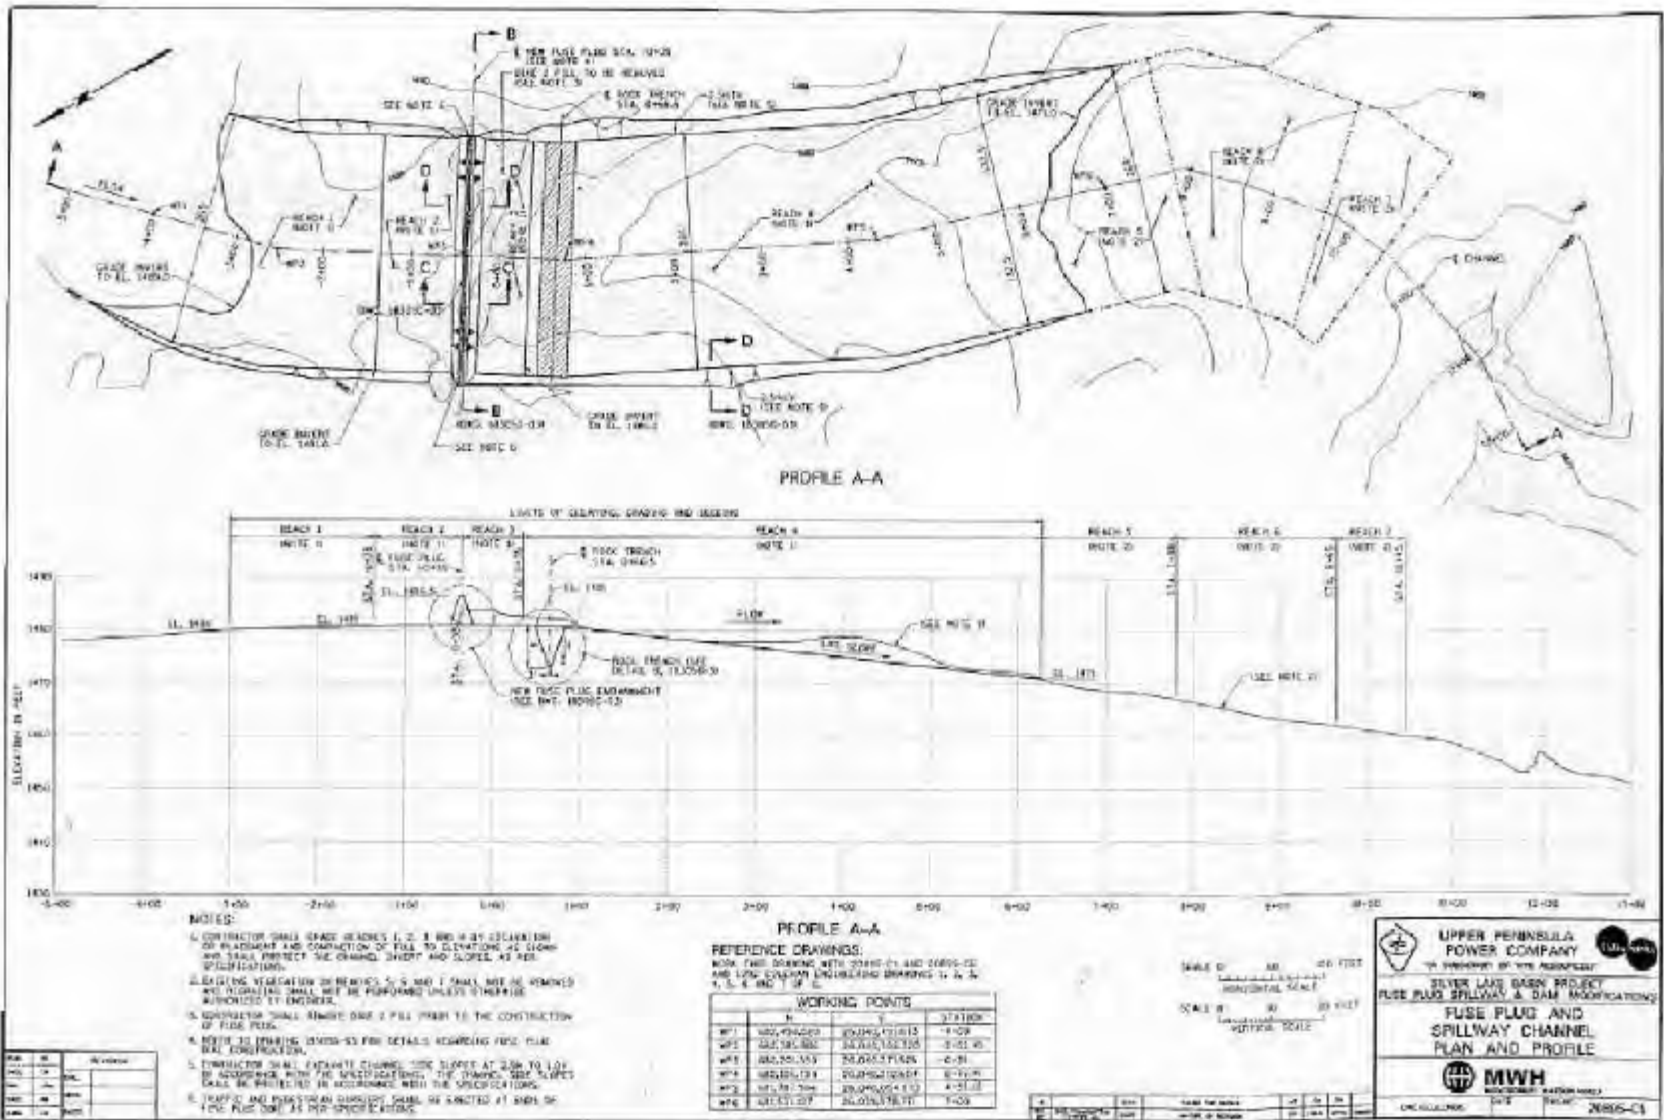
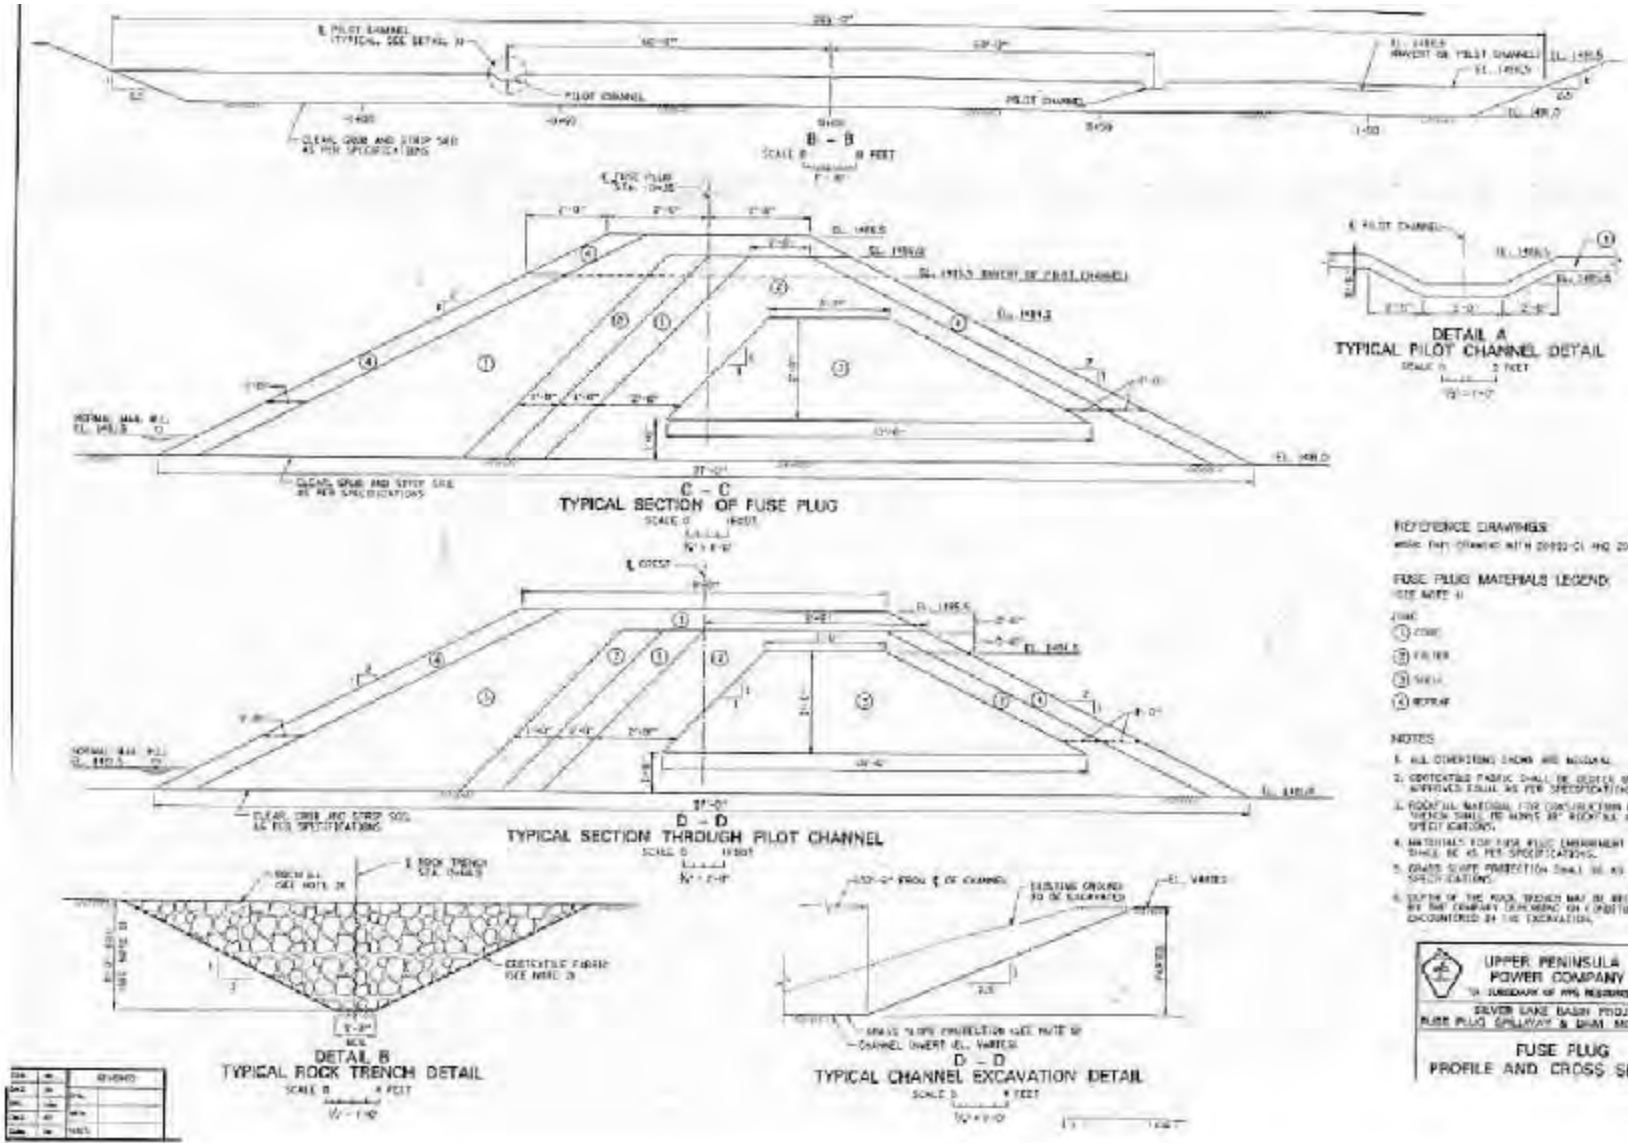
The design plan of the fuse plug, its spillway channel, and profile are shown in MWH drawing 20895-C5. The design cross section of the fuse plug and rock trench section are in MWH drawing 20895-C6.

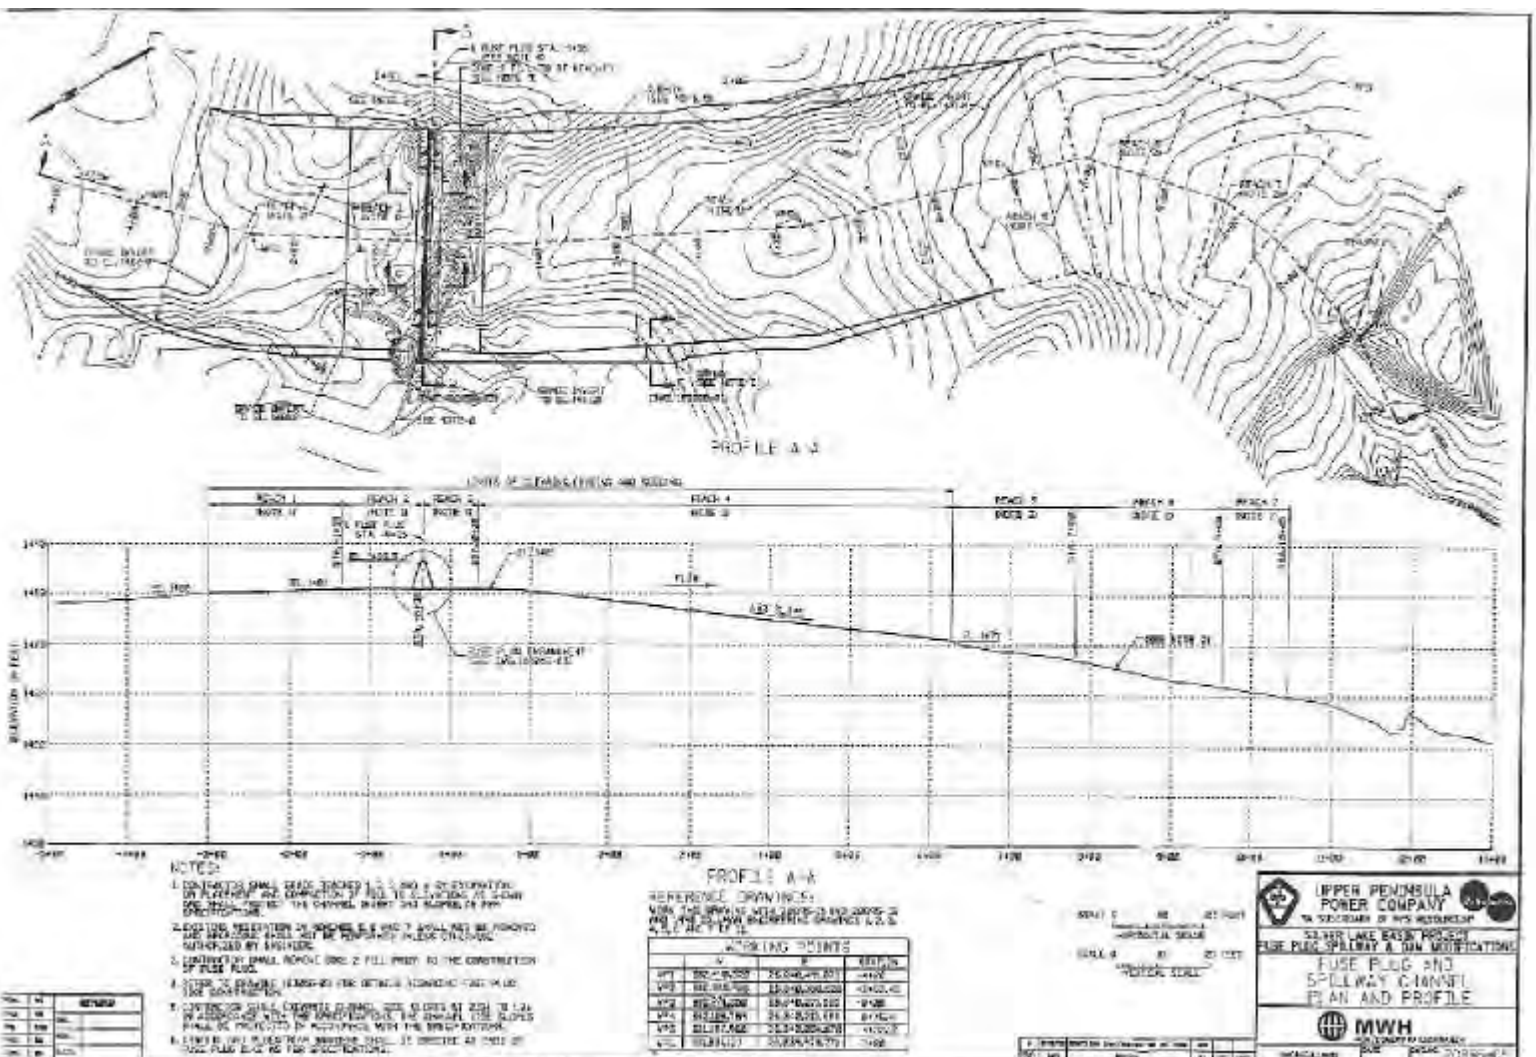
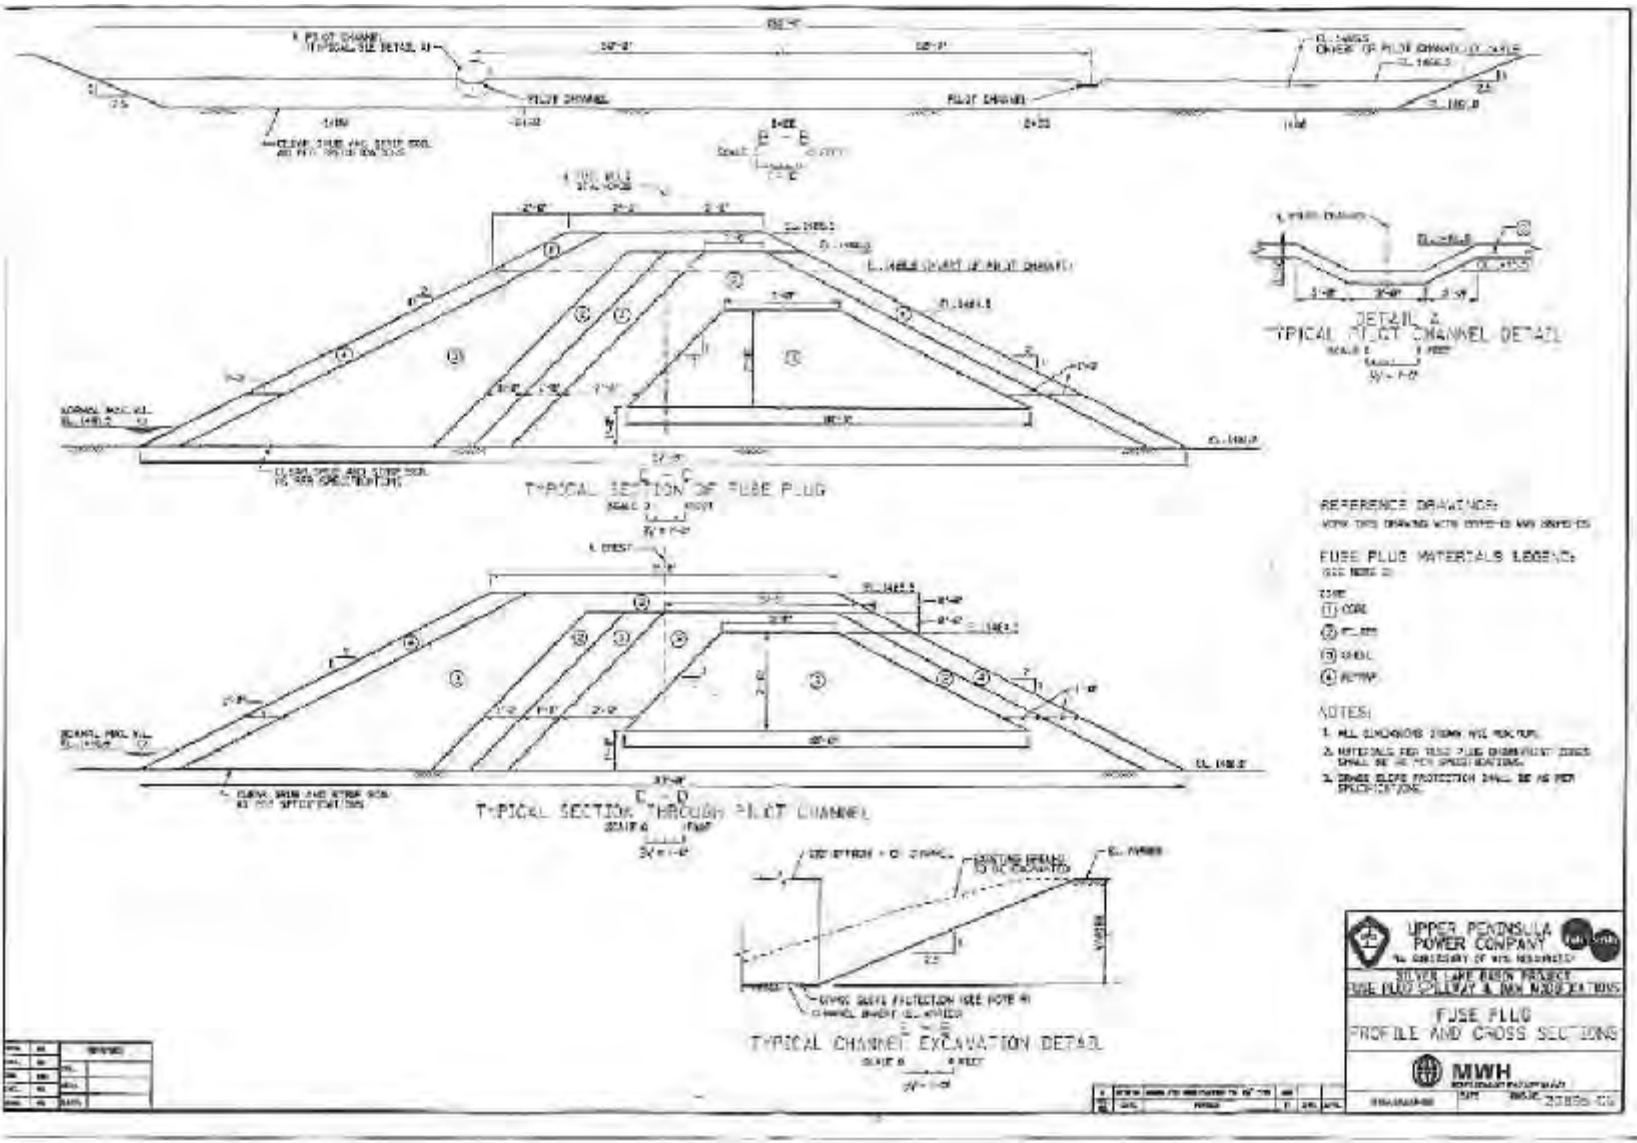
Final Construction Report drawing MWH 20895-C5

Revised MWH drawings 20895-C5 and 20895-C6 reflect the as-built construction of the fuse plug including removal of the rock trench, which was requested several times from MWH before being accepted.

As noted on the design and as-built fuse plug cross section and pilot channel cross section drawings, the top of the design fuse plug is elevation 1486.5 feet and the pilot channel elevation is 1485.5 feet respectively. As-constructed survey of the fuse plug dike indicates the two pilot channels to have invert elevations of 1,485.37 and 1,485.28 feet, approximately 1.5 to 2.6 inches below the design elevation of 1,485.5 feet. When these fuse plug elevations are compared to the elevation of the concrete ogee spillway crest elevation of 1486.25 feet, it becomes obvious that the concrete ogee spillway will no longer be the primary spillway. The fact the fuse plug will erode before the reservoir reaches the concrete ogee spillway crest elevation of 1486.25 feet was not discussed in the Design Report or pointed out in any other documentation that we have found. The design and as-built fuse plug cross sections and pilot channel cross sections indicate that the normal maximum water level will be 1481.5 feet. This elevation is also stated in Section 5.3 Reservoir Level, "The initial water level prior to the PMF event is at the normal maximum operating reservoir level of El. 1481.5 feet." The consultant apparently did not revised the plans and design documents to show that the normal maximum operating level was changed to El. 1482.5 feet per his letter dated September 24, 2001, which was enclosed with the licensee's September 27, 2001 letter to FERC.

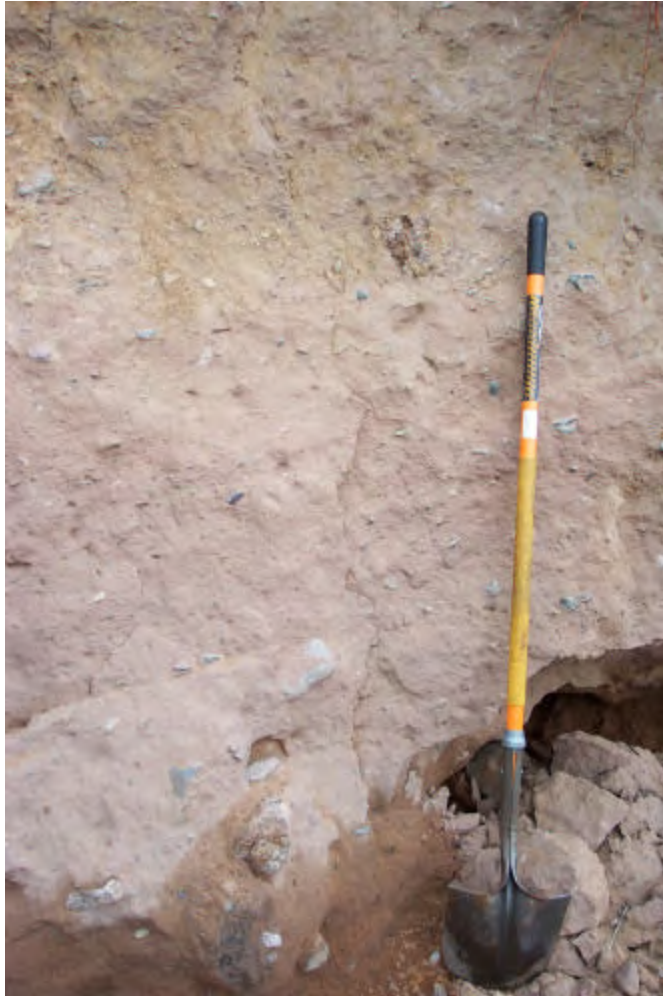
This material is visually classified as “poorly graded sand with silt (SP-SM), with occasional gravel, cobbles and boulders.” It is generally 90% fine to coarse sand and 10% non-plastic fines. Upon exposure to air, it quickly dries out and may contain a minor amount of (carbonate?) weak cementation. It displays properties similar to loess in that it stands vertically but is cohesionless. It has a low dry strength (crushes easily with light finger pressure), rapid dilatancy, low toughness, and is nonplastic. This material contains approximately 10% angular, hard gravel on average about 2 inches in diameter and a trace amount of sub-rounded cobbles and boulders.

Figure 2 Detail of "Coarse-textured glacial till." This material is generally 90% fine to coarse sand and 10% non-plastic fines (SP-SM), with occasional gravel, cobbles and boulders. Note that some faint stratification is present. The stratification and coarse-grained material point to a higher-energy glacial environment, possibly originating closer toward the ice terminus. View is of left channel downstream of former fuse plug.

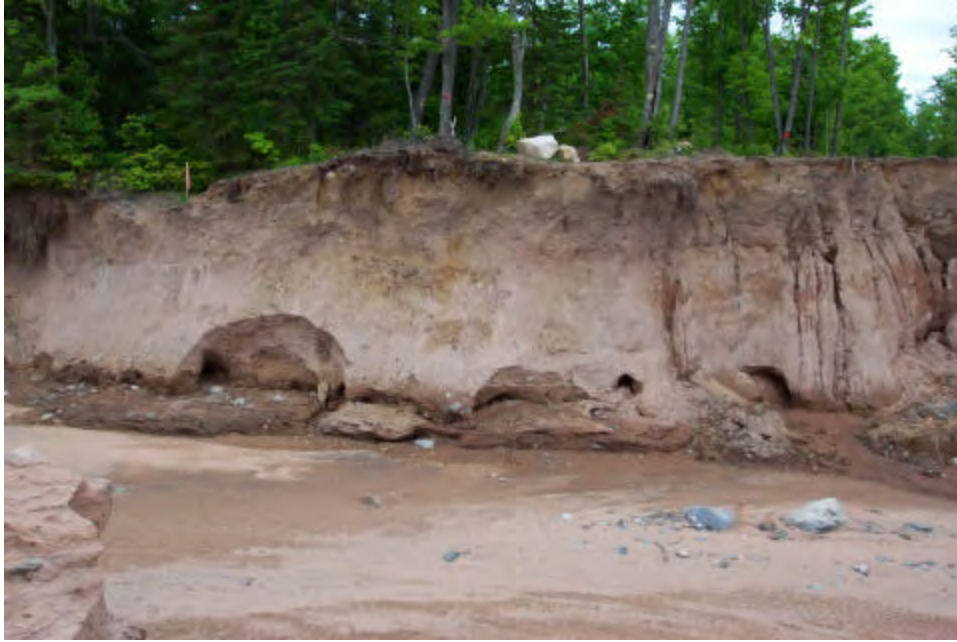
The upper 12- to 18-inches of this deposit is oxidized to a medium to dark brown color, with some organic root material from surface vegetation. The lower 6 feet is unweathered, light tan in color, and is massive to faintly stratified. This material displays an unusual circular erosional characteristic (Figures 2 through 6) at the base of this unit that appears to concentrate immediately above the change in lithology. This erosion may be the result of washing away of silt and/or carbonate cementation.

Figure 3 Overall view of "Coarse-textured glacial till." Note vertical erosional gullies (at right) and circular erosional features near base. Upper horizon is oxidized and contains some roots from surface vegetation. This deposit stands vertically similar to loess. On surface exposures, this material is dry. This unit likely contains weak carbonate cementation, but is a cohesionless soil. View is of left channel downstream of former fuse plug.

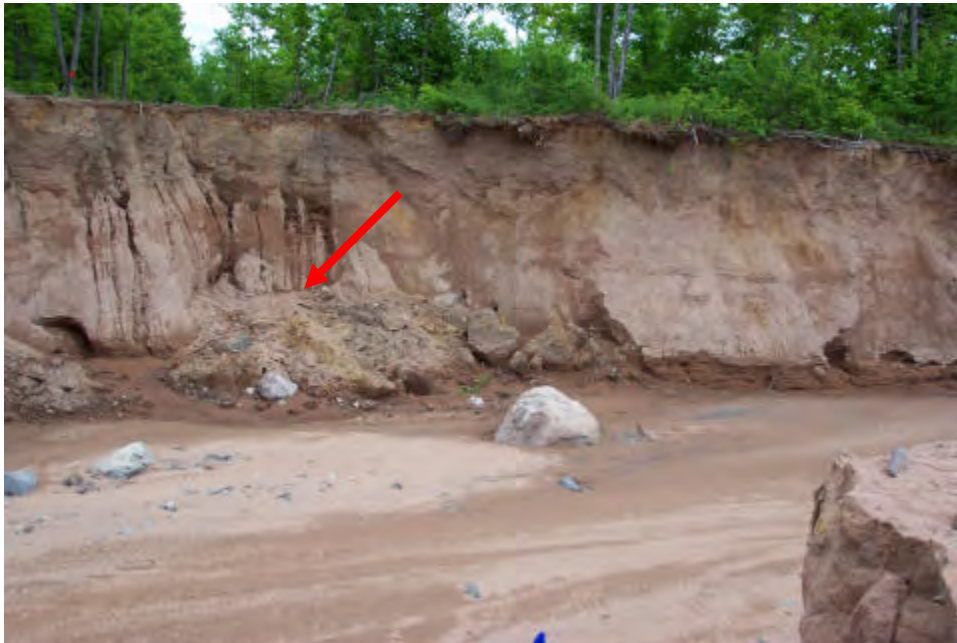
Figure 4 The upper SP-SM unit appears to contain a weak soil structure (weak carbonate cementation?) that when disturbed loses strength and crumbles (pile at arrow). This unit has a low dry strength and is easily broken by light finger pressure. View is of left channel downstream of former fuse plug.

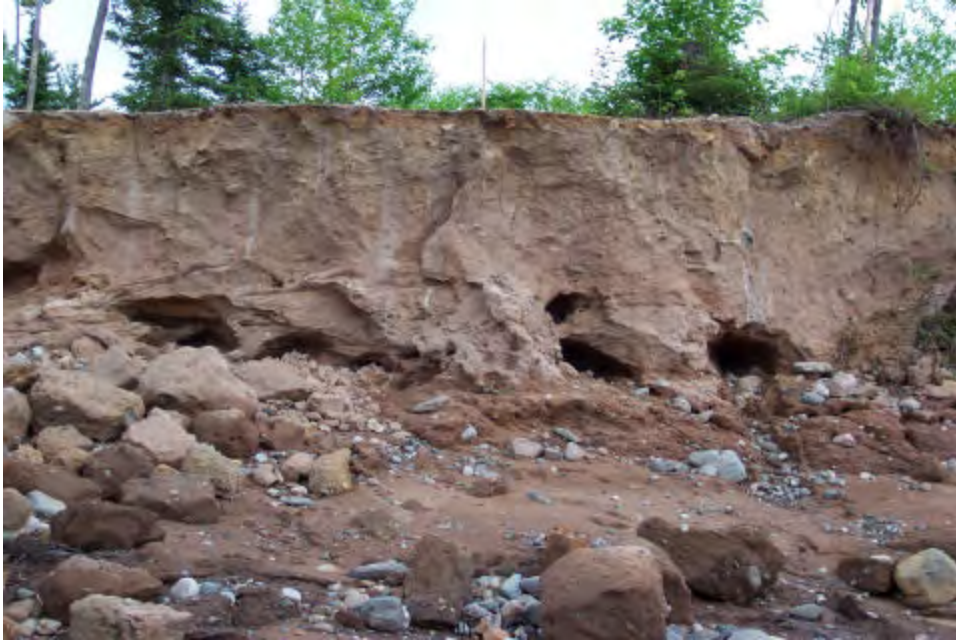
Figure 5 Note the dark brown unit immediately below the circular erosional features. This unit is a fine to medium clean sand (SP), is moist to wet, and contains prominent thin bedding (locally cross-bedded). The circular erosion appears to concentrate immediately above this change in lithology, and may be related to solution of the silt and/or carbonate content of the “coarse-textured glacial till”. View is of left channel downstream of former fuse plug.

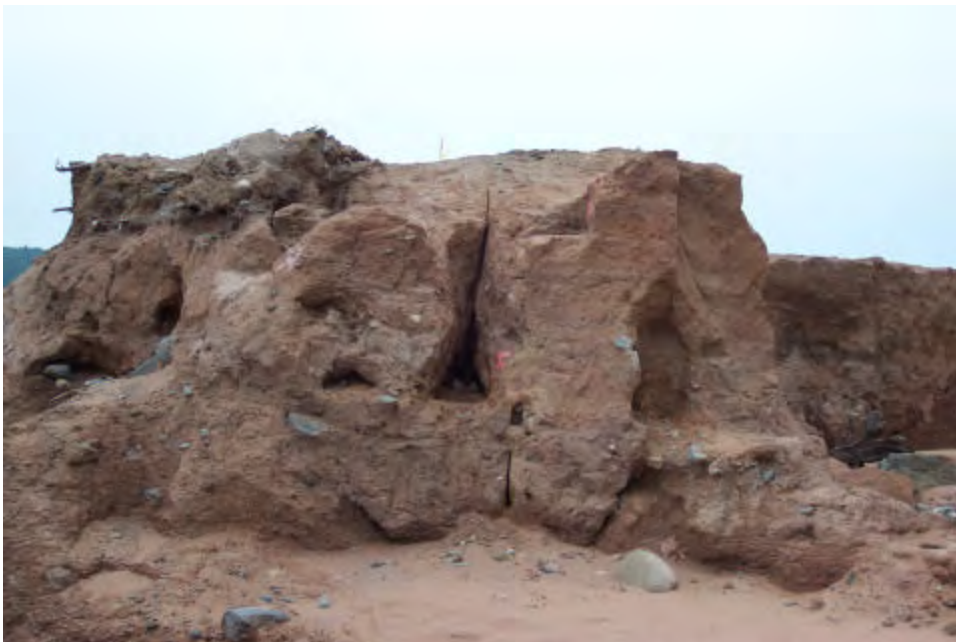
Figure 6 View of similar erosional features as described in Figure 5. Note the association of a vertical fracture with two of these erosional pockets. View is of an “island” remnant downstream of former fuse plug.

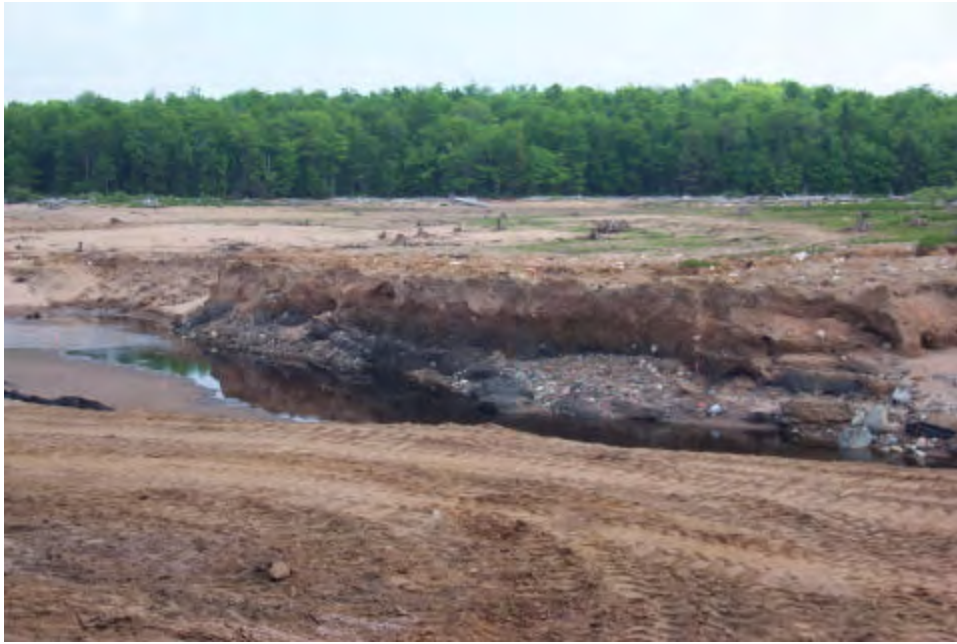
Immediately below the fluvioglacial sands is a dark gray to black deposit that appears to be an organic silt (OL). This unit may represent a swampland or low-lying glacial slough that accumulated large amounts of vegetation during glacial times. Although predominantly fine-grained, it appears to be fibrous, dries rapidly upon exposure to air, and has high to very high dry strength (could not be crushed between fingers and a hard surface). A total exposure of this unit was not observed, but it appears to exceed two feet in thickness. The aerial extent of this deposit is unknown, but it is observed upstream of and along the old alignment of the original Dike No. 2.

Figure 7 Note the dark gray to black unit stratigraphically below the "Coarse-textured glacial till." This deposit appears to be an organic silt (OL) with a very high dry strength and contains a significant fibrous organic content. View is of left channel upstream of former fuse plug.

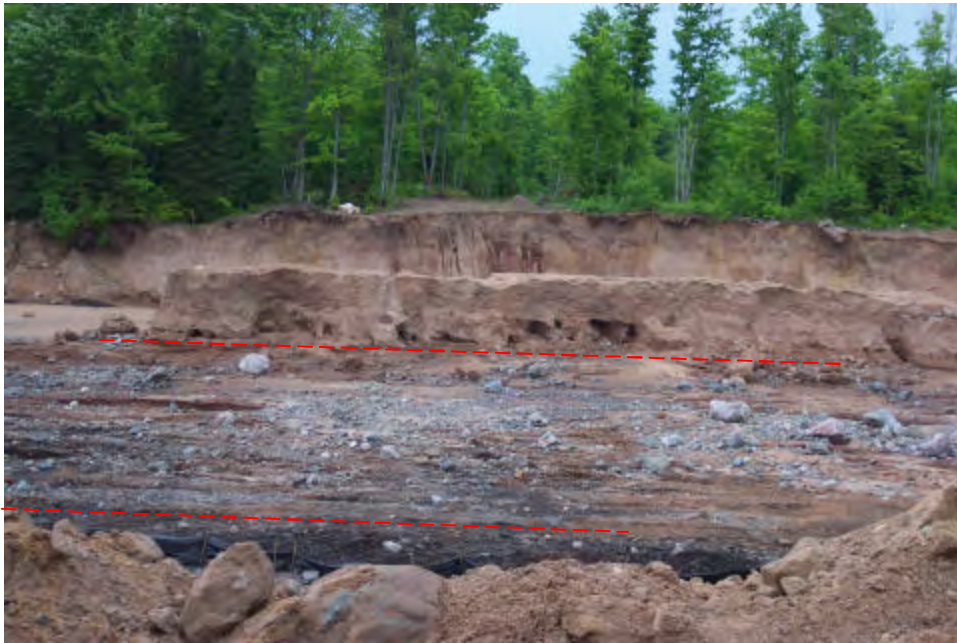
Figure 8 Overall stratigraphy of the area. Note the light-brown, dry SP-SM unit on the far channel wall and erosional remnant within the channel (above upper red line), the dark-brown, moist to wet finely bedded SP unit below the SP-SM unit (between the red lines), and the black organic silt (OL) unit at the base (below lower red line). View is from the right channel wall looking to the left directly along the alignment of the former fuse plug.

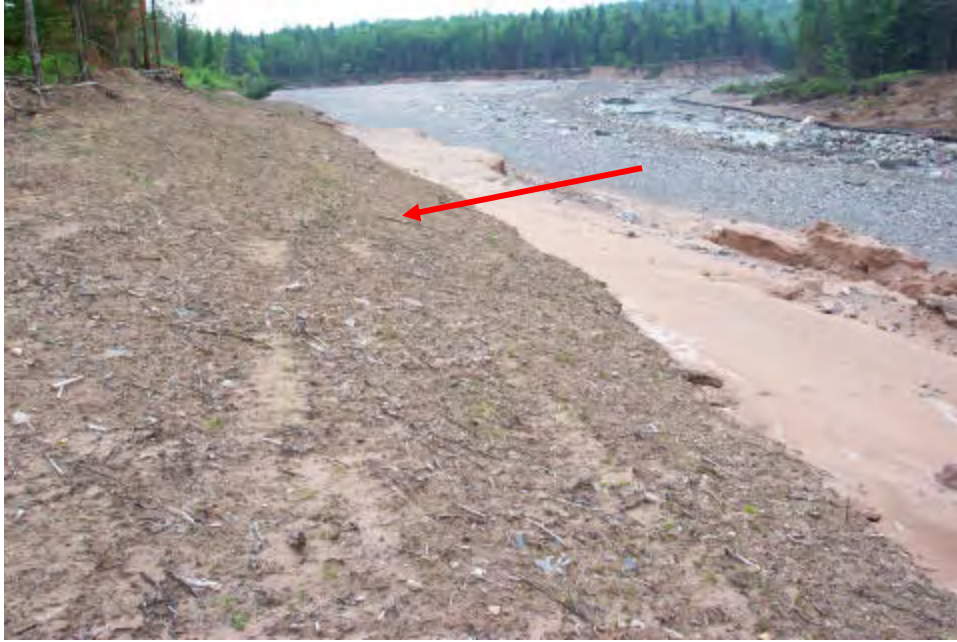
Channel erosion during the Fuse Plug activation cut easily through the un-vegetated coarse-textured glacial till (Figure 9). Much of the sand from this unit appears to have settled out along the inner curve of the Fuse Plug channel, approximately 1,100 feet downstream of the old dike alignment (Figure 10).

Figure 9 Foreground shows the original ground surface of the fuse plug channel. Flood erosion occurred to the right of the line marked by the arrow. Note the coarse-grained cobble and boulder deposition along the channel centerline. View is on left channel downstream of former fuse plug.

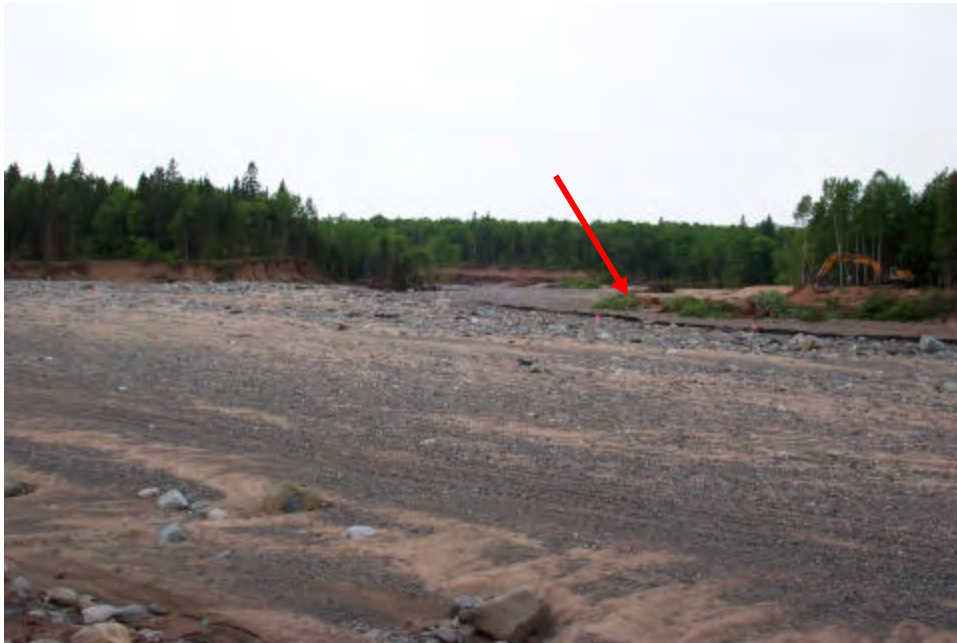
Figure 10 View of channel erosion and flood deposition downstream of former fuse plug. Note the light-colored deposits in the upper right of the photograph (arrow). This shows large amounts of well graded sand that were deposited along an inner bend of the channel alignment, approximately 1,100 feet downstream of the former fuse plug.
