Mechanisms. Based on the high water mark and the as-built survey of the constructed fuse plug, only 1 to 3 inches of flow entered the 3-foot-wide pilot channel. It cannot be concluded with certainty that the fuse plug was activated by overtopping.

e) Channel Erosion. Regardless of what mechanism initiated the fuse plug dike breach, the downstream consequences would have been minor if the channel floor had remained in place with a sill elevation of 1481 msl. Channel erosion allowed the entire reservoir to empty in a relatively short time period.

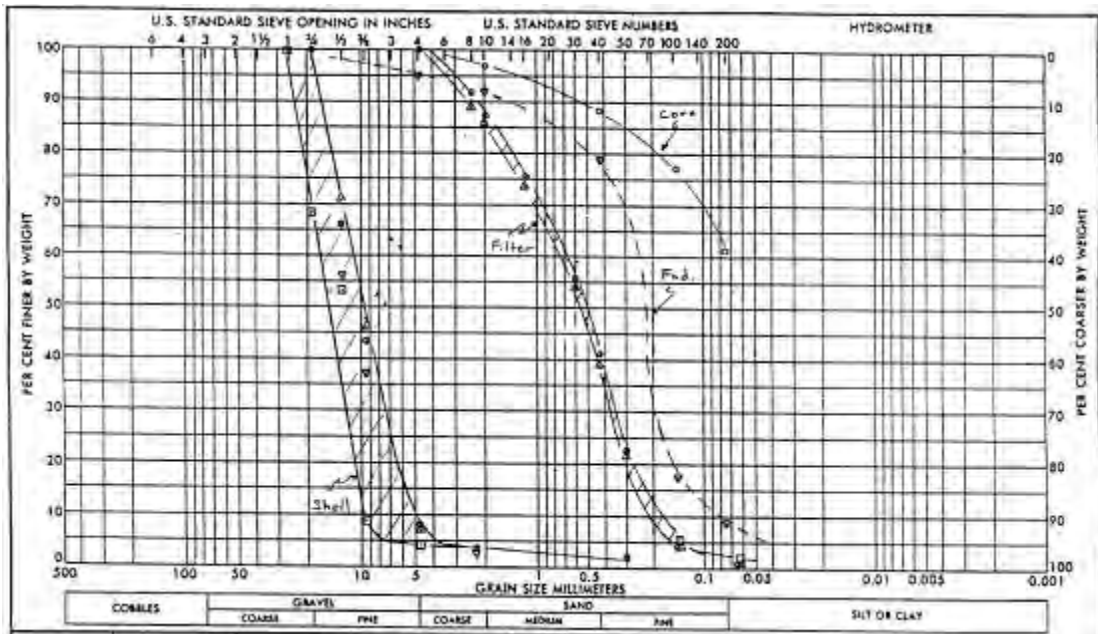
Figure 1, Gradation Curves

The foundation observed in the side walls of the breach includes a stratum of tan loose to medium dense sand from the ground surface to an approximate depth of 8-10 feet. This stratum contains some outwash material, but is primarily weathered till. The repeated freezing and thawing, with the resultant volume increase of in-situ water, is primarily responsible for creating the loose structure from the original dense till. Beneath the surface layer is a zone of tan very dense weathered till approximately 10 feet thick, followed by dark gray very dense unweathered till to great depth. Both of these stratum appeared cemented. The grain size distribution of all till layers appeared to be a slightly silty coarse to fine sand with some gravel, with the most noticeable difference in stratums being the tan coloration of the upper two weathered zones, and the looser density of the uppermost zone. The till was in general void of clayey or plastic fines. When samples of either the dense tan weathered or gray unweathered till were placed in water, they quickly “melted” into a cohesionless mass. During construction, one grain size analysis was performed on material identified as "foundation soil," sample S-10 in the MWH final construction report. This gradation curve is shown on Figure 1.

c) Fuse Plug. The gradation of four zone 2 filter samples, four zone 3 shell samples, and one core sample are also shown on Figure 1. Being processed materials, the filter and shells have relatively narrow gradation bounds, and filter D15/D85 criteria are met as long as segregation does not occur. These criteria are also satisfied between the core/foundation and placed filter. The forthcoming investigation report by STS should include additional gradation curves for the foundation samples, taken from the small island (original graded channel) that remained after the breach.

With regard to other potential failure mechanisms, slope stability and potential piping cannot be positively eliminated. Neither should have been a problem, as long as the foundation was homogenous and less pervious than the overlying filter, as would be the case for the gradation shown on Figure 1. Distinct and drastic gradation changes in the foundation were not observed in the walls of the breach. The potential for non-homogenous conditions in the drag-line pit backfill have already been discussed.

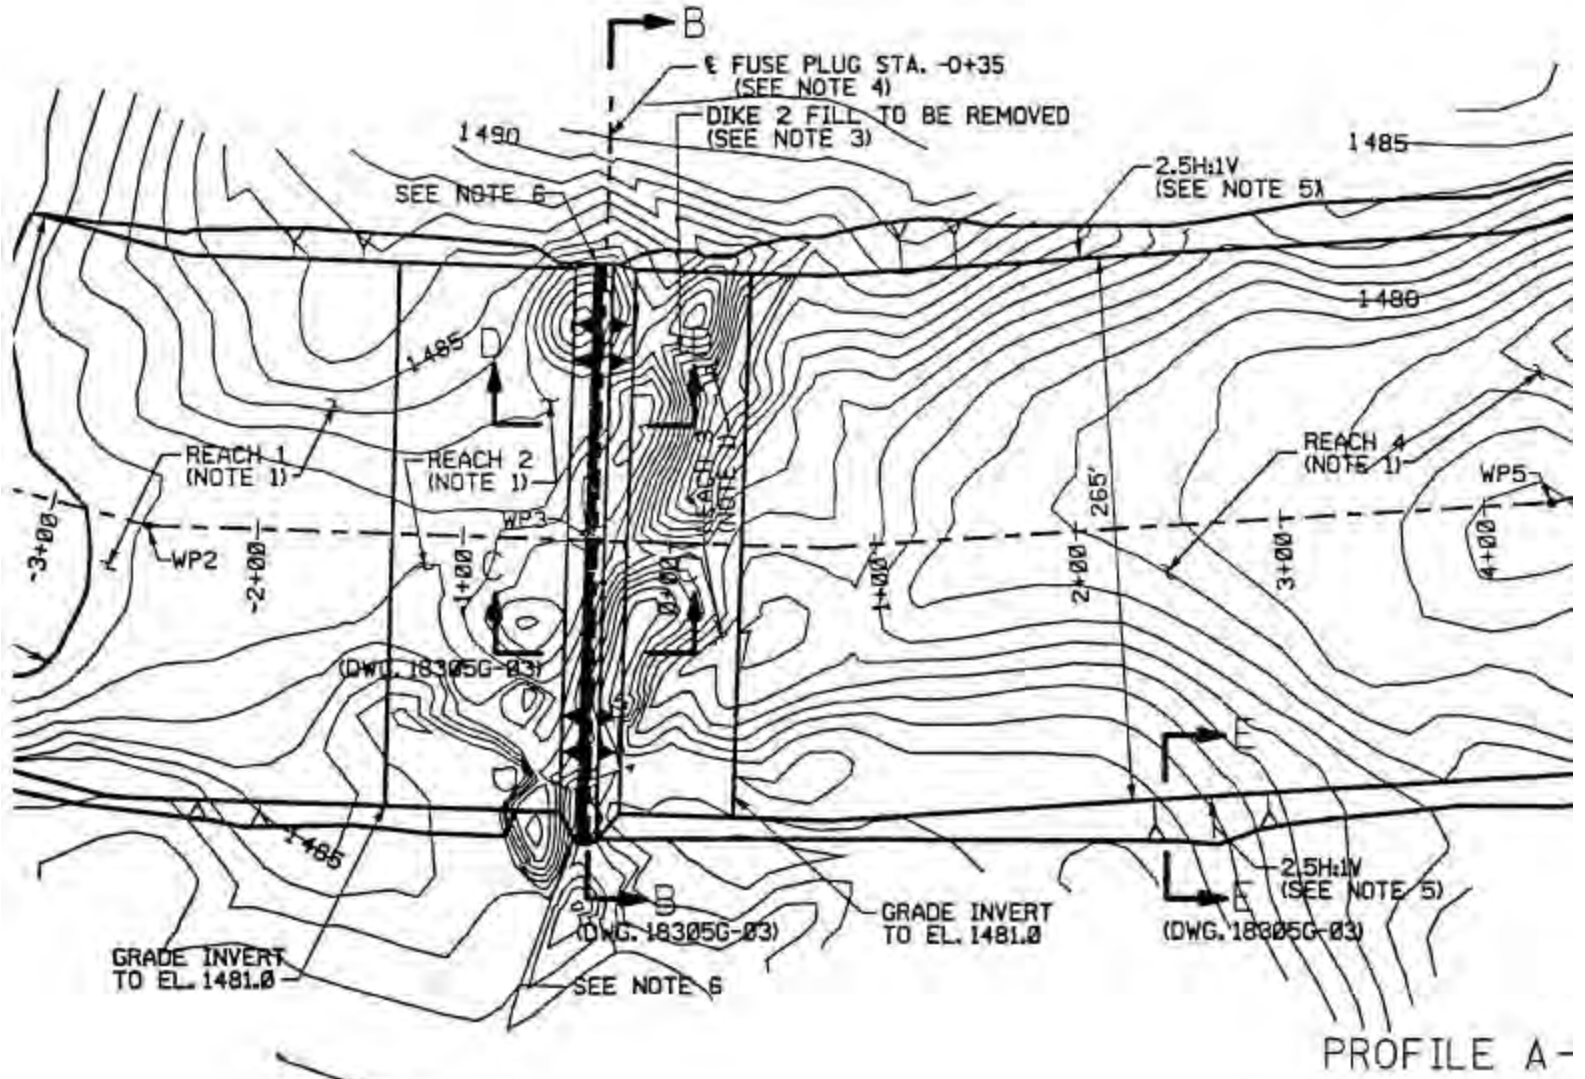
Figure 2, Preconstruction Topography

The original topography shown on the MWH 20895-C5 drawing includes several interesting dike and foundation features, as shown in enlargement on Figure 2. The original dike 2 crest was skewed compared to the constructed fuse plug, and appears to contain two low points in the crest; one at elevation 1484 near the dike centerline, and one at elevation 1486 near the western abutment. These features, if real, would have allowed minor overtopping flows during high water periods in previous years. The topography downstream of dike 2 also suggests small flows and erosion could have been occurring in the past.

Of greater interest to the fuse plug construction are the pits shown upstream of dike 2, in particular the pit near the east abutment. These are drag-line pits and were the borrow source for the original dike construction during the 8-foot-high dam rising in the 1940's. These drag-line pits are shown in photos from operation reports prior to fuse plug construction, and remain visible today at the other dike locations. The large drag-line pit, with bottom elevation 1478, was subsequently overlain by the new fuse plug alignment. It is likely that the 1478 elevation shown includes several feet of muck or washed in soil, and the original pit would have been deeper. The implications of performing muck removal and compaction with backfill having a permeability comparable to the remainder of the foundation are significant, and could represent a foundation weakness for seepage and piping if not properly addressed. Interviews with construction personnel, which have not occurred to date, should address this issue.

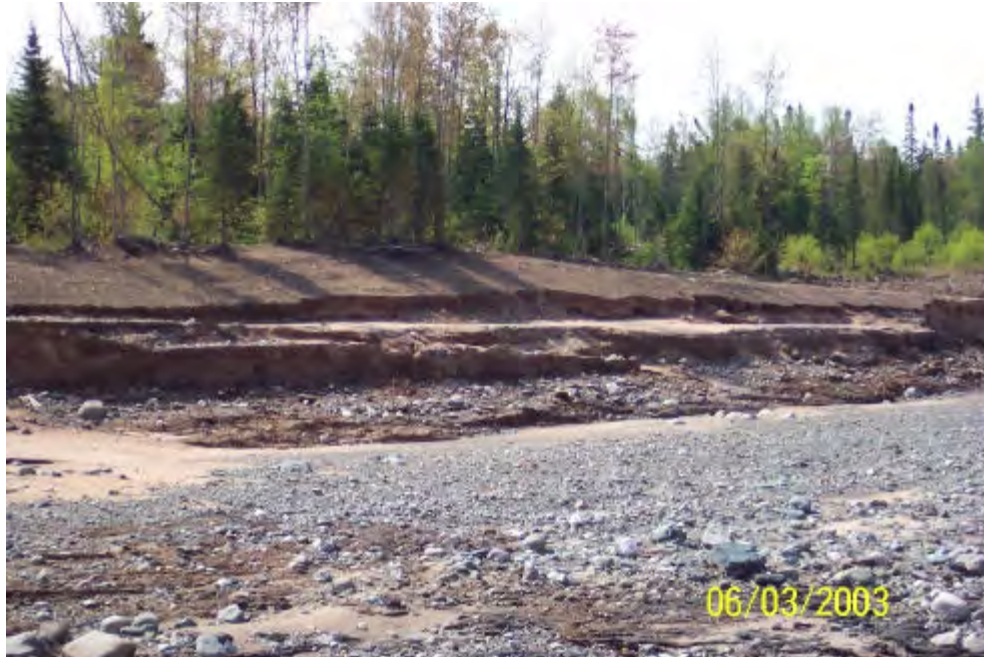
Hydraulic failures involving earth structures typically remove the forensic evidence needed to reconstruct the failure. One aspect is known, i.e., it is conclusive that the final phase of the breach involved channel floor cutting on the right side of the channel, due either to the shorter hydraulic distance of the curving channel or slightly more erodible soils. However, the Silver Lake breach channel may provide other evidence to allow speculation on the sequence of events. The modest left bank erosion along the original channel slope, shown in Photograph 1, indicates moderate flow in this area prior to the major breach and erosion along the right side of the channel. This may indicate that the problem originated near the left abutment. If this interpretation is correct, the previous discussion regarding construction over the left abutment drag-line pit has added credence.

Photo 1. Left bank erosion with remnants of original slope. Upper bench and slope erosion indicates level of initial flow

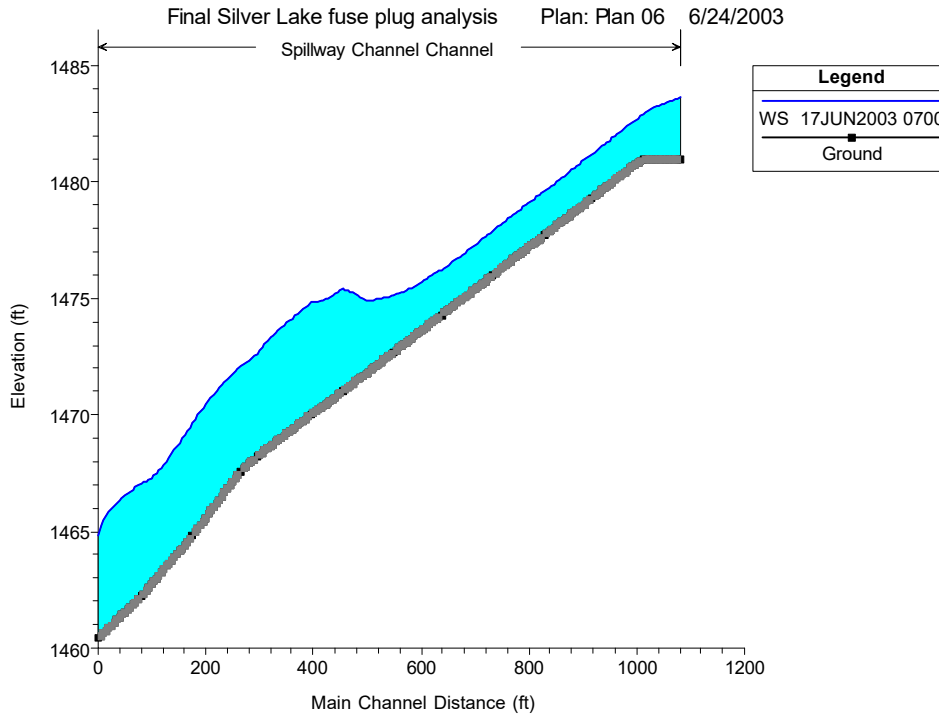
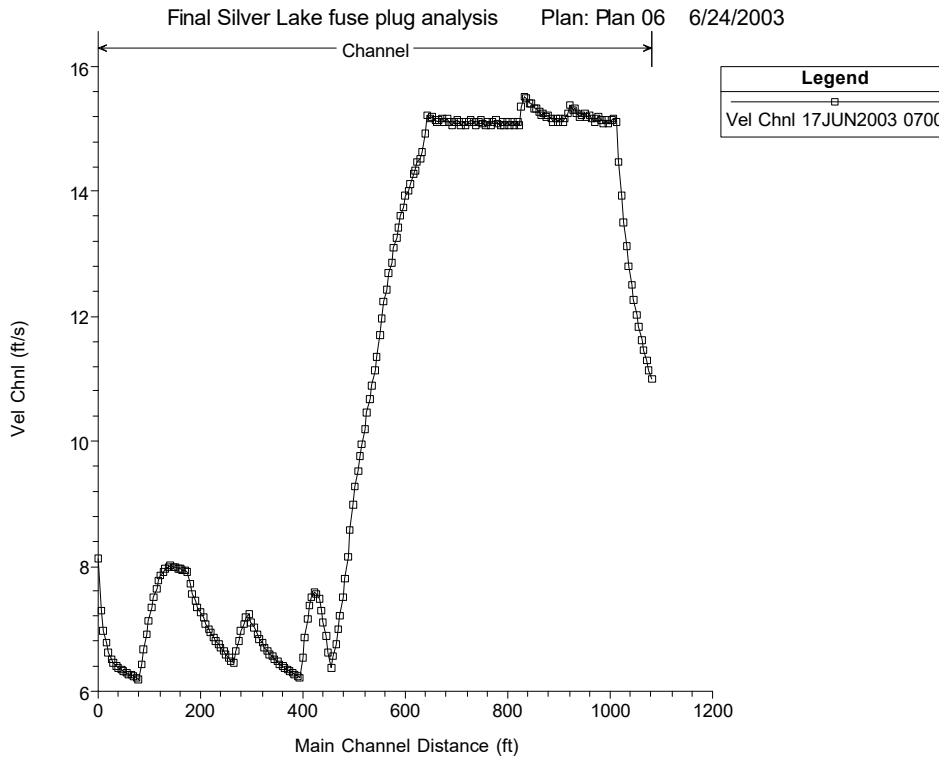
Similar analyses were conducted for peak flows during the breach at the reservoir high water mark of 1485.6, assuming the channel floor did not erode, as shown in Figures 3 and 4. Figure 3 models the earth channel without grass, which was the existing condition during the breach. Calculated velocities over 15 fps occur for much of the exit channel. If the grass had been established, the calculated velocities would have been around 10 fps, as shown in Figure 4. With or without grass, it appears the channel floor was susceptible to erosion.

MAX. WATER SURFACE ELEVATION – Flow: 7,750 cfs  
Uniform channel section n=0.02

MAX. CHANNEL VELOCITIES – Flow: 7,750 cfs  
Uniform channel section n=0.02

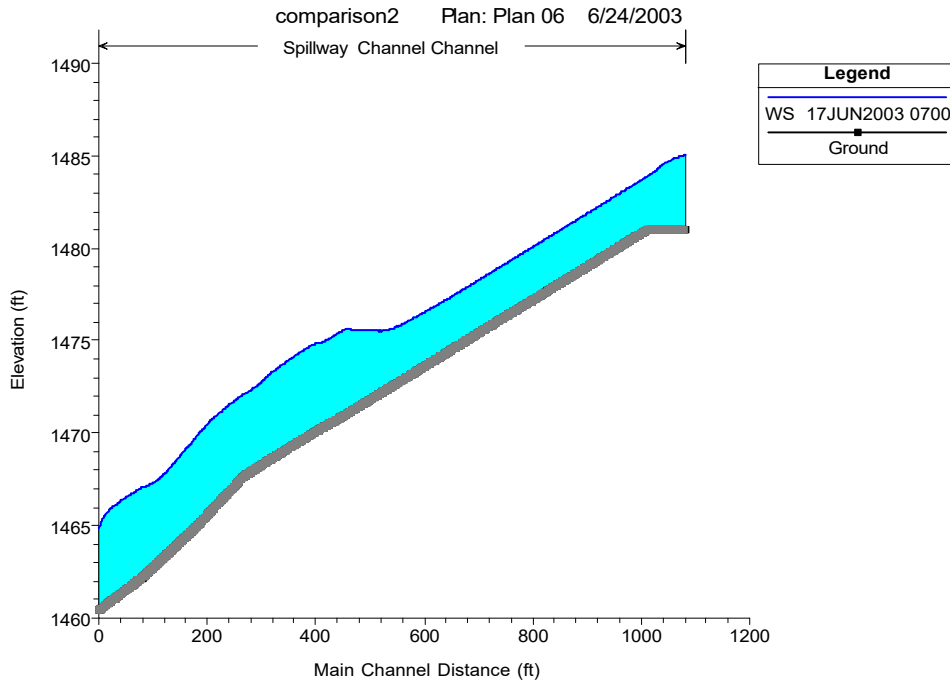
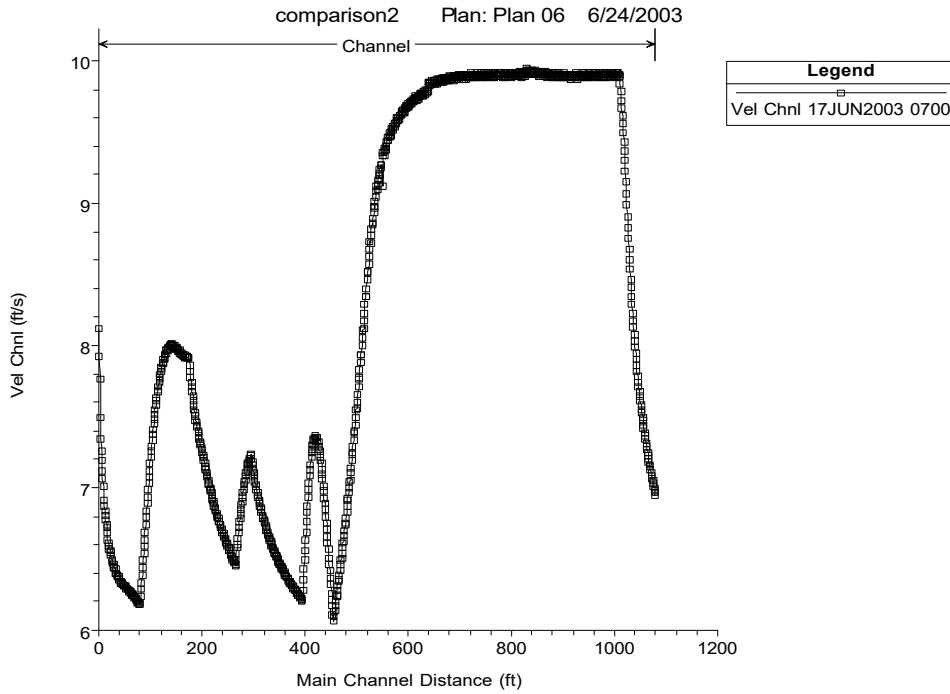
Figure 4

MAX. WATER SURFACE ELEVATION – Flow: 7,750 cfs  
Revised model with uniform channel section n=0.04

MAX. CHANNEL VELOCITIES – Flow: 7,750 cfs  
Revised model with uniform channel section n=0.04
