P-10855

Re: Report No. 2
FERC Independent Consultants Review Panel
Silver Lake Dam

REPORT NO. 2
FERC INDEPENDENT CONSULTANTS REVIEW PANEL
SILVER LAKE DAM

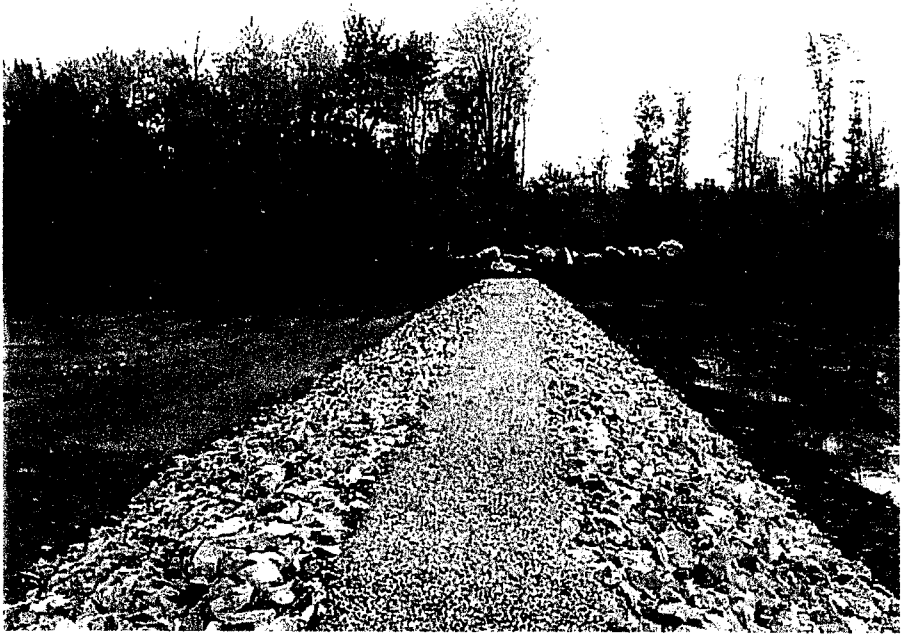
Fuse plug embankment at end of construction, October 8, 2002

Pilot channel across fuse plug embankment, October 8, 2002

Figure 2.3.3-1 Fuse plug embankment during post-construction inspection

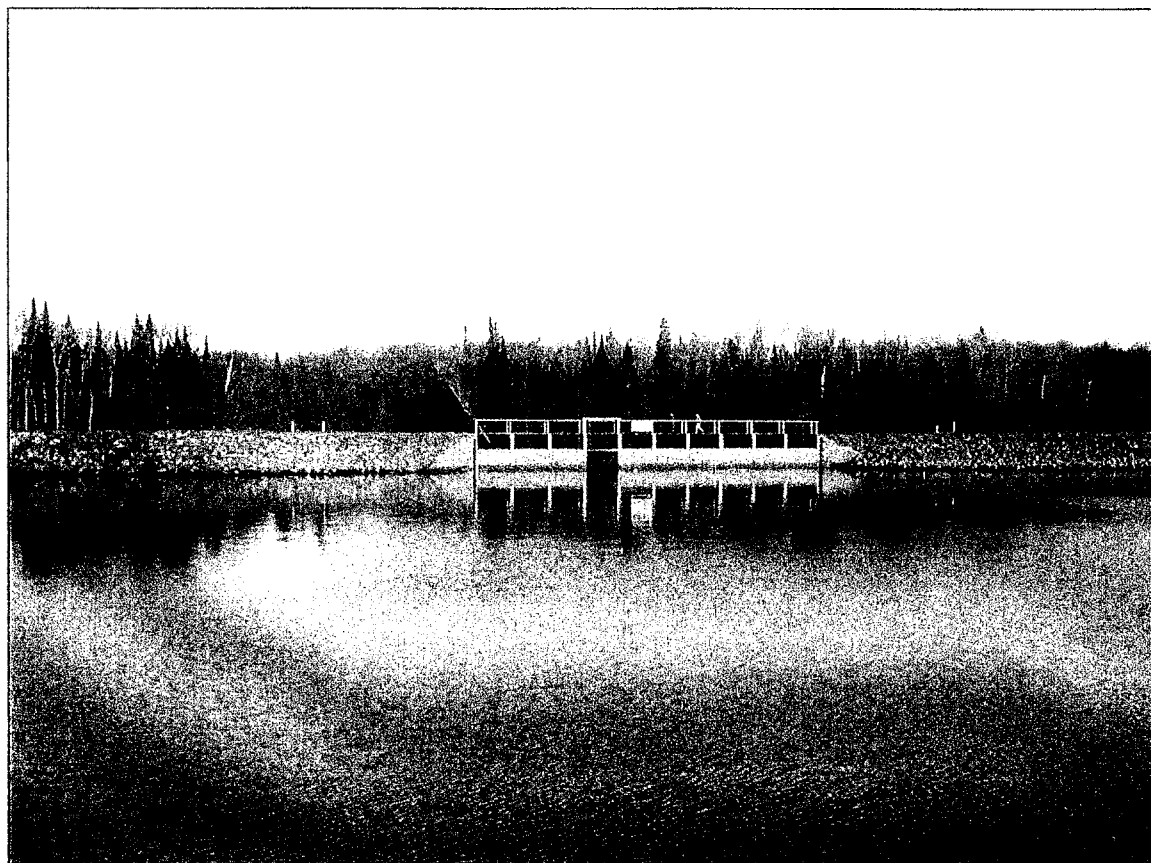
Figure 3.6.2-2 Upstream side of concrete spillway at about 8:30 PM, May 14, 2003

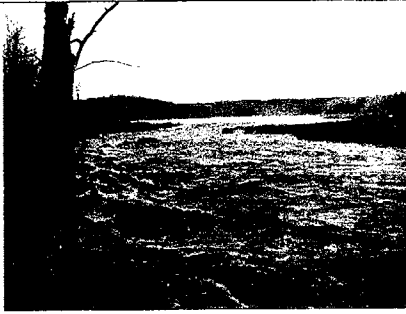
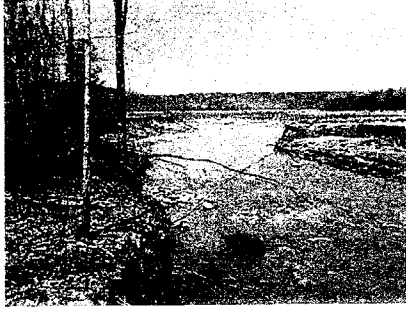
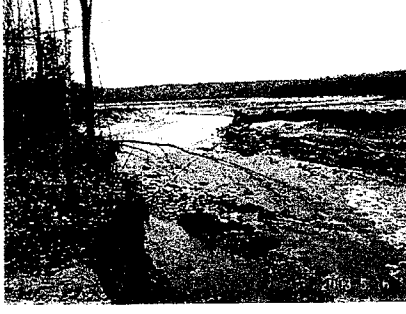
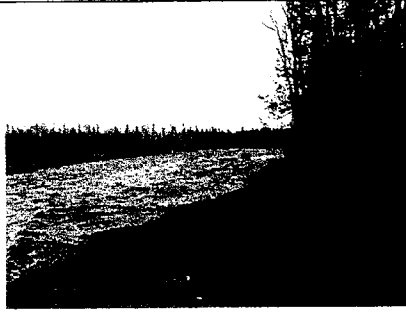
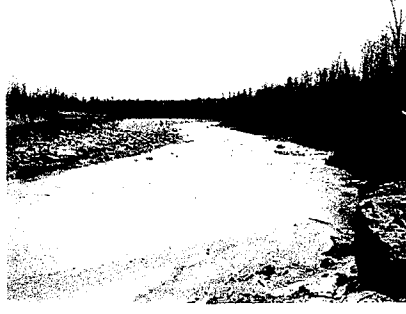
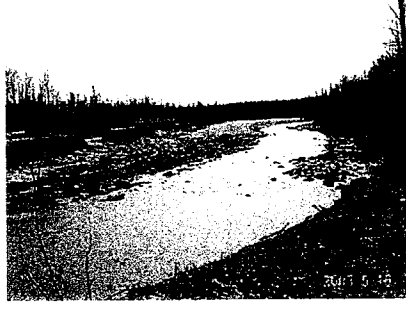
Upstream, October 8, 2002 (during post-construction inspection)	Upstream, May 14, 2003, about 8:30 PM (operator photo)	Upstream, May 15, 2003 (Spicer photo)	Upstream, May 16, 2003 (Evans photo)

Downstream, October 8, 2002 (during post-construction inspection)	Downstream, May 14, 2003, about 8:30 PM (operator photo)	Downstream, May 15, 2003 (Spicer photo)	Downstream, May 16, 2003 (Evans photo)

Figure 3.6.4-1 Photographs upstream and downstream from fuse plug embankment on October 8, 2002 at the end of construction, and on May 14; May 15; and May 16; 2003, showing progressively deepening erosion

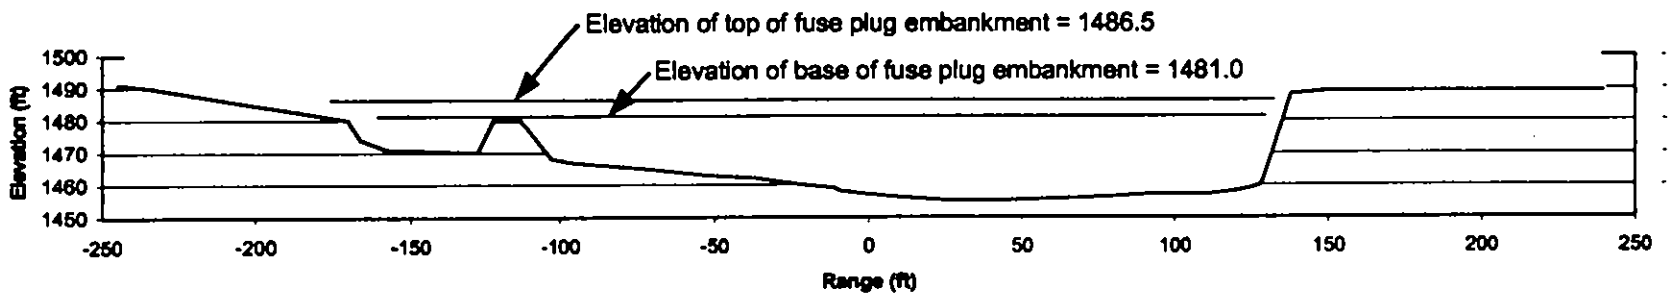
Figure 3.6.4-2 Cross section through eroded channel at STS Station 27+00, near fuse plug axis

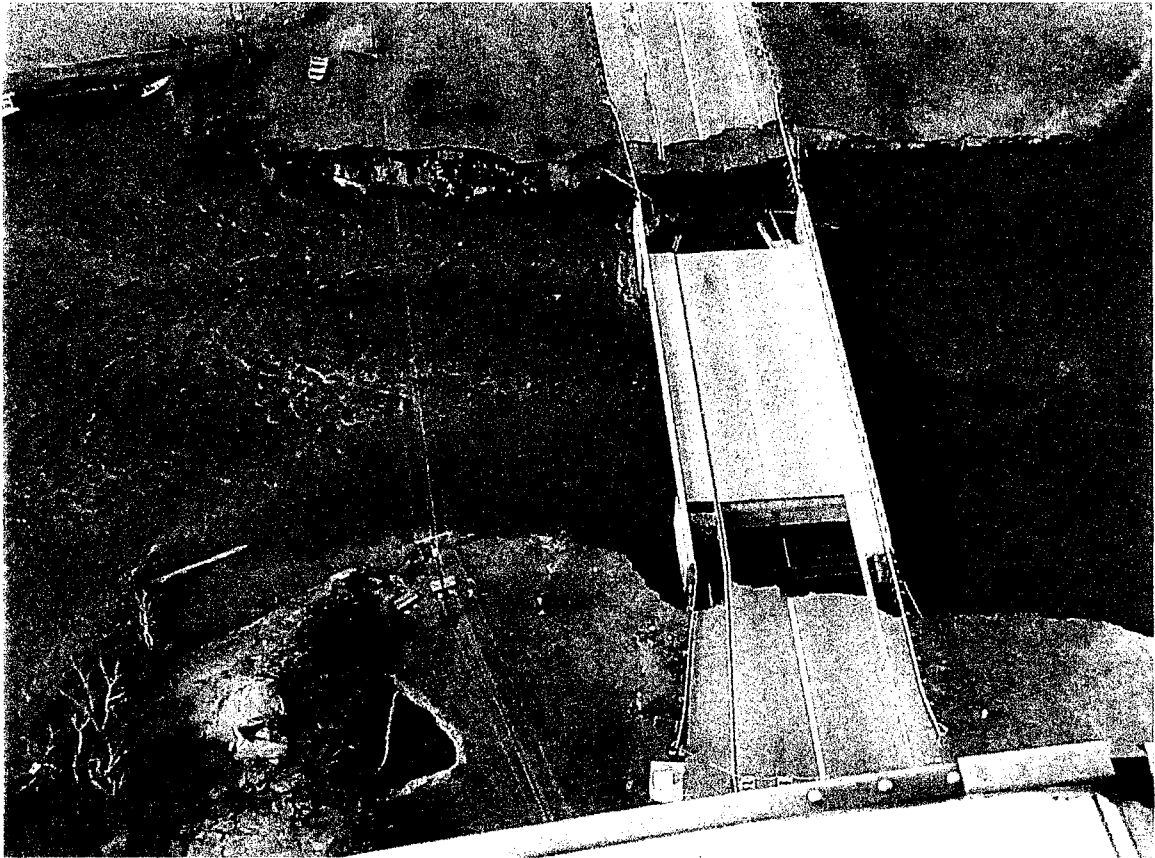
Several railroad and highway bridges suffered damage to foundations or abutments that rendered them unusable. One of the damaged highway bridges is shown in Figure 3.6.5-1. More than 1,700 people were evacuated from an area of about 485 acres (195 ha) in the city of Marquette from 8:45 AM on May 15 through 1:00 PM on May 16.

Figure 3.6.5-1 Bridge at mouth of Dead River after fuse plug breach
