Area A Recovery Work on Upper Dead River

The project consisted of dredging sediment from the first 1,166 feet of river channel downstream of the AAO Bridge, installing a two-tier cross-vane, and installing one riffle.

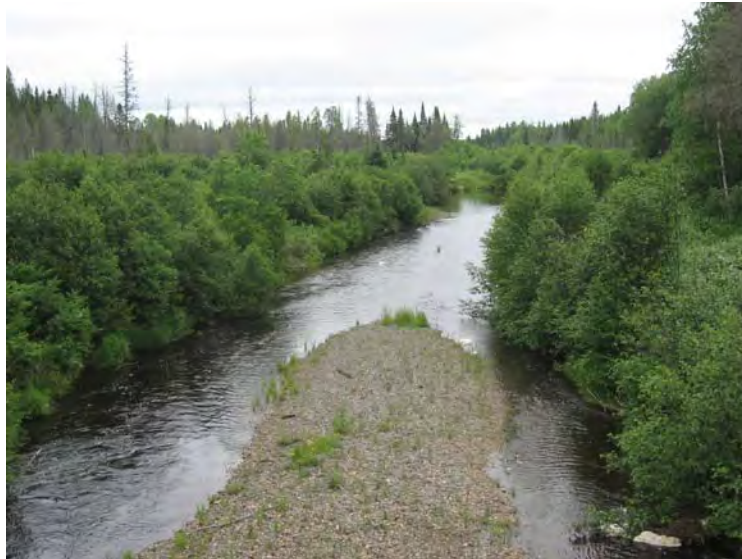
The picture below illustrates how the river began to move sediment downstream, but it did not have the stream power to move all of it. As a result, the water flowed along the banks of the stream and a middle channel bar was formed.

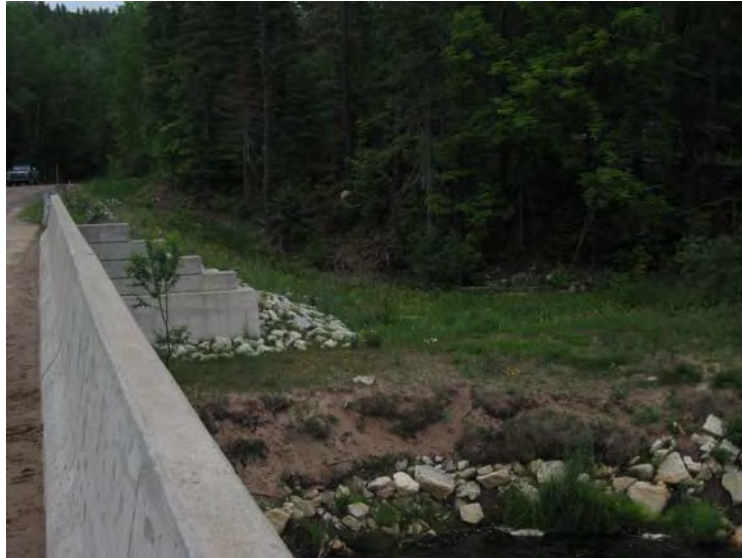
When the mid-channel bar forms, it puts additional stress on the banks and they begin to erode as evidenced in the photo below.

In addition to dredging a channel down the middle, a two-step cross-vane was installed to direct the stream channel down the middle. The two-step cross-vane reduces the stress on the banks, deepens the channel, and keeps the deep channel from attempting to move upstream. A two-step cross-vane was used in this situation because the channel in this area is very deep. Too great of a drop on the cross-vane can undermine it and cause it to fall into the hole created by the water passing over the cross-vane.

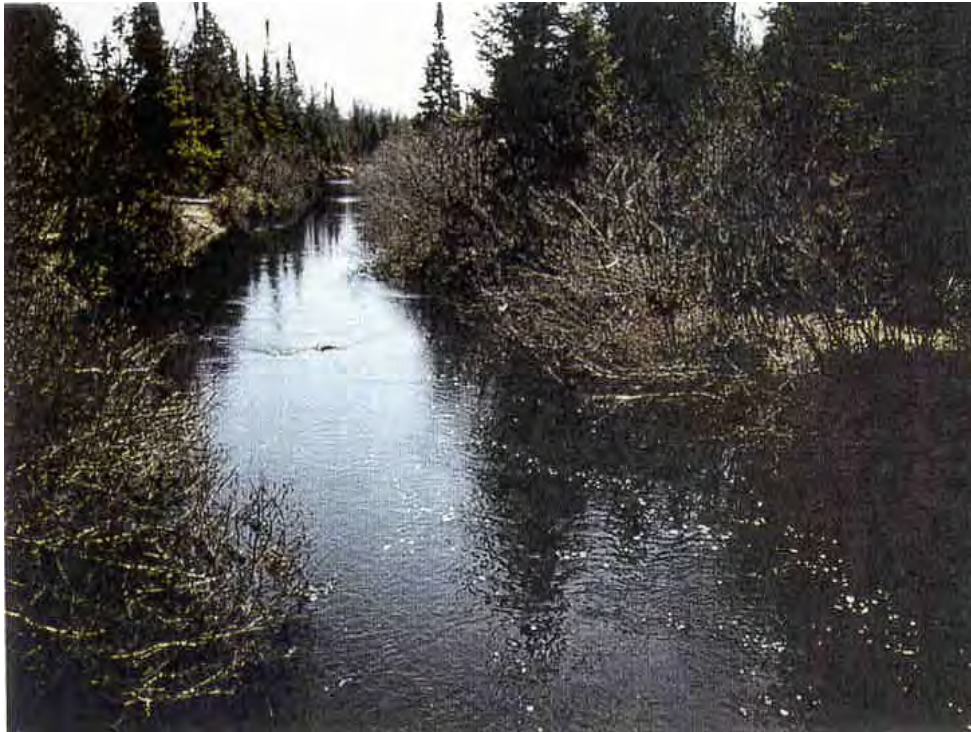
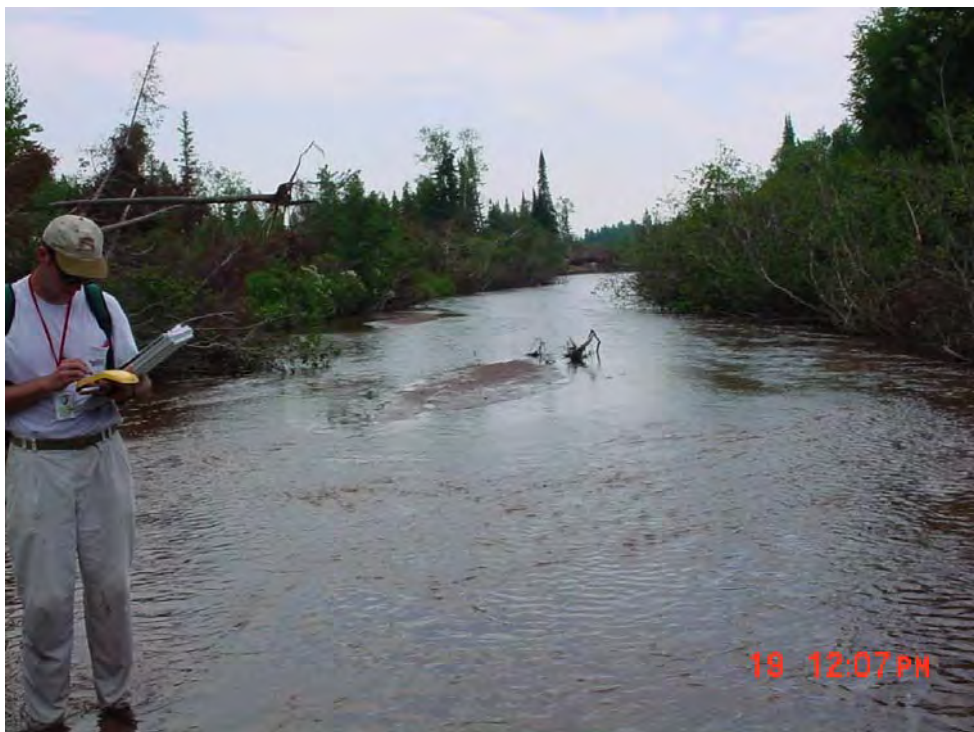
UPPCO has been monitoring this section of river since 2003. During the 2003 event, this stretch of river received large flows and large amounts of sediment, but the banks were not impacted. Only the stream channel was filled with sediment. It was expected that the sediment would continue to move downstream and the channel would recover on its own. However, in 2008, it was determined that it was not recovering at an acceptable rate and additional recovery work would be required.

The two following pictures show the river before 2003 and after the event in 2003.

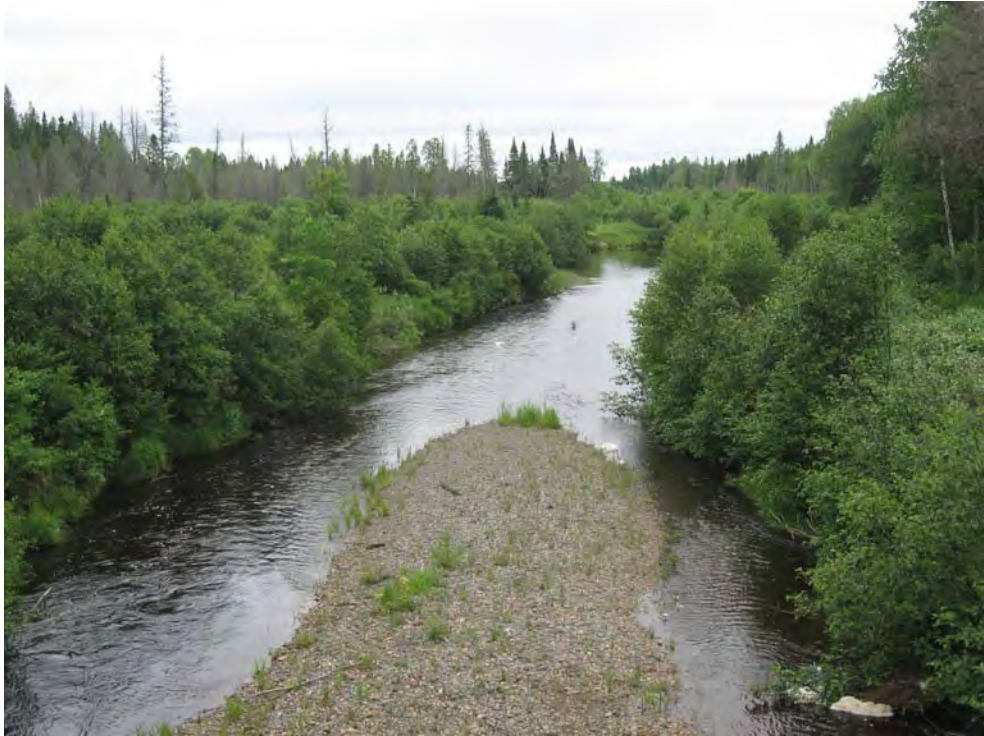
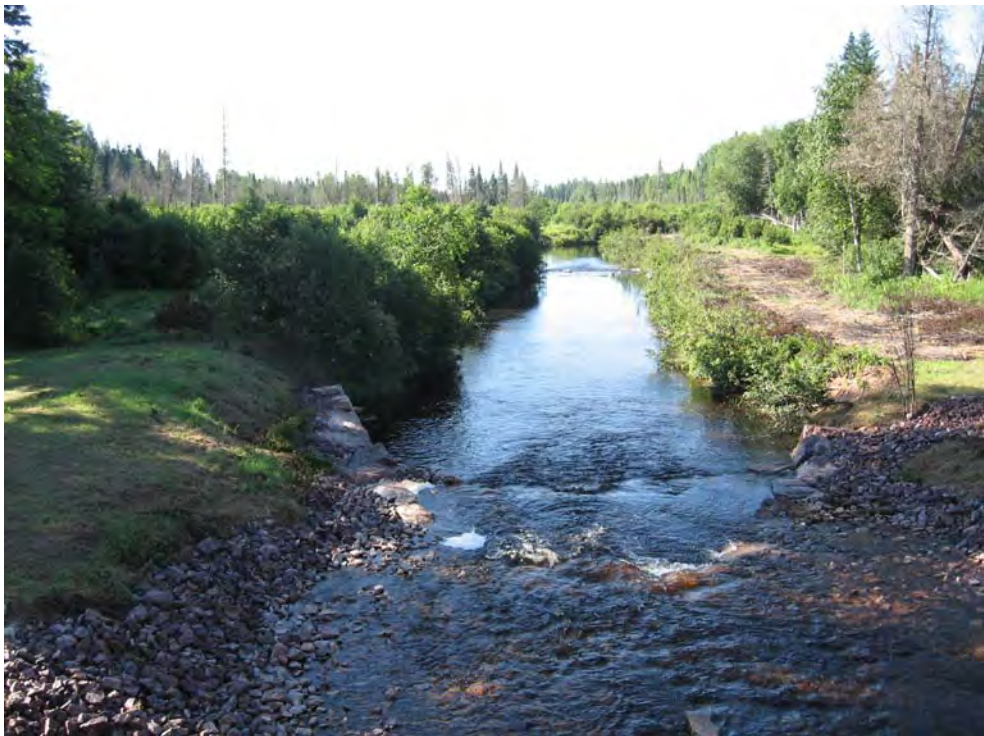
The two following pictures show the area before the 2010 work and after the 2010 work.
