Upper Peninsula Power Company

McClure Penstock Revegetation Report: The McClure Penstock Replacement Project as part of the Dead River Hydroelectric Project (FERC Project No. 10855)

**UPPCO – McClure Penstock Replacement
Revegetation Monitoring
Photo Log**

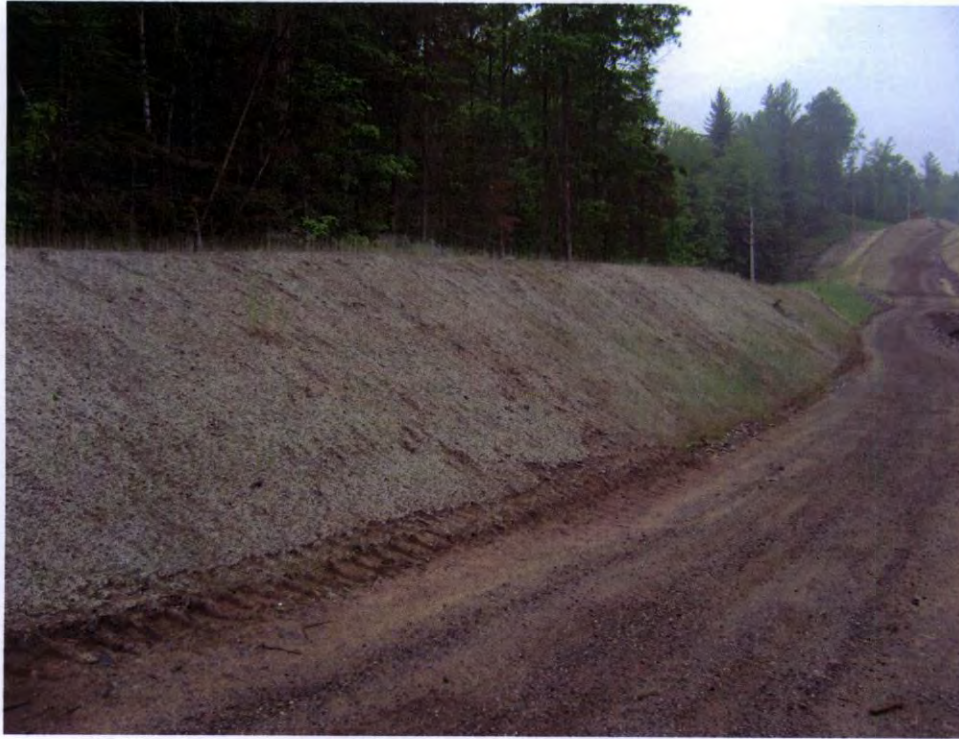
RM-7 looking northeast (North side of corridor)

Percent Cover	Vegetative	Bare Soil	Mulched (Straw & Hydro)	Percent Cover	Vegetative	Bare Soil	Mulched (Blanket or Hydro)
	20%	0%	100%		60%	0%	100%
Condition of Erosion Control	Excellent – Hydromulch and straw			Condition of Erosion Control	Excellent – Mulch Blanket and Silt Fence		
Description of Erosion (if any)	None			Description of Erosion (if any)	None

Other Observations
Drought conditions exist on site. National Weather Service website shows <1.0" of rain has fallen since the last monitoring date of June 16, 2011.

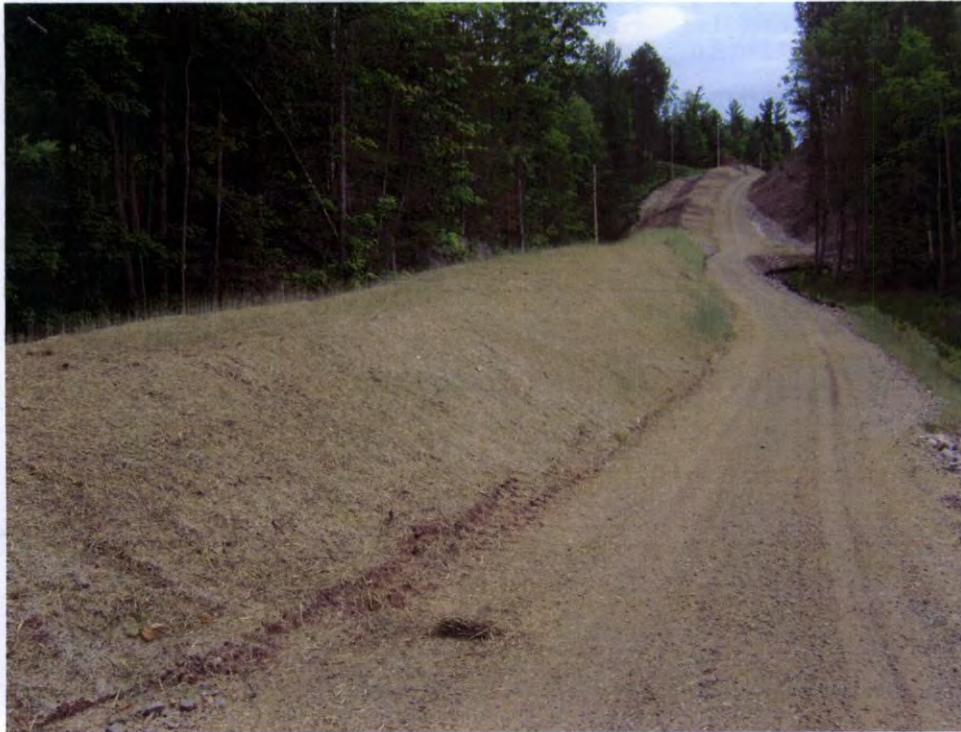
RM-7 looking northeast (North side of corridor)

Percent Cover	Vegetative	Bare Soil	Mulched (Straw & Hydro)	Percent Cover	Vegetative	Bare Soil	Mulched (Blanket or Hydro)
	30%	0%	100%		70%	0%	100%
Condition of Erosion Control	Excellent – Hydromulch and straw			Condition of Erosion Control	Excellent – Mulch Blanket and Silt Fence		
Description of Erosion (if any)	None			Description of Erosion (if any)	None

Other Observations
Drought conditions exist on site. National Weather Service website shows <0.75" of rain has fallen since the last monitoring date of July 15, 2011.

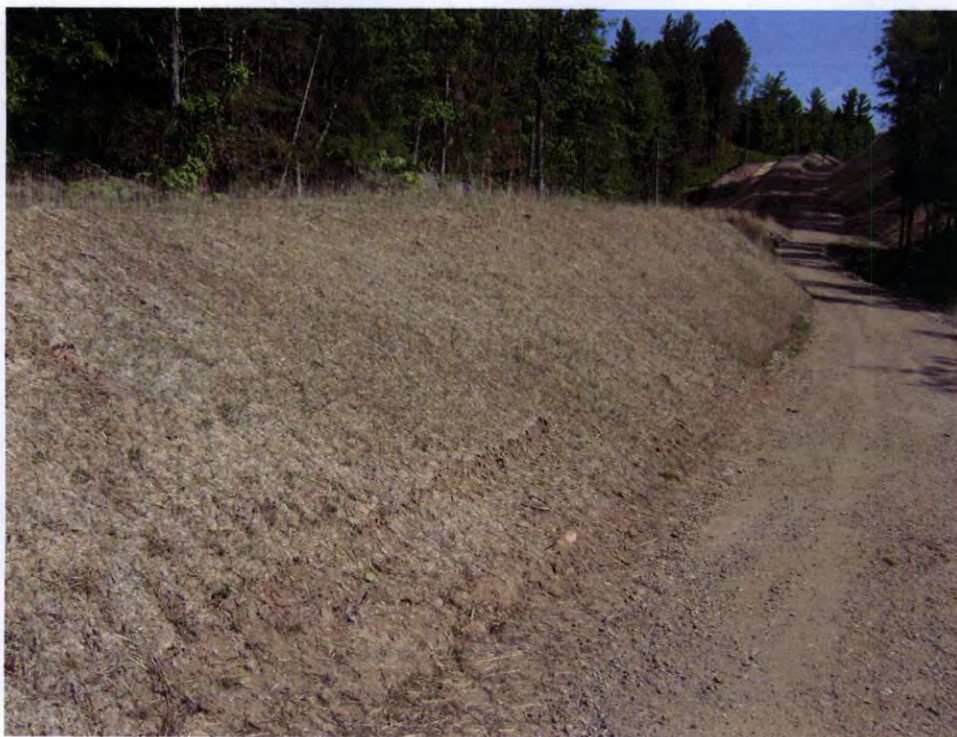
RM-7 looking northeast (North side of corridor)

Percent Cover	Vegetative	Bare Soil	Mulched (Straw & Hydro)	Percent Cover	Vegetative	Bare Soil	Mulched (Blanket or Hydro)
	40%	0%	100%		70%	0%	100%
Condition of Erosion Control	Excellent – Hydromulch and straw			Condition of Erosion Control	Excellent – Mulch Blanket and Silt Fence		
Description of Erosion (if any)	None			Description of Erosion (if any)	None

Other Observations
Drought conditions exist on site. National Weather Service website shows <1.75" of rain has fallen since the last monitoring date of August 17, 2011.

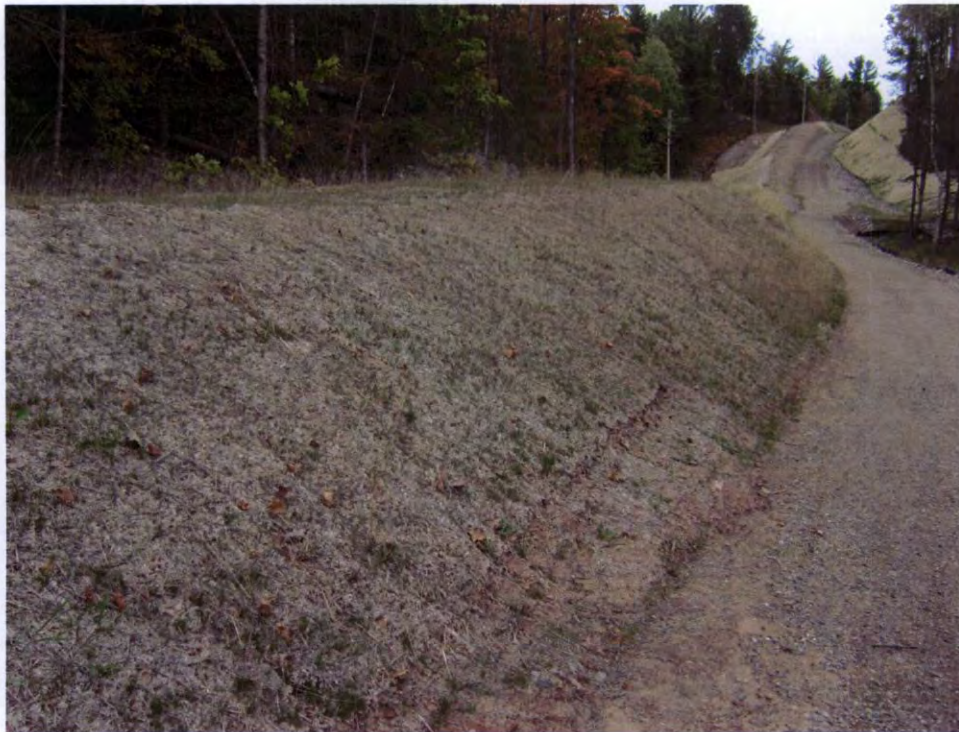
RM-7 looking northeast (North side of corridor)

Percent Cover	Vegetative	Bare Soil	Mulched (Straw & Hydro)	Percent Cover	Vegetative	Bare Soil	Mulched (Blanket or Hydro)
	45%	0%	100%		70%	0%	100%
Condition of Erosion Control	Excellent – Hydromulch and straw			Condition of Erosion Control	Excellent – Mulch Blanket		
Description of Erosion (if any)	None			Description of Erosion (if any)	None

Other Observations
Slight drought conditions still exist on site. National Weather Service website shows approx. 5.5" of rain has fallen since the last monitoring date of September 20, 2011.

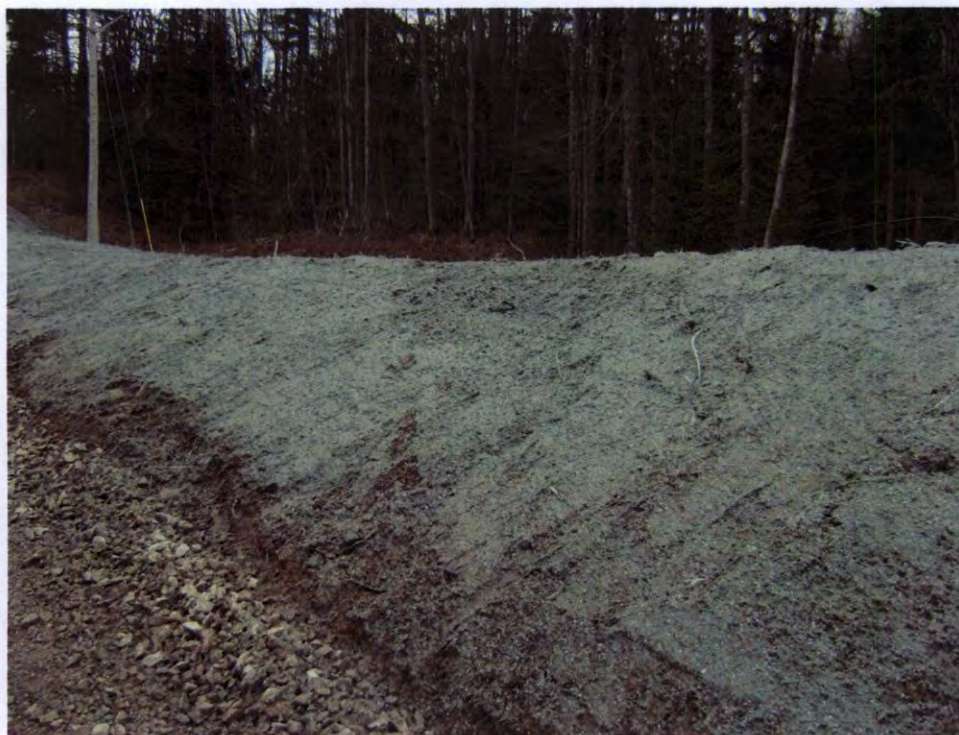
RM-8 looking northwest (North side of corridor)

Percent Cover	Vegetative	Bare Soil	Mulched (Blanket or Hydro)	Percent Cover	Vegetative	Bare Soil	Mulched (Blanket or Hydro)
	0%	10%	90%		0%	0%	100%
Condition of Erosion Control	Excellent - Hydromulch			Condition of Erosion Control	Excellent – Mulch Blanket and Silt Fence		
Description of Erosion (if any)	None			Description of Erosion (if any)	None

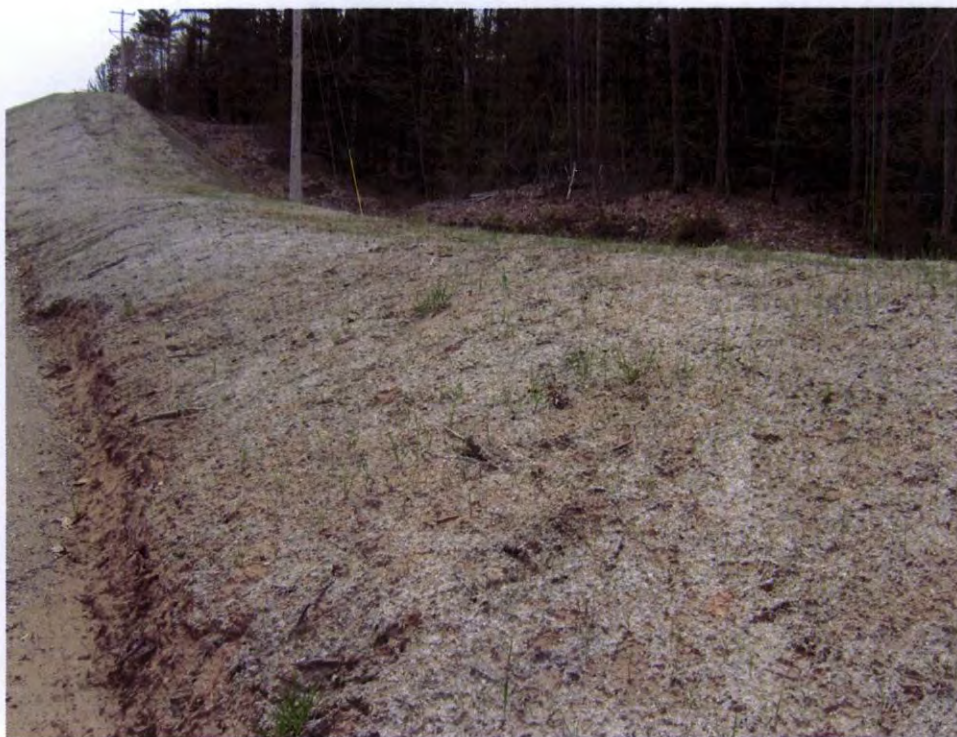
RM-8 looking west (North side of corridor)

Percent Cover	Vegetative	Bare Soil	Mulched (Blanket or Hydro)	Percent Cover	Vegetative	Bare Soil	Mulched (Blanket or Hydro)
	25%	10%	90%		40%	0%	100%
Condition of Erosion Control	Excellent - Hydromulch			Condition of Erosion Control	Excellent – Mulch Blanket and Silt Fence		
Description of Erosion (if any)	None			Description of Erosion (if any)	None

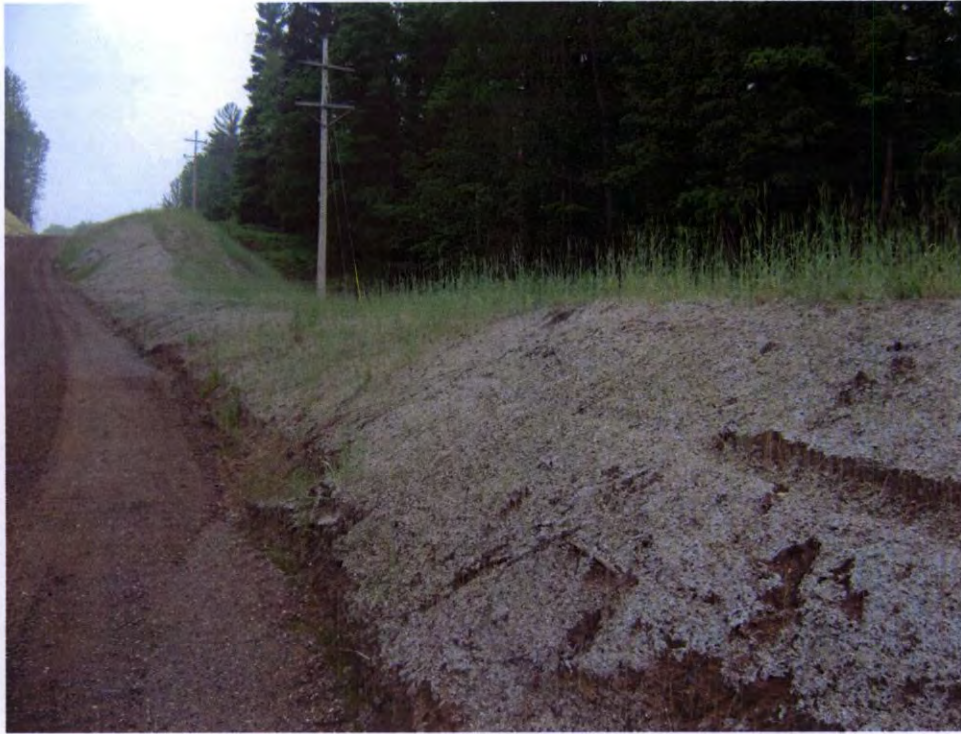
RM-8 looking west (North side of corridor)

Percent Cover	Vegetative	Bare Soil	Mulched (Straw & Hydro)	Percent Cover	Vegetative	Bare Soil	Mulched (Blanket or Hydro)
	25%	10%	90%		55%	0%	100%
Condition of Erosion Control	Excellent – Hydromulch and straw			Condition of Erosion Control	Excellent – Mulch Blanket and Silt Fence		
Description of Erosion (if any)	None			Description of Erosion (if any)	None

Other Observations
Drought conditions exist on site. National Weather Service website shows <1.0" of rain has fallen since the last monitoring date of June 16, 2011.

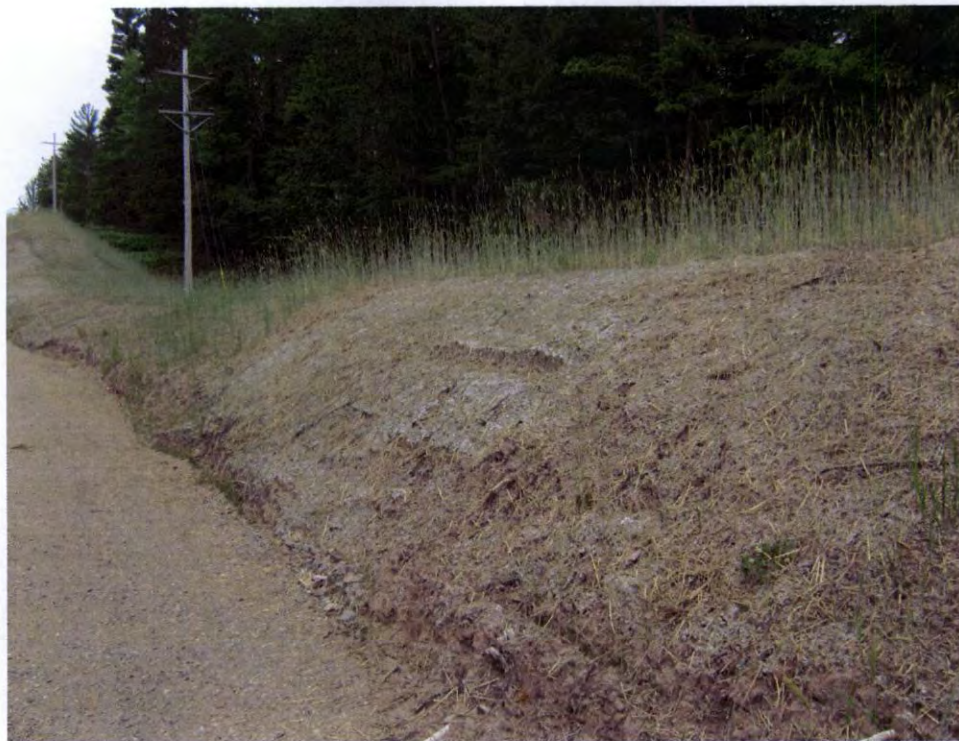
RM-8 looking west (North side of corridor)

Percent Cover	Vegetative	Bare Soil	Mulched (Straw & Hydro)	Percent Cover	Vegetative	Bare Soil	Mulched (Blanket or Hydro)
	40%	10%	90%		70%	0%	100%
Condition of Erosion Control	Excellent – Hydromulch and straw			Condition of Erosion Control	Excellent – Mulch Blanket and Silt Fence		
Description of Erosion (if any)	None			Description of Erosion (if any)	None

Other Observations
Drought conditions exist on site. National Weather Service website shows <0.75" of rain has fallen since the last monitoring date of July 15, 2011.

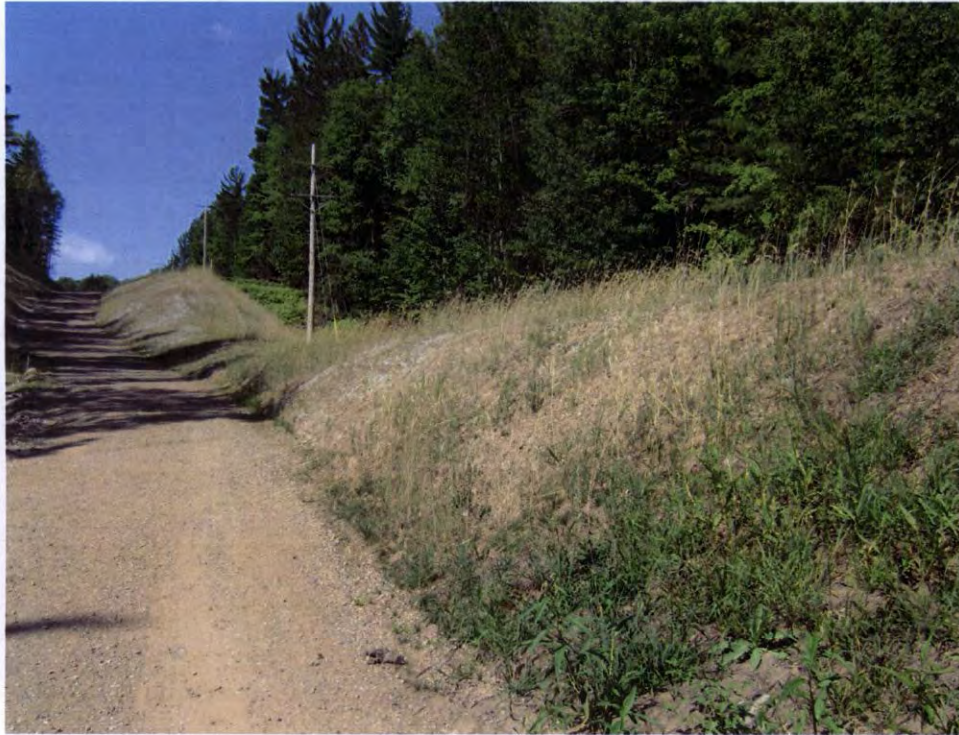
RM-8 looking west southwest (North side of corridor)

Percent Cover	Vegetative	Bare Soil	Mulched (Straw & Hydro)	Percent Cover	Vegetative	Bare Soil	Mulched (Blanket or Hydro)
	55%	10%	90%		80%	0%	100%
Condition of Erosion Control	Excellent – Hydromulch and straw			Condition of Erosion Control	Excellent – Mulch Blanket and Silt Fence		
Description of Erosion (if any)	None			Description of Erosion (if any)	None

Other Observations
Drought conditions exist on site. National Weather Service website shows <1.75" of rain has fallen since the last monitoring date of August 17, 2011.

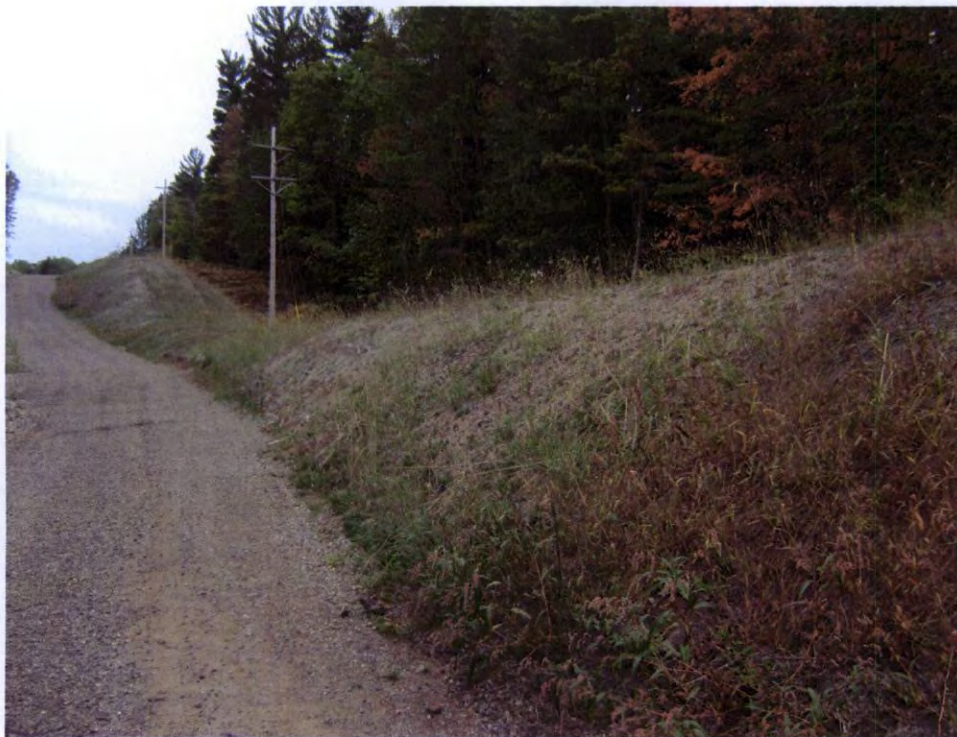
RM-8 looking west southwest (North side of corridor)

Percent Cover	Vegetative	Bare Soil	Mulched (Straw & Hydro)	Percent Cover	Vegetative	Bare Soil	Mulched (Blanket or Hydro)
	60%	10%	90%		85%	0%	100%
Condition of Erosion Control	Excellent – Hydromulch and straw			Condition of Erosion Control	Excellent – Mulch Blanket and Silt Fence		
Description of Erosion (if any)	None			Description of Erosion (if any)	None

Other Observations
Slight drought conditions still exist on site. National Weather Service website shows approx. 5.5" of rain has fallen since the last monitoring date of September 20, 2011.
