Upper Peninsula Power Company

FERC Project No. 10855
NATDAM Nos. MI00175, MI00183,
and MI00197

Dead River Hydroelectric Project
2013 Annual Report - Operation Monitoring Plan & Report of Deviations Less Than Sixty Minutes

Annual Report

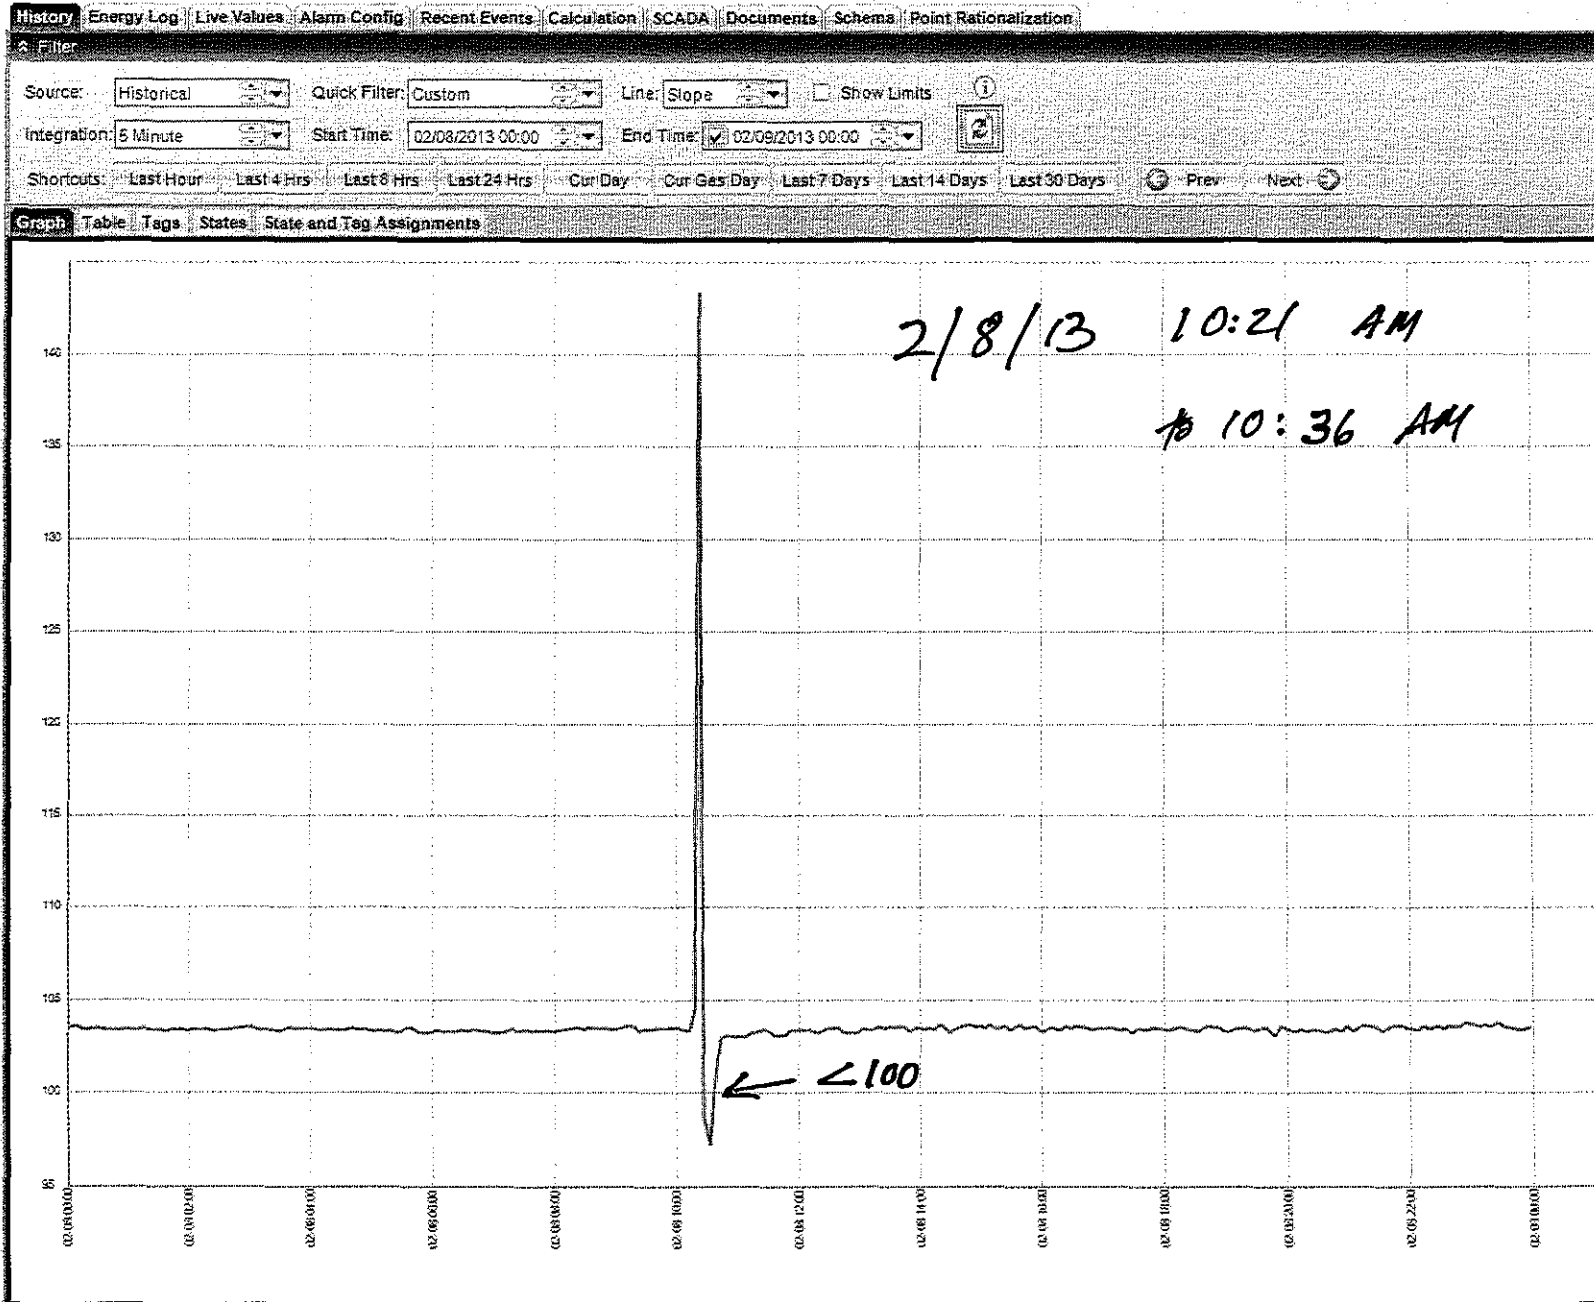
#1

NC Record Number: NCREG4602		Entity: Regional Generation	
Company - Level 1 - Level 2: UPP-Hoist Hydro			
Event Date:	02/08/2013	Discovery Date/Time:	2/8/13 10:26
Event Title: Hoist plant flow <100 cfs during unit swap.			
Event Details: While the local Operator was adjusting flow following swapping of the units, the indicated flow temporarily fell below 100 cfs.			
Immediate Action: Indormed local Operator.			
Recommendations: none			
Potential Causes/Contributors to incident		Possibly the lack of good local flow indication.	
Entered By Name:	Thomas R Grow	Creation Date/Time:	2/8/13 10:50
Entered By Department:	Energy Supply & Control-GenCo	Status:	Closed
Reportable to External Agency:	no	Basis for Reportability:	Not a deviation, flucuation from swapping units
Additional Followup Required:	no		
Category:	Other	Type:	
Sub Type:		Description:	Instrument flucuation
Causal Analysis Level:	Closed - No further action required	Causal Analysis Basis:	Bounce in the reading for flow with two units one, during the a plant unit swap

Event Start:	2/8/2013 10:21 AM	Event End:	2/8/2013 10:36 AM
		Event Duration (HH:MM):	00:15
Evaluator Name:		Evaluator Dept:	
Evaluation Accepted:		Acceptance Comments:	
Eval Due Date:		Eval Completion Date:	
Approver Name:		Corrective Action Approver Name:	
Analysis Description:			
Causes:			
Primary Causes:			
Does Eval Require Sceening Committee Approval upon Completion		no	
Evaluation Reviewed/Approved by Screening Committee

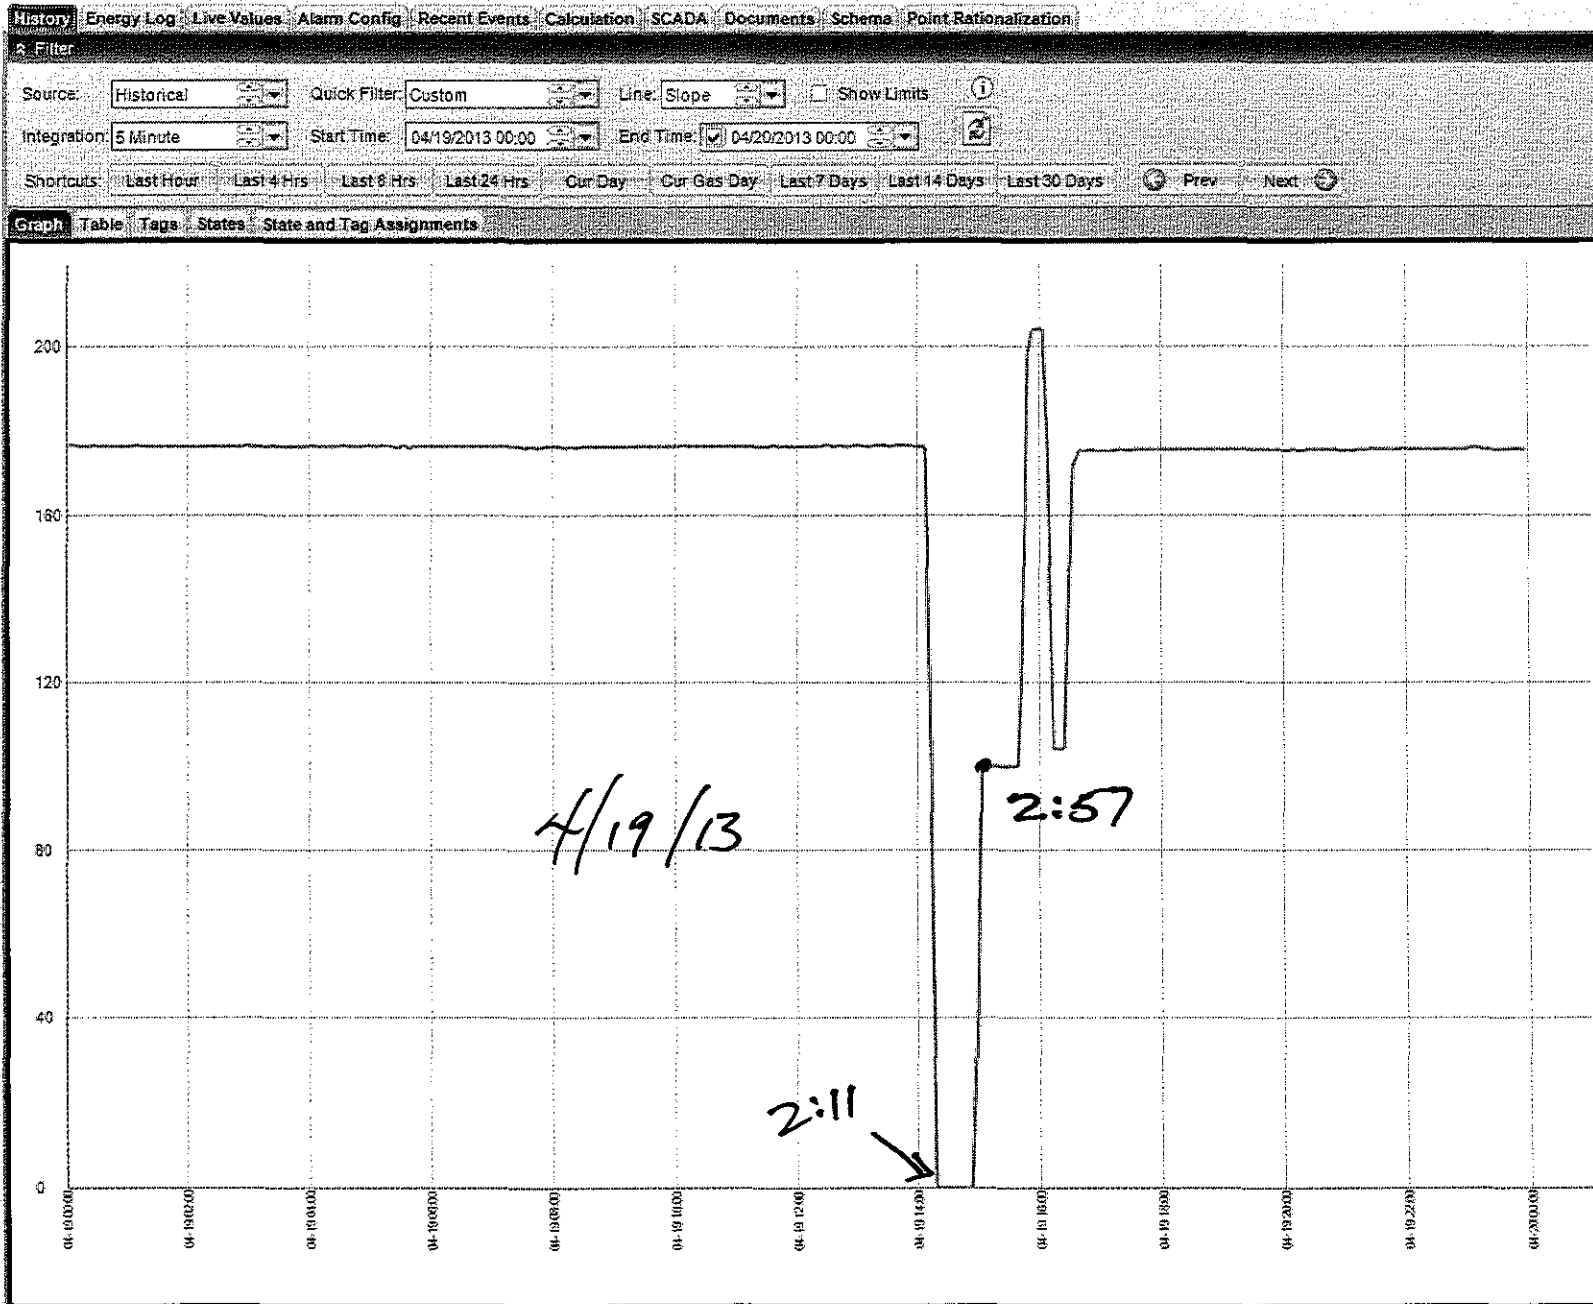
#2

NC Record Number: NCREG4776		Entity: Regional Generation	
Company - Level 1 - Level 2: UPP-Hoist Hydro			
Event Date:	04/19/2013	Discovery Date/Time:	4/19/13 14:12
Event Title:	Run of River deviation		
Event Details:	Plant trip due to power outage		
Immediate Action:	Notified hydro operator.		
Recommendations:	None		
Potential Causes/Contributors to incident	None		
Entered By Name:	Terrie S Taylor	Creation Date/Time:	4/19/13 14:24
Entered By Department:	Energy Supply & Control-GenCo	Status:	Closed
Reportable to External Agency:	yes	Basis for Reportability:	Part of A FERC Deviation letter submitted May 2nd to VS
Additional Followup Required:	no		
Category:	Regulatory	Type:	FERC Deviation
Sub Type:	Trans. Sys. (storm related)	Description:	
Causal Analysis Level:	Closed - No further action required	Causal Analysis Basis:	Event happened, unit tripped and came back on
Event Start:	4/19/2013 2:11 PM	Event End:	4/19/2013 2:57 PM

Event Duration (HH:MM):	00:46
Evaluator Name:		Evaluator Dept:	
Evaluation Accepted:		Acceptance Comments	L60
Eval Due Date:		Eval Completion Date:	
Approver Name:		Corrective Action Approver Name	
Analysis Description:			
Causes:			
Primary Causes:			
Does Eval Require Screening Committee Approval upon Completion			no
Evaluation Reviewed/Approved by Screening Committee

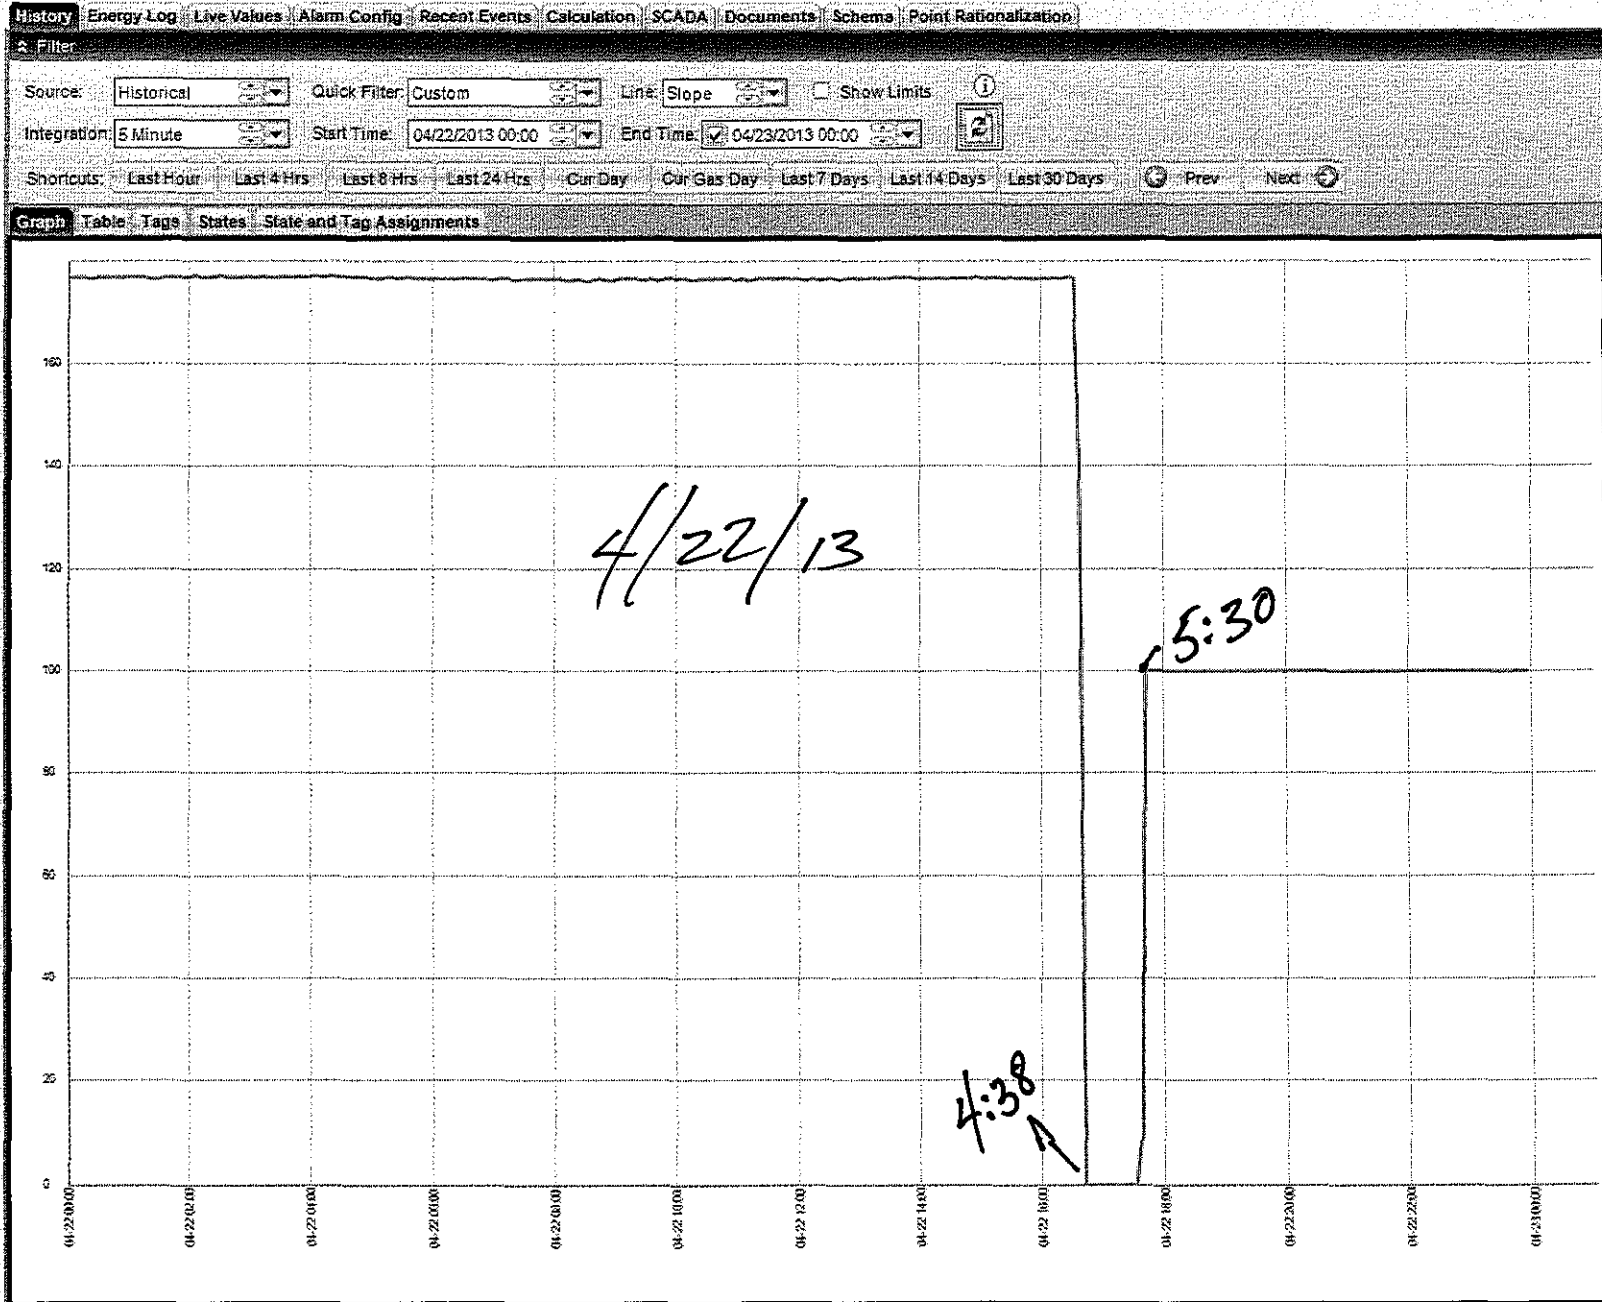
NC Record Number:	NCREG4788	Entity:	Regional Generation
Company - Level 1 - Level 2:	UPP-Hoist Hydro		
Event Date:	04/22/2013	Discovery Date/Time:	4/22/13 16:39
Event Title:	Unit tripped offline		
Event Details:	Unit tripped offline due to a possible distribution system event		
Immediate Action:	ARCOS call for operator (s)		
Recommendations:	n/a		
Potential Causes/Contributors to Incident	possible distribution event..		
Entered By Name:	David C Paananen	Creation Date/Time:	4/22/13 17:41
Entered By Department:	Energy Supply & Control-GenCo	Status:	Closed
Reportable to External Agency:	yes	Basis for Reportability:	Part of a FERC letter drafted to VES May 2nd
Additional Followup Required:	no		
Category:	Regulatory	Type:	FERC Deviation
Sub Type:	Trans. Sys. (storm related)	Description:	
Causal Analysis Level:	Closed - No further action required	Causal Analysis Basis:	Event happened and units retrund to servic

Event Start:	4/22/2013 4:38 PM	Event End:	4/22/2013 5:30 PM
Evaluator Name:		Evaluator Dept:	
Evaluation Accepted:		Acceptance Comments	
Eval Due Date:		Eval Completion Date:	
Approver Name:		Corrective Action Approver Name	
Analysis Description:			
Causes:			
Primary Causes:			
Does Eval Require Sceening Committee Approval upon Completion	no		
Evaluation Reviewed/Approved by Screening Committee

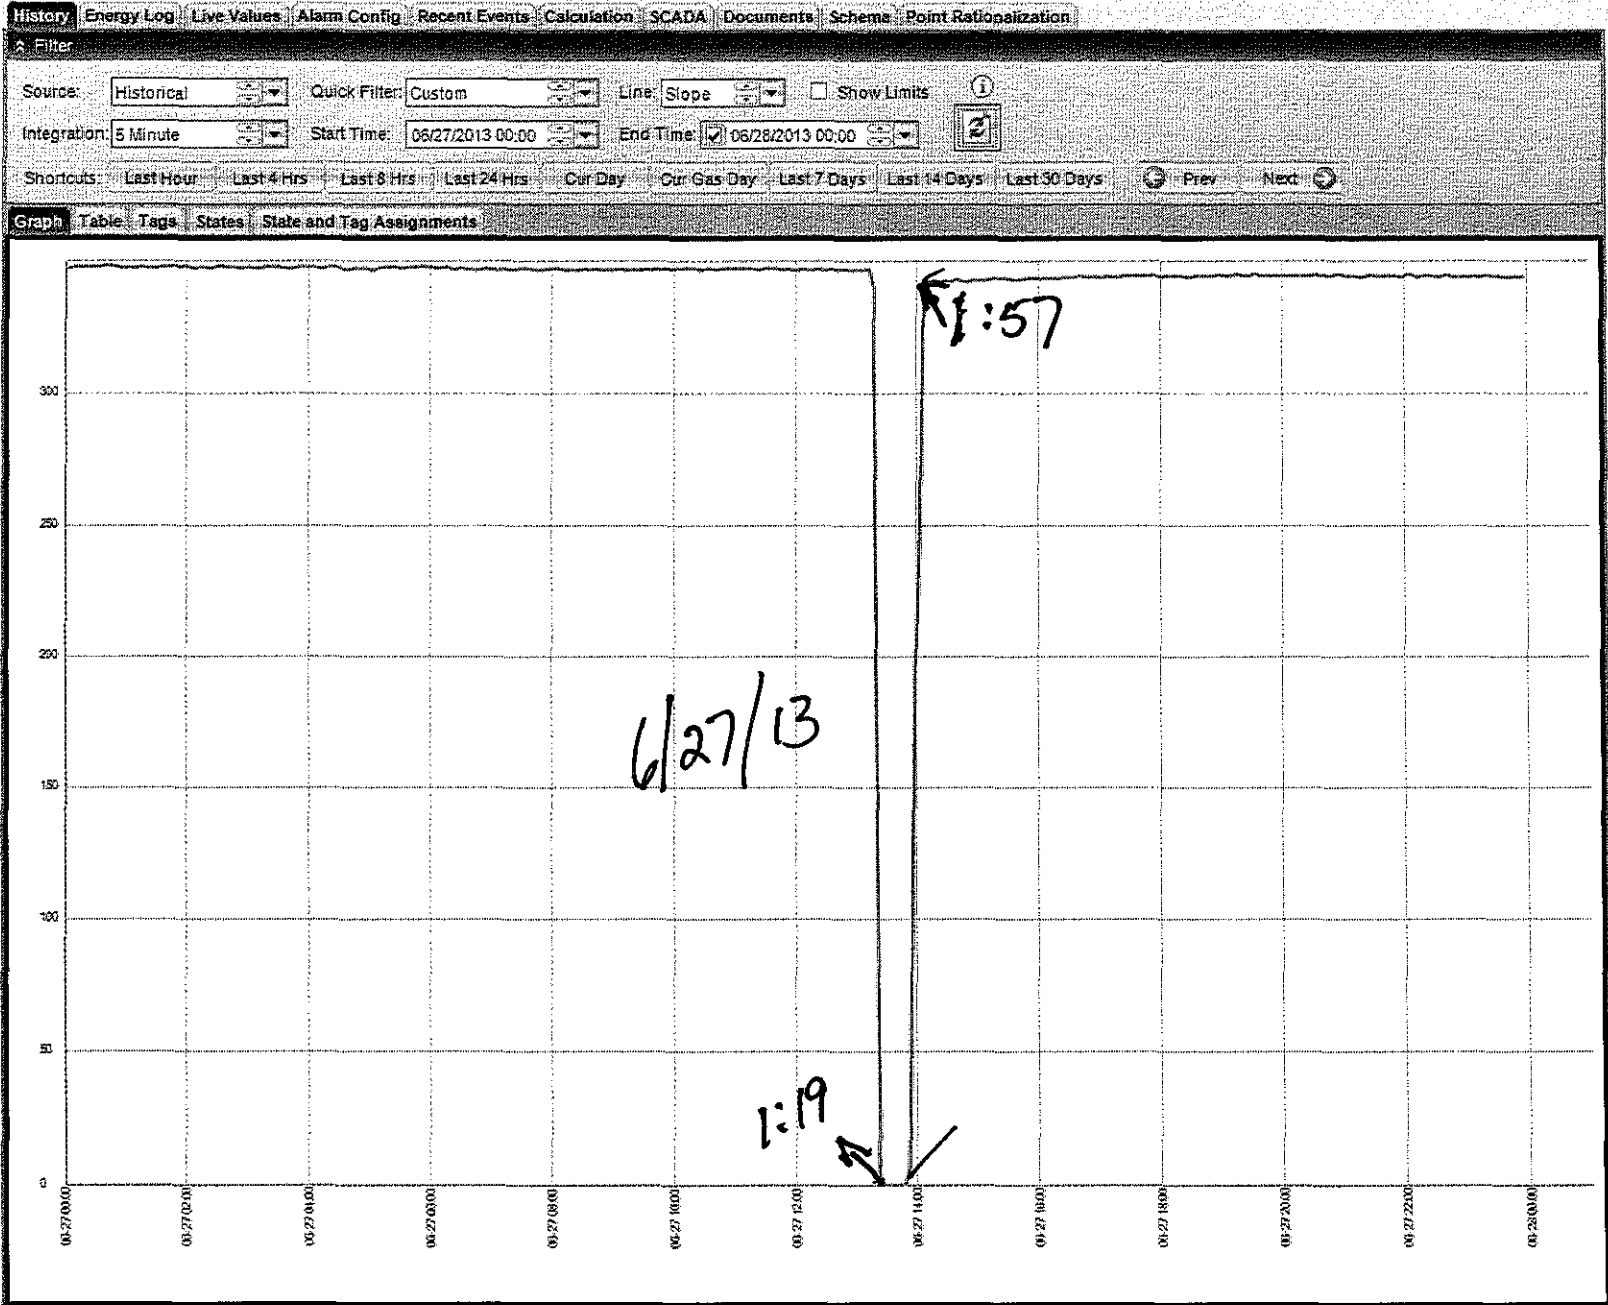
#4

NC Record Number: NCREG5013		Entity: Regional Generation	
Company - Level 1 - Level 2: UPP-Hoist Hydro			
Event Date:	06/27/2013	Discovery Date/Time:	6/27/13 13:19
Event Title:	Hoist generators trip		
Event Details:	Both units tripped. Had difficulty contacting operators due to intermittent phone problem. Contacted local operator at 13:33.		
Immediate Action:	Contacted operator.		
Recommendations:	n/a		
Potential Causes/Contributors to incident	weather		
Entered By Name:	Jonathon J Jenkins	Creation Date/Time:	6/27/13 14:49
Entered By Department:	Energy Supply & Control-GenCo	Status:	Closed
Reportable to External Agency:	yes	Basis for Reportability:	Letter to FERC - Draft to VES 7/15
Additional Followup Required:	yes		
Category:	Regulatory	Type:	FERC Deviation
Sub Type:	Trans. Sys. (storm related)	Description:	
Causal Analysis Level:	Closed - No further action required	Causal Analysis Basis:	Units put back on line

Event Start:	6/27/2013 1:19 PM	Event End:	6/27/2013 1:57 PM
		Event Duration (HH:MM):	00:38
Evaluator Name:		Evaluator Dept:	
Evaluation Accepted:		Acceptance Comments:	
Eval Due Date:		Eval Completion Date:	
Approver Name:		Corrective Action Approver Name:	
Analysis Description:			
Causes:			
Primary Causes:			
Does Eval Require Scceening Committee Approval upon Completion	no		
Evaluation Reviewed/Approved by Screening Committee

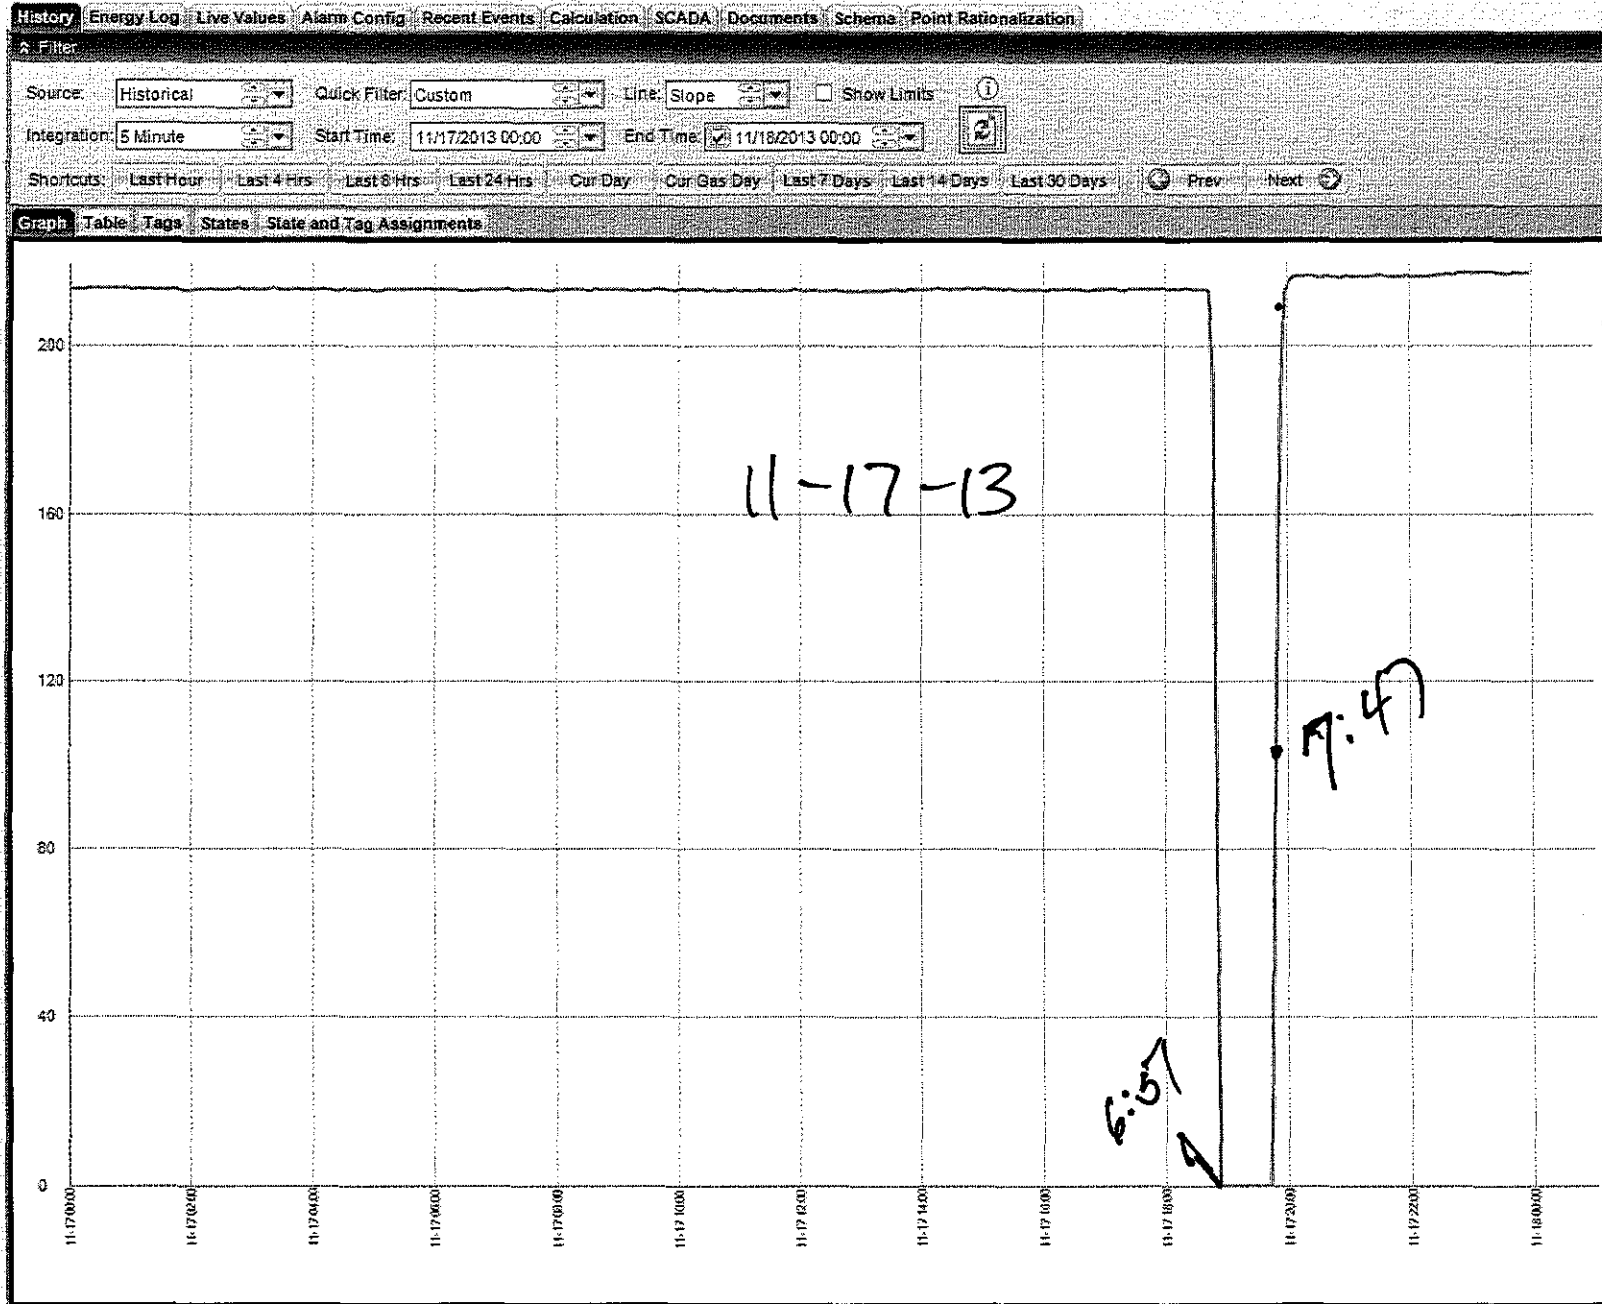
#5

NC Record Number:	NCREG5507	Entity:	Regional Generation
Company - Level 1 - Level 2:	UPP-Hoist Hydro		
Event Date:	11/17/2013	Discovery Date/Time:	11/17/13 18:49
Event Title:	Hoist Unit 3 Tripped		
Event Details:	Unit #3 tripped offline due to generator overspeed		
Immediate Action:	Called out local operator		
Recommendations:	None		
Potential Causes/Contributors to incident	Generator overspeed - possibly weather related, high winds		
Entered By Name:	Brian K Ellison	Creation Date/Time:	11/17/13 20:52
Entered By Department:	Energy Supply & Control-GenCo	Status:	Closed
Reportable to External Agency:	no	Basis for Reportability:	< 60 minutes, end of year reporting
Additional Followup Required:	yes		
Category:	Regulatory	Type:	FERC Deviation
Sub Type:	Trans. Sys. (storm related)	Description:	high winds
Causal Analysis Level:	Closed - No further action required	Causal Analysis Basis:	High winds caused the transmission system to trip, operator was called out and got the plant back on line < 60 minute time frame

Event Start:	11/17/2013 6:51 PM	Event End:	11/17/2013 7:47 PM
		Event Duration (HH:MM):	00:56
Evaluator Name:		Evaluator Dept:	
Evaluation Accepted:		Acceptance Comments	
Eval Due Date:		Eval Completion Date:	
Approver Name:		Corrective Action Approver Name	
Analysis Description:			
Causes:			
Primary Causes:			
Does Eval Require Screening Committee Approval upon Completion	no		
Evaluation Reviewed/Approved by Screening Committee

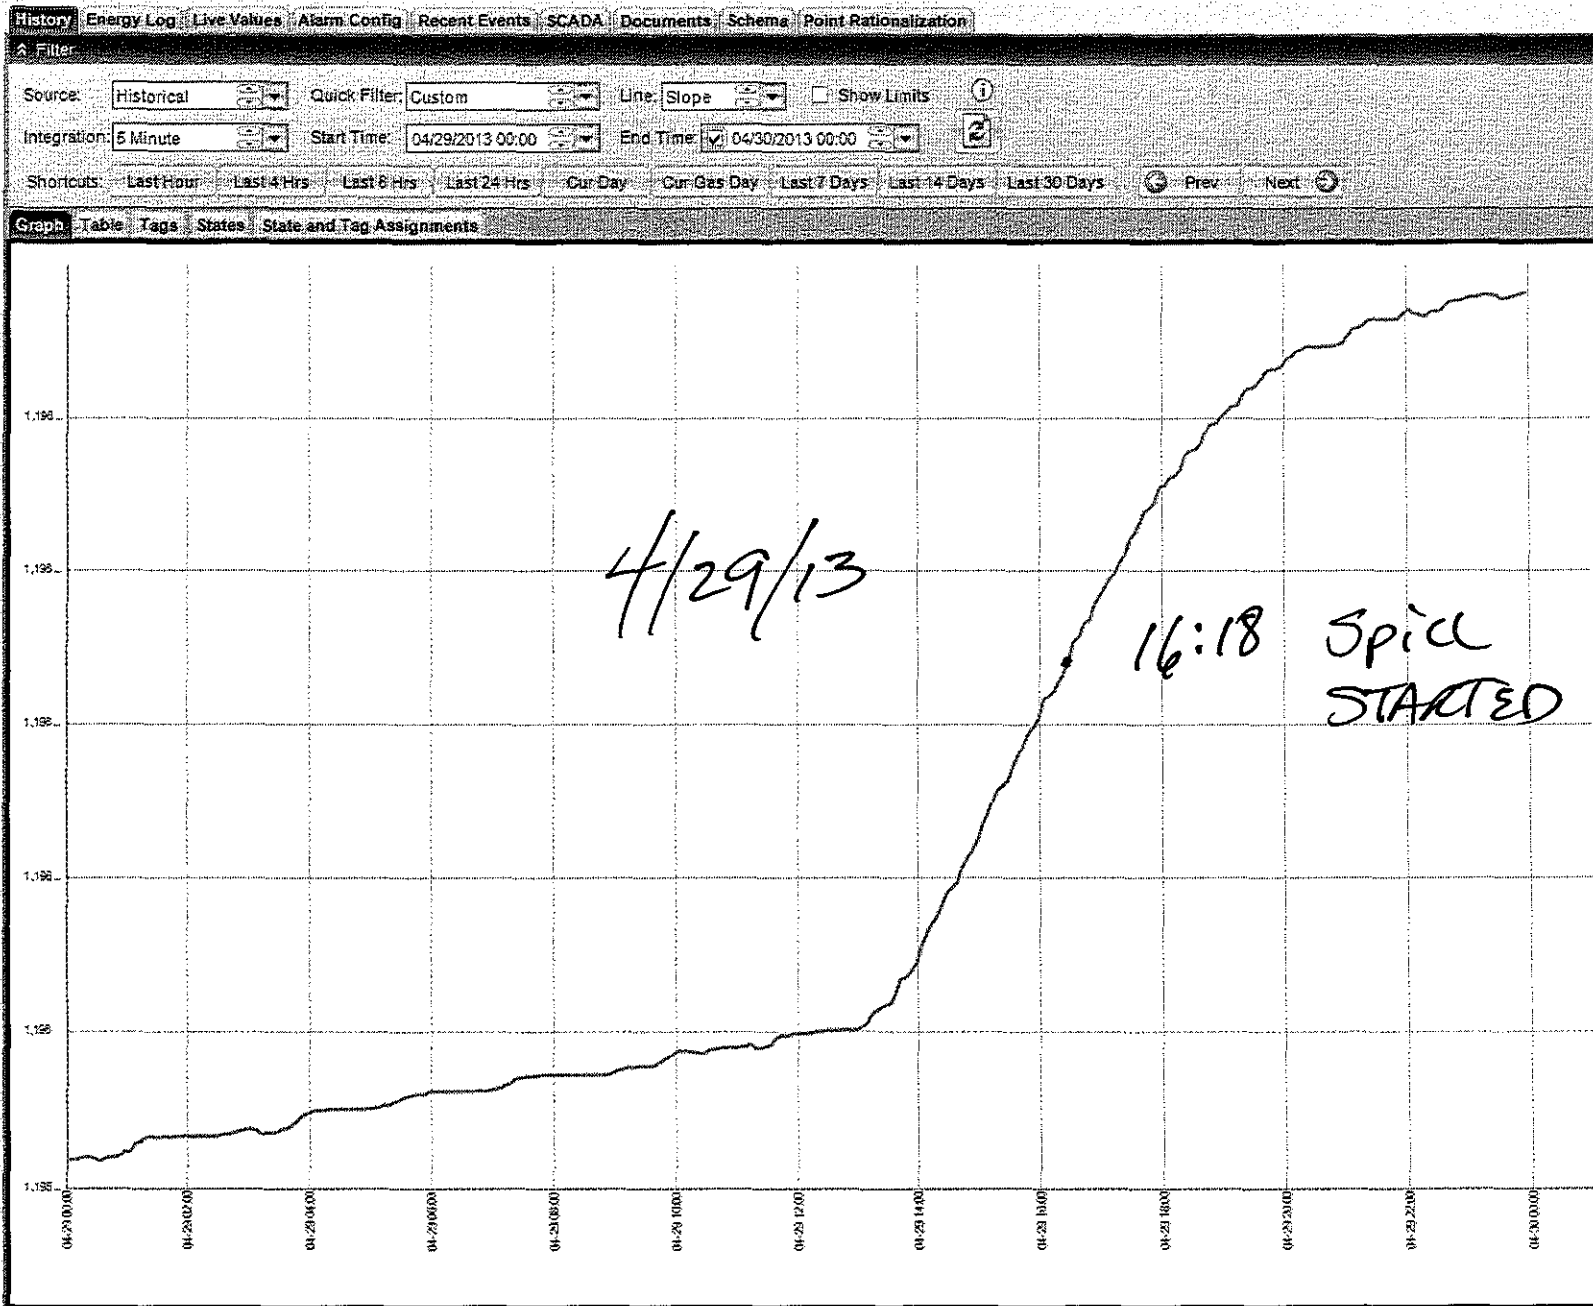
NC Record Number:	NCREG4817	Entity:	Regional Generation
Company - Level 1 - Level 2:	UPP-McClure Hydro		
Event Date:	04/29/2013	Discovery Date/Time:	4/29/13 15:56
Event Title:	McClure greater than elevation alarm limit		
Event Details:	Due to higher inflows, McClure elevation exceeds alarm setpoint and the pond is spilling.		
Immediate Action:	documented		
Recommendations:	none		
Potential Causes/Contributors to Incident			
Entered By Name:	Jonathon J Jenkins	Creation Date/Time:	4/29/13 15:56
Entered By Department:	Energy Supply & Control-GenCo	Status:	Closed
Reportable to External Agency:	yes	Basis for Reportability:	FERC Letter required
Additional Followup Required:	yes		
Category:	Regulatory	Type:	FERC Deviation
Sub Type:	River cond. (drought, highflows, etc)	Description:	
Causal Analysis Level:	Closed - No further action required	Causal Analysis Basis:	Water increase from Spring run off
Event Start:		Event End:	Event Duration (HH:MM):

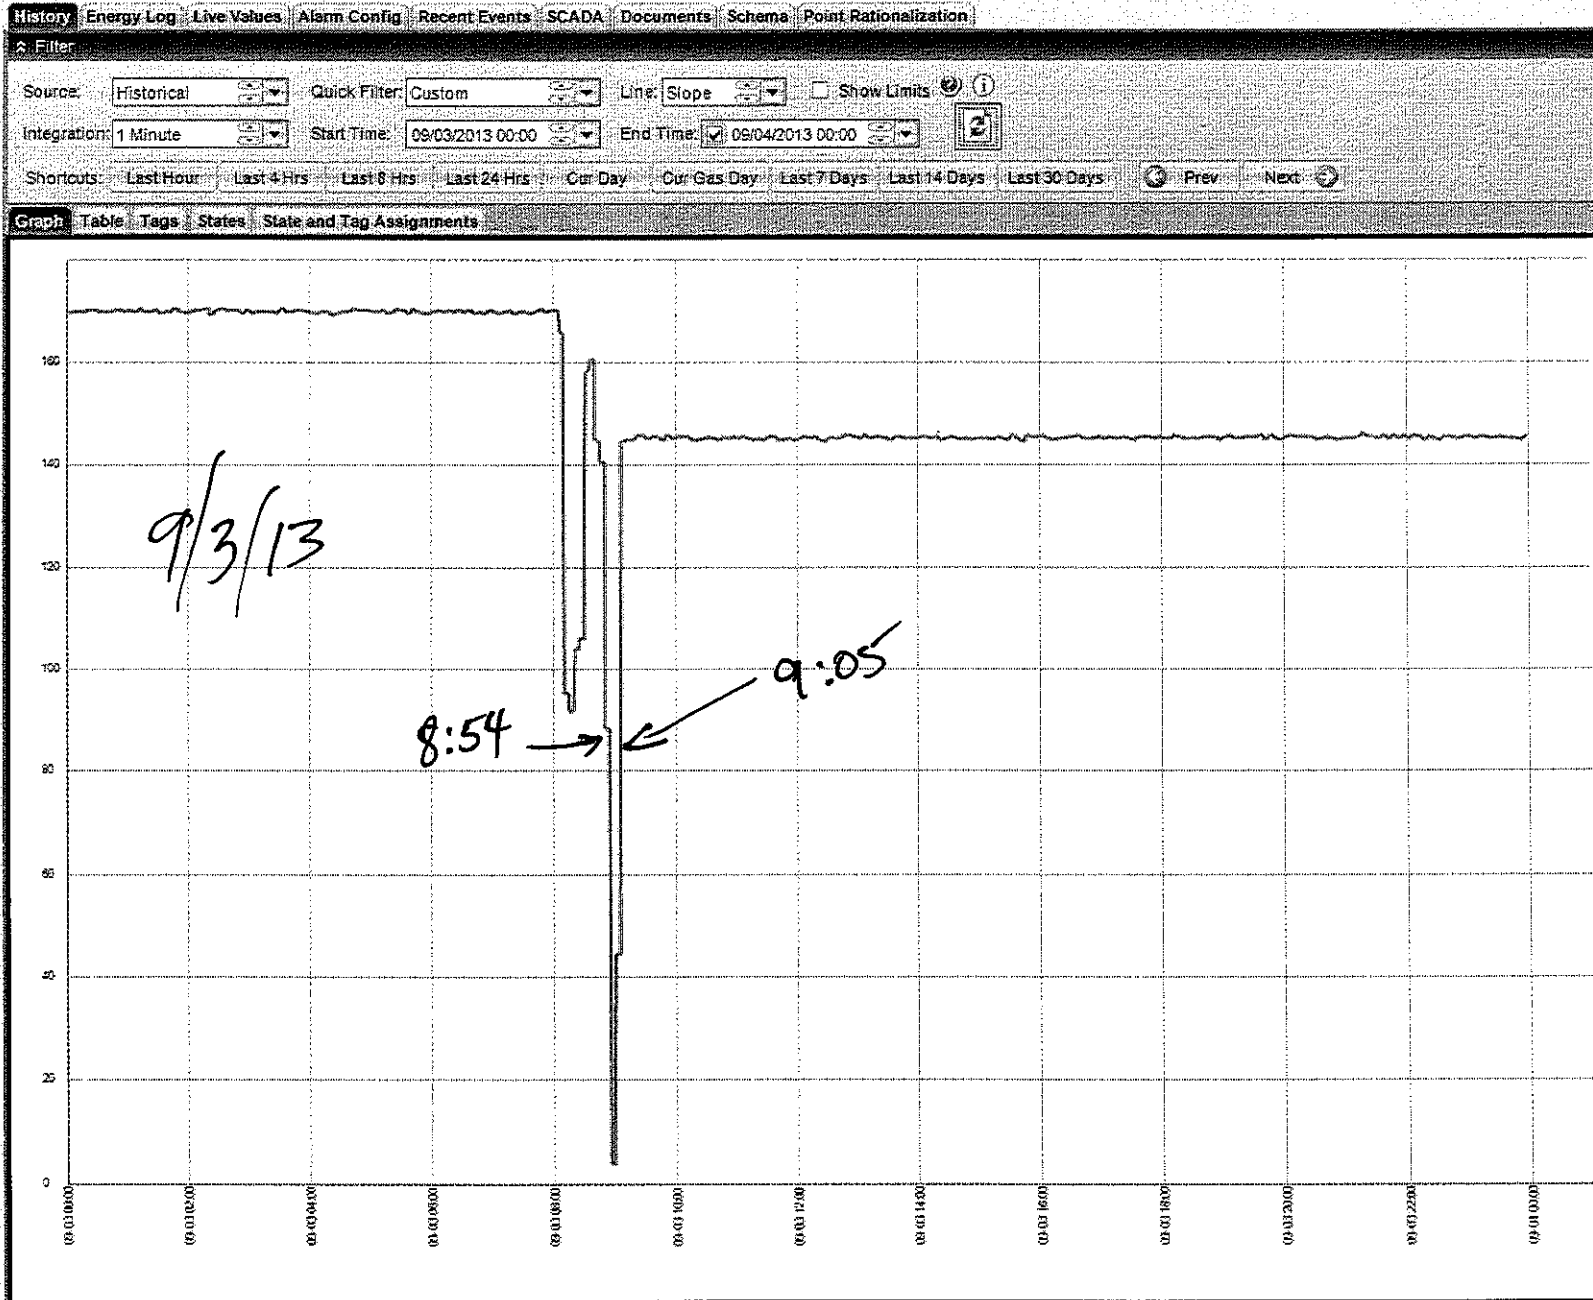
#4

NC Record Number: NCREG5272		Entity: Regional Generation	
Company - Level 1 - Level 2: UPP-McClure Hydro			
Event Date:	09/03/2013	Discovery Date/Time:	9/3/13 9:05
Event Title:	Unit Trip		
Event Details:	John ia at McClure to swap units. Unit #1 was put online and #2 was taken offline. After the swap at 0851 unit #1 tripped offline due to a bearing temp. alarm, I called the plant and John said they would be putting unit #2 back online. While both units were off the flow dropped below 80 cfs. At 0903 unit #2 was back online and flows were back above 80 cfs.		
Immediate Action:	Called the plant and they placed unit #2 back online.		
Recommendations:	None		
Potential Causes/Contributors to incident	Bearing Temperature alarms on unit#1.		
Entered By Name:	Stephen M Beirne	Creation Date/Time:	9/3/13 9:12
Entered By Department:	Energy Supply & Control-GenCo	Status:	Closed
Reportable to External Agency:	no	Basis for Reportability:	Will be done as part of the Year end report of events < 60 minutes

Additional Followup Required:	yes		
Category:	Regulatory	Type:	FERC Deviation
Sub Type:	Plant equip. failure	Description:	Unit trip
Causal Analysis Level:	Closed - No further action required	Causal Analysis Basis:	Units were being swapped as part of the normal monthly operation, unit one was started up, after it was steady on line, unit two was removed from service. about 1 minute after unit two was removed, Unit one tripped on high bearing oil temperature. Unit two was put back on line.
Event Start:	9/3/2013 8:53 AM	Event End:	9/3/2013 9:04 AM
		Event Duration (HH:MM):	00:11
Evaluator Name:		Evaluator Dept:	
Evaluation Accepted:		Acceptance Comments	
Eval Due Date:		Eval Completion Date:	
Approver Name:		Corrective Action Approver Name	
Analysis Description:			
Causes:			
Primary Causes:			
Does Eval Require Scenning Committee Approval upon Completion			no
Evaluation Reviewed/Approved by Screening Committee
