CR AAO Bridge

Dead River Flood & Natural Channel Design

Mitch Koetje
Water Resources
Division
UP District

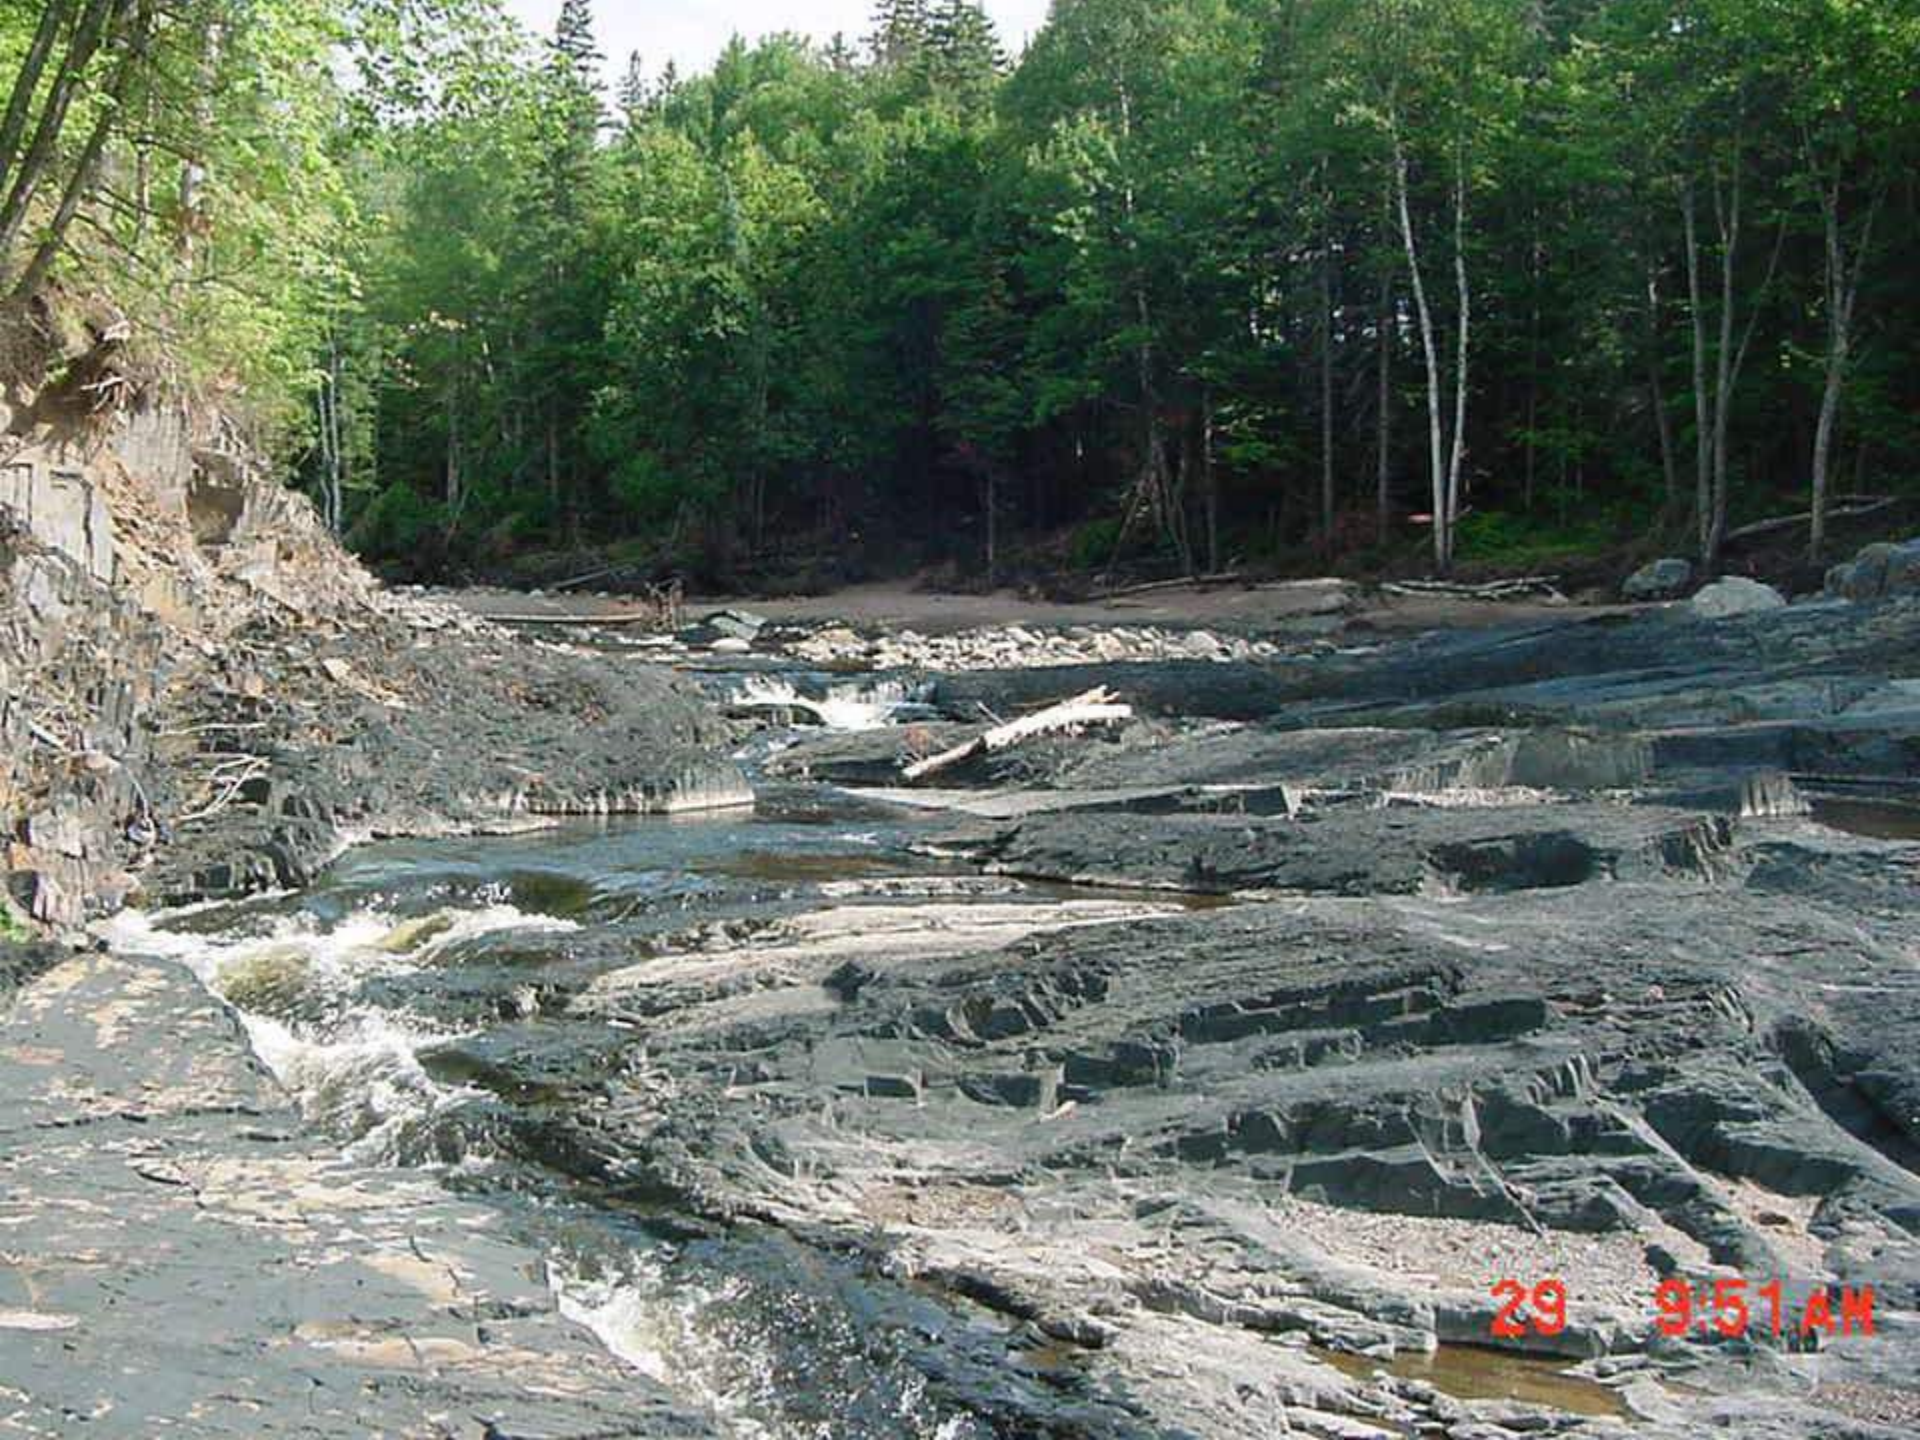
Start of Connors Creek Area/Reach B -
Looking Upstream on 7-15-04

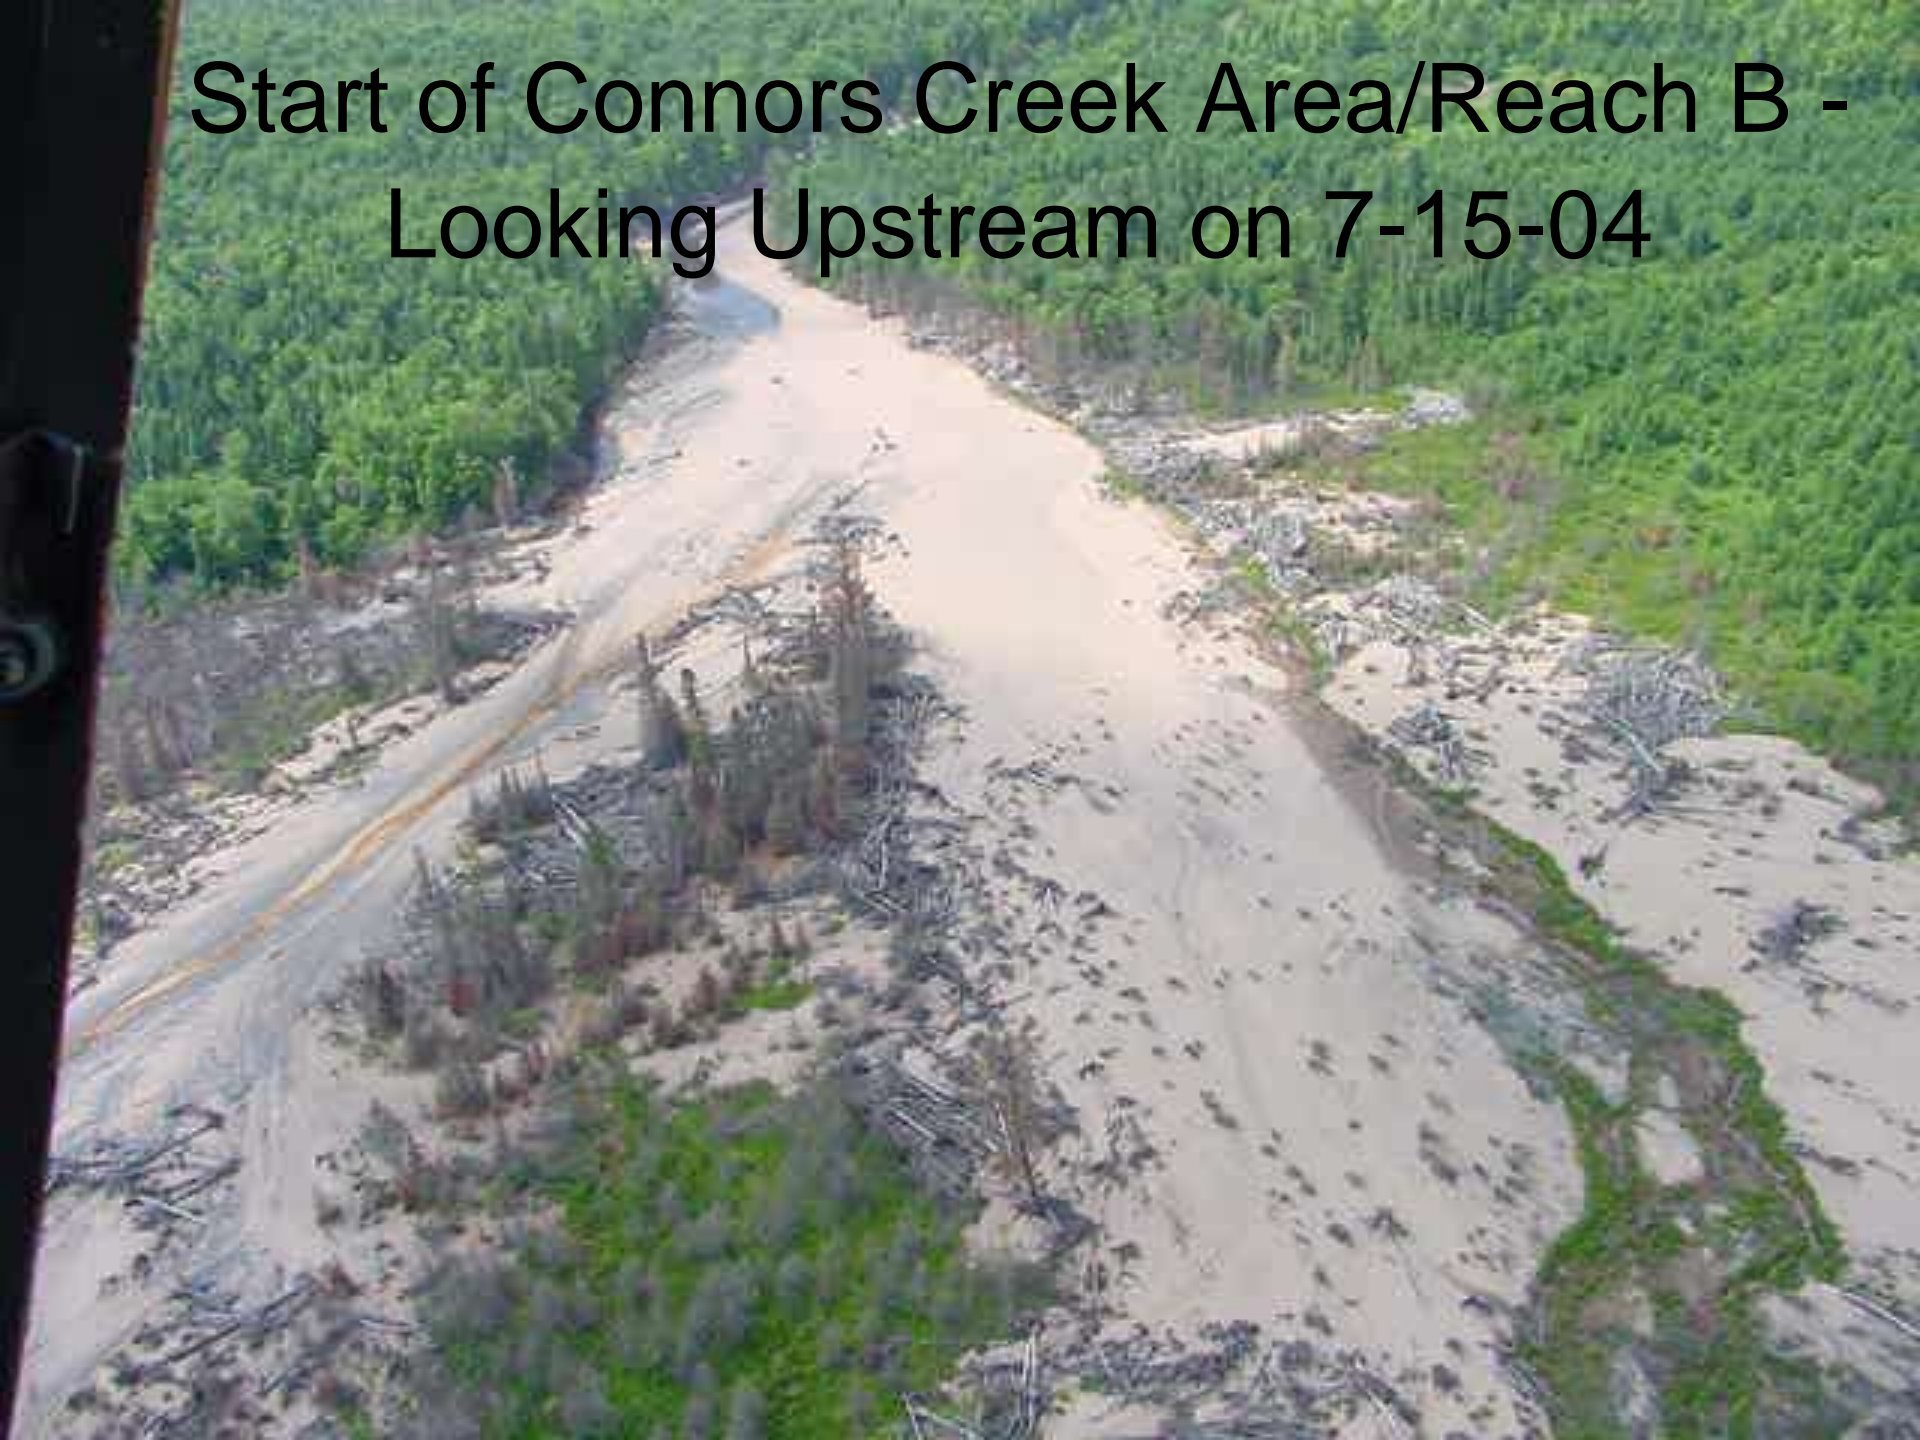
Once forested, there are now several sand plains left from the flood damage downstream of the fuse plug failure at Silver Lake Basin. (Connors Ck. Area 10/15/03)

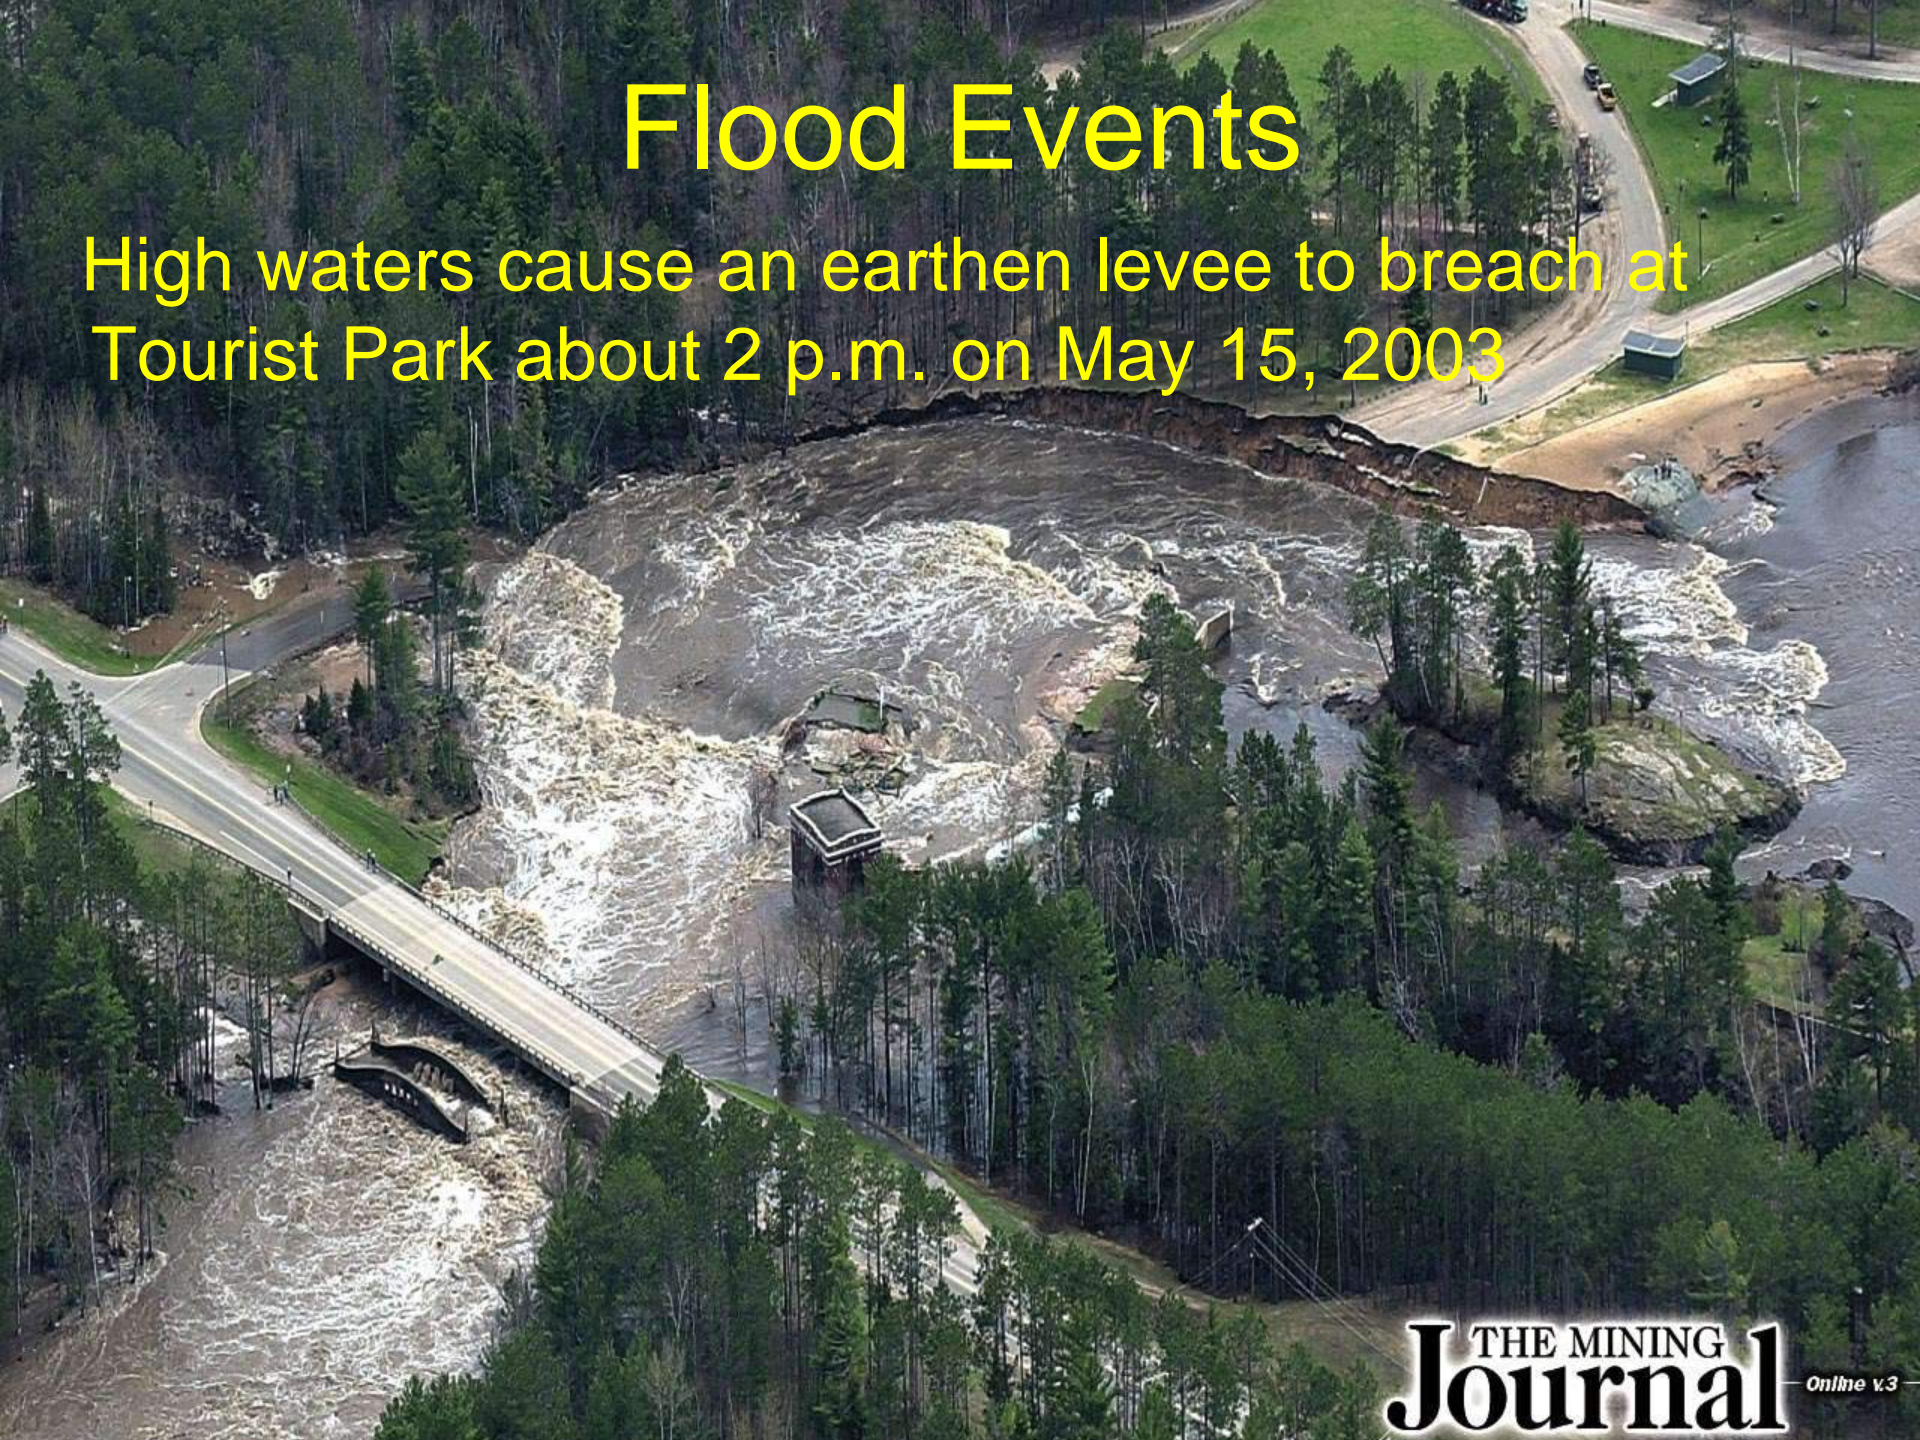
Tourist Park Basin Looking Upstream - Right after the Event on 5/16/03

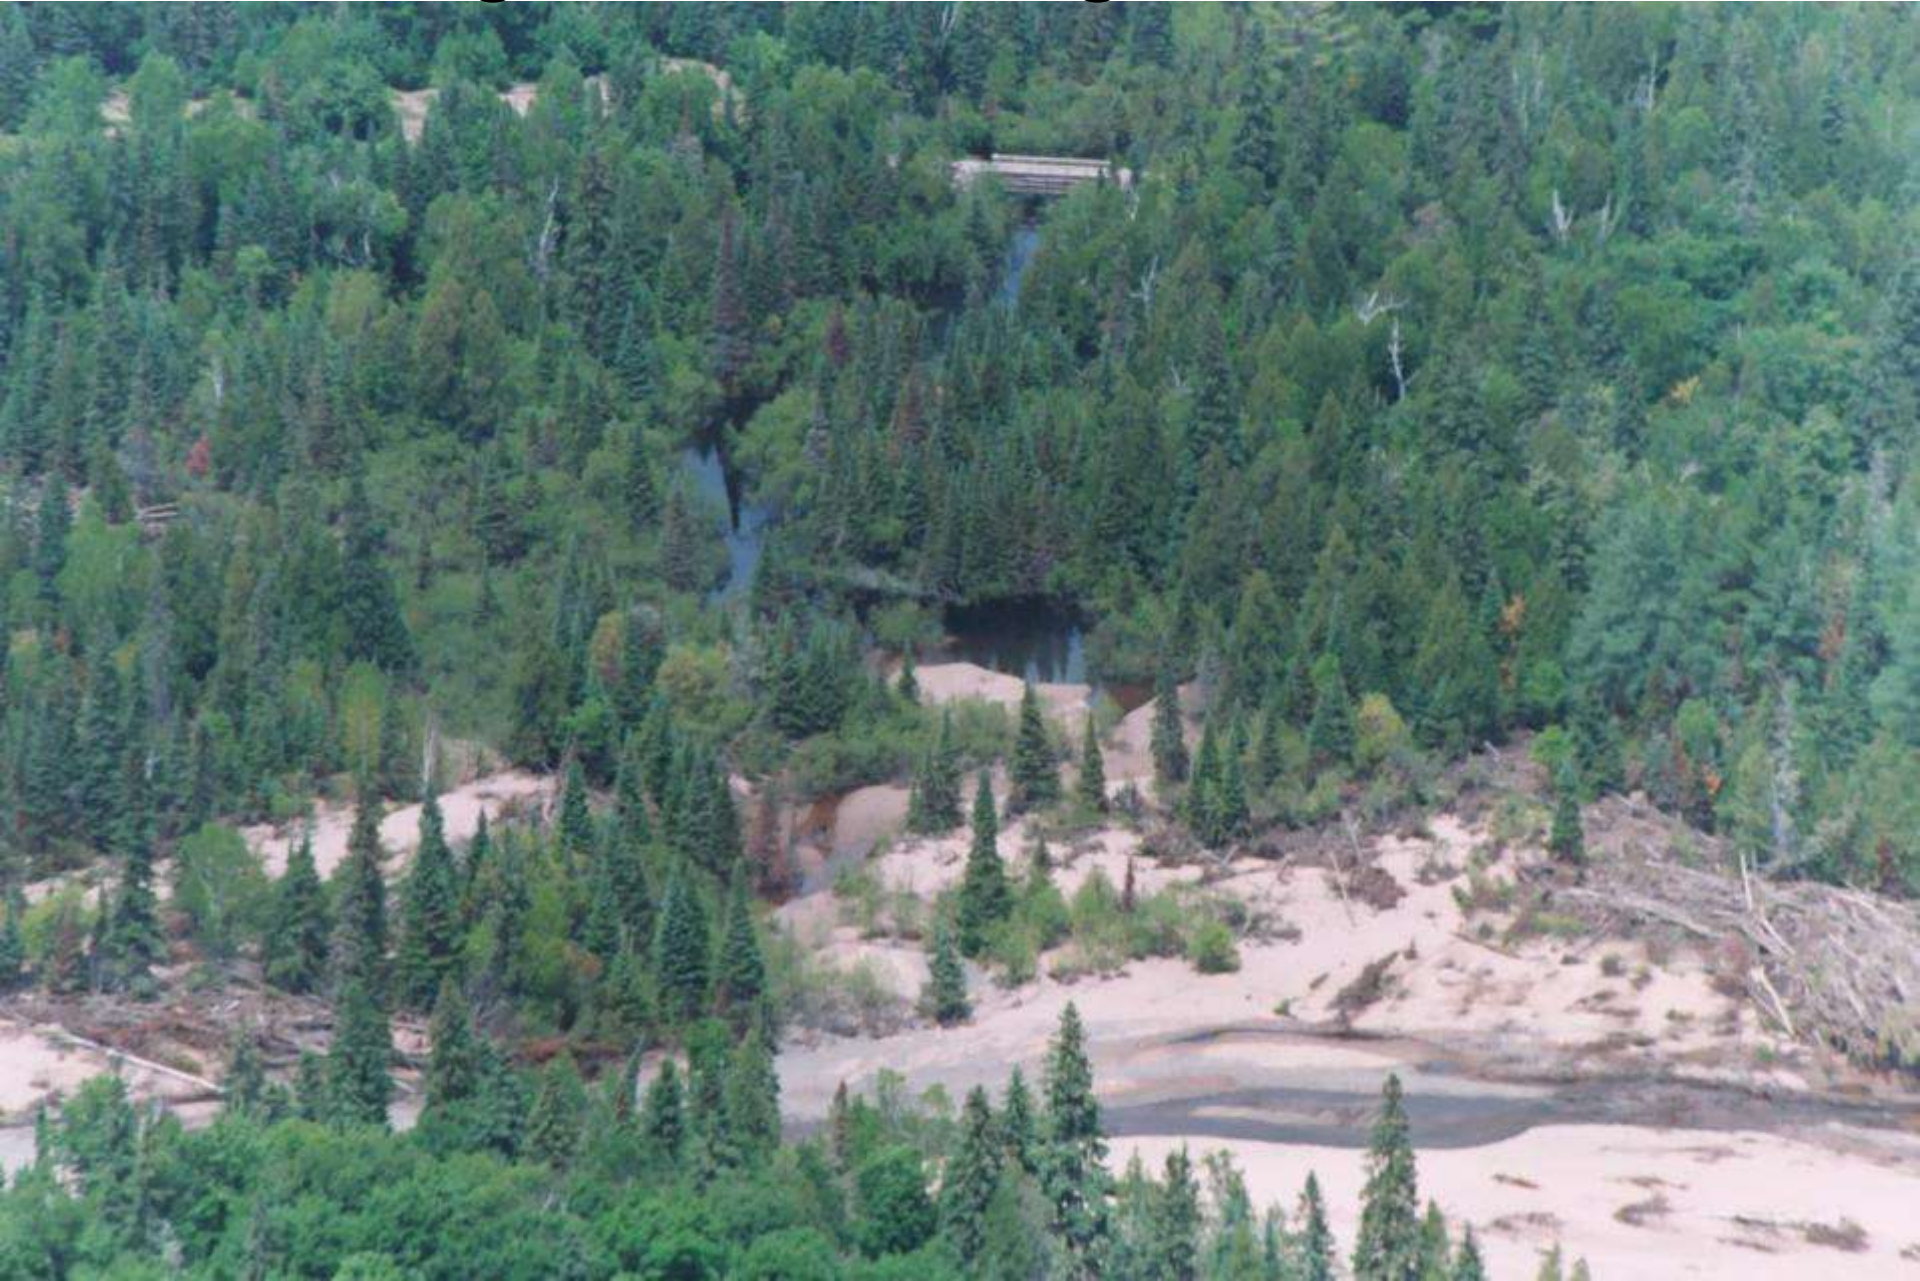
Sand Trap area looking US to
Mulligan Mouth 7-15-04

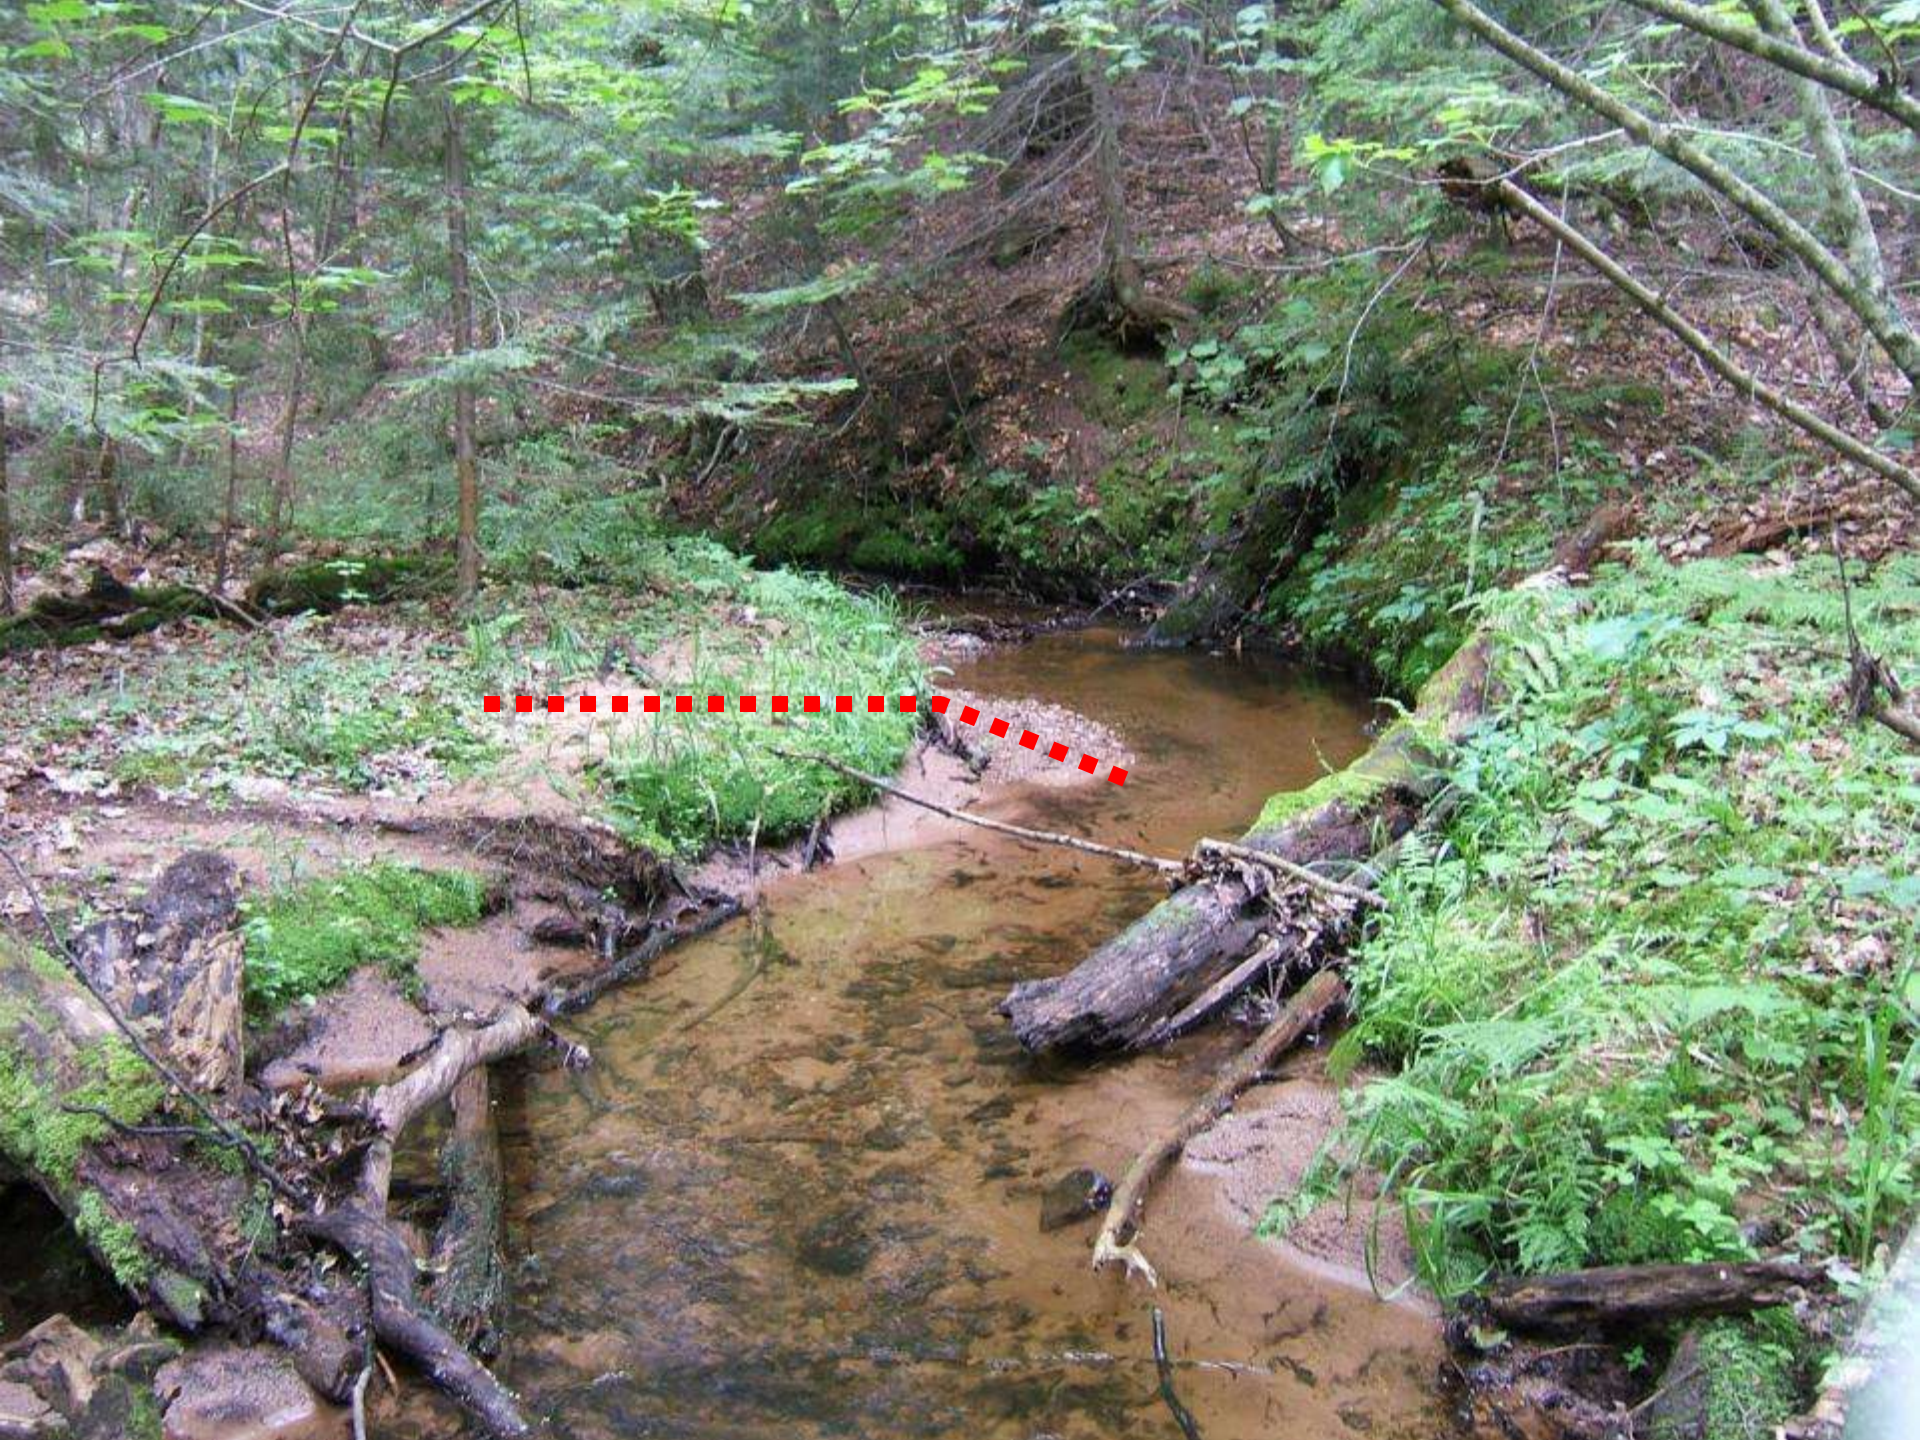
Once forested, there are now several sand plains left from the flood damage downstream of the fuse plug failure at Silver Lake Basin. (Connors Ck. Area 10/15/03)

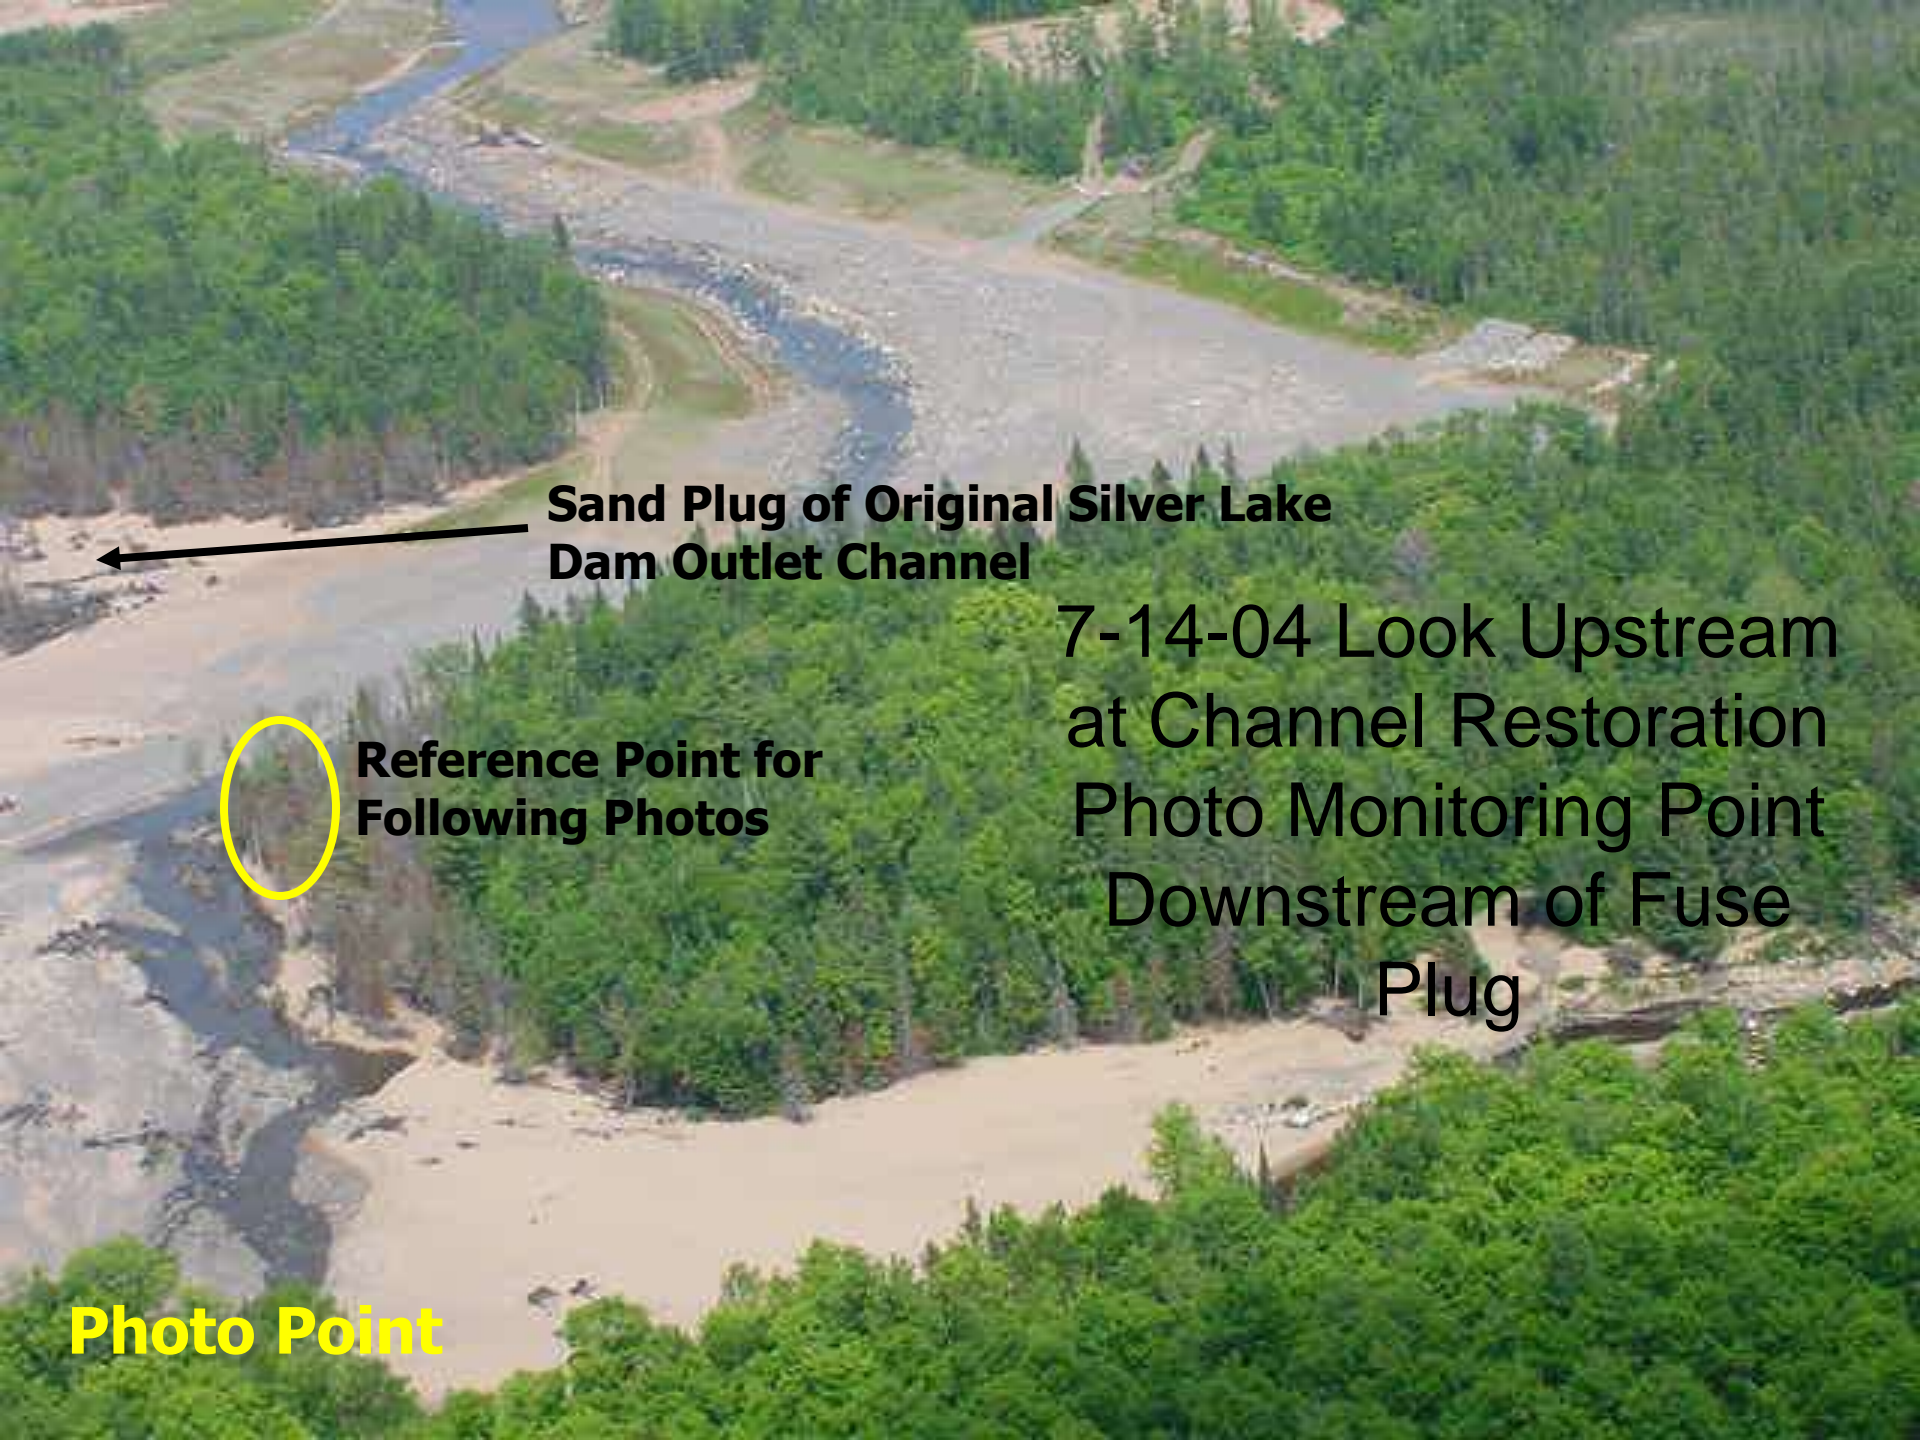
**Sand Plug of Original Silver Lake
Dam Outlet Channel**

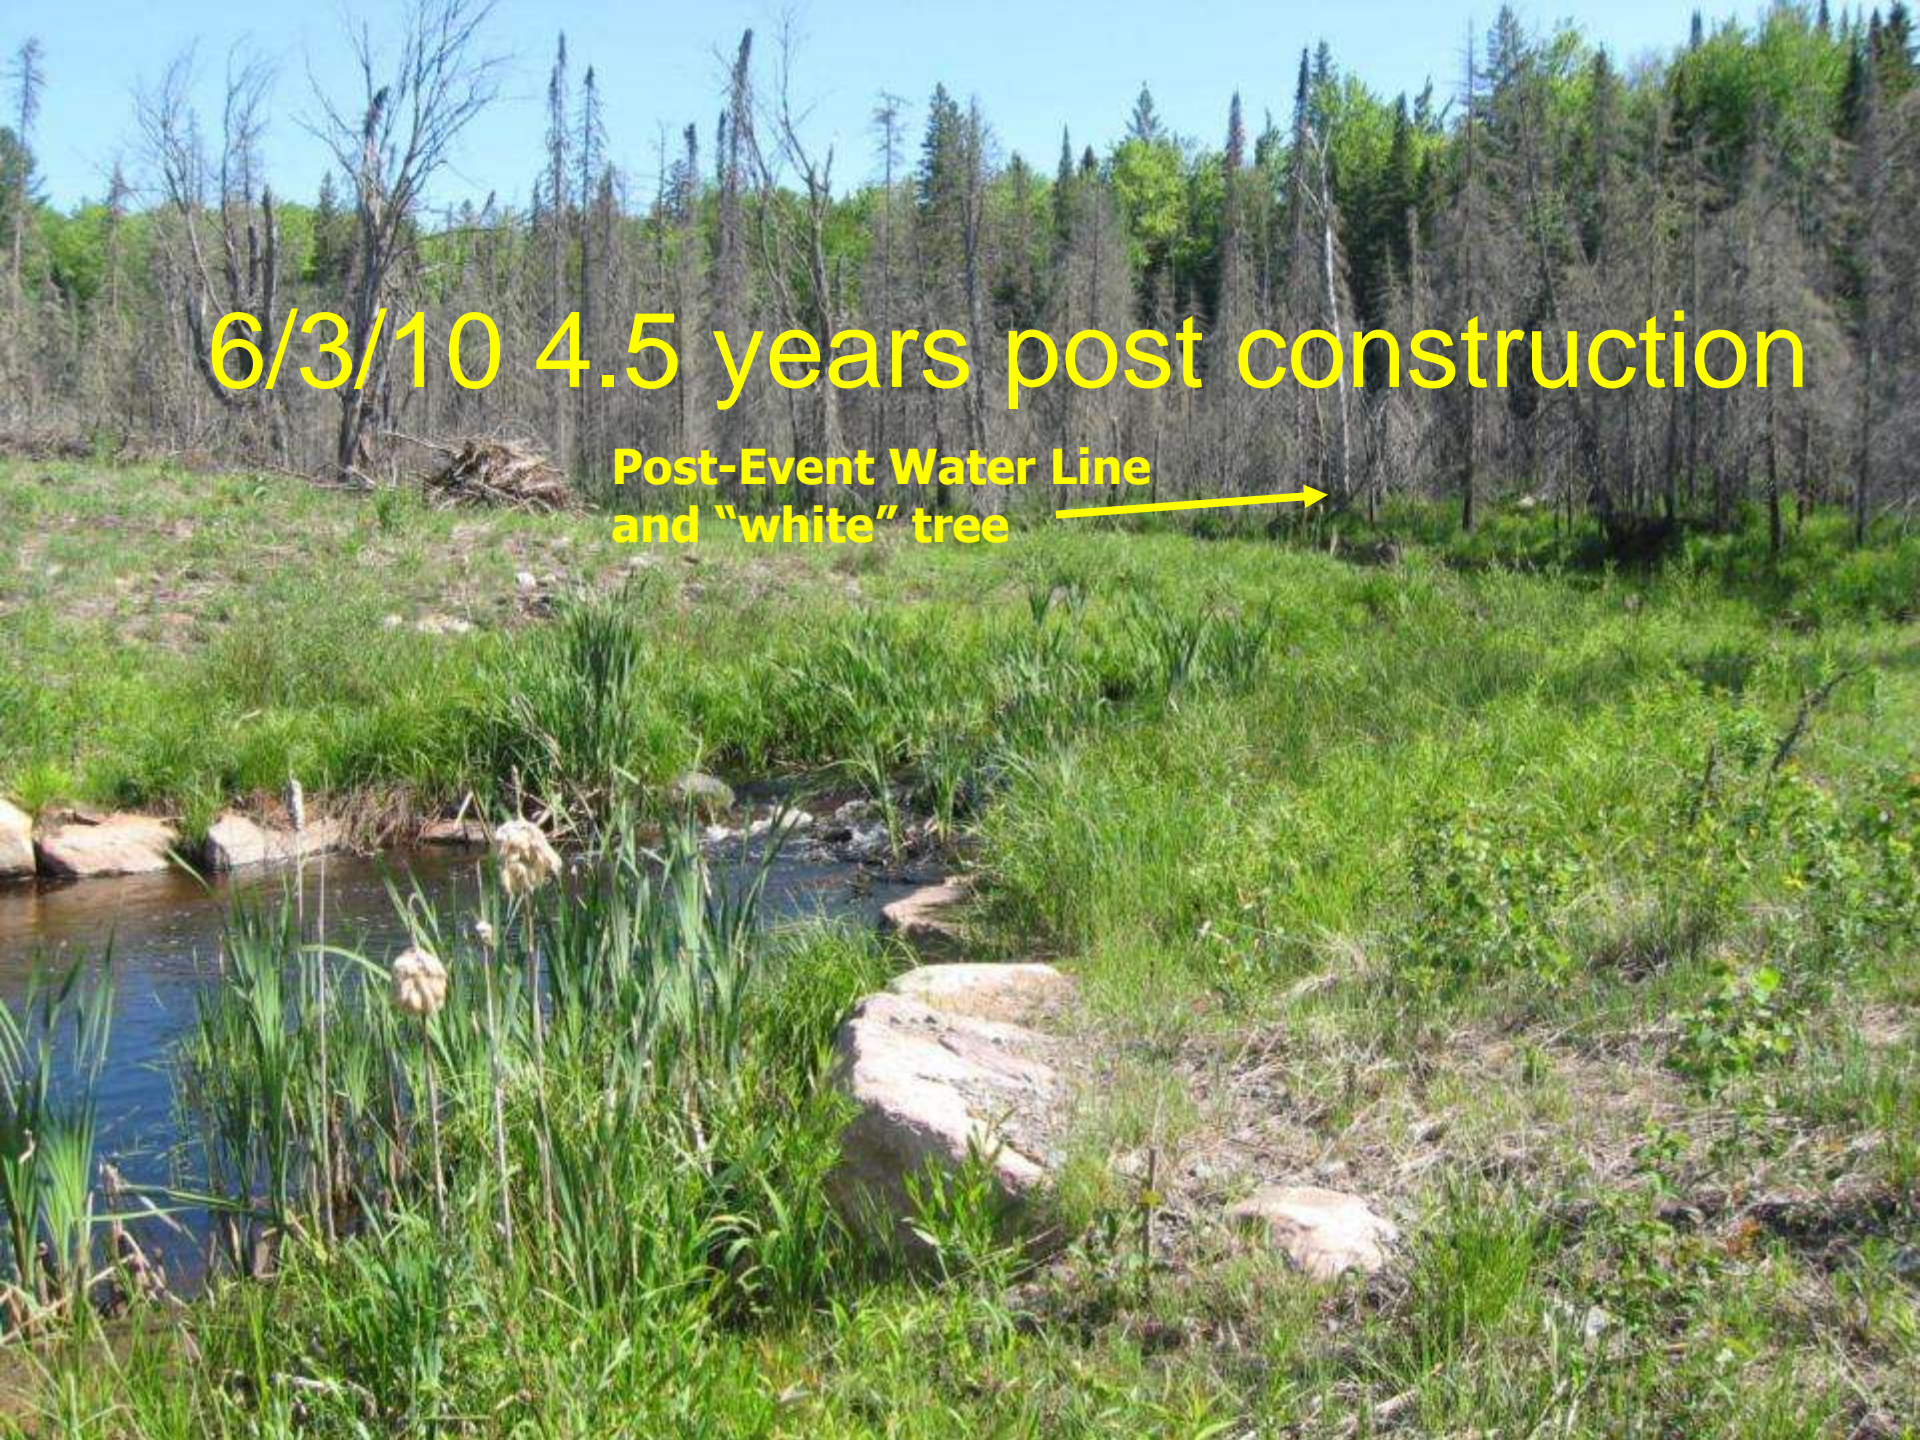
CR AAT Overlook Upstream of Mulligan Creek on the Dead River 6-30-03

**Note: wetted
soil line**

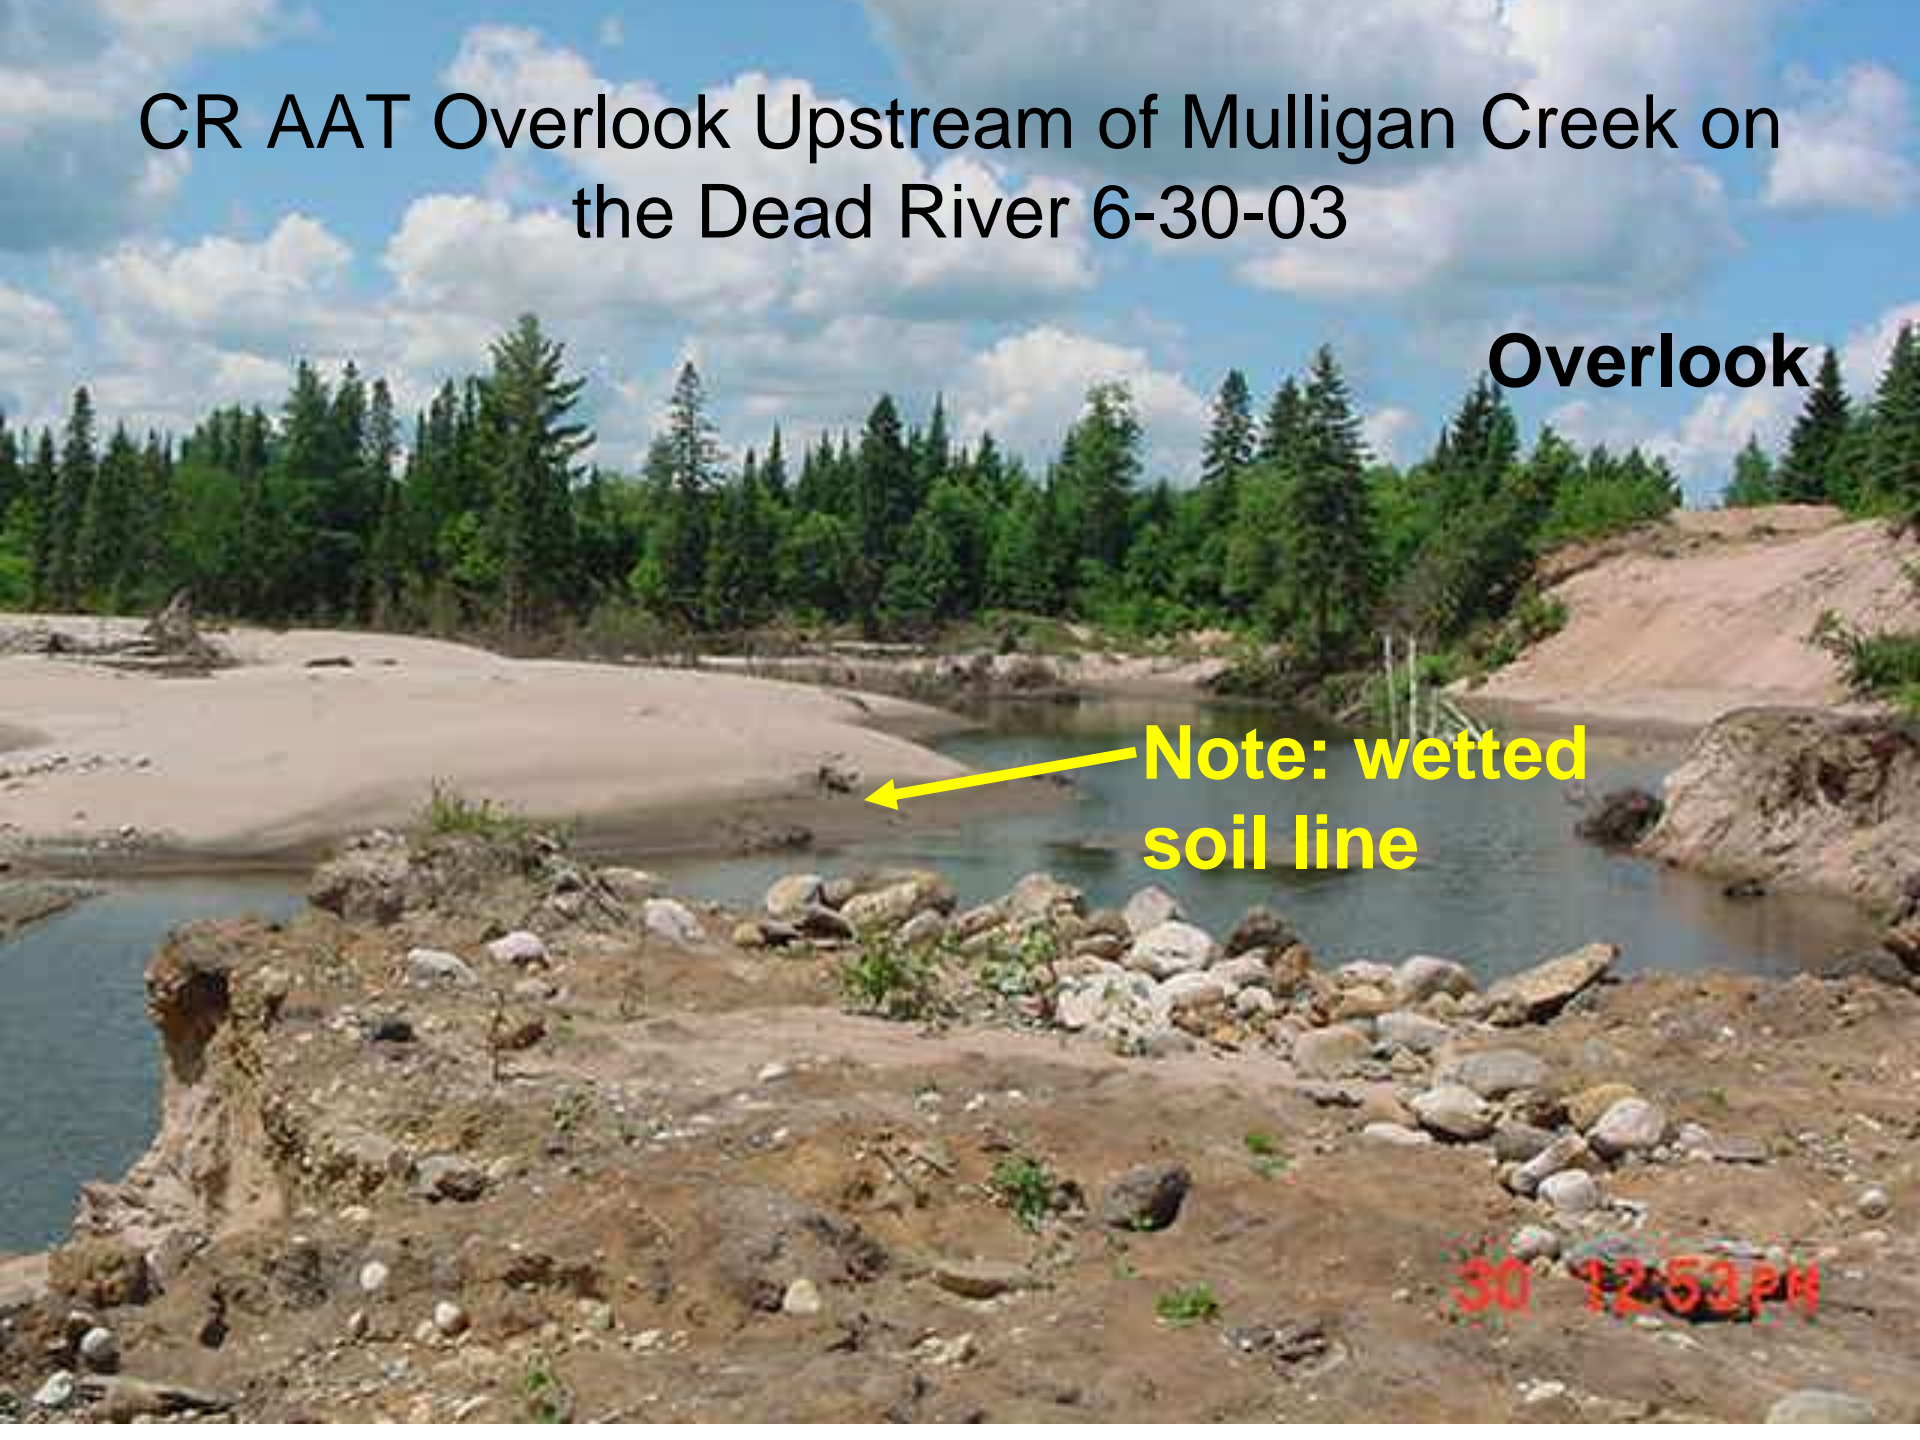
County Road AAT Overlook on 8-1-06 (3 years later)

Note: wetted
soil line
