CR AAO Bridge

Dead River Flood & Natural Channel Design

Mitch Koetje
Water Resources
Division
UP District

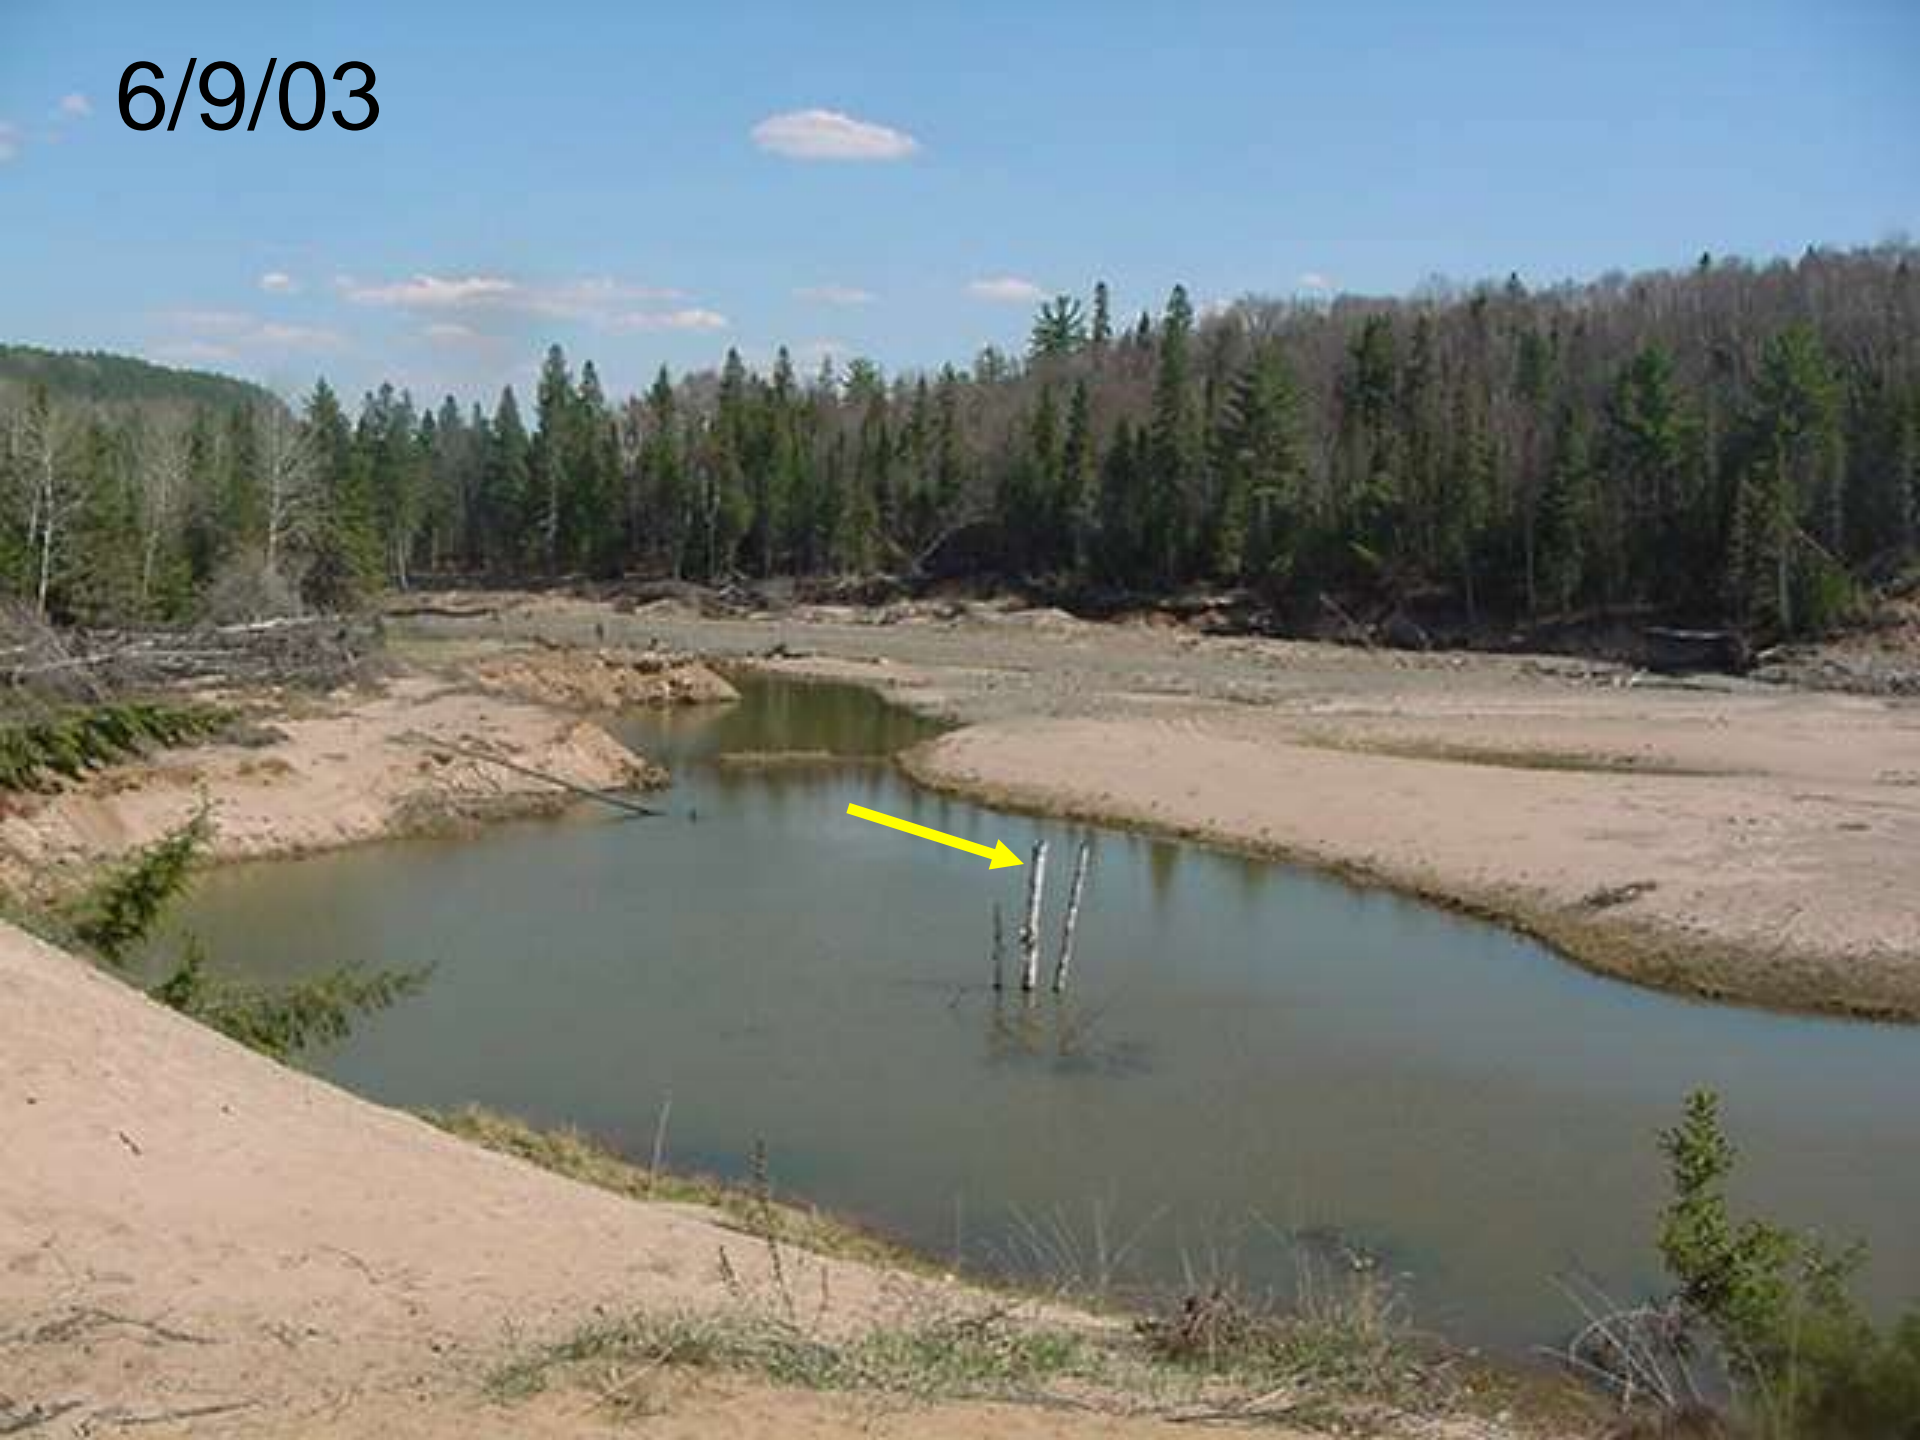
View of previous photo – Look
Upstream from the Road Overlook on
7-9-09 **6 years after the event**

**Less than 3 years after
construction**
