FERC Project No. 10855
NATDAM Nos. MI00178, MI00183,
& MI00197

Dead River Hydroelectric Project
2015 Annual Report - Operation Monitoring Plan &
Report of Deviations Less Than Sixty Minutes

Dead River Hydroelectric Project: Article 405
Operation Monitoring Plan Report of Deviations Less Than Sixty Minutes – 2015 Report

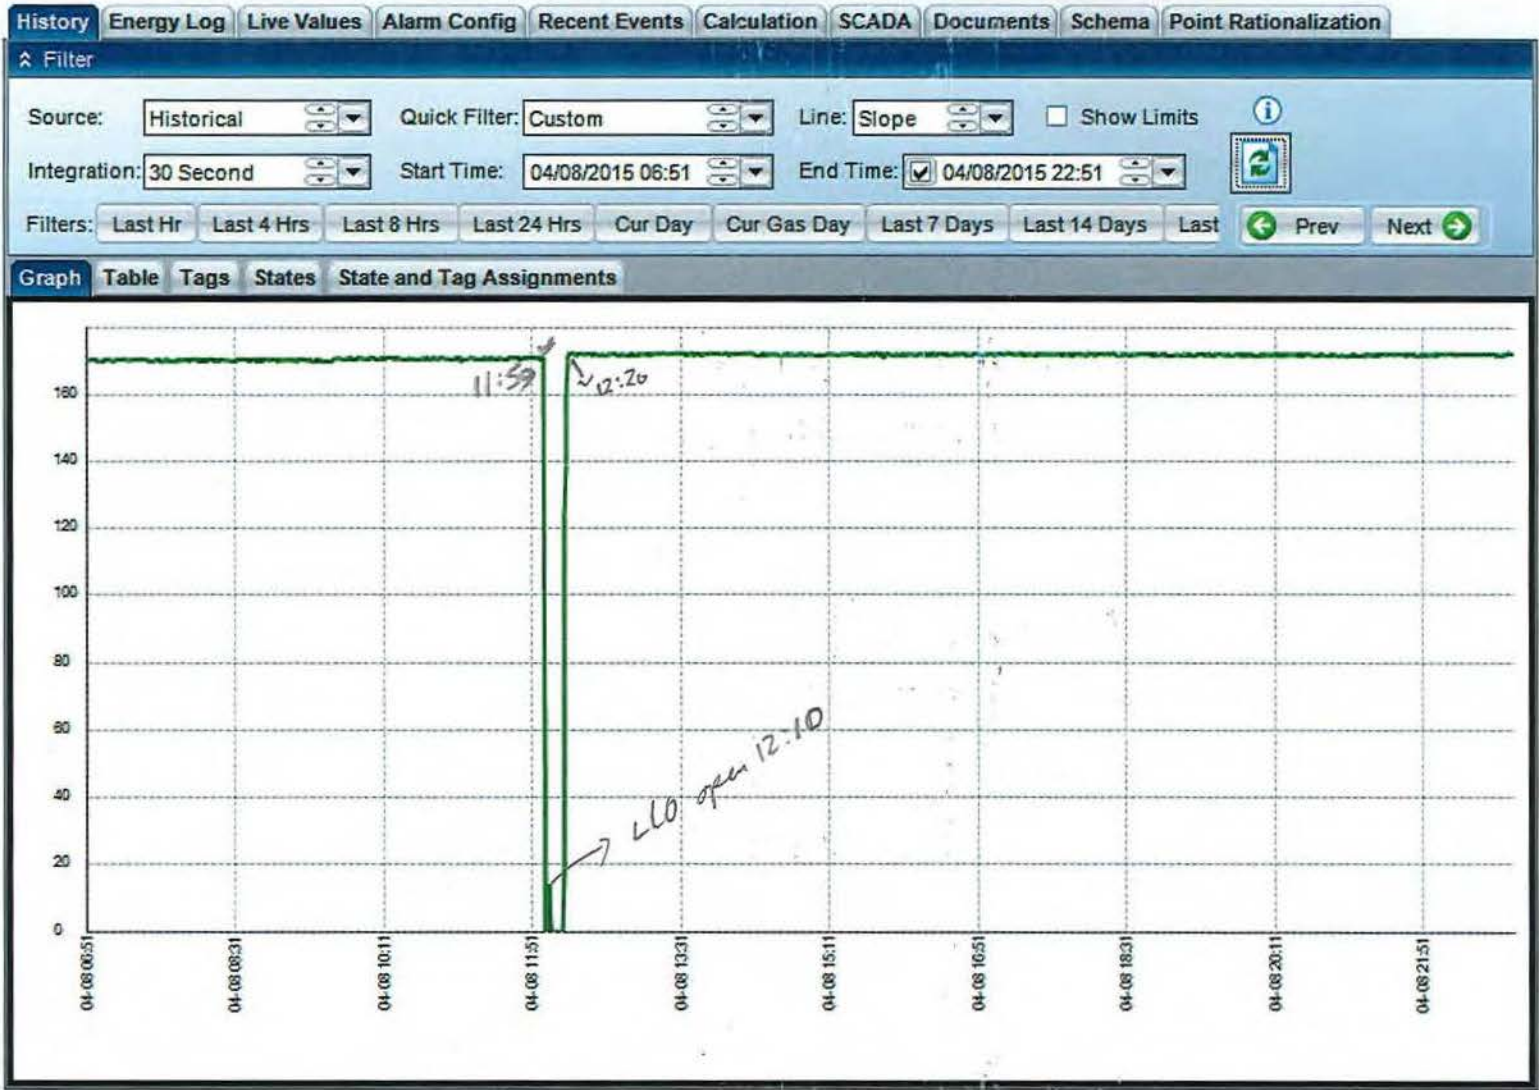
Point Info - UPPCO-HST: Total Plant Flow

NC Record Number:	NCREG7300		Entity:	Regional Generation	
Company - Level 1 - Level 2:	UPP-Hoist Hydro				
Event Date:	04/08/2015	Discovery Date/Time:	4/8/15 12:03		
Event Title:	Plant trip				
Event Details:	Plant tripped while electrical work was being performed				
Immediate Action:	Notified operator				
Recommendations:	Investigate and repair				
Potential Causes/Contributors to incident	unknown				
Entered By Name:	Garry D Gentry	Creation Date/Time:	4/8/15 12:04		
Entered By Department:	Energy Supply and Control	Status:	Closed		
Reportable to External Agency:	yes	Basis for Reportability:	Part of the < 60 minute requirement for FERC compliance, end of year report		
Additional Followup Required:	yes	Type:	FERC Deviation		
Category:	Regulatory	Description:			
Sub Type:	Plant equip. failure	Causal Analysis Basis:	Plant tripped when Maint was being done in plant, and a ground wire was removed on Unit 1 causing Unit 2 to trip. Ground was tied into the PT/CT protection circuit. Work on any further wires from Unit #1 will be stopped. Less than 100 CFS flow was interrupted for 11 minutes

Causal Analysis Level:	Closed - No further action required	Event Start:	4/8/2015 12:03 PM	Event End:	4/8/2015 12:14 PM
		Event Duration (HH:MM):	00:11		
Evaluator Name:		Evaluator Dept:			
Evaluation Accepted:		Acceptance Comments:			
Eval Due Date:		Eval Completion Date:			
Approver Name:		Corrective Action Approver Name:			
Analysis Description:					
Causes:					
Primary Causes:					
Does Eval Require Sceening Committee Approval upon Completion	no				
Evaluation Reviewed/Approved by Screening Committee

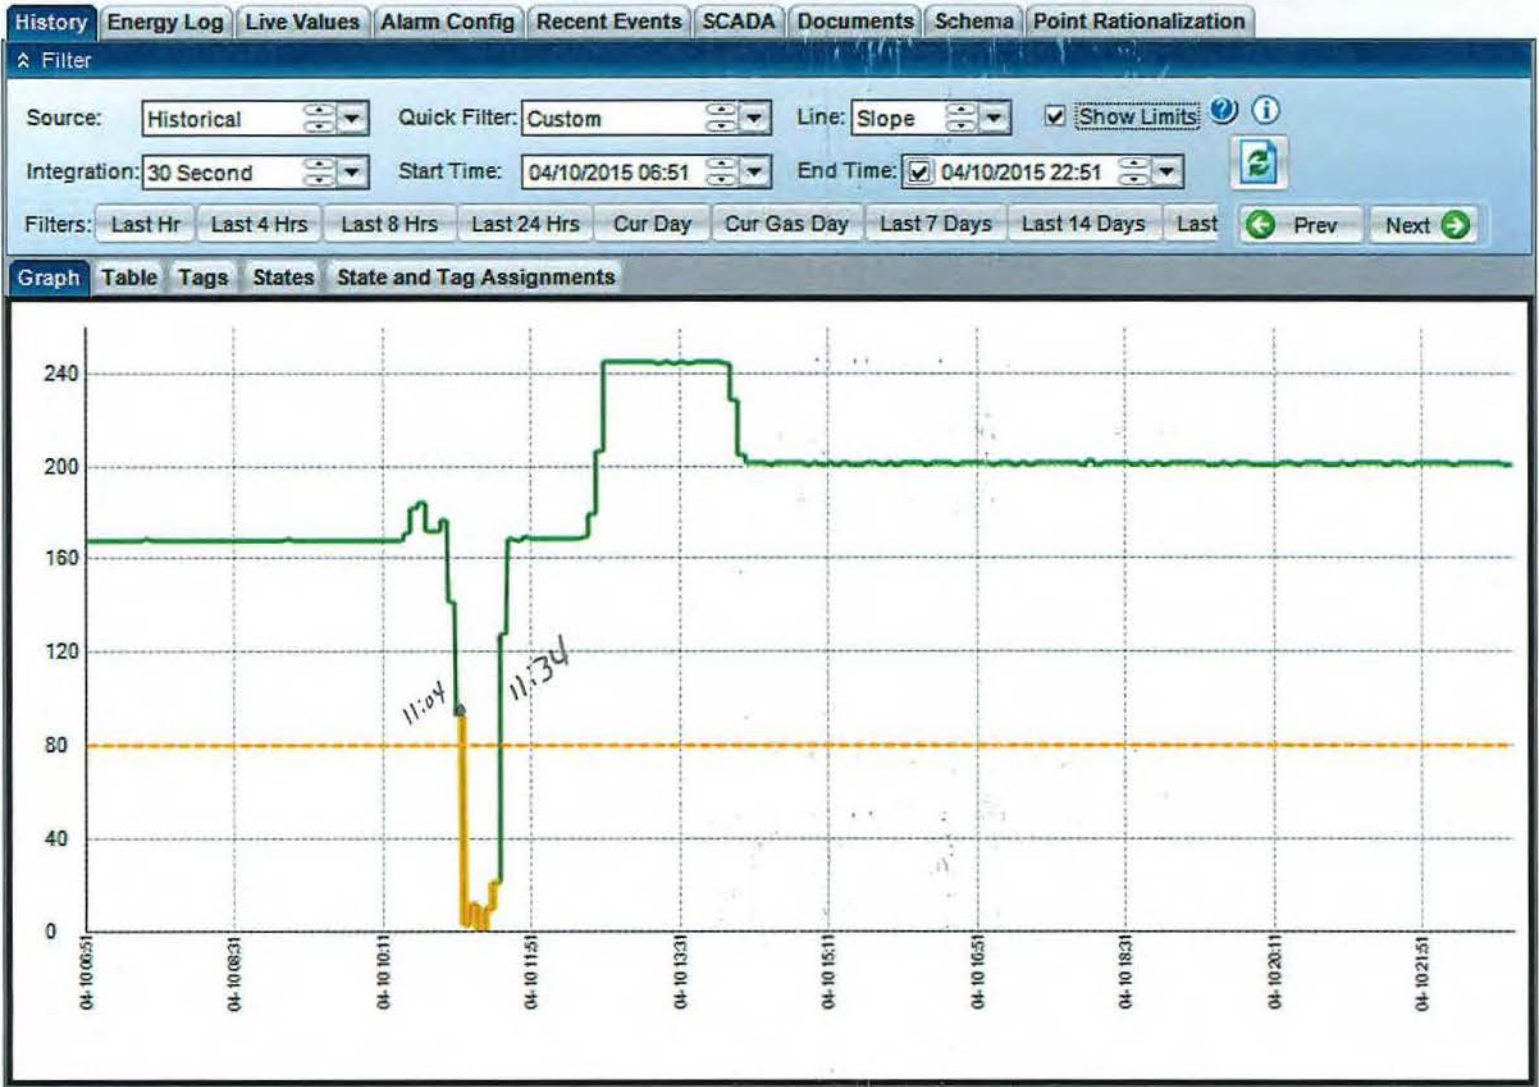
Point Info - UPPCO-MCL: Powerhouse Penstock Flow

NC Record Number:	NCREG7309	Entity:	Regional Generation
Company - Level 1 - Level 2:	UPP-McClure Hydro		
Event Date:	04/10/2015	Discovery Date/Time:	4/10/15 12:09
Event Title:	Plant trip		
Event Details:	At 1104 central time on 4-10-2015 Unit #2 tripped offline, according to the operator they smoked a packing. They were unable to get Unit #1 online. At 1129 Central time unit #1 was online and flows were restored.		
Immediate Action:	Called the plant and spoke to the operator.		
Recommendations:	None.		
Potential Causes/Contributors to Incident	Packing failure.		
Entered By Name:	Stephen M Beirne	Creation Date/Time:	4/10/15 12:12
Entered By Department:	Energy Supply and Control	Status:	Closed
Reportable to External Agency:	no	Basis for Reportability:	< 60 minutes event, will be end of year report to FERC
Additional Followup Required:	yes	Category:	Regulatory
Sub Type:	Plant equip. failure	Type:	FERC Deviation

Causal Analysis Level:	Closed - No further action required	Description:	
Causal Analysis Basis:	When adjusting unit for Operation, packing burned, and unit was tripped off line. Other unit was started and flow restored.		
Event Start:	4/10/2015 11:04 AM	Event End:	4/10/2015 11:29 AM
Event Duration (HH:MM):	00:25		
Evaluator Name:			
Evaluator Dept:			
Evaluation Accepted:			
Acceptance Comments:			
Eval Due Date:			
Eval Completion Date:			
Approver Name:			
Corrective Action Approver Name:			
Analysis Description:			
Causes:			
Primary Causes:			
Does Eval Require Screening Committee Approval upon Completion	no		
Evaluation Reviewed/Approved by Screening Committee

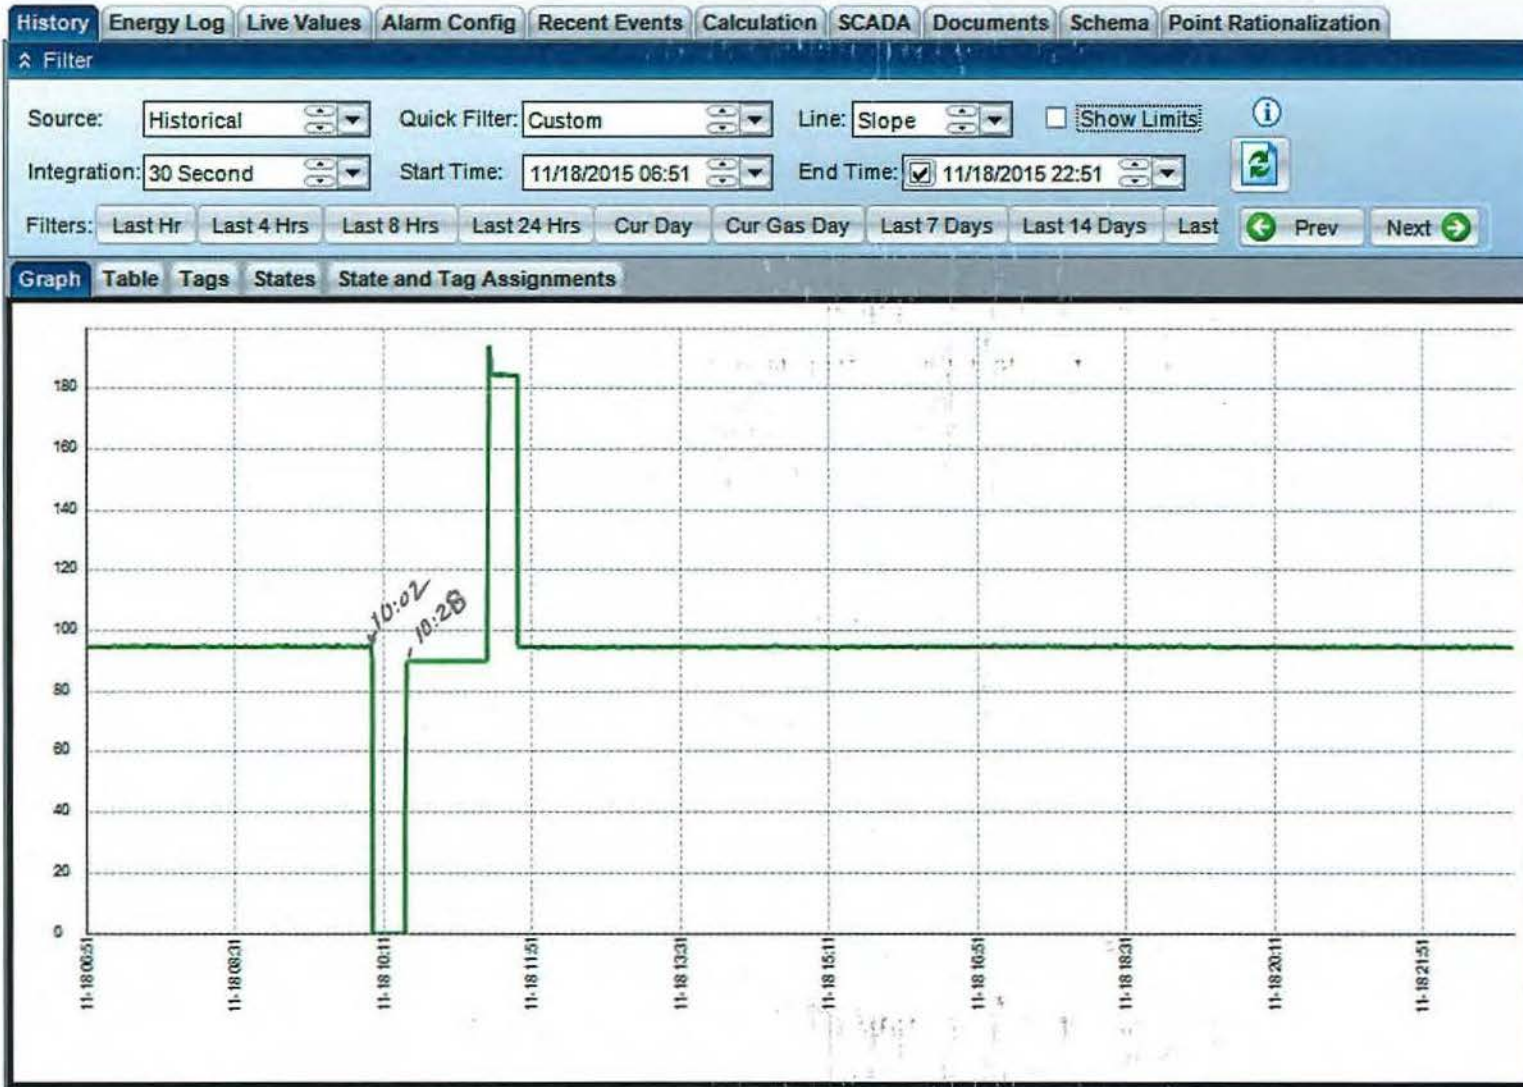
Point Info - UPPCO-HST: Total Plant Flow

NC Record Number:	NCREG8233	Entity:	Regional Generation
Company - Level 1 - Level 2:	UPP-Hoist Hydro		
Event Date:	11/18/2015	Discovery Date/Time:	11/18/15 10:03
Event Title:	Hoist Plant Trip		
Event Details:	Plant tripped at 1003CST Loss of power. Paged local operator. He went to plant and opened LLO to 90CFS. Power returned to the plant at 1113CST. Unit #2 back online at 1121CST		
Immediate Action:	Paged local operator		
Recommendations:	None		
Potential Causes/Contributors to incident	Weather		
Entered By Name:	Brian K Ellison	Creation Date/Time:	11/18/15 13:39
Entered By Department:	Energy Supply and Control	Status:	Closed
Reportable to External Agency:	no	Basis for Reportability:	Will be sent to FERC as part of overall outage
Additional Followup Required:	yes		
Category:	Regulatory	Type:	FERC Deviation
Sub Type:	Trans. Sys. (storm related)	Description:	tree
Causal Analysis Level:	Closed - No further action required	Causal Analysis Basis:	Unit tripped, after tree was cleared, unit went back into service. LLO was opened within 26 minutes, but since McClure was taken off also, it will be reported as the same event.

Event Start:	11/18/2015 10:02 AM	Event End:	11/18/2015 10:28 AM
Event Duration (HH:MM):	00:26		
Evaluator Name:		Evaluator Dept:	
Evaluation Accepted:		Acceptance Comments:	
Eval Due Date:		Eval Completion Date:	
Approver Name:		Corrective Action Approver Name:	
Analysis Description:			
Causes:			
Primary Causes:			
Does Eval Require Scening Committee Approval upon Completion	no		
Evaluation Reviewed/Approved by Screening Committee

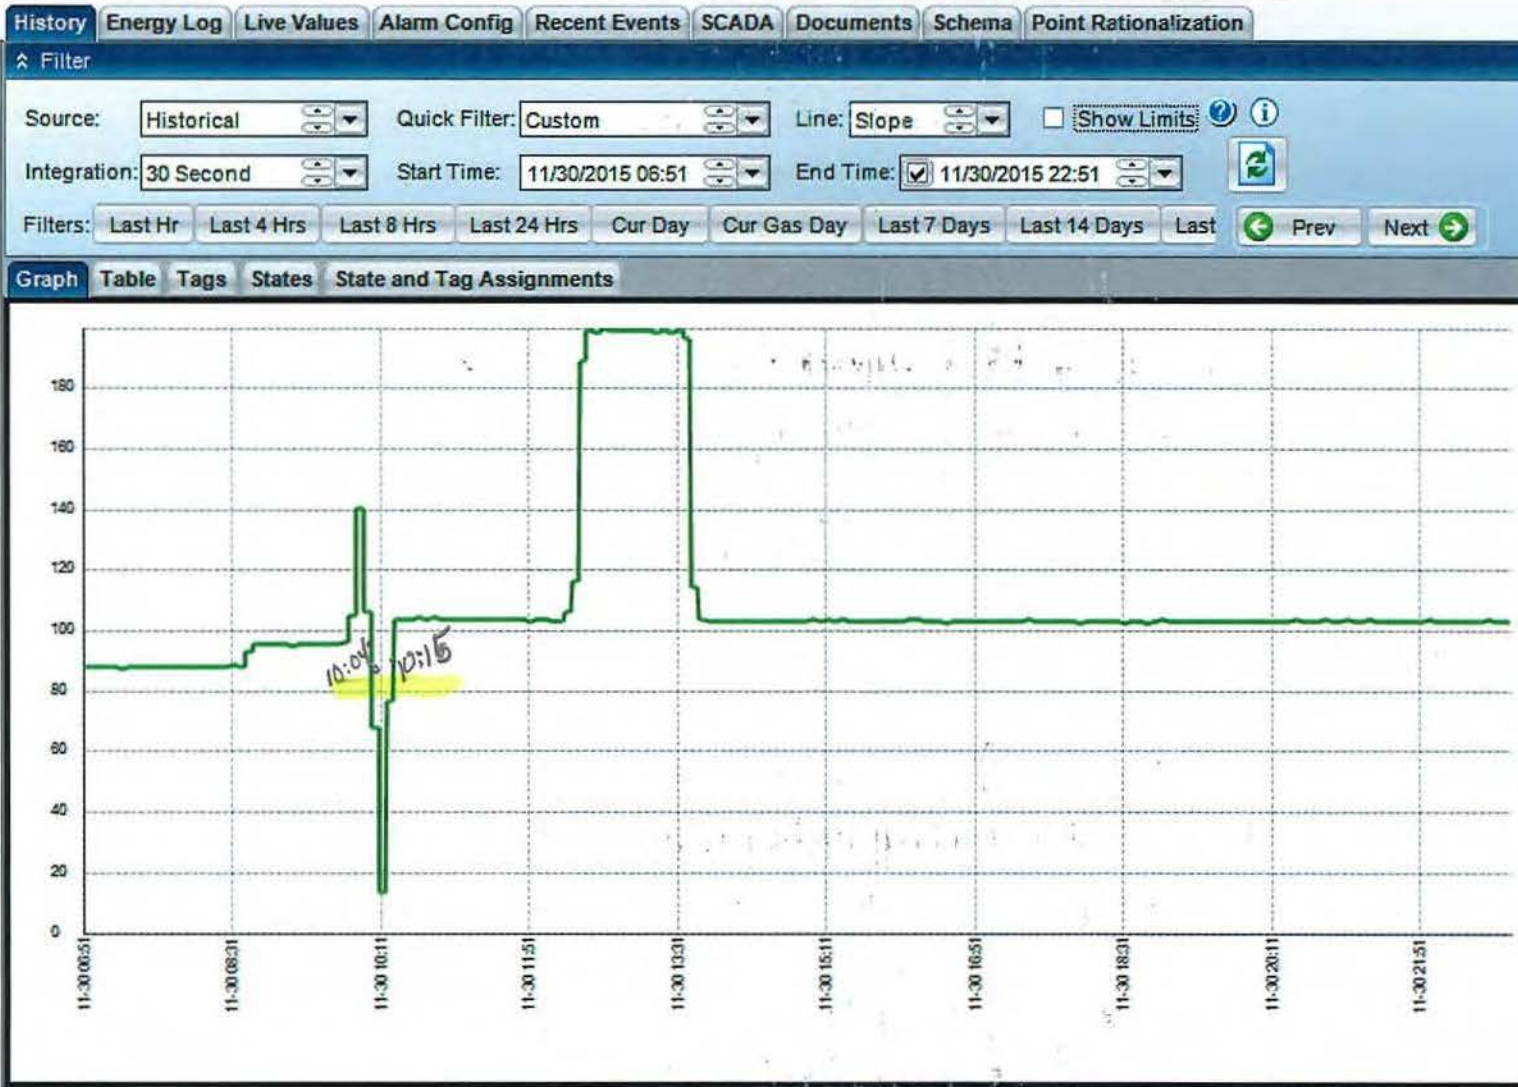
Point Info - UPPCO-MCL: Powerhouse Penstock Flow

NC Record Number:	NCREG8282	Entity:	Regional Generation
Company - Level 1 - Level 2:	UPP-McClure Hydro		
Event Date:	11/30/2015	Discovery Date/Time:	11/30/15 10:08
Event Title:	Minimum flow deviation		
Event Details:	After swapping units, unit 1 placed online and unit 2 taken offline, unit 1 tripped due to packing problems and flow decreased to 0 cfs which deviated from the minimum flow of 80 cfs.		
Immediate Action:	Flow was restored whe local hydro operator placed unit 2 back online at 10:16 CST		
Recommendations:	None		
Potential Causes/Contributors to incident	Unit 1 packing problems		
Entered By Name:	Terrie S Taylor	Creation Date/Time:	11/30/15 10:18
Entered By Department:	Energy Supply and Control	Status:	Closed
Reportable to External Agency:	no	Basis for Reportability:	Need to go in as a <60 minute event end of the year
Additional Followup Required:	yes		
Category:	Regulatory	Type:	FERC Deviation

Sub Type:	Plant equip. failure	Description:	packing
Causal Analysis Level:	Closed - No further action required	Causal Analysis Basis:	When units were swapped, unit one was stopped and other unit had a packing issue when it was on line on its own.
Event Start:	11/30/2015 10:06 AM	Event End:	11/30/2015 10:17 AM
		Event Duration (HH:MM):	00:11
Evaluator Name:		Evaluator Dept:	
Evaluation Accepted:		Acceptance Comments:	
Eval Due Date:		Eval Completion Date:	
Approver Name:		Corrective Action Approver Name	
Analysis Description:			
Causes:			
Primary Causes:			
Does Eval Require Scenning Committee Approval upon Completion			no
Evaluation Reviewed/Approved by Screening Committee

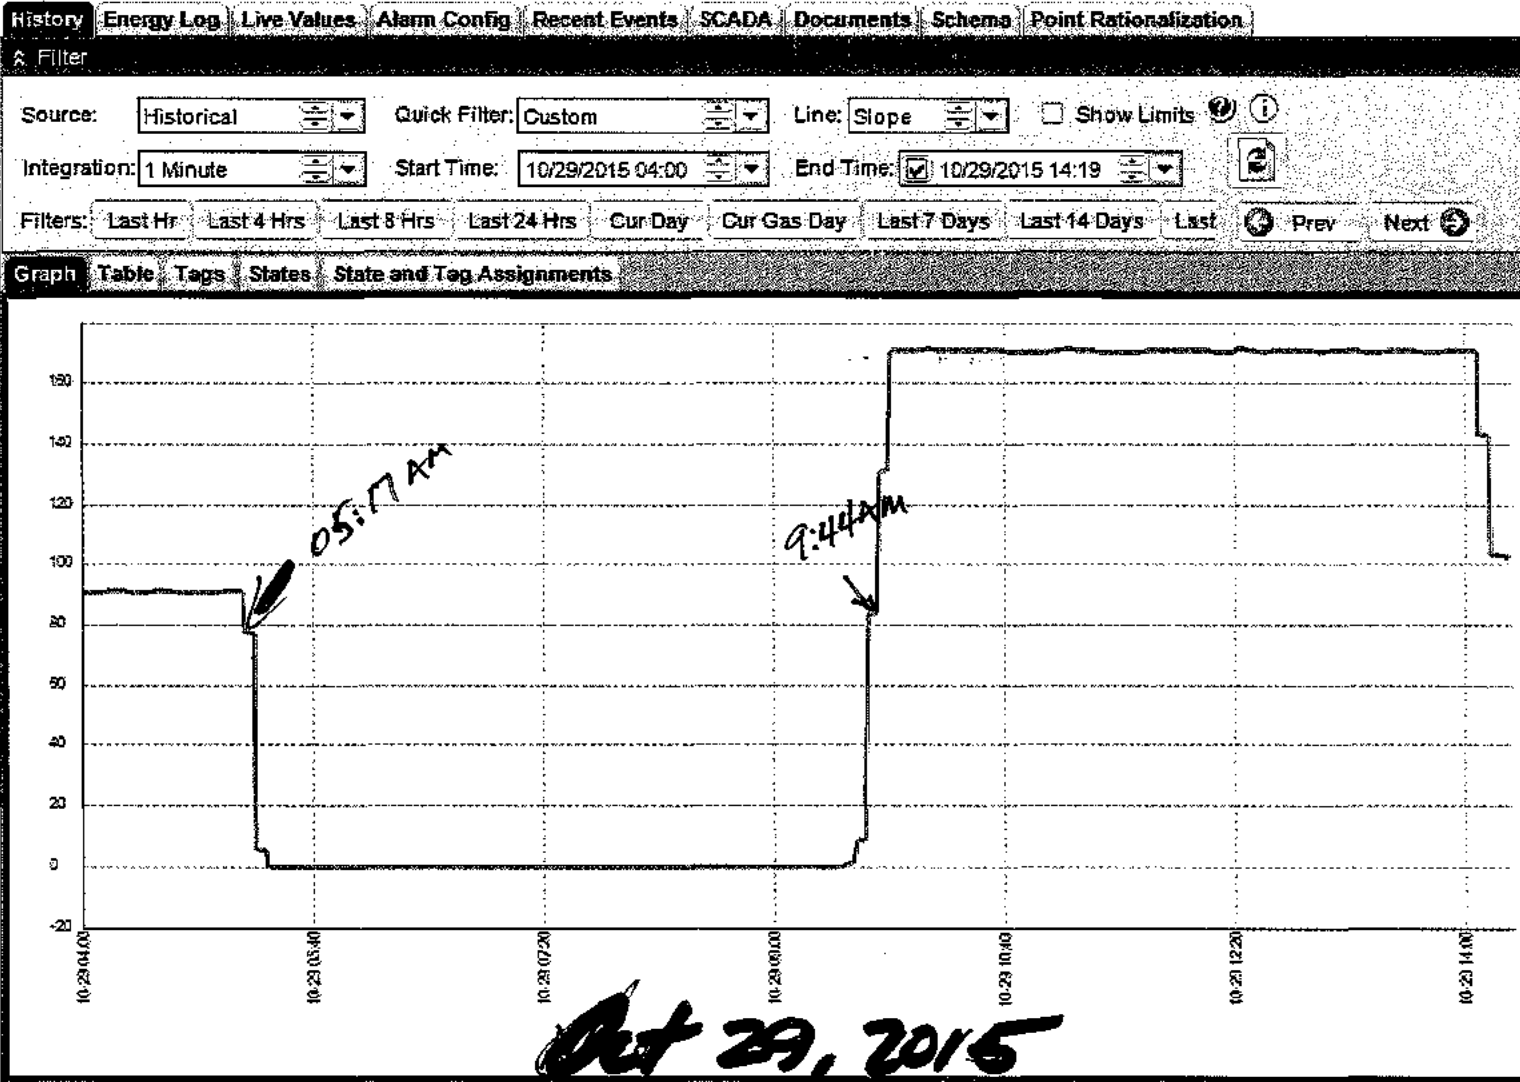
McClure Power House Flow
FERC Project No. 10855

The McClure Development tripped offline at 05:17 CDT, Thursday October 29, 2015, due to an electrical problem in the substation. An operator was dispatched, and flows at the McClure Development were re-established at 09:44 CDT, Thursday October 29, 2015, when the issue with the substation was isolated and the other unit was put into service. The substation issue was determined to be caused by a blown insulator. The insulator was replaced and the McClure Development returned to normal operation at 09:44 CDT October 29, 2015.

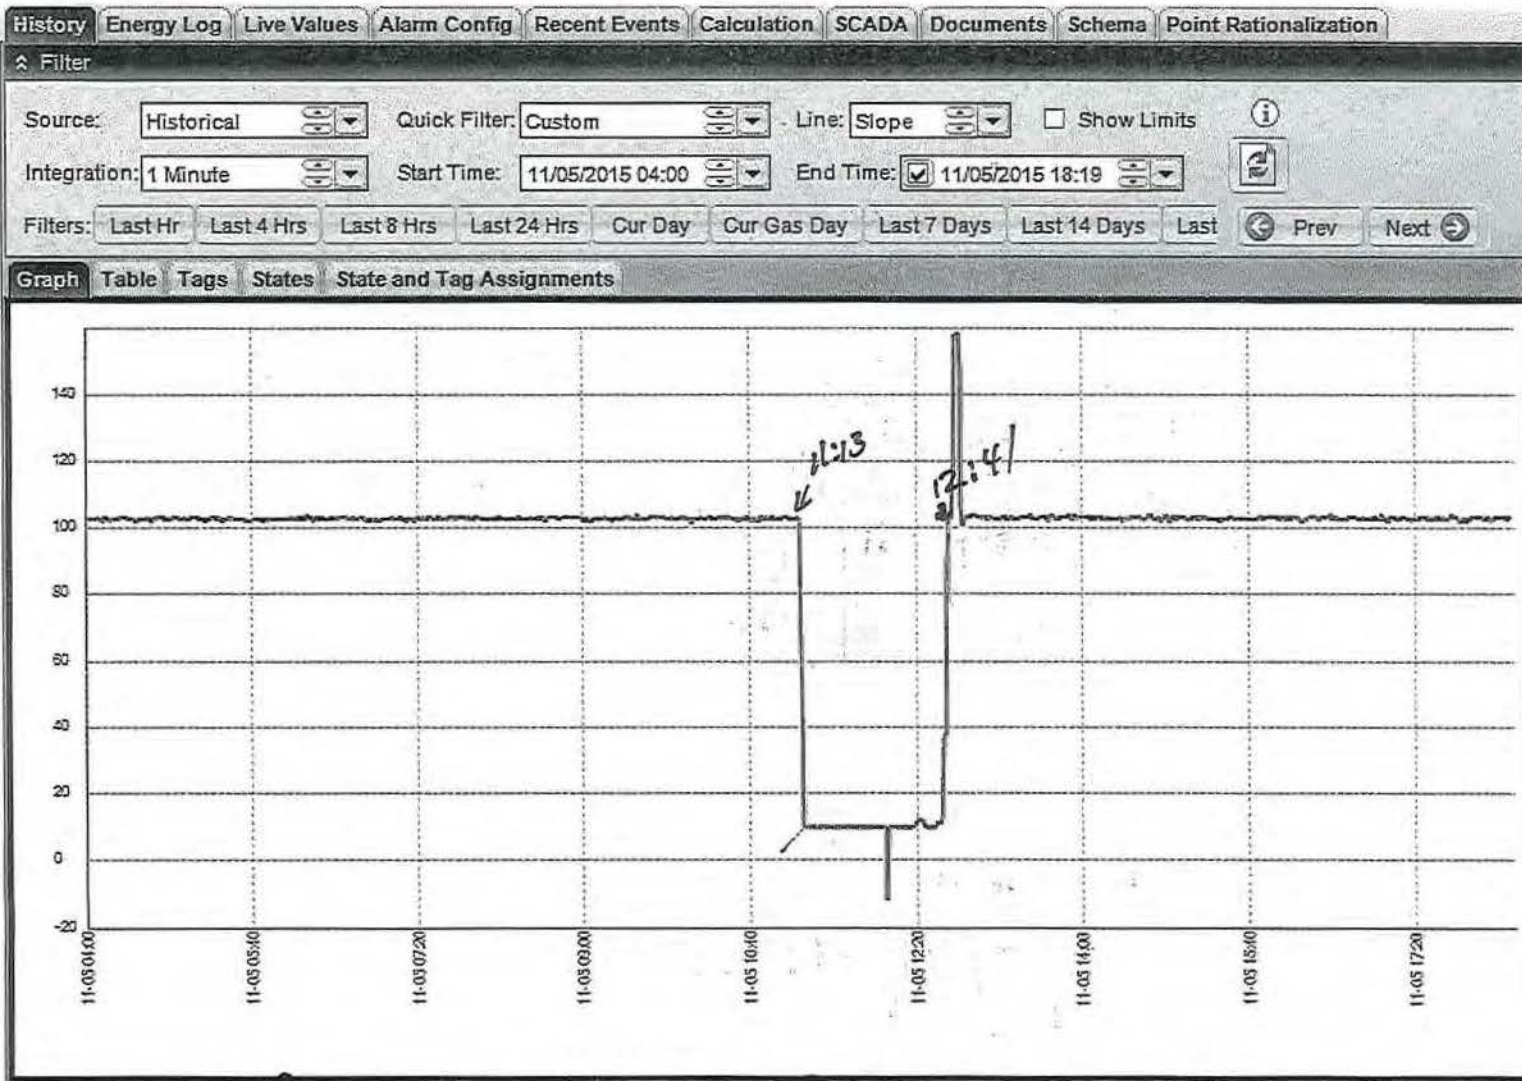
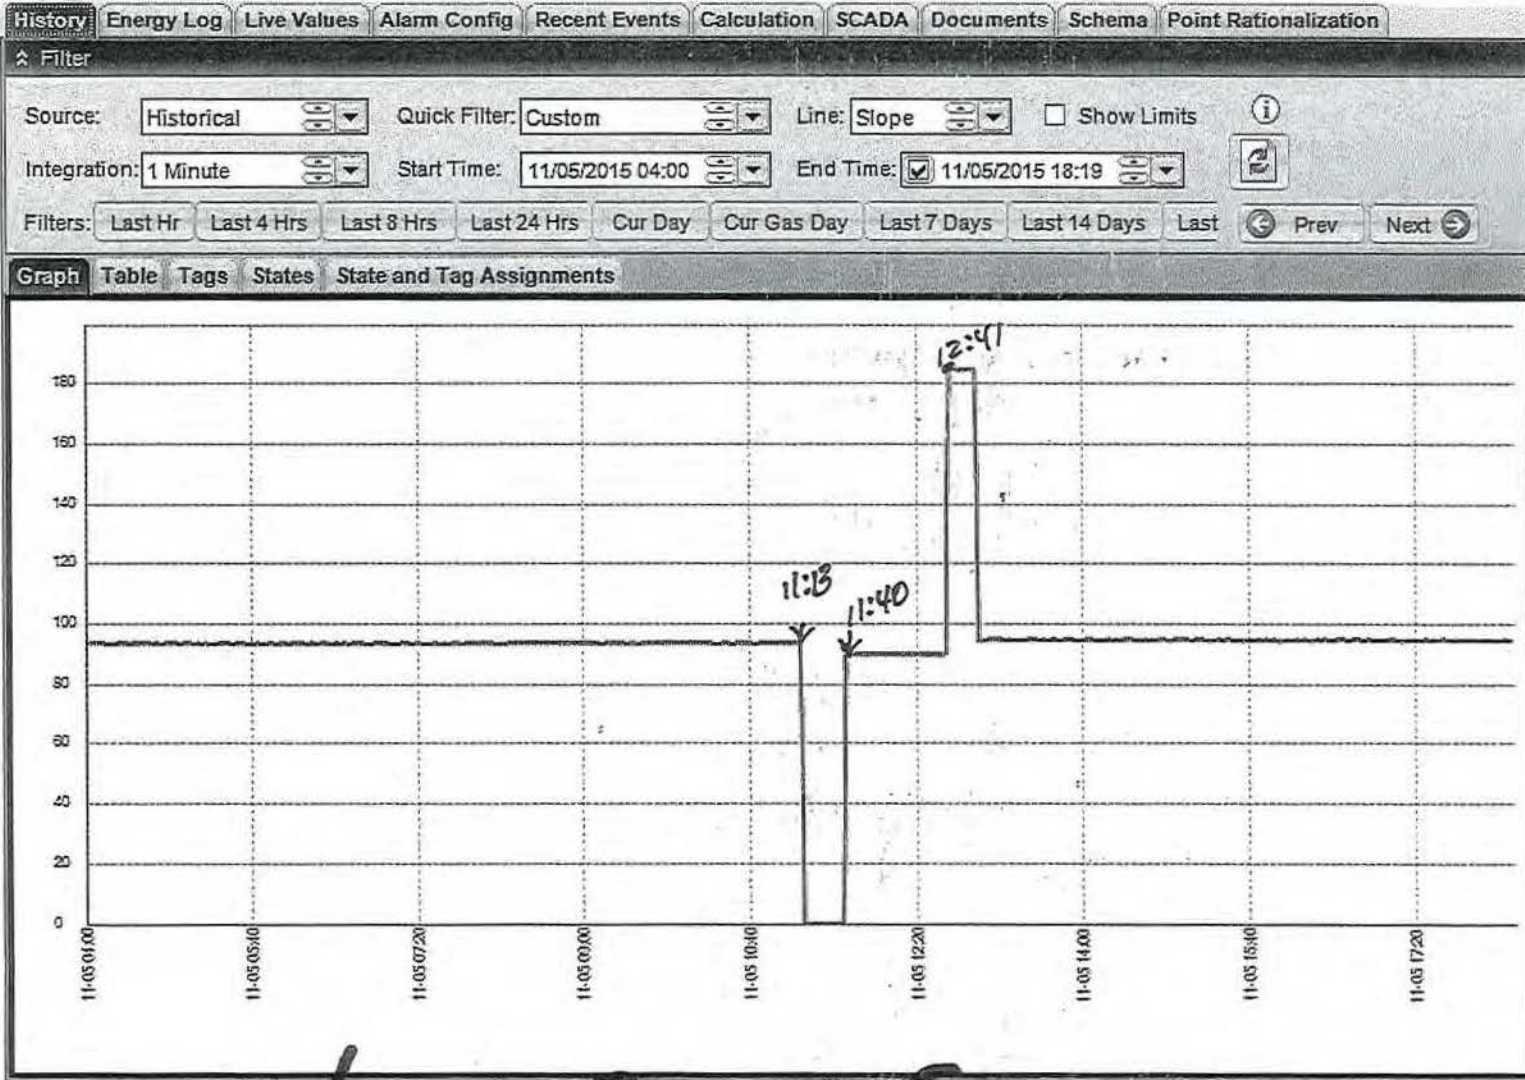
NC Record Number:	NCREG8185	Entity:	Regional Generation
Company - Level 1 - Level 2:	UPP-Hoist Hydro; UPP-McClure Hydro		
Event Date:	11/05/2015	Discovery Date/Time:	11/5/15 12:38
Event Title:	Plants tripped off line.		
Event Details:	plant trips		
Immediate Action:	2 operators were at each plant. LLO opened at about 1136 to 90 cfs Both plants back online at 1237		
Recommendations:	none		
Potential Causes/Contributors to incident	Wind		
Entered By Name:	Jeffrey S Greaves	Creation Date/Time:	11/5/15 12:39
Entered By Department:	Energy Supply and Control	Status:	Closed
Reportable to External Agency:	no	Basis for Reportability:	>60 minutes needs a letter to FERC
Additional Followup Required:	yes		
Category:	Regulatory	Type:	FERC Deviation
Sub Type:	Trans. Sys. (storm related)	Description:	
Causal Analysis Level:	Closed - No further action required	Causal Analysis Basis:	Tree from off the rightaway took fell, took off the McClure and Hoist plants

Both the Hoist and McClure Developments tripped offline at 11:13 CDT, Thursday, November 5, 2015, due to an electrical fault caused by trees from off the right away falling onto the line, which caused an electrical outage on the transmission system. Operators were able to re-establish the minimum flows for the Hoist Development through the low level outlet November 5, 2015 11:40 CDT. Minimum flows at the McClure Development were re-established on November 5, 2015 12:41 CDT, when the Development came back online. Both the Hoist and McClure Developments were returned to normal operation with the return of the transmission system at 12:41 CDT.

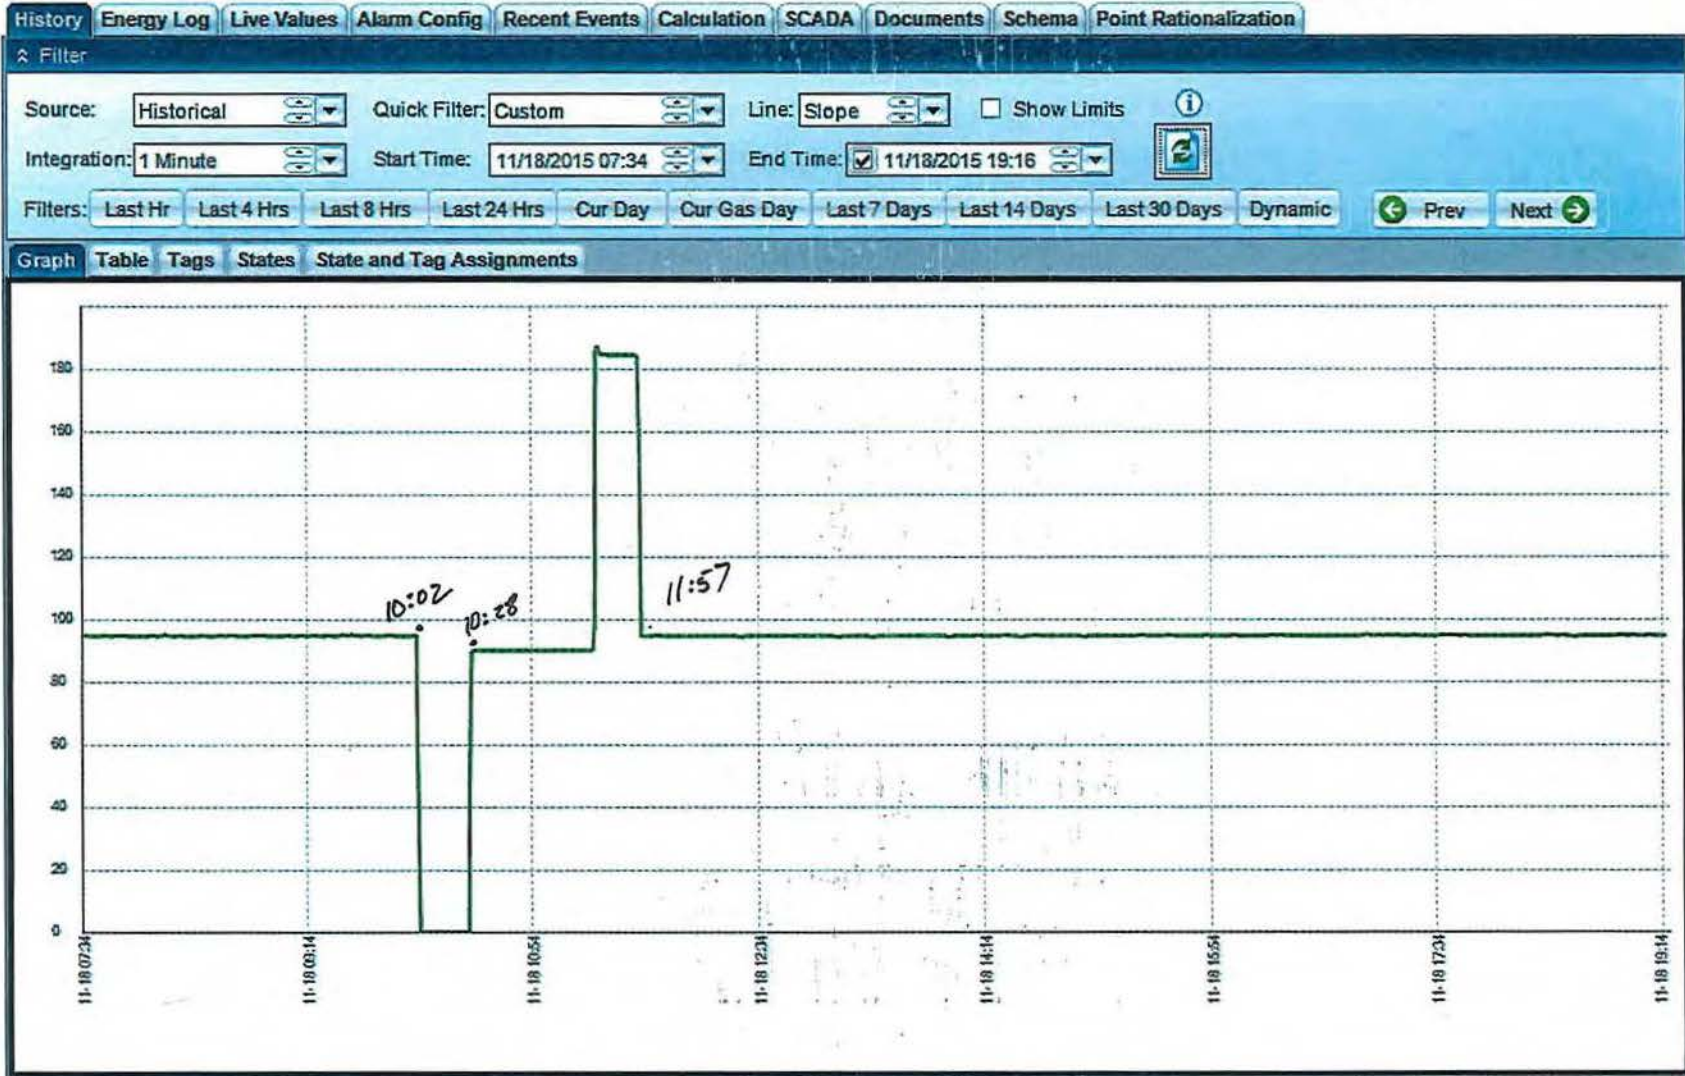
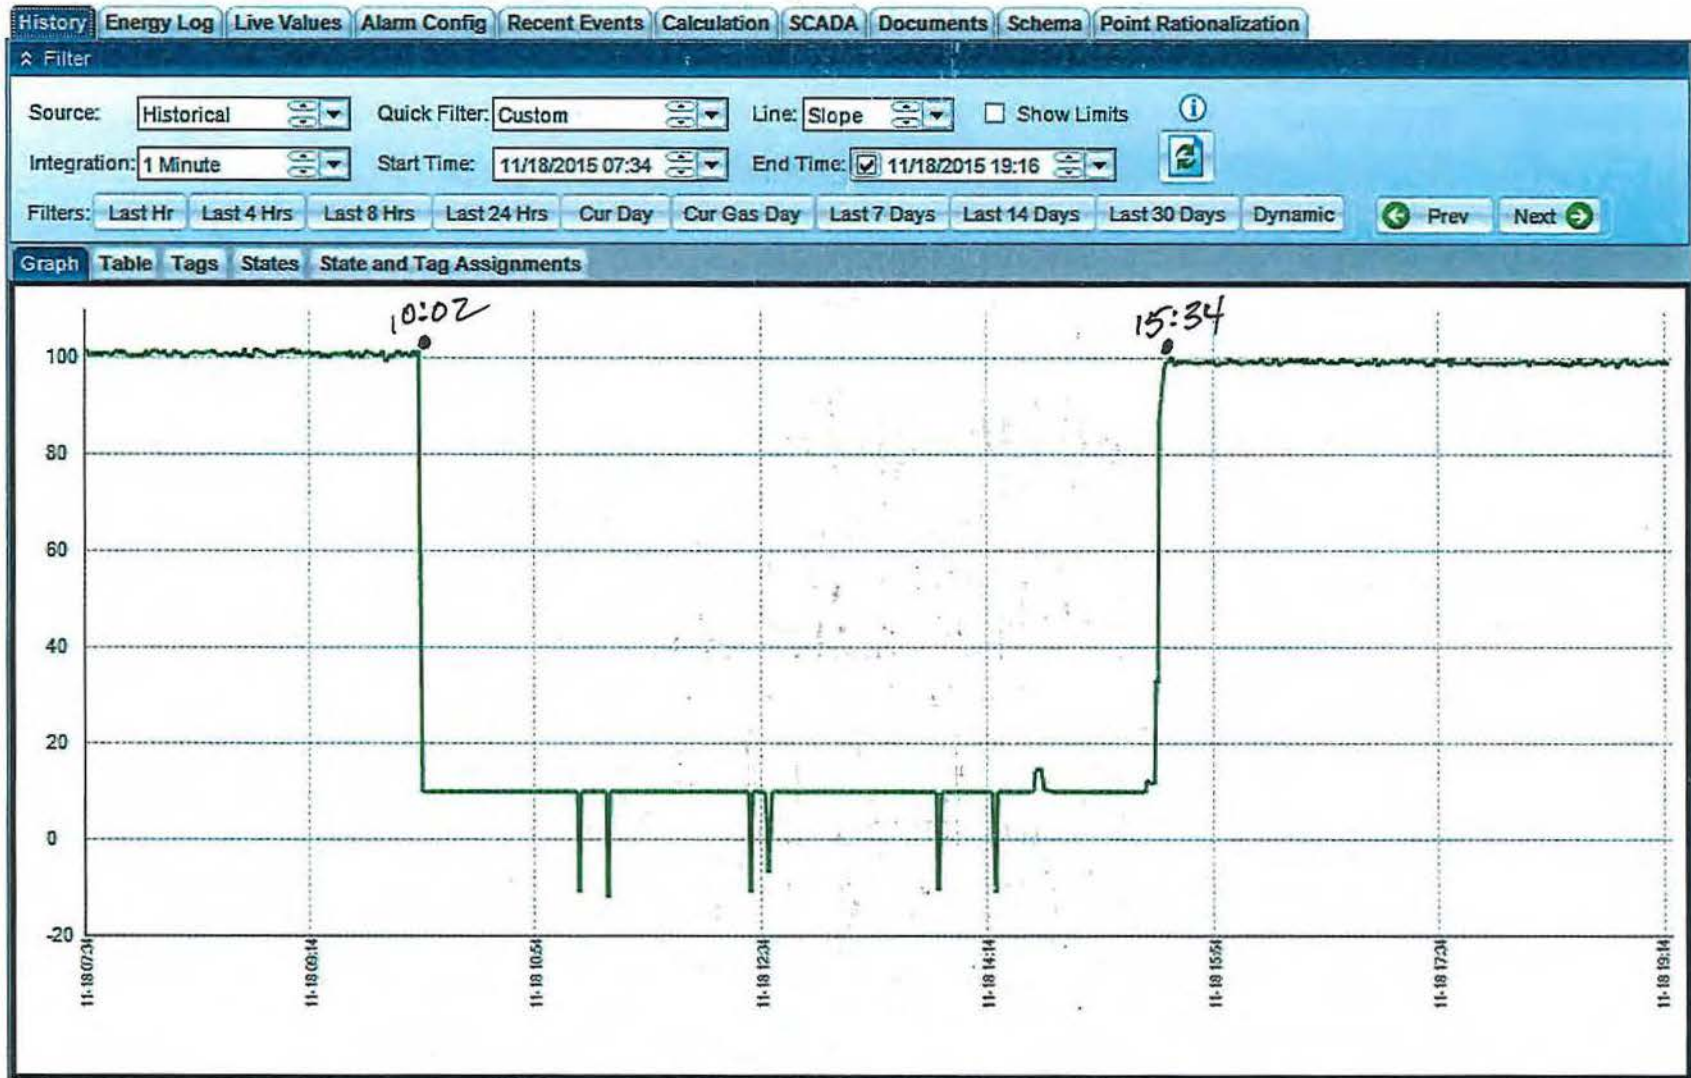
NC Record Number:	NCREG8234		Entity:	Regional Generation	
Company - Level 1 - Level 2:	UPP-McClure Hydro				
Event Date:	11/18/2015	Discovery Date/Time:	11/18/15 10:11		
Event Title:	McClure Plant Trip				
Event Details:	Plant tripped at 1011CST. Loss of power. Paged local operator to man the plant.				
Immediate Action:	Paged local operator to man the plant				
Recommendations:	None				
Potential Causes/Contributors to incident	Weather				
Entered By Name:	Brian K Ellison	Creation Date/Time:	11/18/15 13:44		
Entered By Department:	Energy Supply and Control	Status:	Closed		
Reportable to External Agency:	no	Basis for Reportability:	Will be submitted to FERC		
Additional Followup Required:	yes				
Category:	Regulatory	Type:	FERC Deviation		
Sub Type:	Trans. Sys. (storm related)	Description:	tree		
Causal Analysis Level:	Closed - No further action required	Causal Analysis Basis:	After tree was cleared, unit went back into service

Both the Hoist and McClure Developments tripped offline at 10:02 CDT, Wednesday, November 18, 2015, due to an electrical fault, caused by high winds and falling trees. As a result of the weather conditions, a tree from off of the right of way fell onto the transmission line, causing an electrical outage. Operators were able to reestablish the minimum flow for the Hoist Development at 10:28 CDT, through the Low Level Outlet (LLO). The line was cleared and the Hoist Development returned to normal operations at 11:45 CDT, November 18, 2015. The McClure Development returned to normal operations at 15:34 CDT on November 18, 2015.
