FERC Project No. 10855
NATDAM Nos. MI00178, MI00183,
& MI00197

Dead River Hydroelectric Project
2015 Annual Report - Operation Monitoring Plan &
Report of Deviations Less Than Sixty Minutes

Dead River Hydroelectric Project: Article 405
Operation Monitoring Plan Report of Deviations Less Than Sixty Minutes – 2015 Report

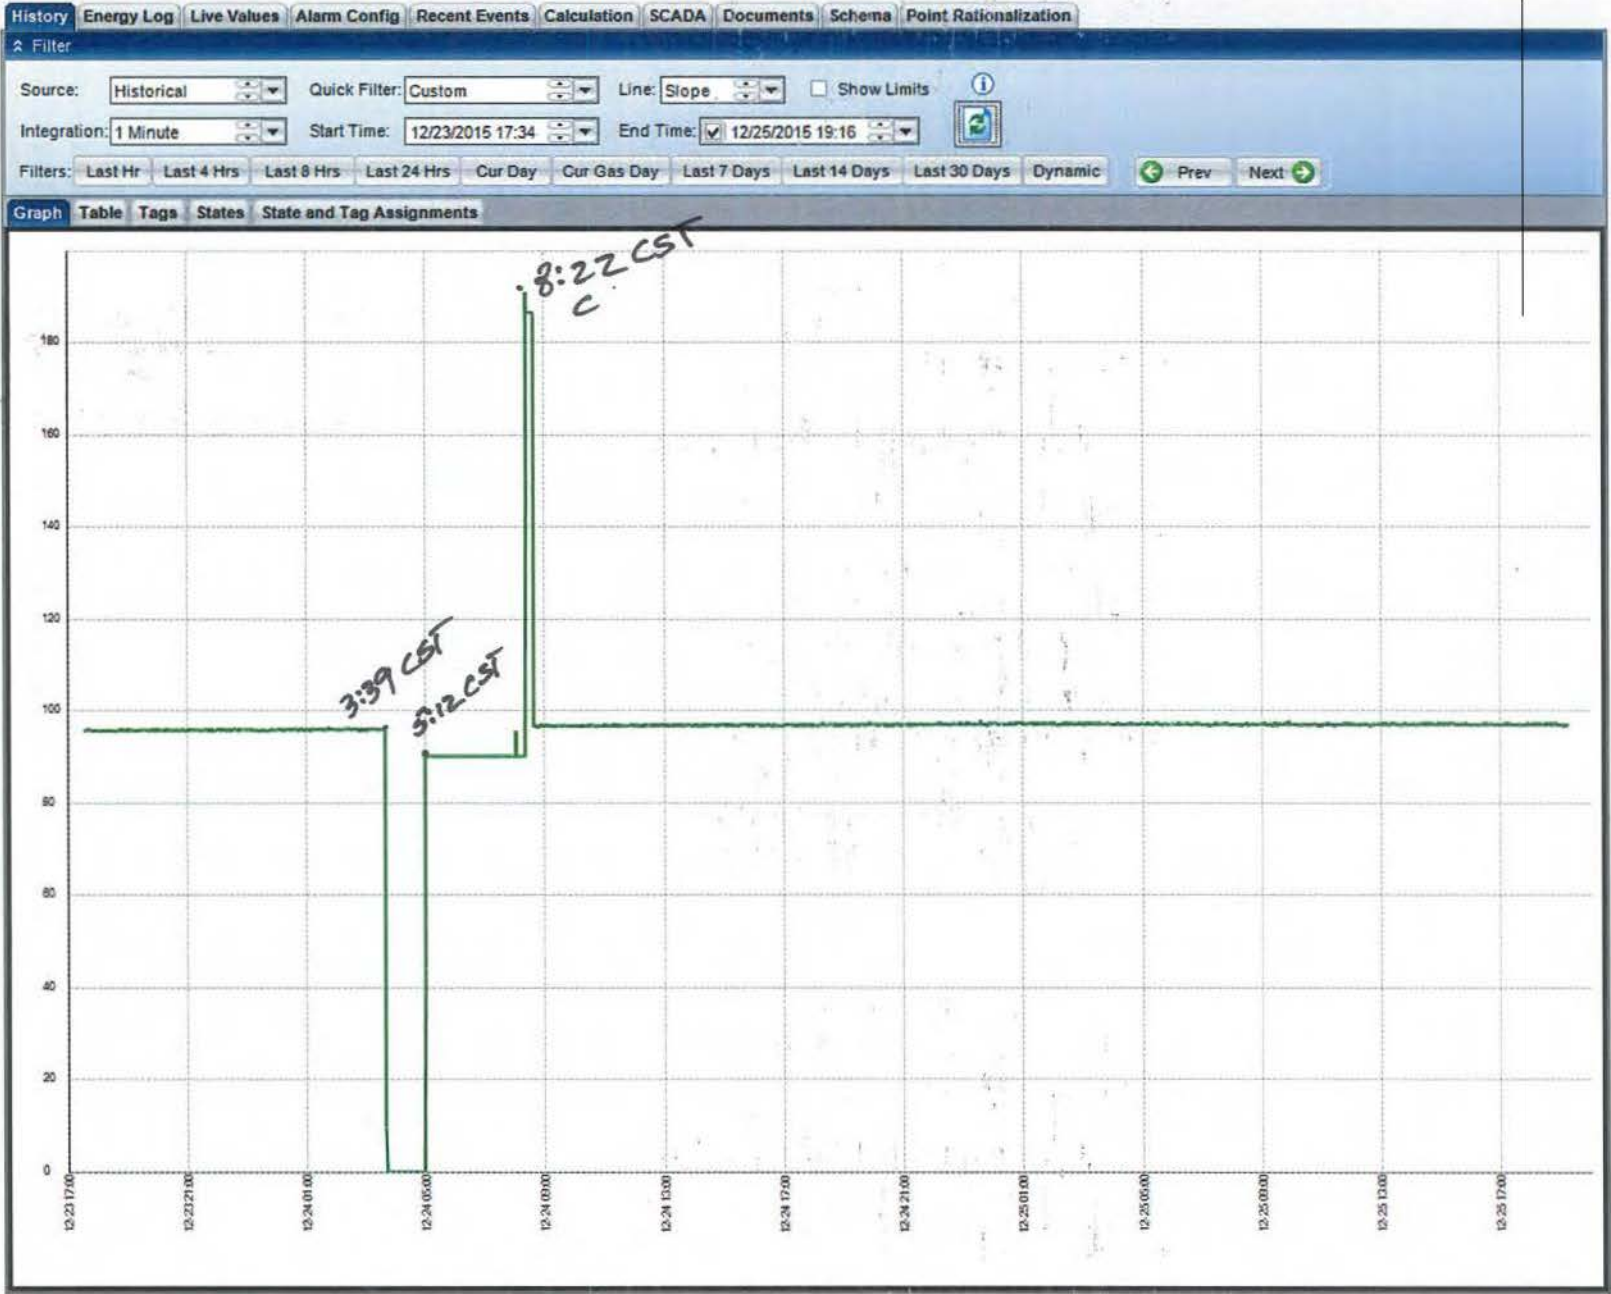
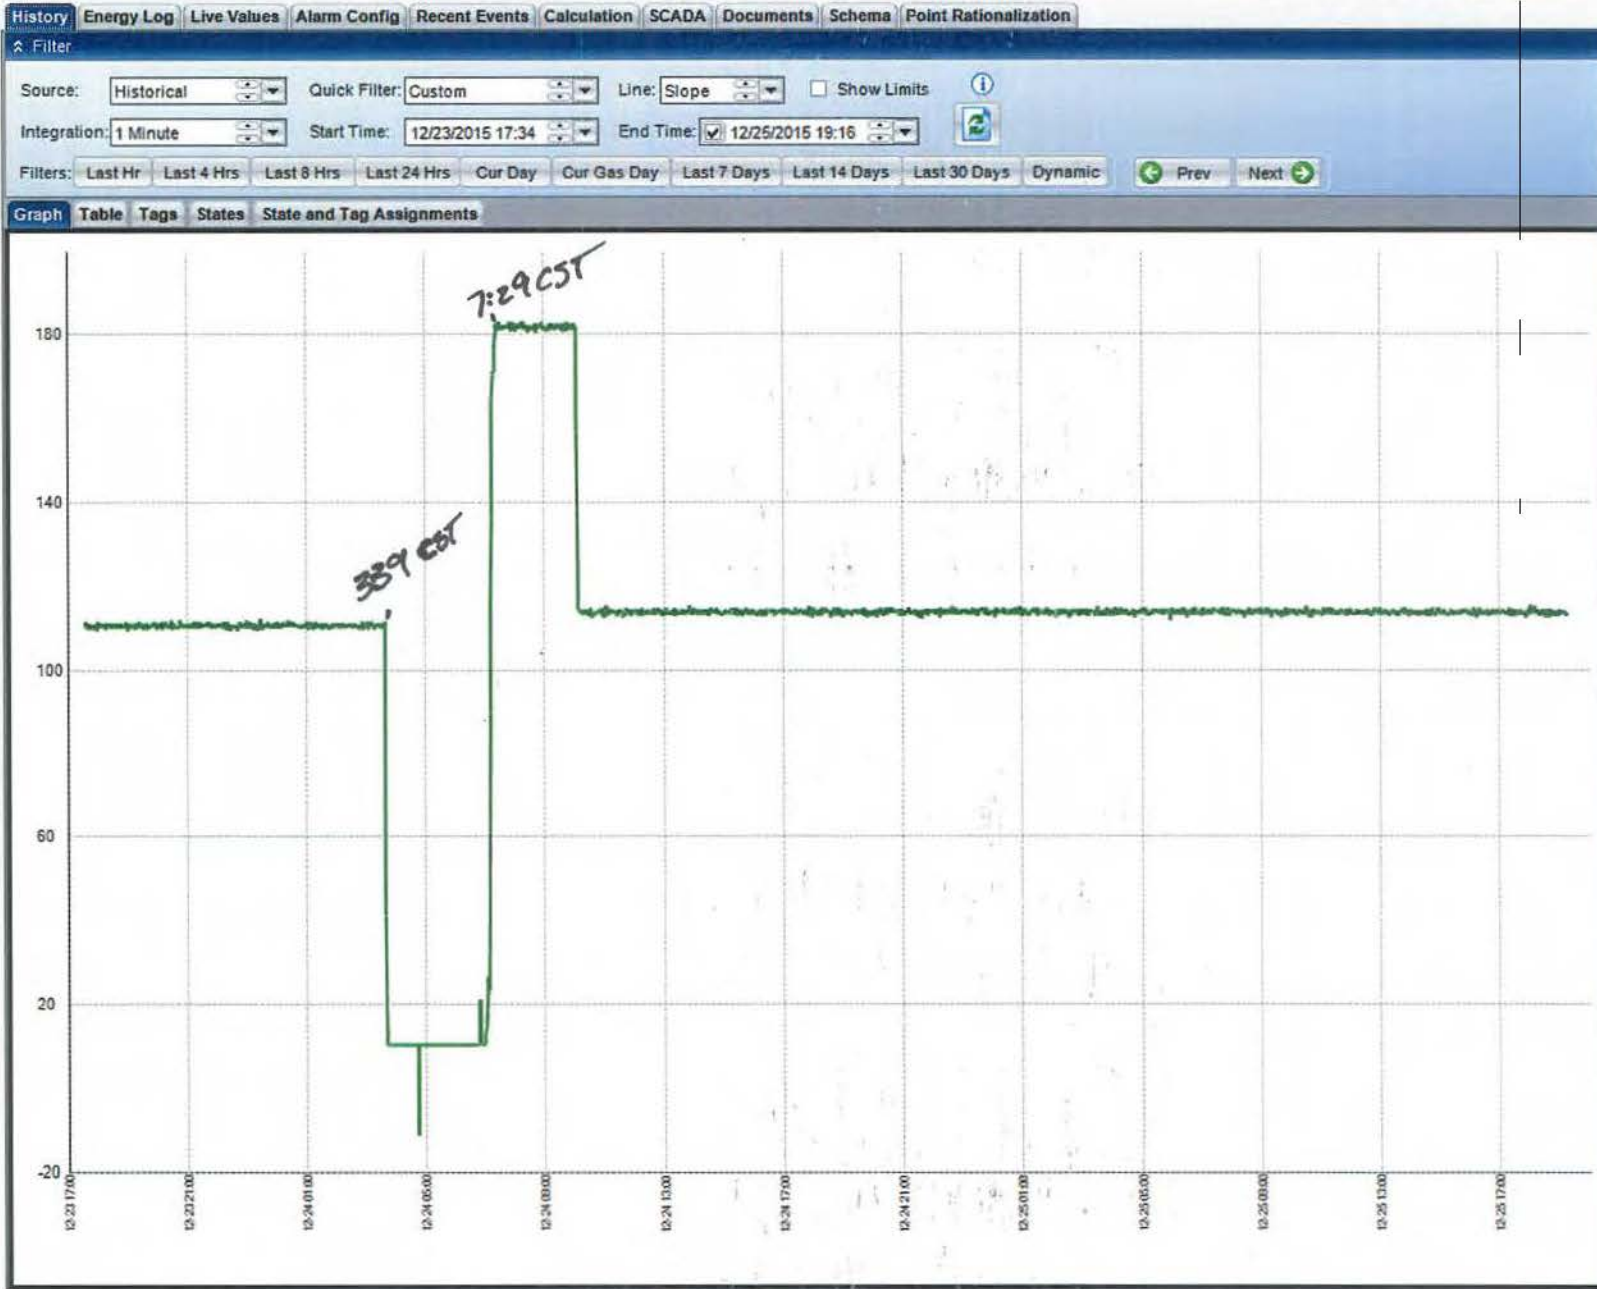
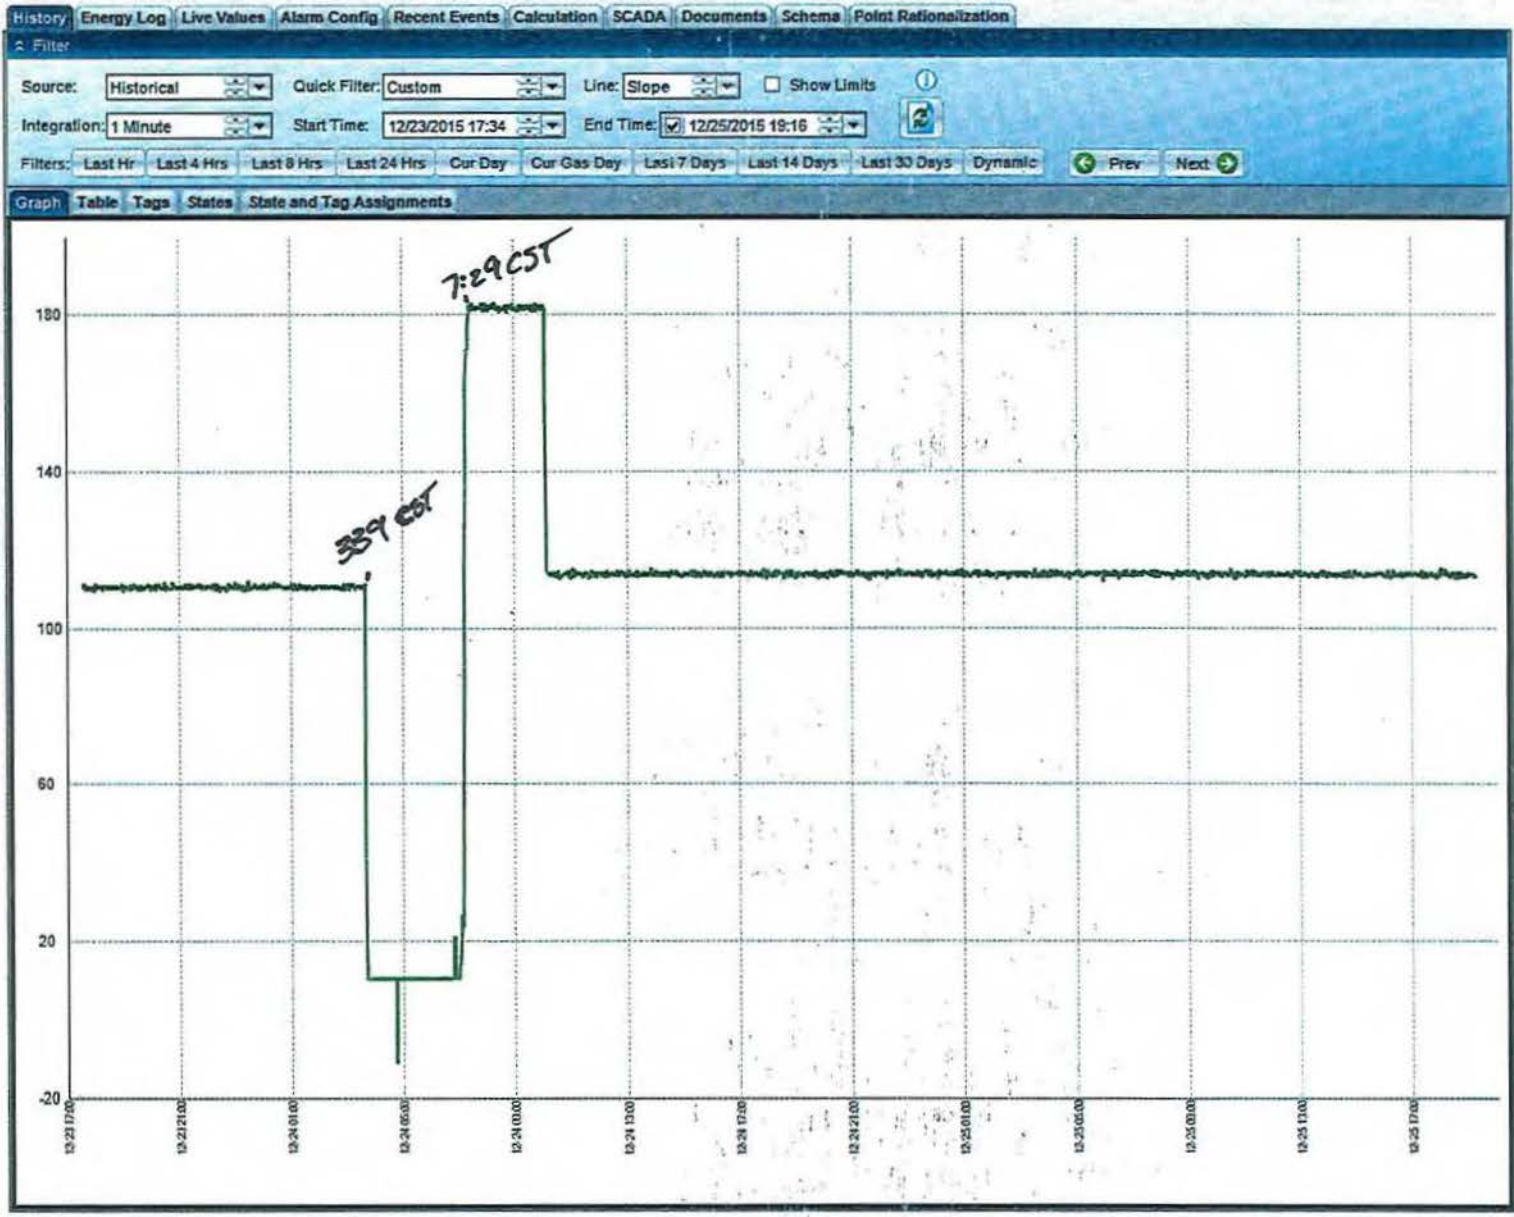
NC Record Number:	NCREG8393	Entity:	Regional Generation
Company - Level 1 - Level 2:	UPP-Hoist Hydro		
Event Date:	12/24/2015	Discovery Date/Time:	12/24/15 3:49
Event Title:	Hoist Plant Trip		
Event Details:	Entire plant went offline, loss of power at 0349. Dispatched local operator to the plant		
Immediate Action:	Paged local operator		
Recommendations:	None		
Potential Causes/Contributors to incident	Power lines down due to strong winds		
Entered By Name:	Brian K Ellison	Creation Date/Time:	12/24/15 4:10
Entered By Department:	Energy Supply and Control	Status:	Closed
Reportable to External Agency:	yes	Basis for Reportability:	Letter sent to JN on 1/8 for review
Additional Followup Required:	yes		
Category:	Regulatory	Type:	FERC Deviation
Sub Type:	Trans. Sys. (storm related)	Description:	
Causal Analysis Level:	Closed - No further action required	Causal Analysis Basis:	After trip, LLO opened to maintain flow, then closed when units could return to service

NC Record Number:	NCREG8394	Entity:	Regional Generation
Company - Level 1 - Level 2:	UPP-McClure Hydro		
Event Date:	12/24/2015	Discovery Date/Time:	12/24/15 3:39
Event Title:	McClure Plant Trip		
Event Details:	Entire plant went offline at 0339. Paged local operator for assistance		
Immediate Action:	Paged local operator		
Recommendations:	None		
Potential Causes/Contributors to Incident	Power lines down due to strong winds		
Entered By Name:	Brian K Ellison	Creation Date/Time:	12/24/15 4:16
Entered By Department:	Energy Supply and Control	Status:	Closed
Reportable to External Agency:	yes	Basis for Reportability:	Draft letter and data sent to JN 1/8
Additional Followup Required:	yes		
Category:	Regulatory	Type:	FERC Deviation
Sub Type:	Trans. Sys. (storm related)	Description:	
Causal Analysis Level:	Closed - No further action required	Causal Analysis Basis:	Unit tripped with storm, when transmission line was ready to be returned, units put back in service

Both the Hoist and McClure Developments tripped offline at 03:39 CST, Wednesday, December 24, 2015, due to an electrical fault. As a result of the weather conditions, a tree from off of the right of way fell onto the transmission line, causing an electrical fault, which tripped the units. Operators were dispatched to both developments. Minimum flows for the Hoist Development were re-established at 5:12 CST, via the Low Level Outlet (LLO). The fault was cleared and the McClure Development returned to normal operation at 7:29 CST with the re-establishment of the required minimum flows through the powerhouse. The Hoist Development was also returned to normal operation at 08:24 CST and the LLO was closed.

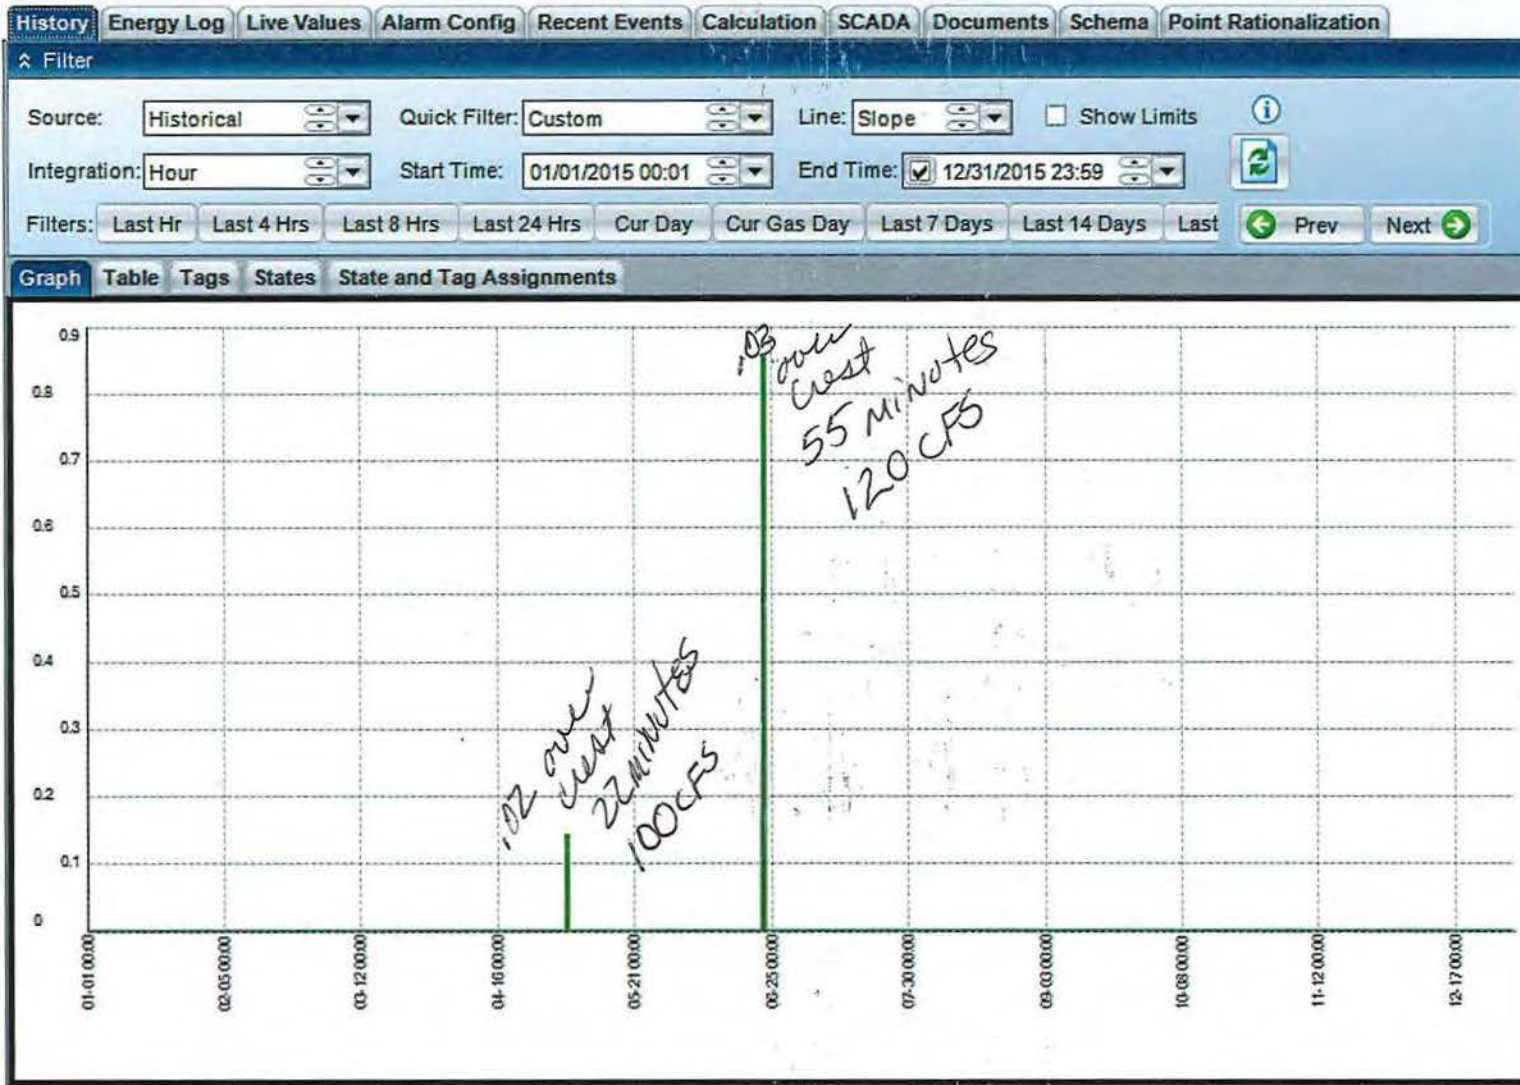
Point Info - UPPCO-MCL: Spillway Flow

2— Events Limited flushing, and no visible wood debris transported
