# PHOTOGRAPHS OF THE MENOMINEE IRON RANGE MINES

*[Compiled and Captioned by William John Cummings]*

## *The Cornish Pumping Engine at D Shaft of the Chapin Mine*

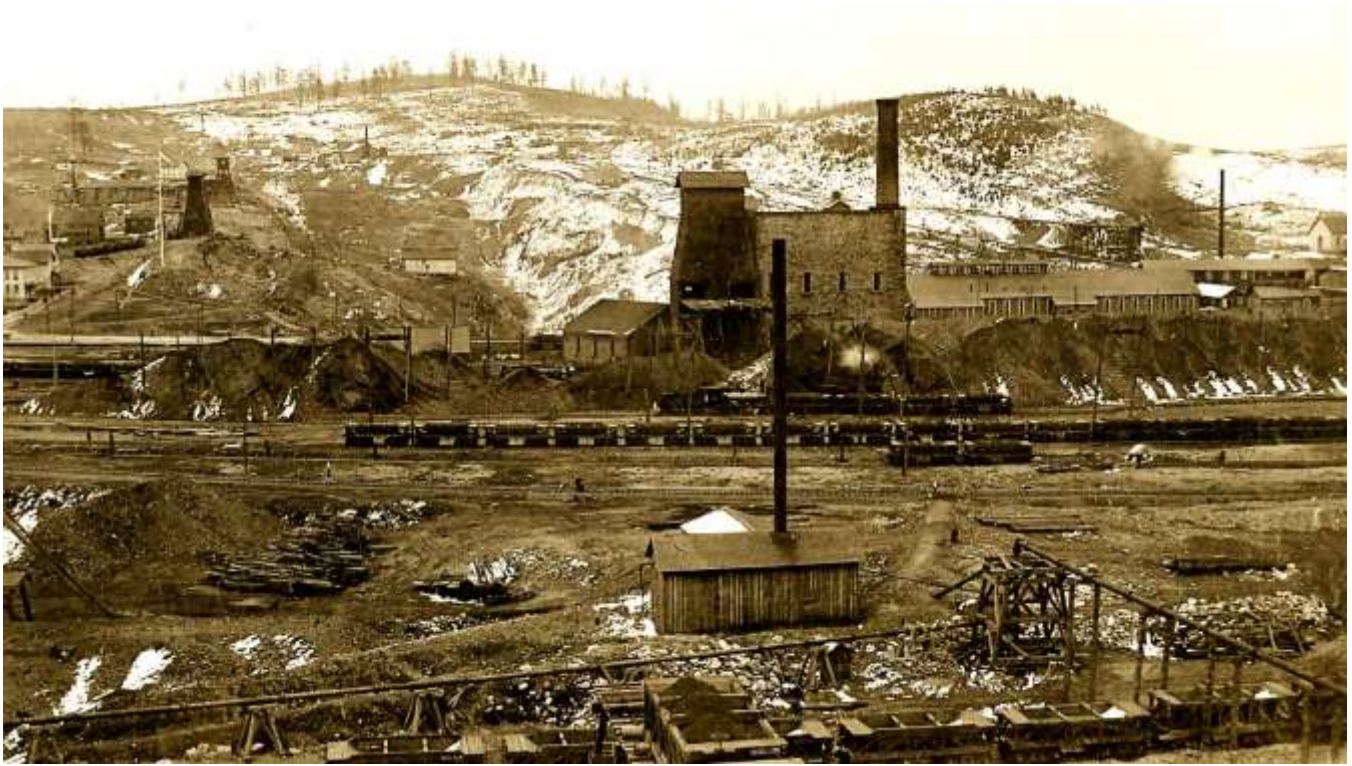
This view of the Chapin Mine's D shaft complex, looking east, was probably taken between 1893 and 1896. Two tramways exit the shaft housing's mid-point. A steam locomotive appears to be pushing four cars directly below, in front of the vast stockpiles. To the right of the sandstone engine house and across the street, on North Stephenson Avenue, some of the Chapin Mining Company's shops are visible. The Millie Mine, originally the Hewitt, can faintly be seen directly above and slightly to the left of the shaft housing near the crest of Millie Hill, with Pewabic Hill rising in the background. The Hydraulic Power Company's air pipe appears in the lower right, extending west to the Ludington shaft and northwest to the Hamilton shaft. *[Menominee Range Historical Museum]*

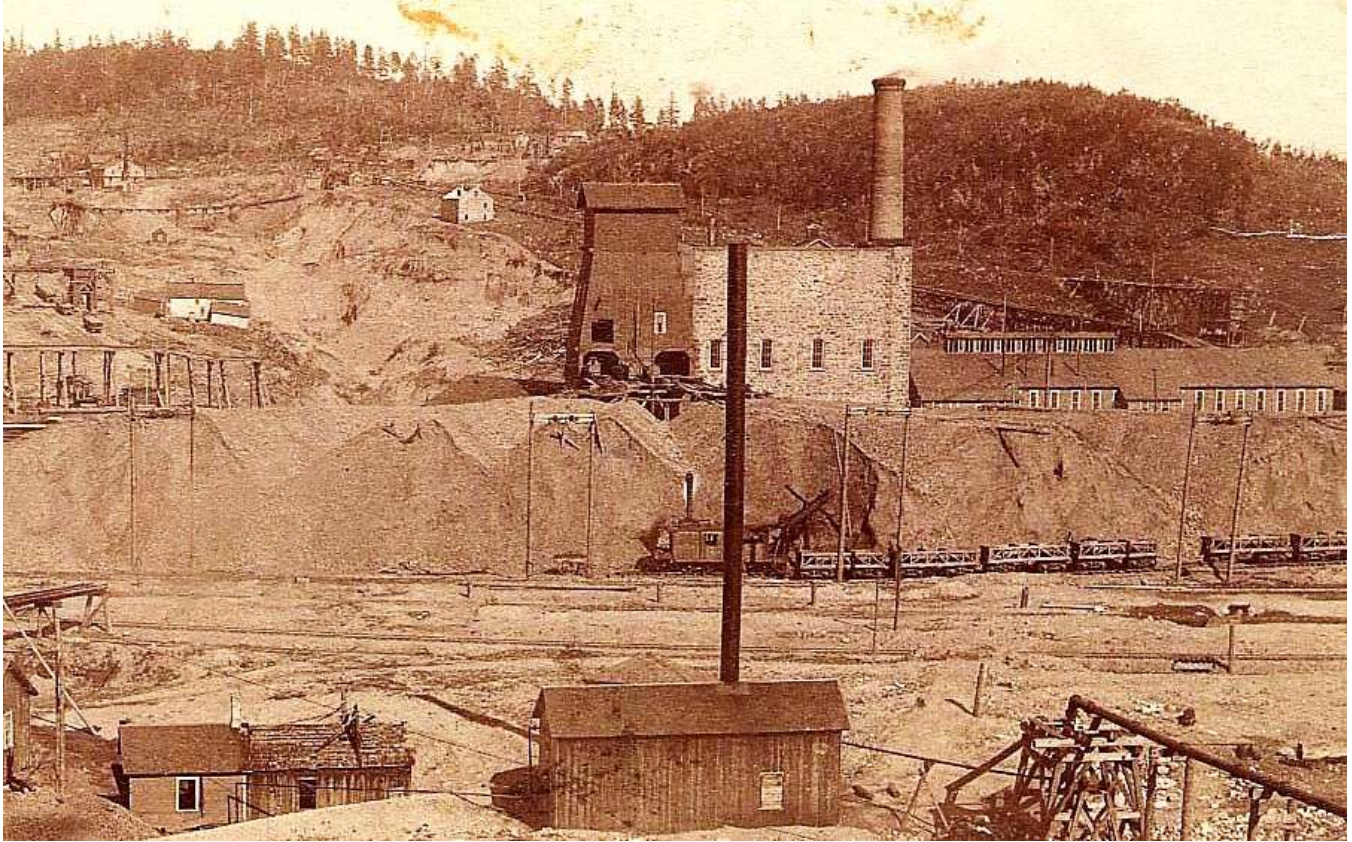
Probably taken between 1893 and 1894, this view, facing east, shows the Chapin Mine's D shaft complex. Note the huge stockpiles of iron ore with the steam shovel ready to load railroad cars, the wooden shaft house and the original sandstone building housing the Cornish pumping engine. Some of the Chapin Mining Company's shops are visible on the east side of South Stephenson Avenue south of the sandstone pump house which was located on the west side of South Stephenson Avenue. *[Keen S. Scott]*

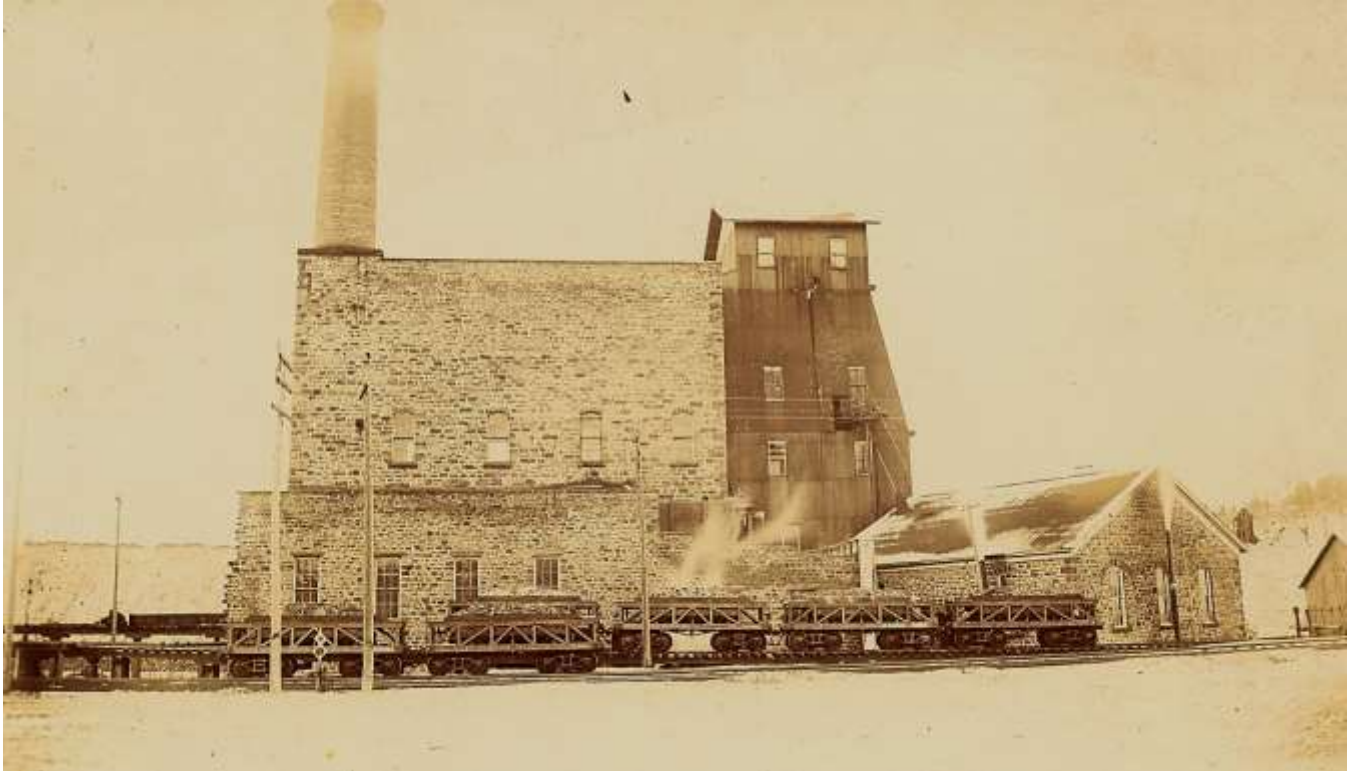
Excavation for the foundation of the original building housing the Cornish pumping engine, located on North Stephenson Avenue on the south side of today's West Chapin Lake or West Chapin Pit, began in the fall of 1889. Measuring 36x42 feet and constructed of native red sandstone, the building, towering four stories high, dominated the landscape a year later. The smokestack was contained at the engine house's south end, while the shaft housing, approximately 100 feet in height, was located to the north. The hoisting plant, powering the half-inch thick by four-inch wide flat cables, was situated in a sandstone building just northeast of the shaft house (at the right in the photograph) and began operation in November, 1891. The sandstone boiler house was an eastern extension of the engine house, and contained the battery of Reynolds' patented boilers. *[Menominee Range Historical Museum]*

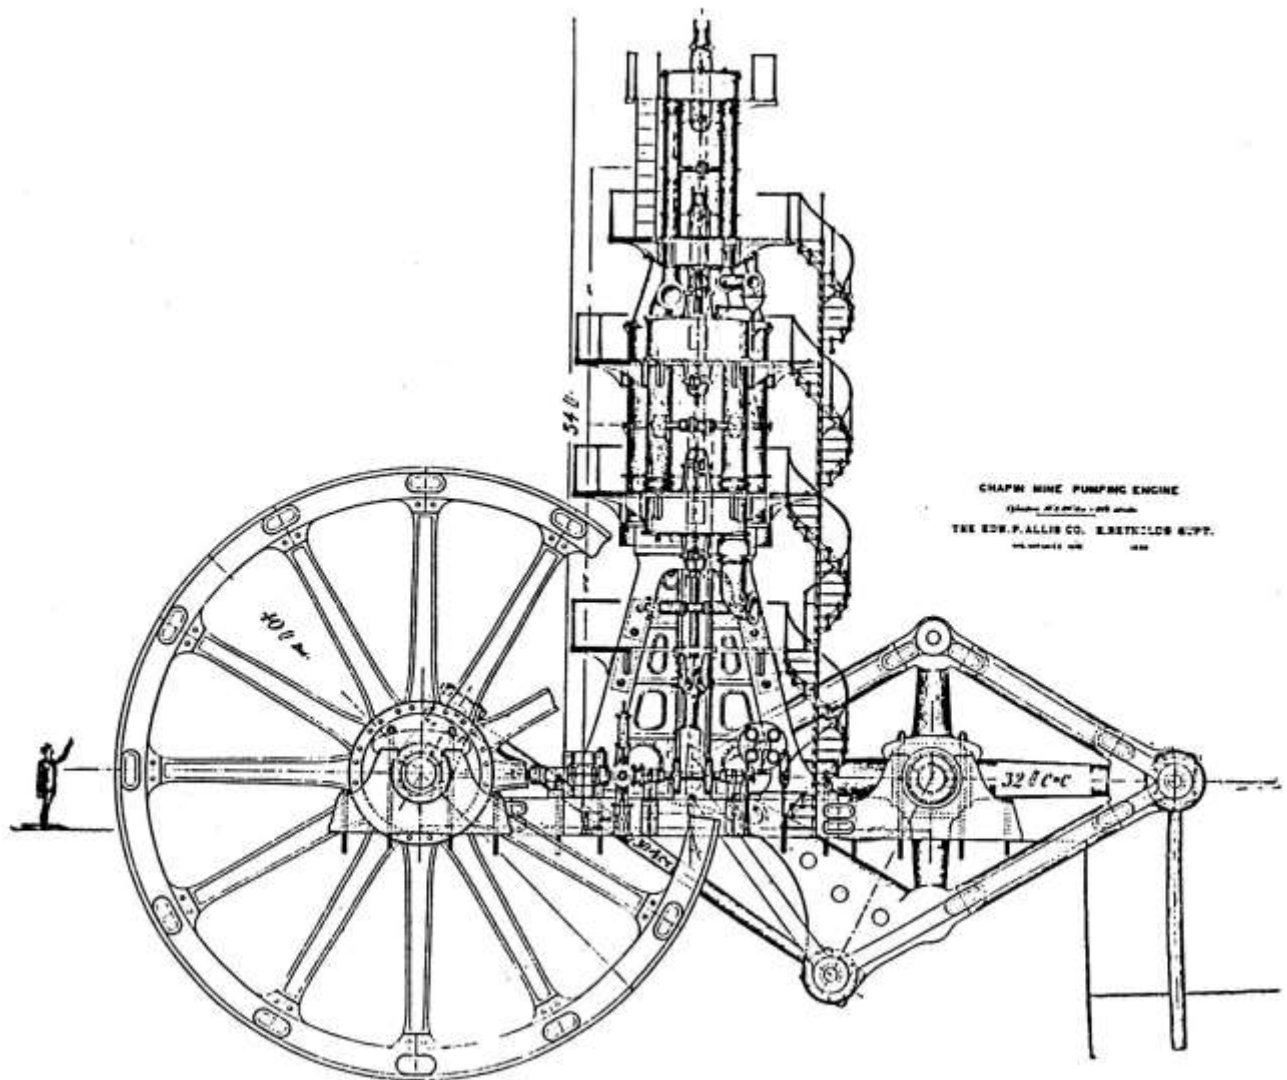
*The Iron Range*, an early Iron Mountain newspaper, ran a front-page feature article on the Cornish pumping engine in the May 19, 1892, edition which contained the above line diagram and read as follows: *We present to our readers this week an illustration of the mammoth pumping engine now being erected at D shaft, Chapin mine, under the supervision of Mr. Chas. Taylor, erecting engineer, and through the courtesy of the builders, The E.P. Allis Company, of Milwaukee, we are able to give the following description of this wonderful machine: This engine is what is known as a steeple compound condensing engine, and was designed by E. and I.H. Reynolds, and the contract calls for ninety million foot pounds duty. It will be capable of lifting 200 tons of water per minute, 1500 feet, 100 feet flow, which will be equivalent to 4,000,000 gallons on 24 hours. So it will be seen that the Chapin Mining Company, in putting in this machine, is providing for any contingency that is likely to arise as the mine is deepened to 1500 feet from the surface. The length from the end of the bob to the back of the fly wheel is about 75 feet and the height above foundation is 54 feet. The high pressure cylinder is 50 inches in diameter and the low pressure cylinder is 100 inches in diameter, and the pumps, to be located about 200 feet apart in the shaft, are 28 inches in*

*diameter, with 120 inches stroke. The bob weighs about 120 tons, and the fly wheel about 160 tons. The fly wheel, as indicated in the illustration, is 40 feet in diameter. The rim of the wheel is 24 inches thick and 24 inches wide. The immensity of this machine is illustrated in the engraving in a most striking manner by the representation of a six foot man standing near the fly wheel. The shaft on which the fly wheel revolves is 27 inches in diameter. The bob is made in seven pieces and firmly held together by 21 wrought iron links shrunk on to the lugs as shown by dotted lines in the engraving. It is further strengthened by eight wrought iron tension rods, 8 x 16 inches, shrunk on to the sides and held in place by pins. The engine is fitted with a surface condenser with 1049 one inch tubes, and a Reynolds patent air pump. The mine water will be used in the condenser for cooling purposes. The boilers being once charged with water, as it is evaporated and the steam performs its office of driving the pumping engine, it exhausts into the condenser and is there cooled to a liquid state and pumped back into the boilers by a pump attached to the air pump, thereby affecting the greatest economy possible in the use of water and the making of steam. But to supply any deficiency arising from possible leakage or waste of any kind a small pipe is connected with the city water works. The boiler plant at present consists of four Reynolds patent boilers, but as the mine increases in depth four more will be added as needed. This engine is the largest and most powerful of its kind ever constructed, and the long established reputation of the builders is sufficient guarantee that it will perform the duty for which it is designed in a perfectly satisfactory manner. The E.P. Allis Company has contracts for and is building nine triple expansion engines of 165,000,000 gallons daily capacity, and among those of this type already built is one with steam cylinders of 40, 70 and 104 inches by 60 inches for the American Water Works Company, of Omaha, Neb. [Dickinson County Library]*

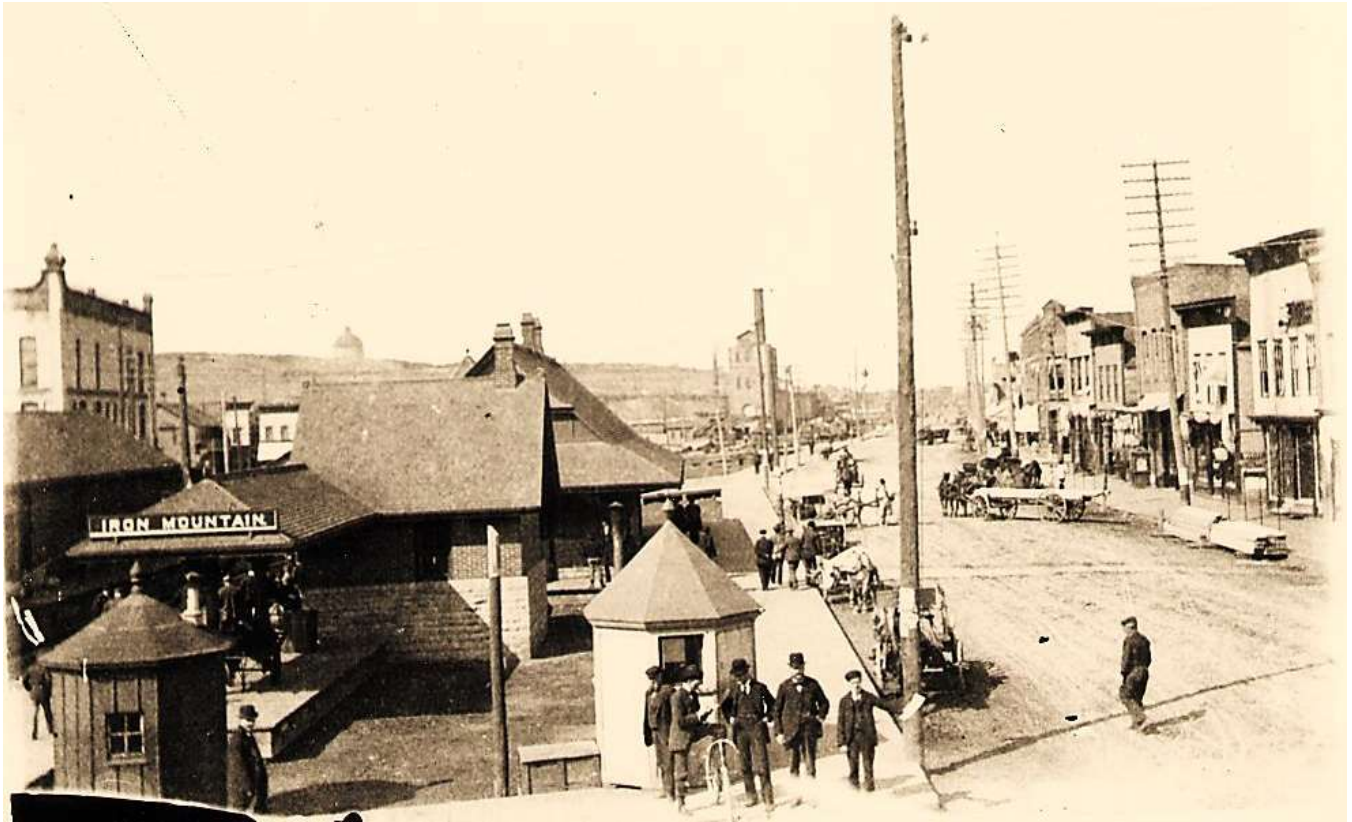
The original sandstone building housing the Cornish pumping engine, slightly right of center, dominated Iron Mountain's landscape in the 1890's, when this photograph was taken. The Chicago & Northwestern depot was located on the west side of the 300 block of South Stephenson Avenue. In the foreground, a flagman's house is on the left, and a similar building, toward the center of the photograph, served as a shelter for the policemen. *[Menominee Range Historical Museum]*

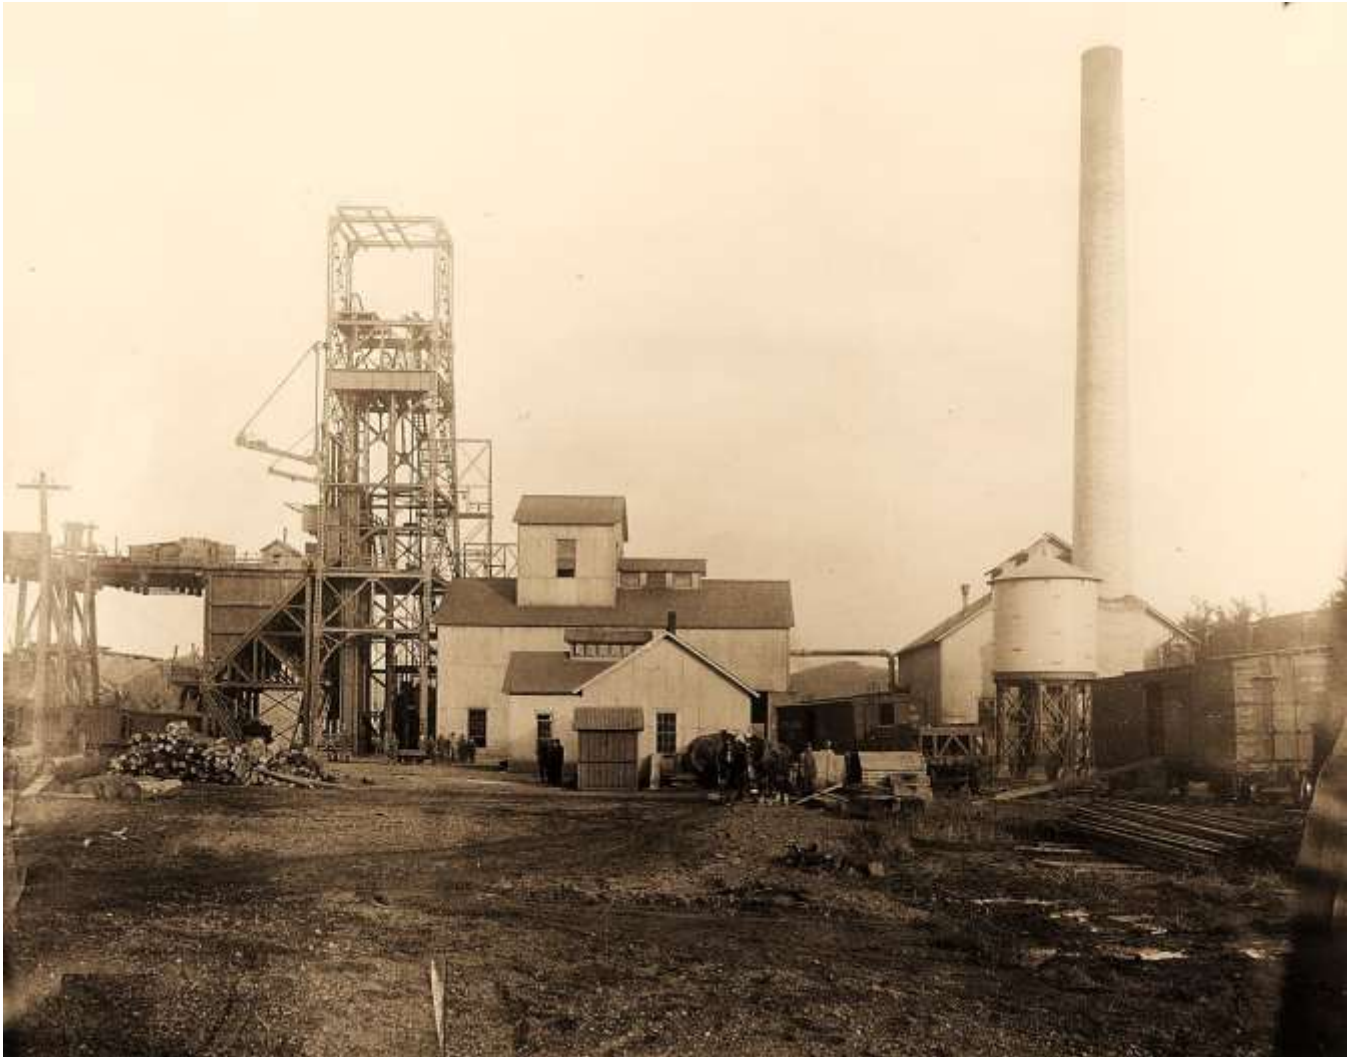
Dated October 19, 1912, this view of the C Ludington Shaft, facing east, shows the shaft housing which rose 114 feet above the collar of Iron Mountain's Chapin Mine. The chutes to the left allowed ore cars, like those pictured, to be loaded directly, as the ore came up in the tram cars on the hoist. The cage in which the men descended and ascended can be seen at the lower left of the shaft housing. The pump house, covering the Cornish pumping engine where it still stands today, was sheathed in corrugated metal and rested on a red sandstone foundation. A pipe can be seen leading from the boiler house to the pump house, feeding steam to the gigantic engine. Another railroad track passed between these two buildings. *[Menominee Range Historical Museum]*

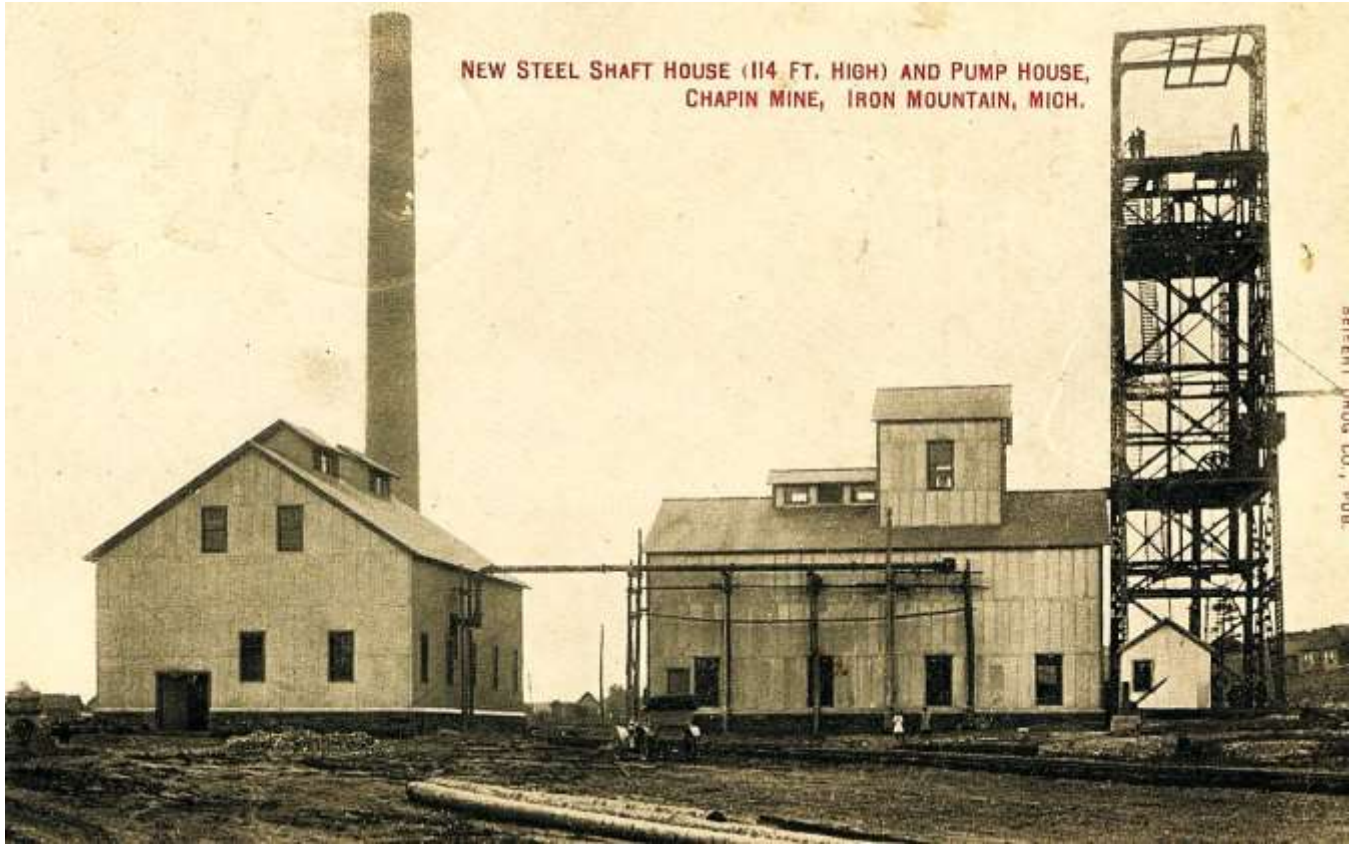
Postmarked in Iron Mountain, March 3, 1908, this black-and-white halftone postcard, looking west, shows the New Steel Shaft House and Pump House at the Chapin Mine. The building housing the Cornish pumping engine is at the right with the shaft, apparently still under construction, at the far right. The boilers were located in the boiler house building at the left with the tall smokestack. The postcard view was sold by the Seibert Drug Co. Note the early automobile in the lower center of the photo. *[William J. Cummings]*

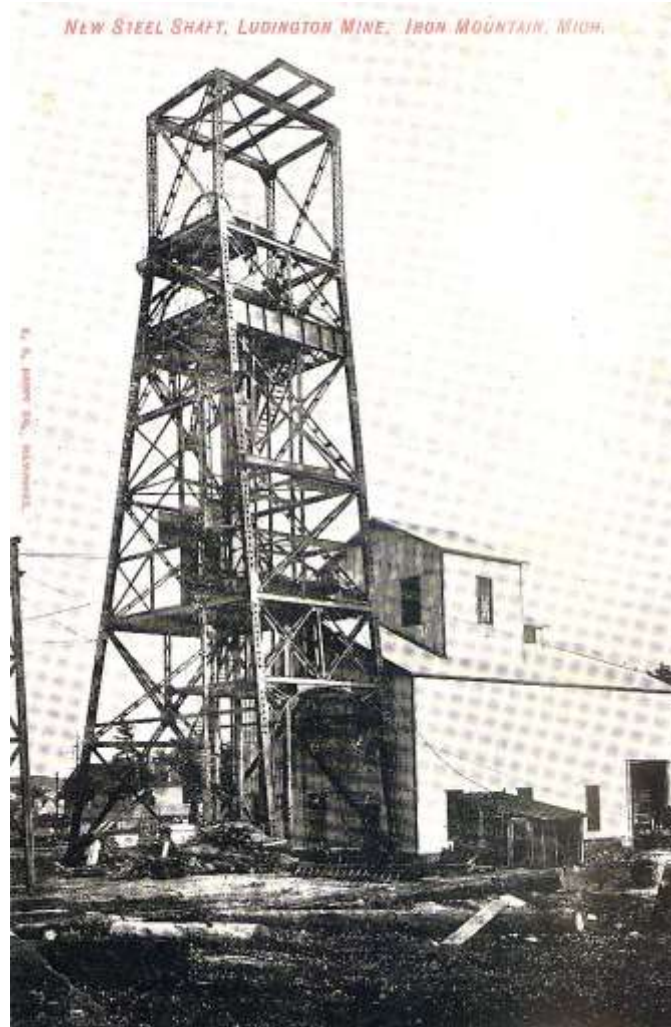
This postcard view, with the camera looking southeast, dates from about 1908, when the new steel C Ludington Shaft of the Chapin Mine was completed. Published by the E.C. Kropf Company of Milwaukee, the postcard shows the shaft housing which rose 114 feet above the collar and the building containing the Cornish pumping engine south of the headframe.

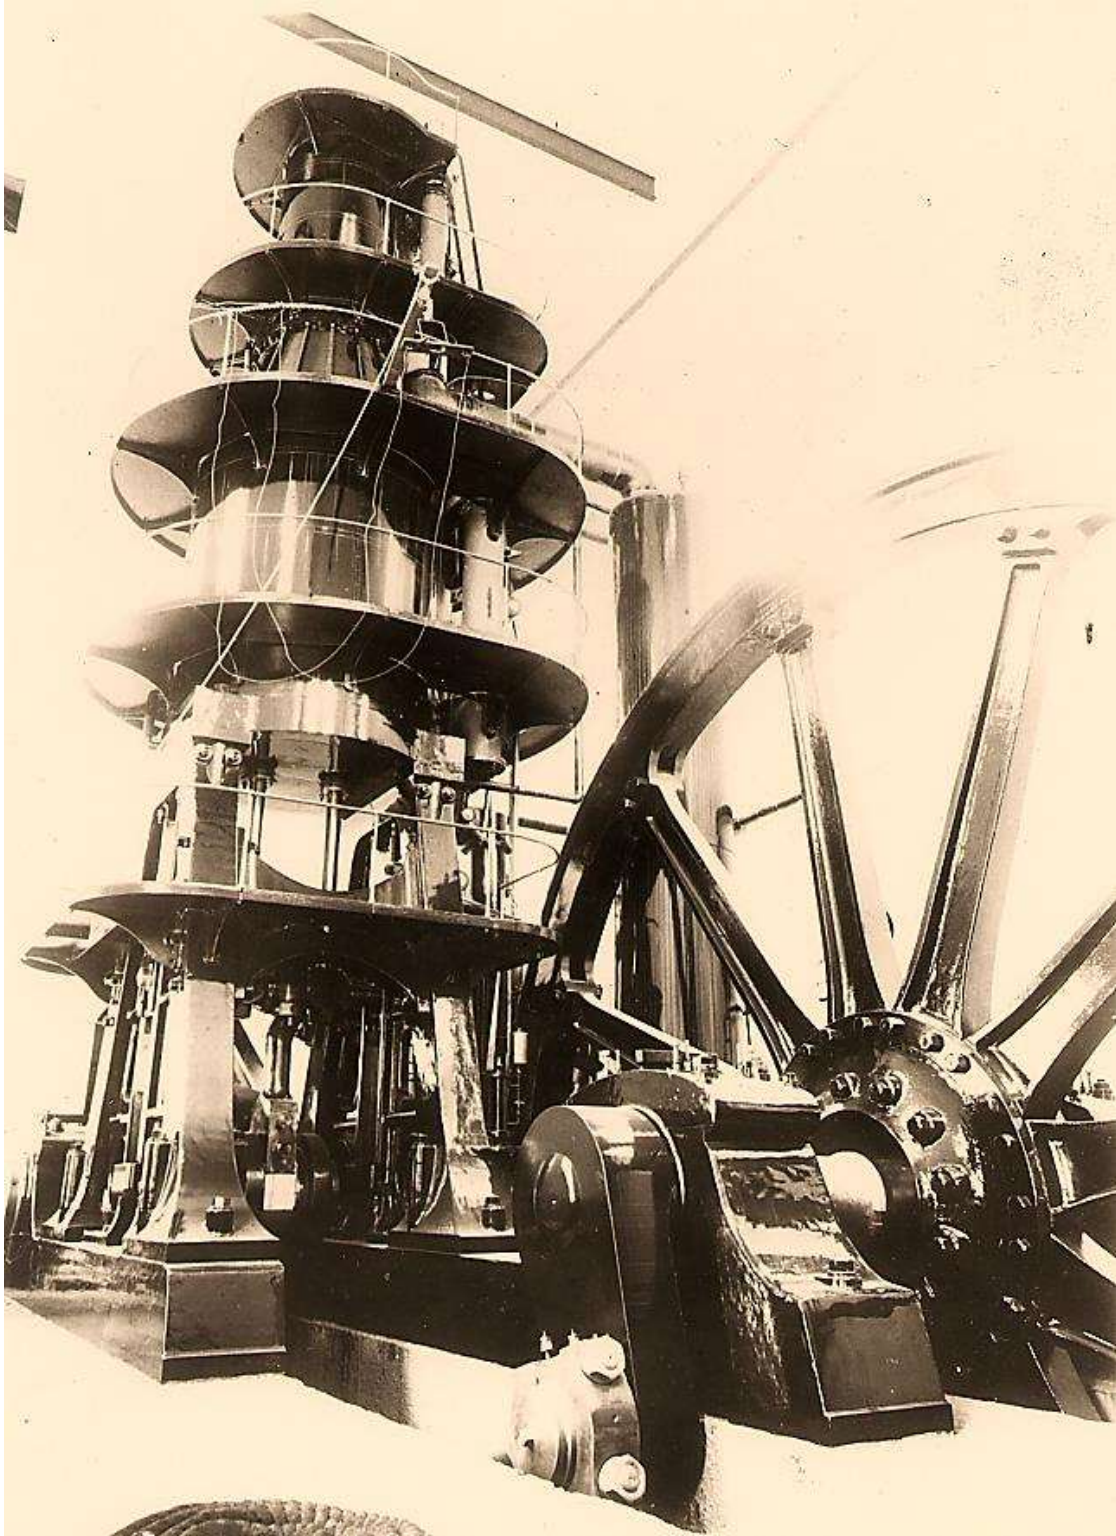
Probably dating to October, 1912, this interior view of the pump house shows the Cornish pumping engine at C Ludington Shaft of the Chapin Mine, where it remains. *[Menominee Range Historical Museum]*

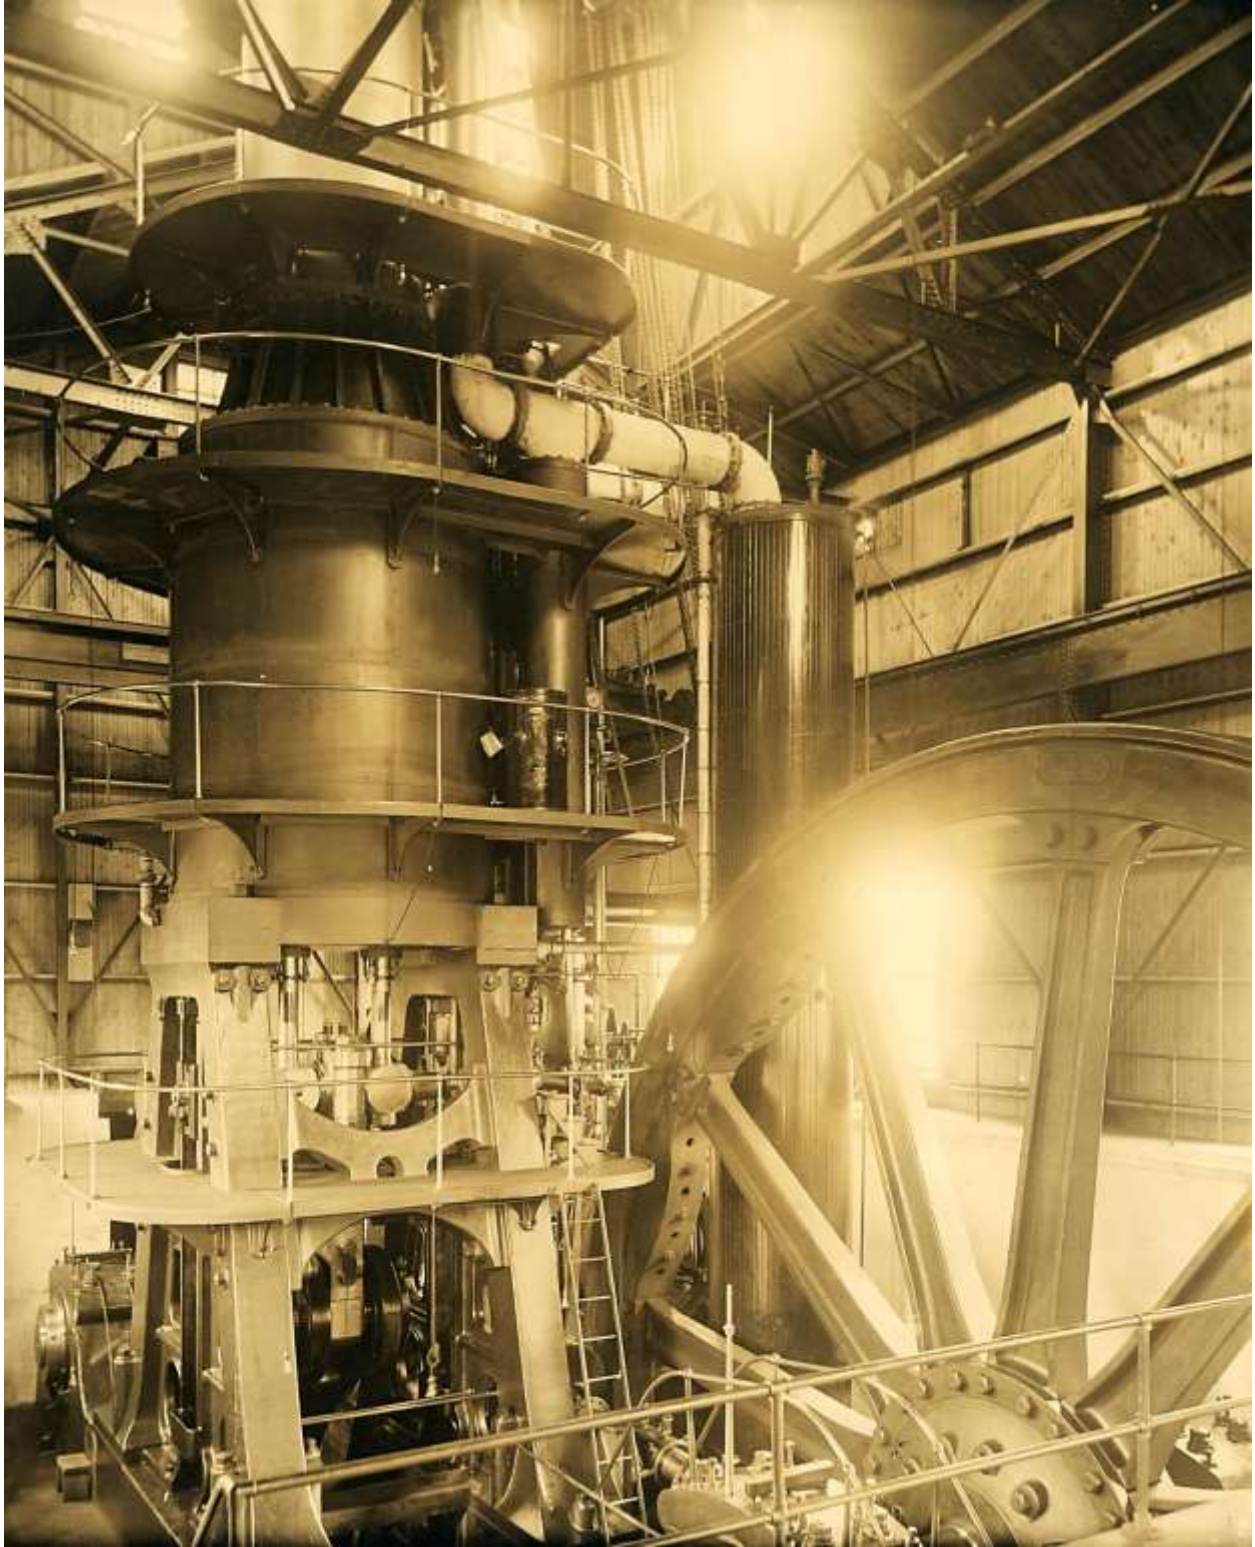
Dated October 19, 1912 and property of the Oliver Iron Mining Company, this photograph shows the interior of the pump house with the Cornish pumping engine at C Ludington Shaft of the Chapin Mine, where the engine remains. *[Menominee Range Historical Museum]*

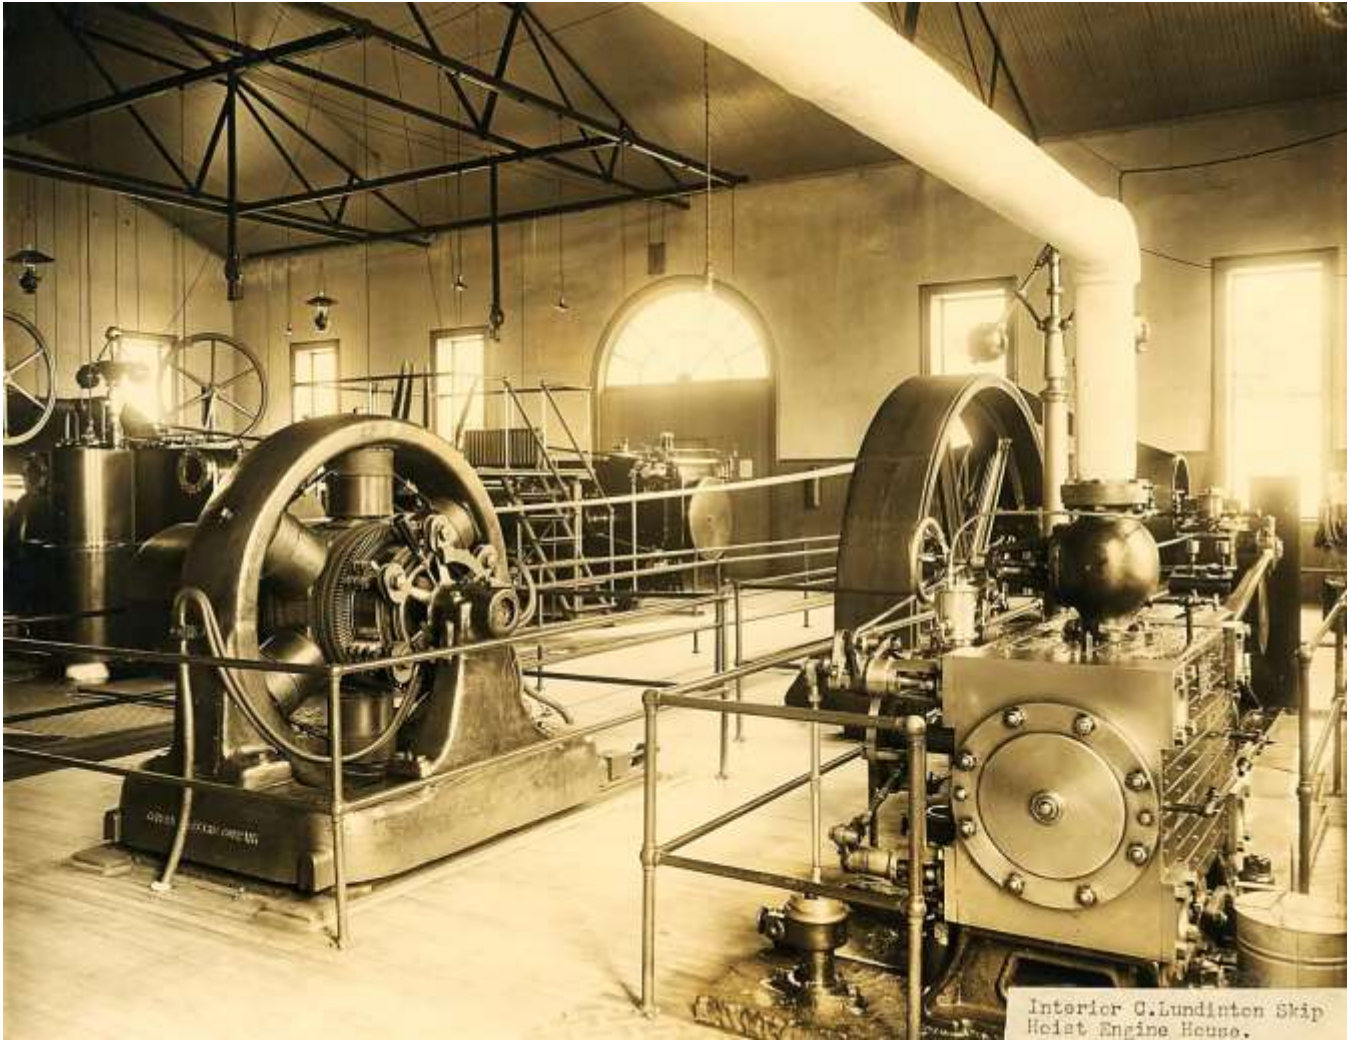
Interior C.Ludington Ship Hoist Engine House.

This interior view of the Chapin Mine's "C" Ludington Shaft hoist engine house, probably dating from October 19, 1912, shows several engines. Note the immaculate condition of the engine house and the fan window above a set of double doors. *[Menominee Range Historical Museum]*

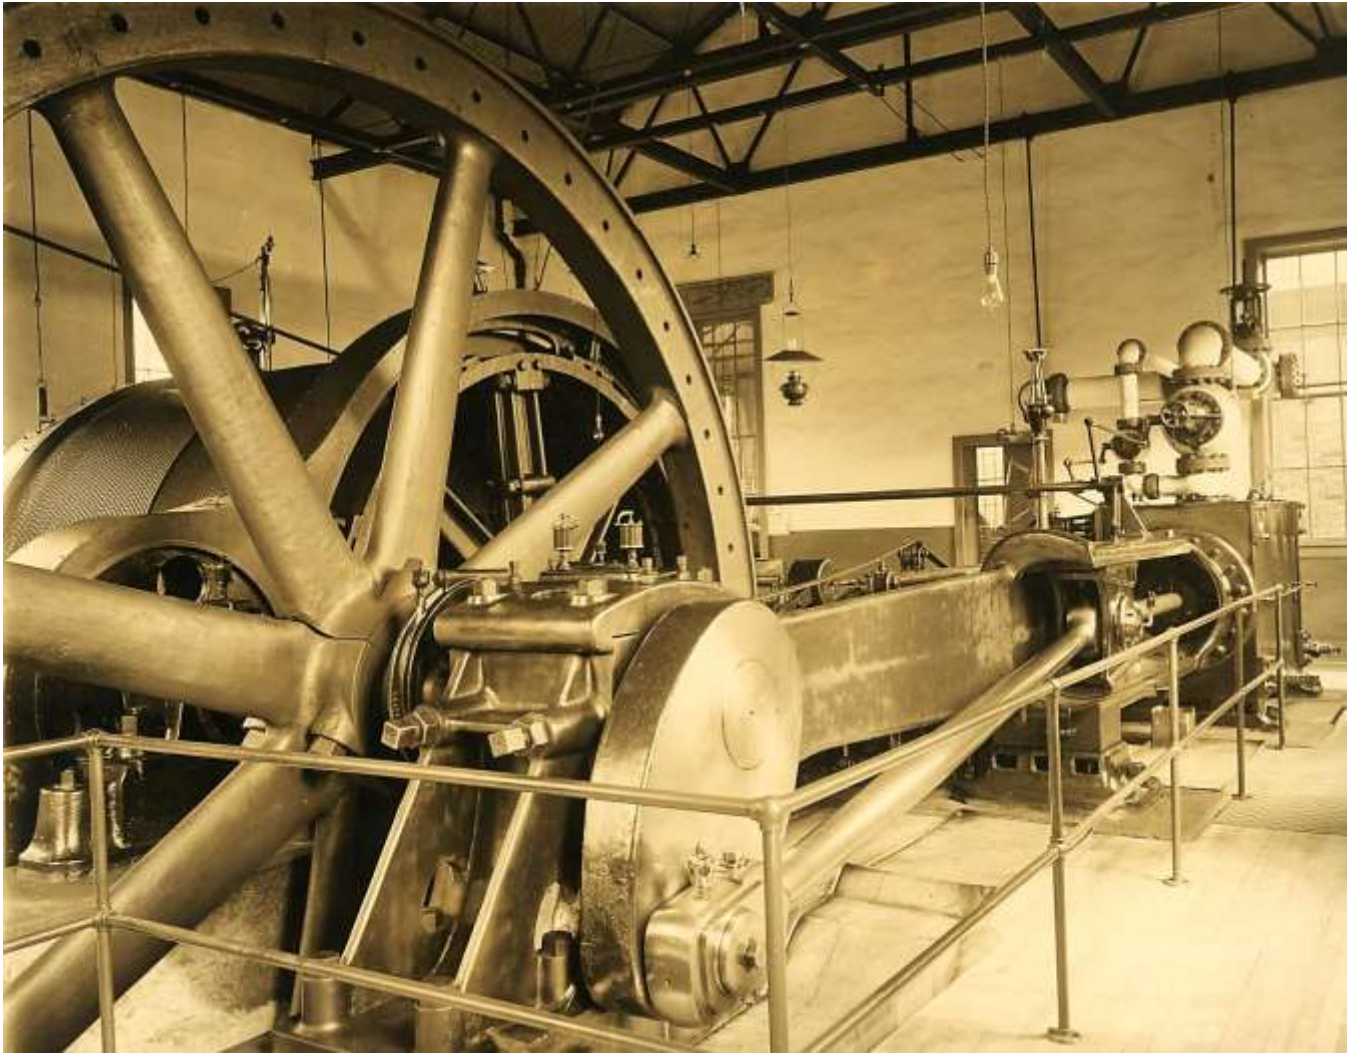
Dated October 19, 1912, this photograph shows the hoisting engine and drum which began operation July 26, 1908. The hoisting drum, keyed to the shaft's depth of 1,522 feet, contained grooves for the 1 3/8-inch steel rope and was 12 feet in diameter. Powered by an engine built by the Allis-Chalmers Company capable of hoisting 22,000 pounds, excluding the weight of the steel rope, the drum raised and lowered two 4,000-pound skips. *[Menominee Range Historical Museum]*

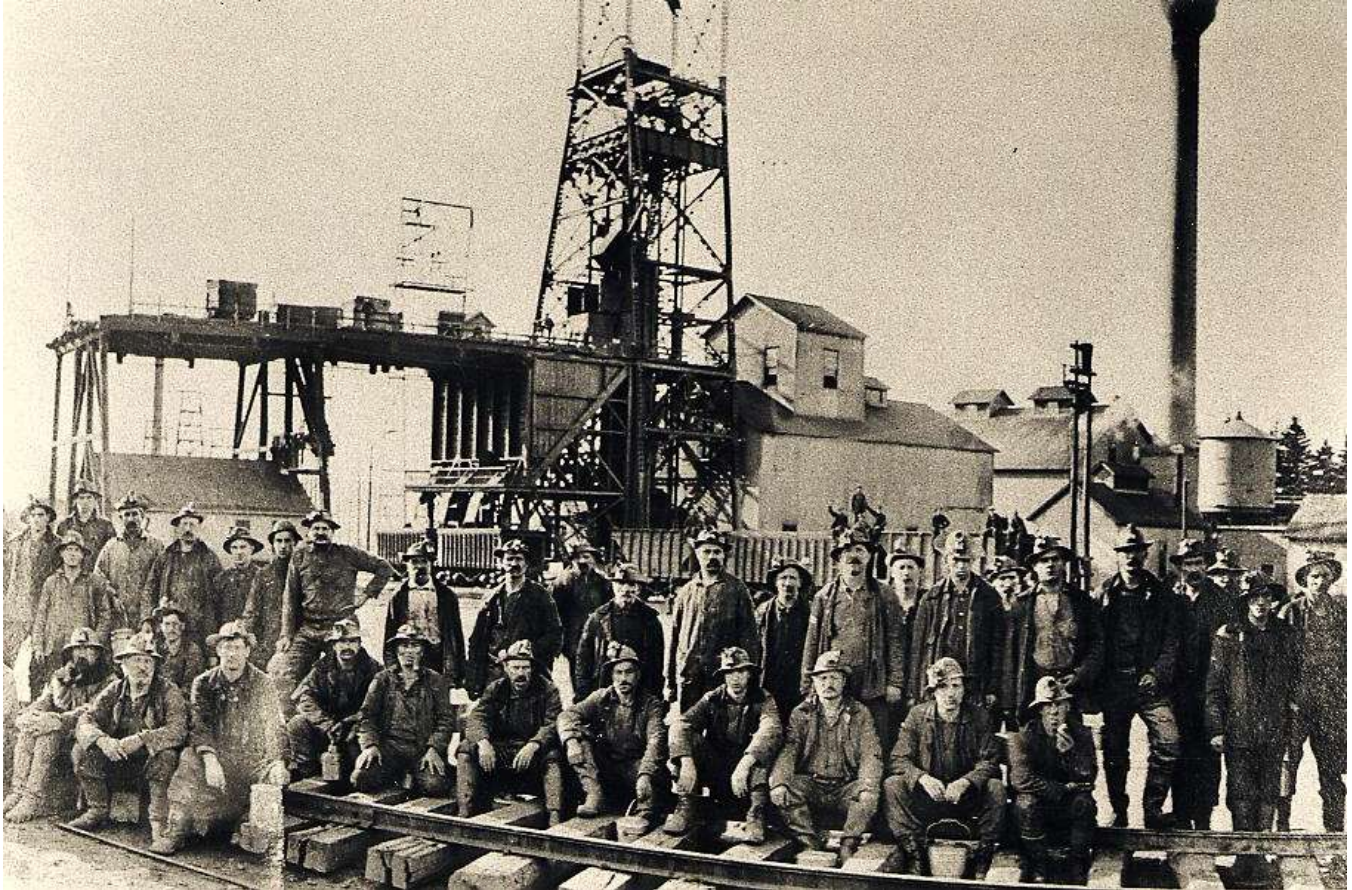
A large group of miners wearing carbide lamps posed at C Ludington Shaft of the Chapin Mine, some carrying their lunch pails, probably in about 1915-1920. The steel shaft housing and the metal pump house building housing the Cornish pumping engine can be seen in the center of the photograph. The building south of the pump house was the boiler house, where steam was produced to operation the Cornish pumping engine. The camera is facing southeast. *[Menominee Range Historical Museum]*

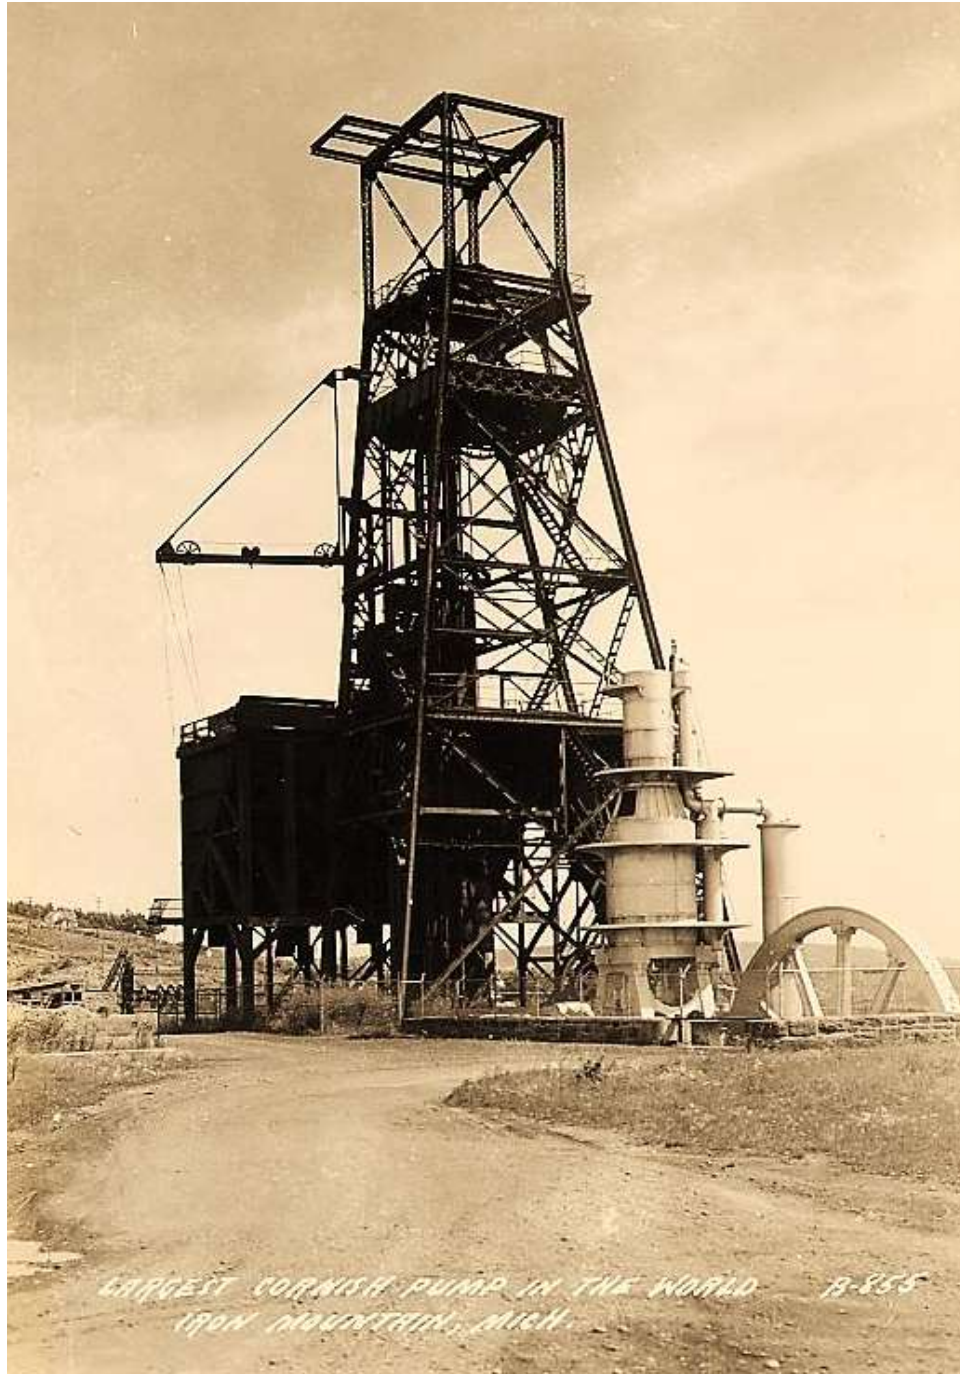
This postcard view of the Cornish pumping engine with the steel shaft housing still standing dates to about 1940. Exactly when the steel head frame and ore chutes were removed has not yet been determined.

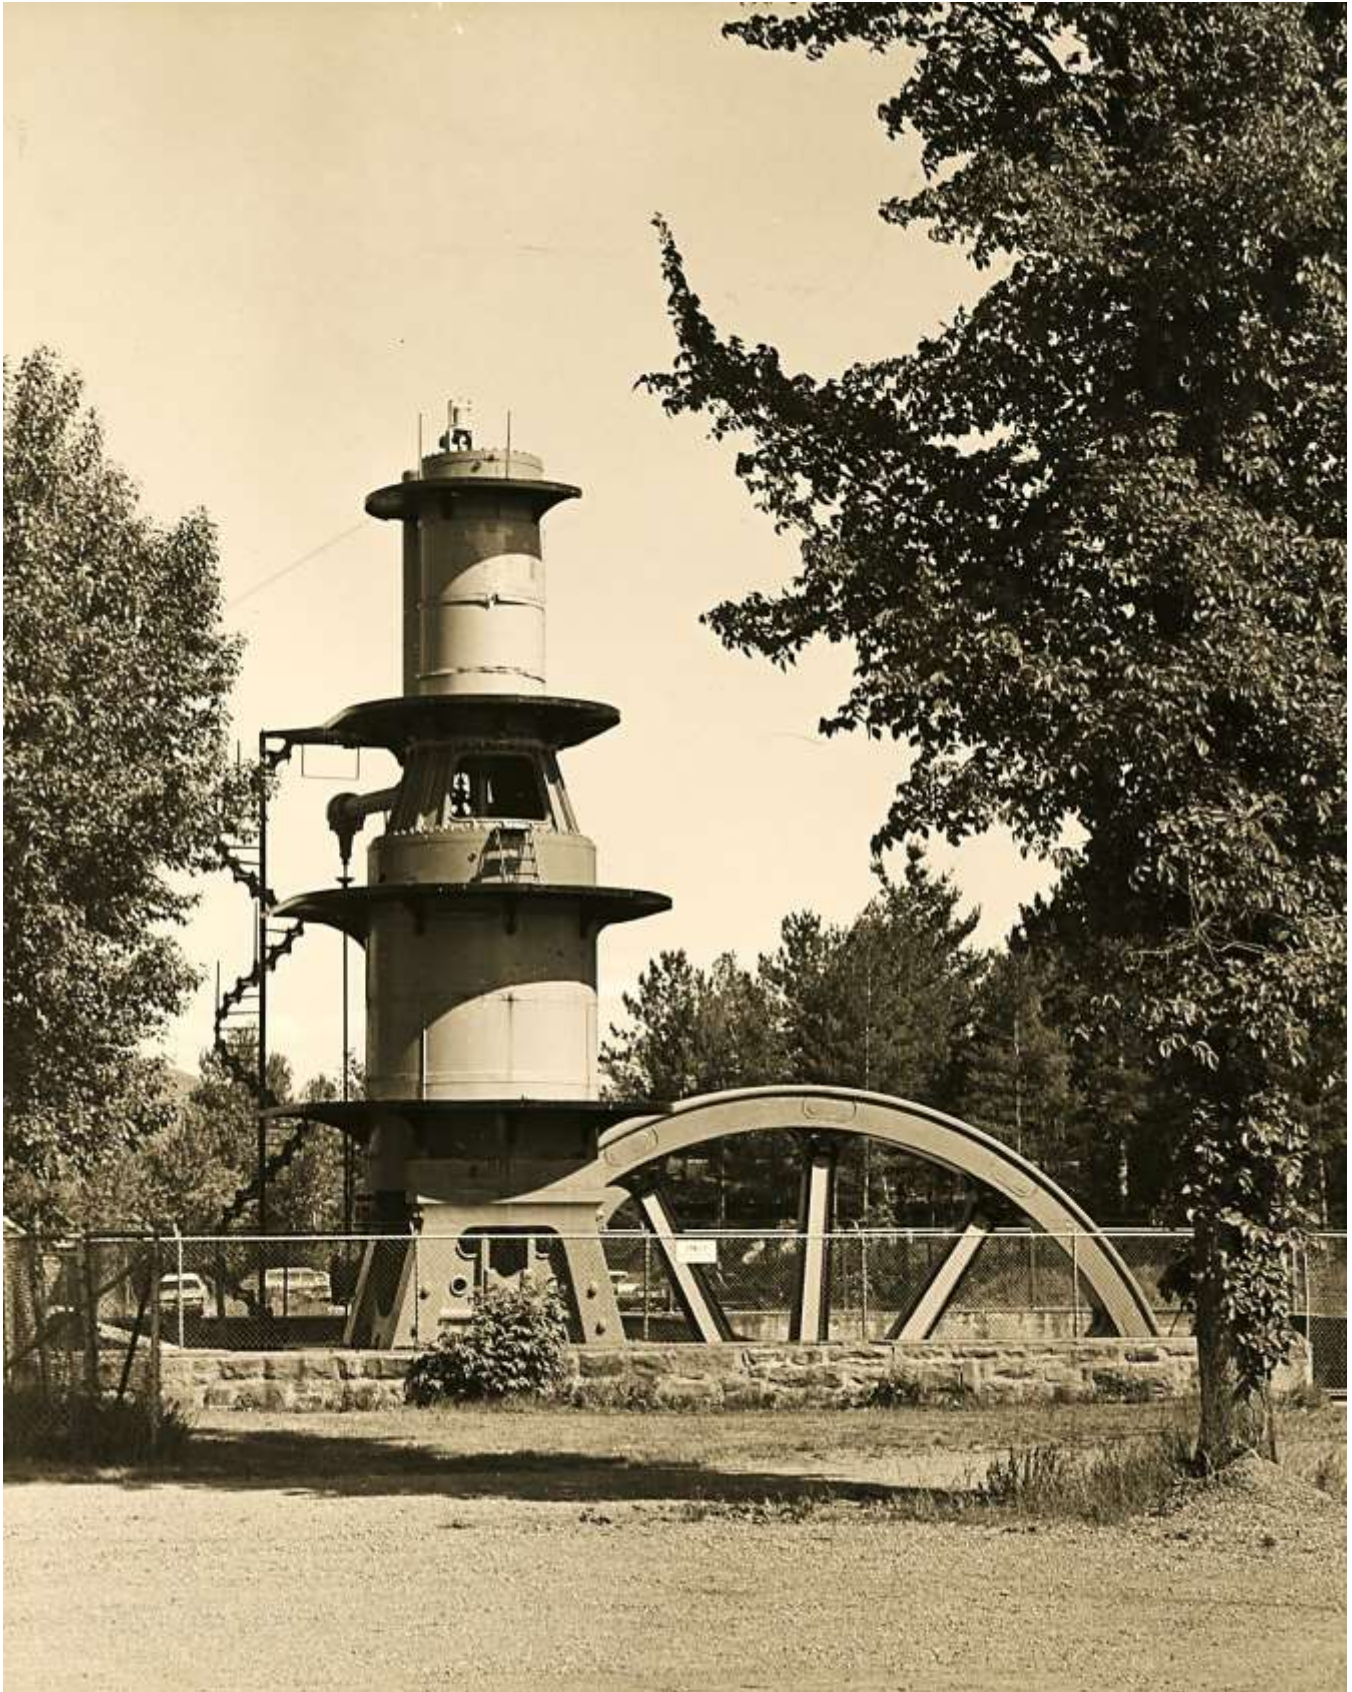
This photograph of the Cornish pumping engine was taken by William Erickson, who owned Erickson's Studio on Hooper Street in Kingsford with his wife Mary (Weinert) Erickson. Although a black-and-white photograph, the black outline on the spokes of the 40-foot flywheel indicate a date after the pump was painted orange and yellow-gold with black highlights, probably sometime in the 1960's.
