# PHOTOGRAPHS OF THE MENOMINEE IRON RANGE MINES

*[Compiled and Captioned by William John Cummings]*

## *The Cornish Pumping Engine at D Shaft of the Chapin Mine*

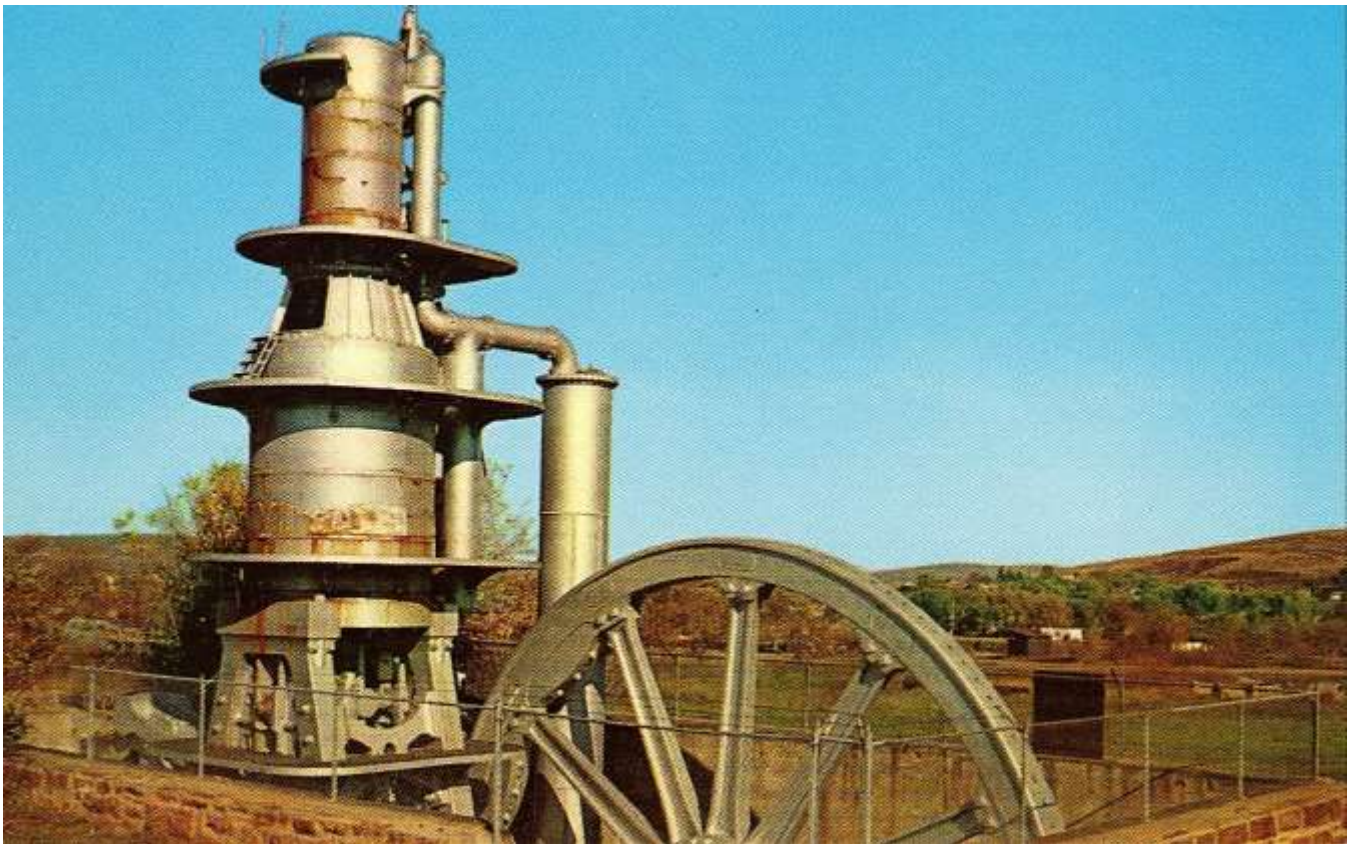
This unused postcard view, probably dating between 1950 and 1960, showed the Cornish Pumping Engine painted with aluminum paint. Chain-link fencing still surrounds the with the red sandstone foundation, but the steel head frame had disappeared, taken during a scrap metal drive during World War II. *[William J. Cummings]*

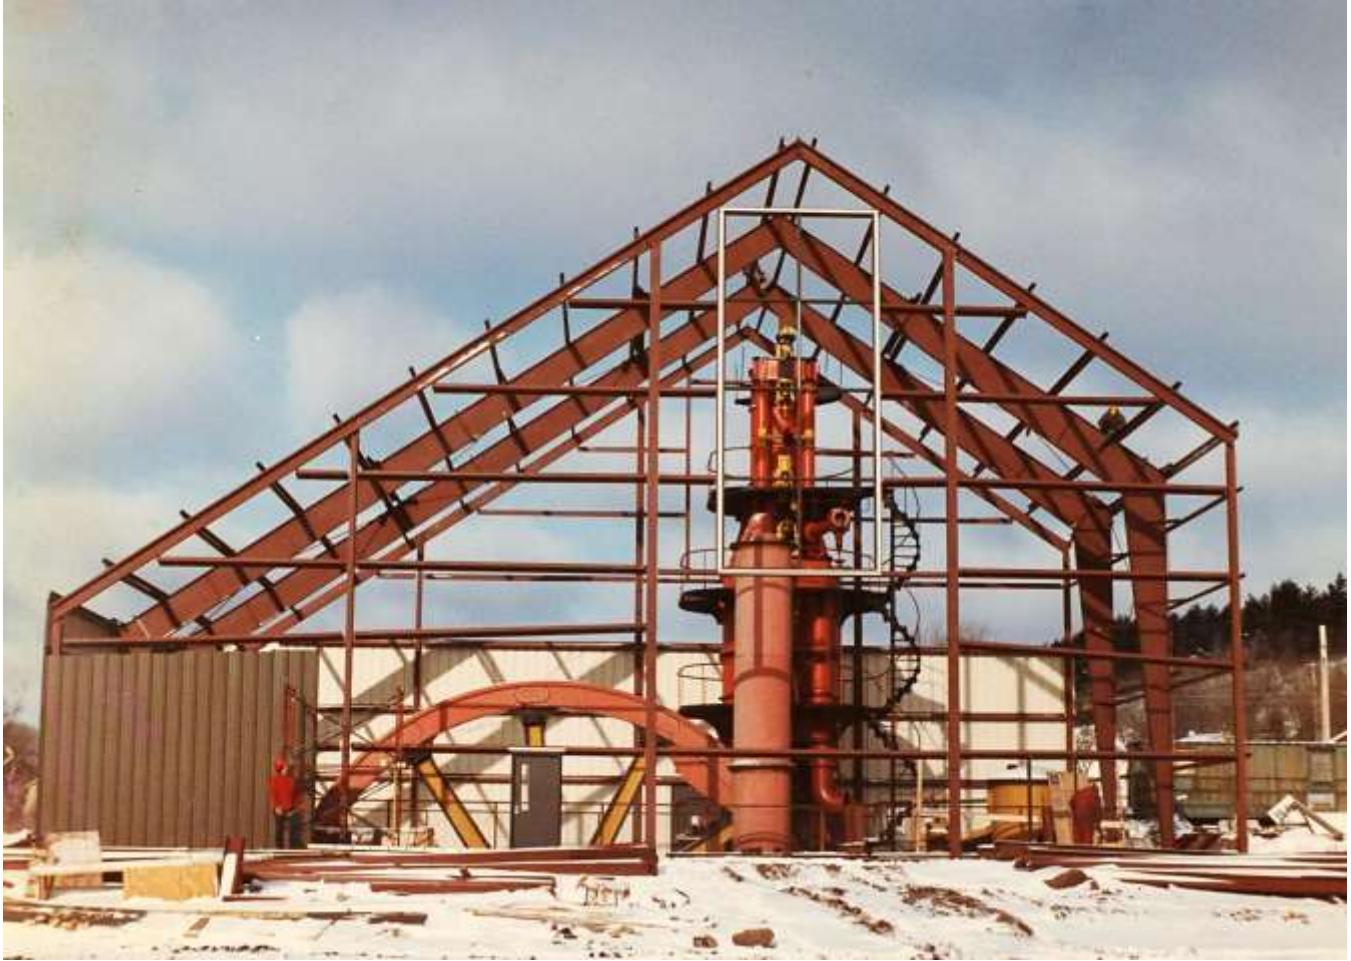
The Menominee Range Historical Foundation purchased the Cornish pumping engine from Dickinson County for one dollar on September 12, 1978, with the understanding that the Foundation would assume all responsibility for developing a permanent historic mining site. In the fall and winter of 1982-1983, a metal building 80 feet by 70 feet and 50 feet in height was erected by Smith Metal Structures, Inc., general contractor, at a cost of \$101,000 to preserve the famous pumping engine for future generations. *[Menominee Range Historical Museum]*

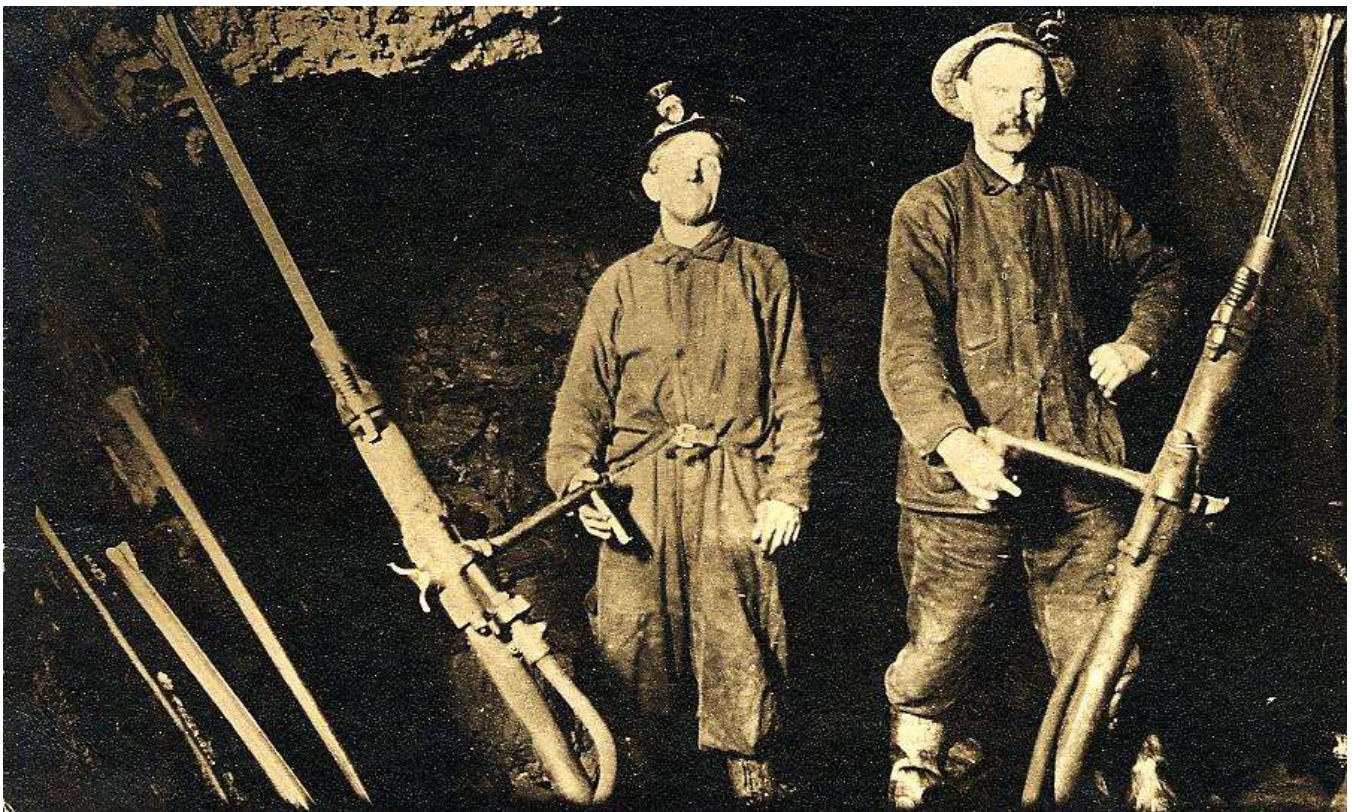
This unused real photo postcard is identified on the reverse in ink as the East Chapin Mine, 1916. The two miners, wearing carbide lamps on their mining hats, are holding Rand drills which used compressed air for power. *[William J. Cummings]*

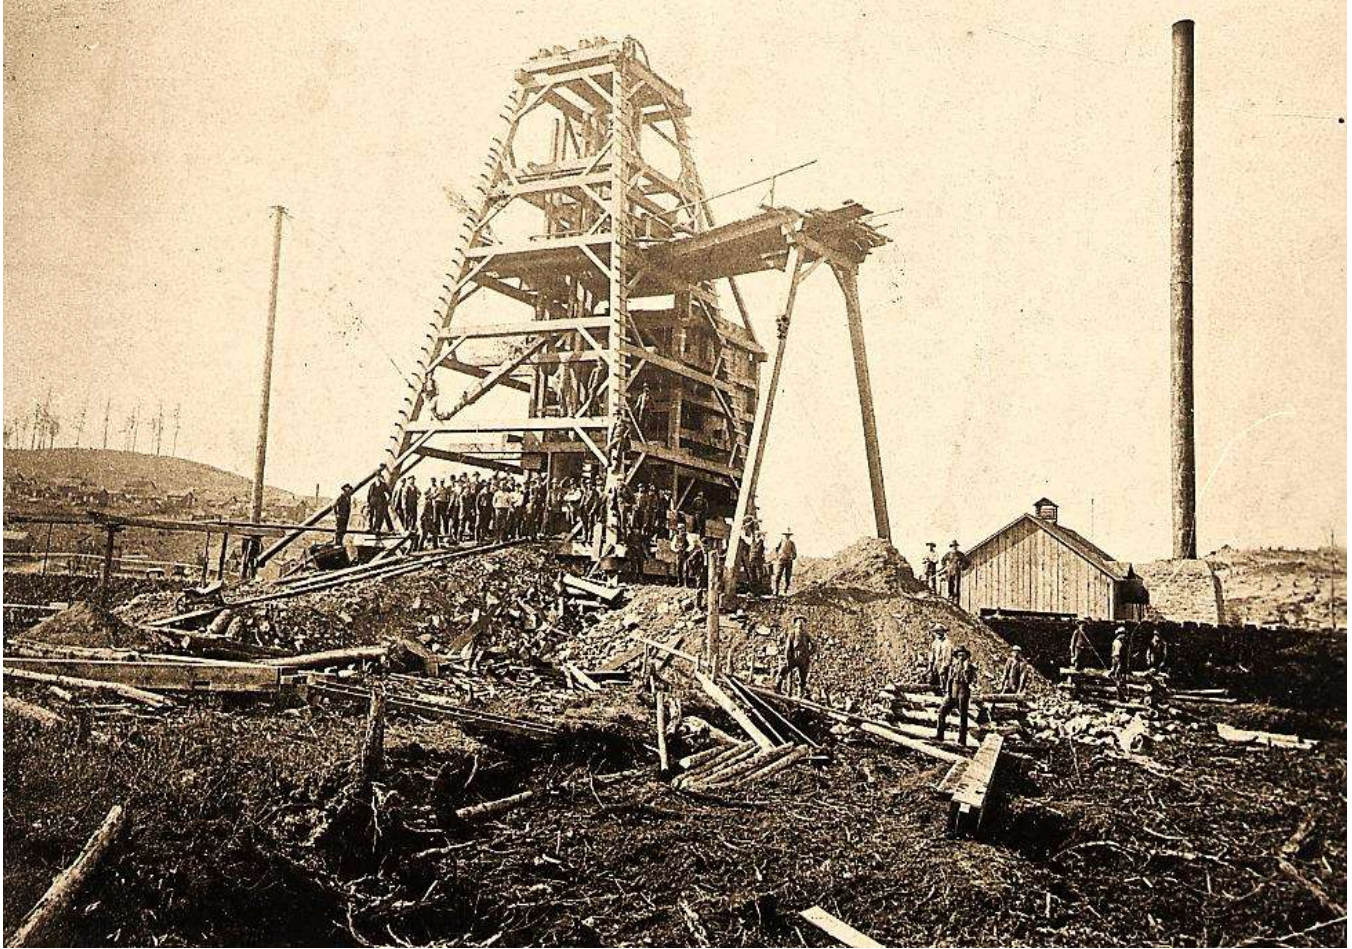
With the buildings surrounding the Chapin Mine at the foot of Iron Mountain's Millie Hill (in the background at left) serving as a reference point, this photograph, documenting early mining construction techniques, has been identified as the Hamilton Mine, and was probably taken in late fall, 1883, when the shaft house and tramway were being erected. *[Menominee Range Historical Museum]*

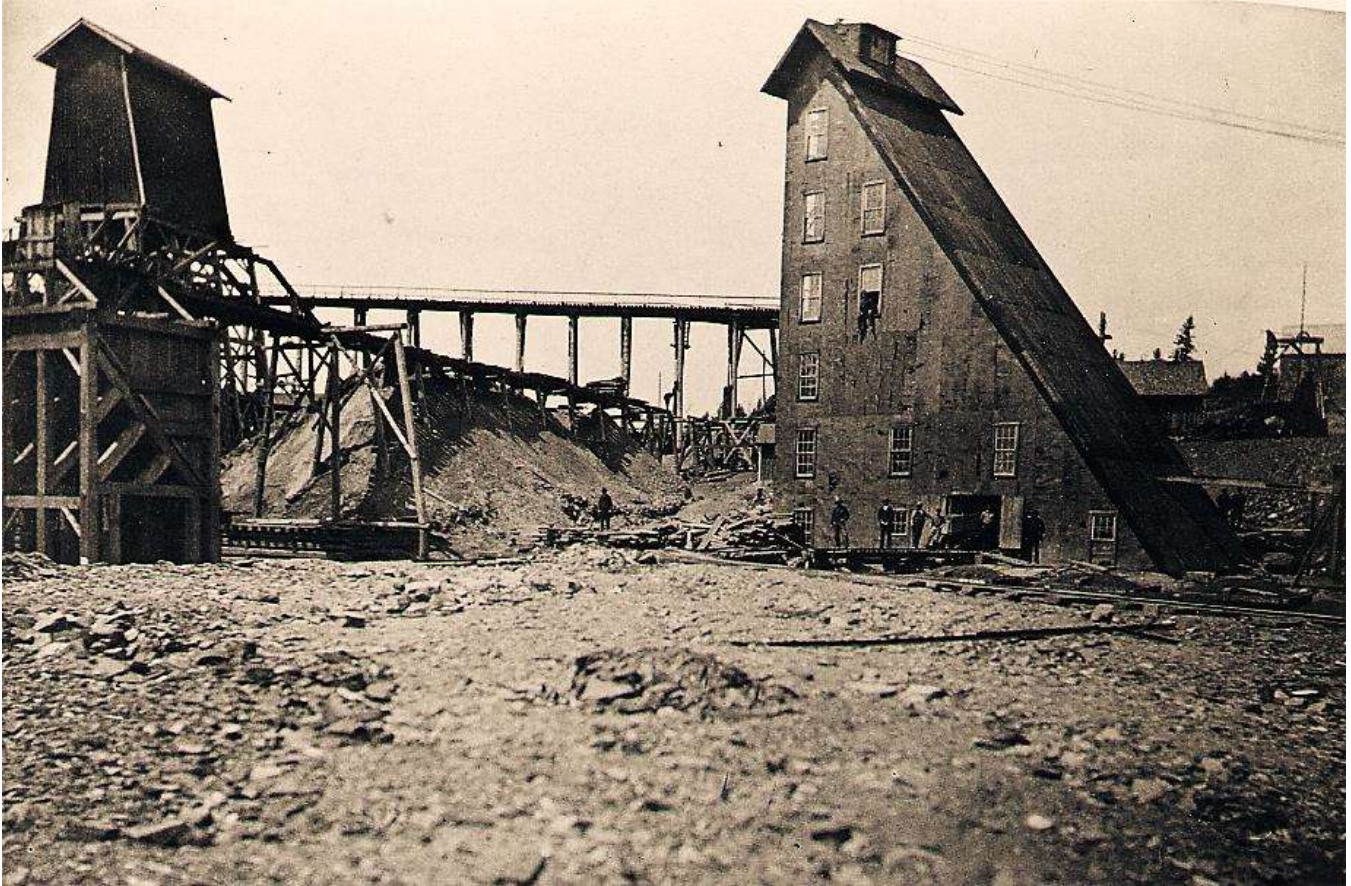
The Hamilton Mine was owned by the Hamilton Ore Company, of Sharon, Pennsylvania, and was located on the N $\frac{1}{2}$  of the SW $\frac{1}{4}$  of Section 30, Township 40, Range 30, a tract which contained 80 acres leased from the Hamilton & Merryman Company. John Tyler Jones prospected in the area in 1883 and discovered the mine that year by using a diamond drill. This early photograph, probably dating between 1886 and 1890, shows the shaft housing at the right and the trestles and tramways where the ore cars dumped the iron ore onto the stockpiles on the left. *[Menominee Range Historical Museum]*

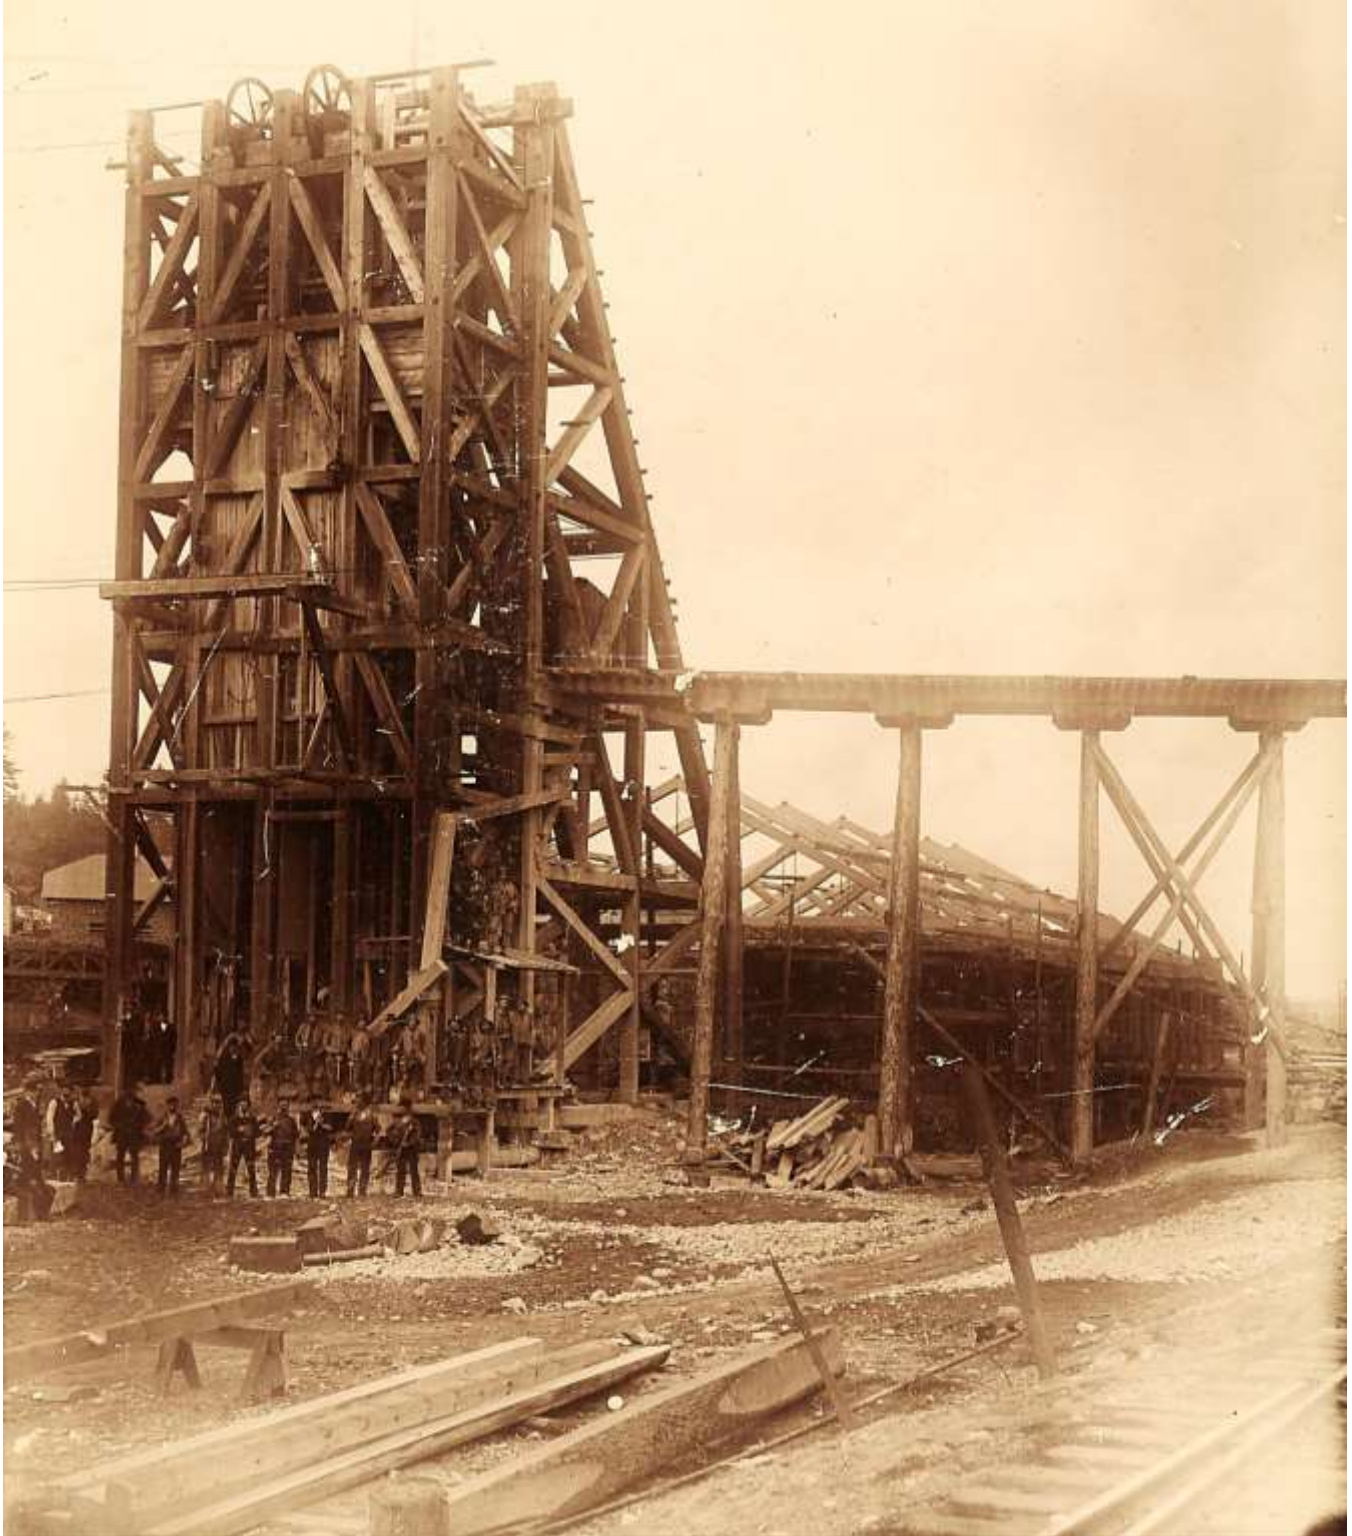
This early view of the wooden shaft house of the Hamilton Mine, possibly showing No. 2 Shaft, belonged to Arthur Jones, son of John Tyler Jones, who was largely responsible for locating the mine and served as the mine's superintendent. The rafters for the building in the background may be for the sandstone building which still stands at the Hamilton Mine site

(2012). Note the size of the men standing in the foreground in relation to the structure giving an idea of the scale of the structure. A trestle to the right would have brought iron ore to the stockpiles. *[Menominee Range Historical Museum]*

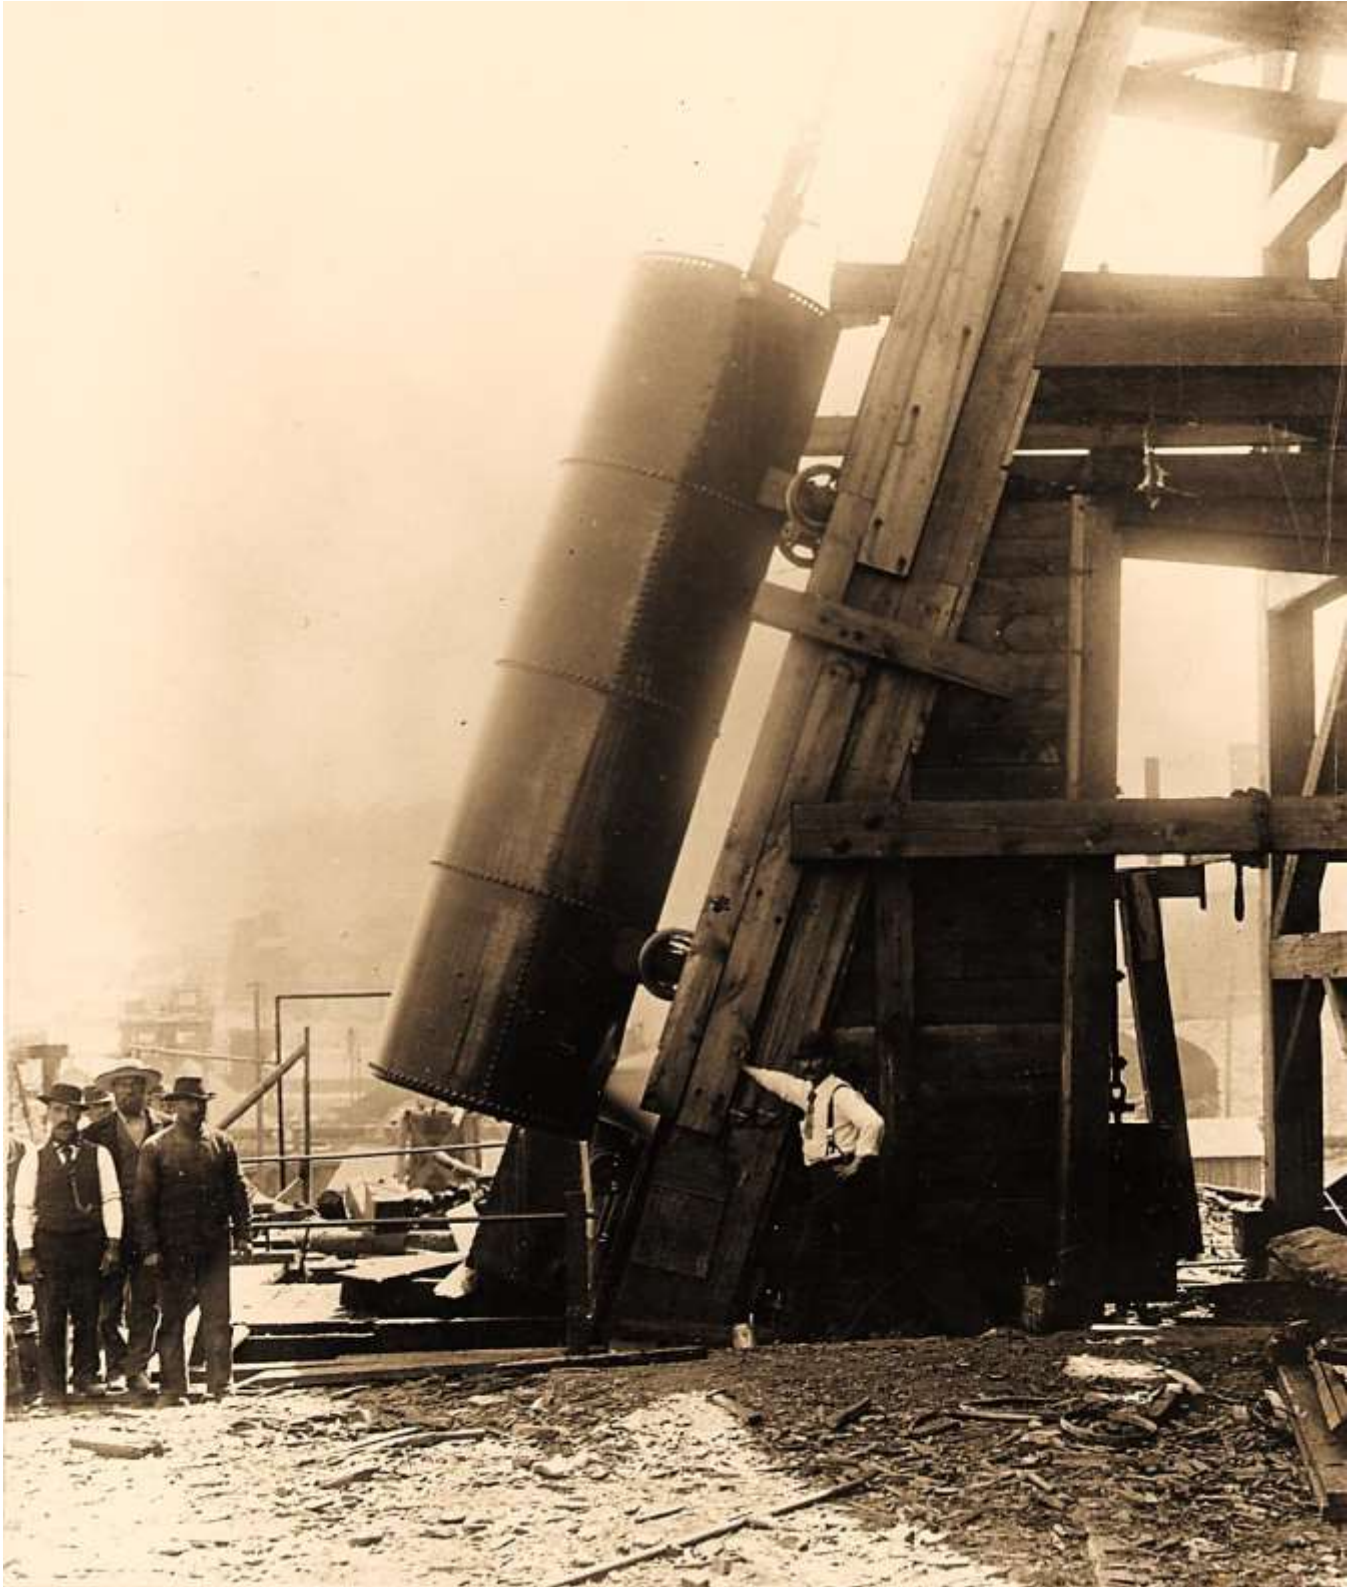
This photograph shows the 2,560-gallon bailer used to dewater No. 2 Shaft of the Hamilton Mine in June, 1892. *[Menominee Range Historical Museum]*

During the fall of 1891, No. 2 shaft was being sunk at the Hamilton Mine in Iron Mountain. On October 22, Superintendent John Tyler Jones, noting an unusual commotion at the shaft's collar, arrived just in time to see James Biddick being brought to the surface, blinded and nearly dead. Biddick had just about finished the last hole in a series prior to blasting when he struck a water-filled cavity, and the released pressure tossed him like a ball. At least a portion of the water came from the Ludington Mine's A shaft sump and continued rising in the Hamilton's No. 2 shaft to within 90 feet of the collar. Since a 10-ton hoisting plant was then being installed, plans were modified to incorporate bailers to dewater the mine.

Installation was still in progress on December 31, when the Ludington Mine's hanging wall moved and water began entering that mine at the 11<sup>th</sup> level of A shaft at a rate of 6,000 gallons per minute. The Ludington was soon filled to the 9<sup>th</sup> level, and the Hamilton's No. 1 shaft, connected to the Ludington's A shaft by drifts, was also filling. The water level at the Hamilton's No. 2 shaft was lowered 182 feet by this second flooding.

A month after the flooding, the Ludington's bailing operations had succeeded in lowering the water level only 10 feet. The management, losing tremendous sums daily, abandoned the mine February 6, 1892, discharging the remaining 150 employees. Once the bailing operations ceased, the water in the Ludington rose at the rate of a foot an hour, reaching the 6<sup>th</sup> level by February 11.

The owner of the Hamilton Mine bought the Ludington Mine and, after considerable work driving a drift to connect the two Hamilton shafts during the winter and early spring of 1893, bailing began June 19. By June 14, the bailers had raised 87,017,954 gallons of water, lowering the water level by 896 feet in the Ludington and 1,325 feet in the Hamilton. The flow was then normal, and in six weeks the water was out of both mines.

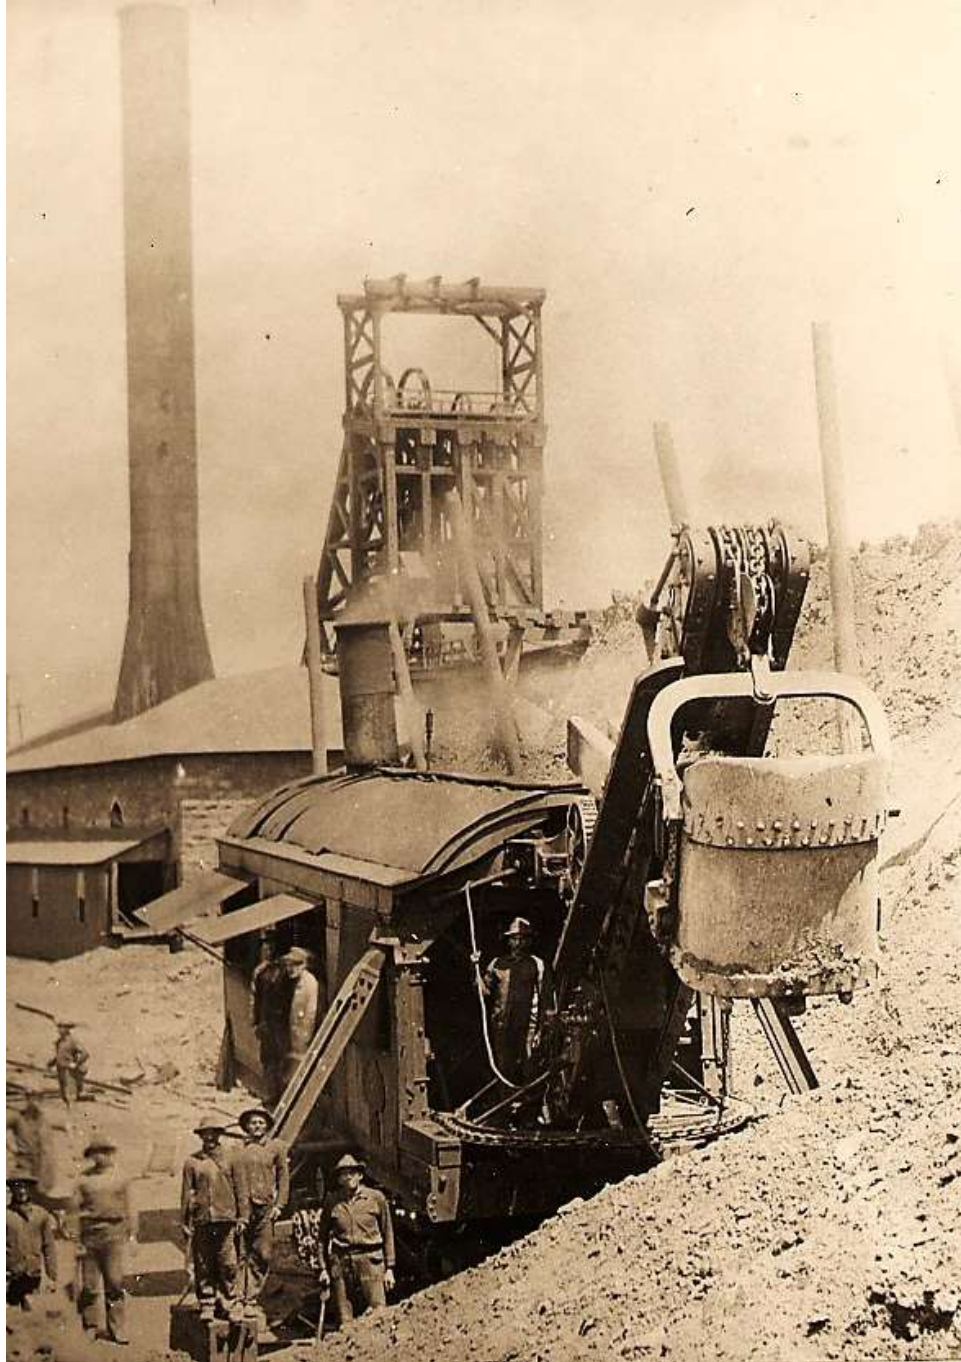
The steam shovel was an expensive and vital piece of machinery, particularly for the larger mining companies, and was used to load stockpiled iron ore into the railroad cars. The steam shovel and crew of the Hamilton Shaft of the Chapin Mine are pictured here in about 1900. *[Menominee Range Historical Museum]*

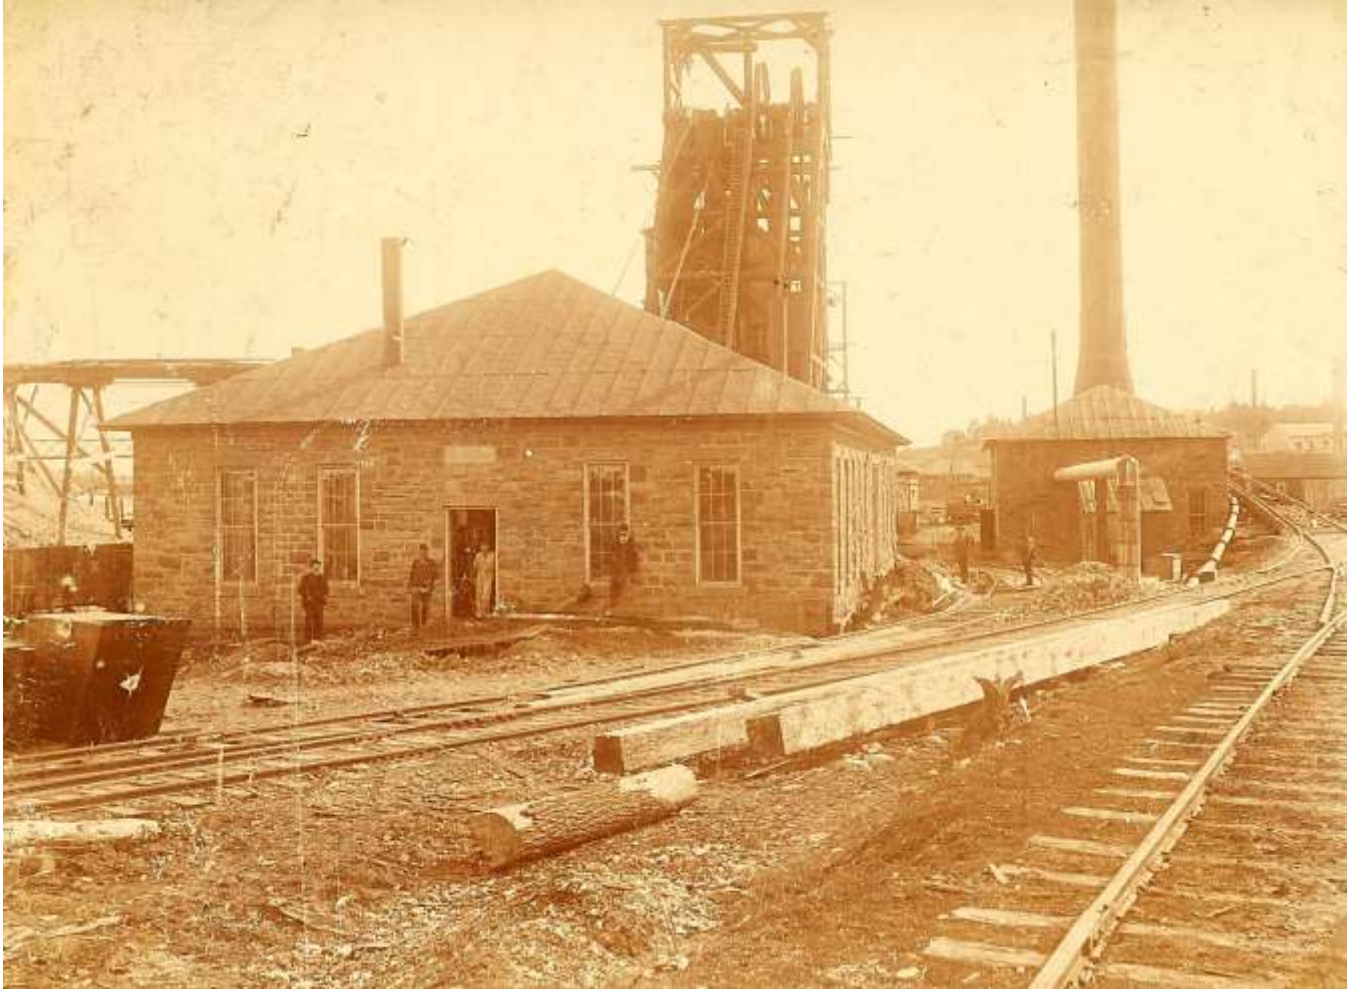
This photograph, probably dating from about 1912, shows the Hamilton Shaft of the Chapin Mine, including the sandstone engine house at the left, which used flat cables to pull up the cage and the skips filled with iron ore. Note the wooden shaft housing and the smokestack rising from another mine building. *[Menominee Range Historical Museum]*

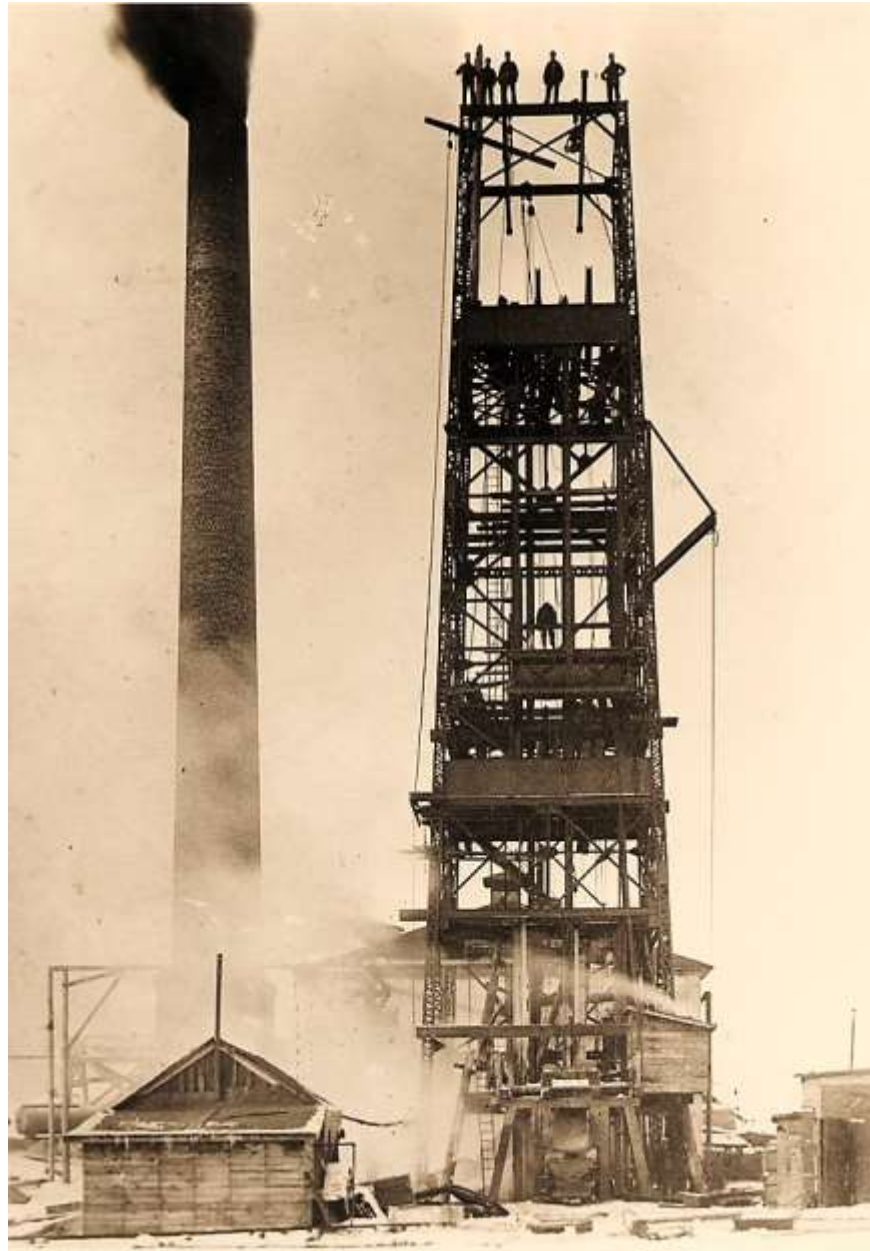
When the Oliver Mining Company decided to rebuild the Hamilton Shaft and install electrical pumps, the era of the Cornish Pumping Engine, a marvel of the steam age, came to a close.

The shaft's inside dimensions, originally 7 x 21 1/3 feet, were increased to 9 x 21 1/3 feet to accommodate the water column pipes and transmission cables for the electrical pumps. The shaft was also converted from six to eight compartments, relined with reinforced concrete dividers, end plates and poured concrete walls. To facilitate this work, a concrete mixing plant was built near the shaft, consisting of a crusher bucket elevator, a revolving screen, two concrete mixers and a pocket divided into three compartments for sand and gravel.

Relining began May 3, 1912, about 83 feet below the shaft's collar and was completed to the surface June 29. Work was carried on in three 8-hour shifts by a force of about 40 men supervised by the company's chief construction engineer, S.W. Tarr, of Duluth.

The work was done in sections, each section started on permanent bearers and worked upward. The average amount of material used to reline one 6-foot vertical section was one cord of stone for back filling, 10 cubic yards of concrete and 550 pounds of steel for reinforcing.

There the first of two pumping stations was cut out, measuring 30 x 100 feet and containing one set of electrical centrifugal pumps. A second plant was located at the sixteenth level, about 430 feet below the twelfth level, and the shaft was relined the entire distance.

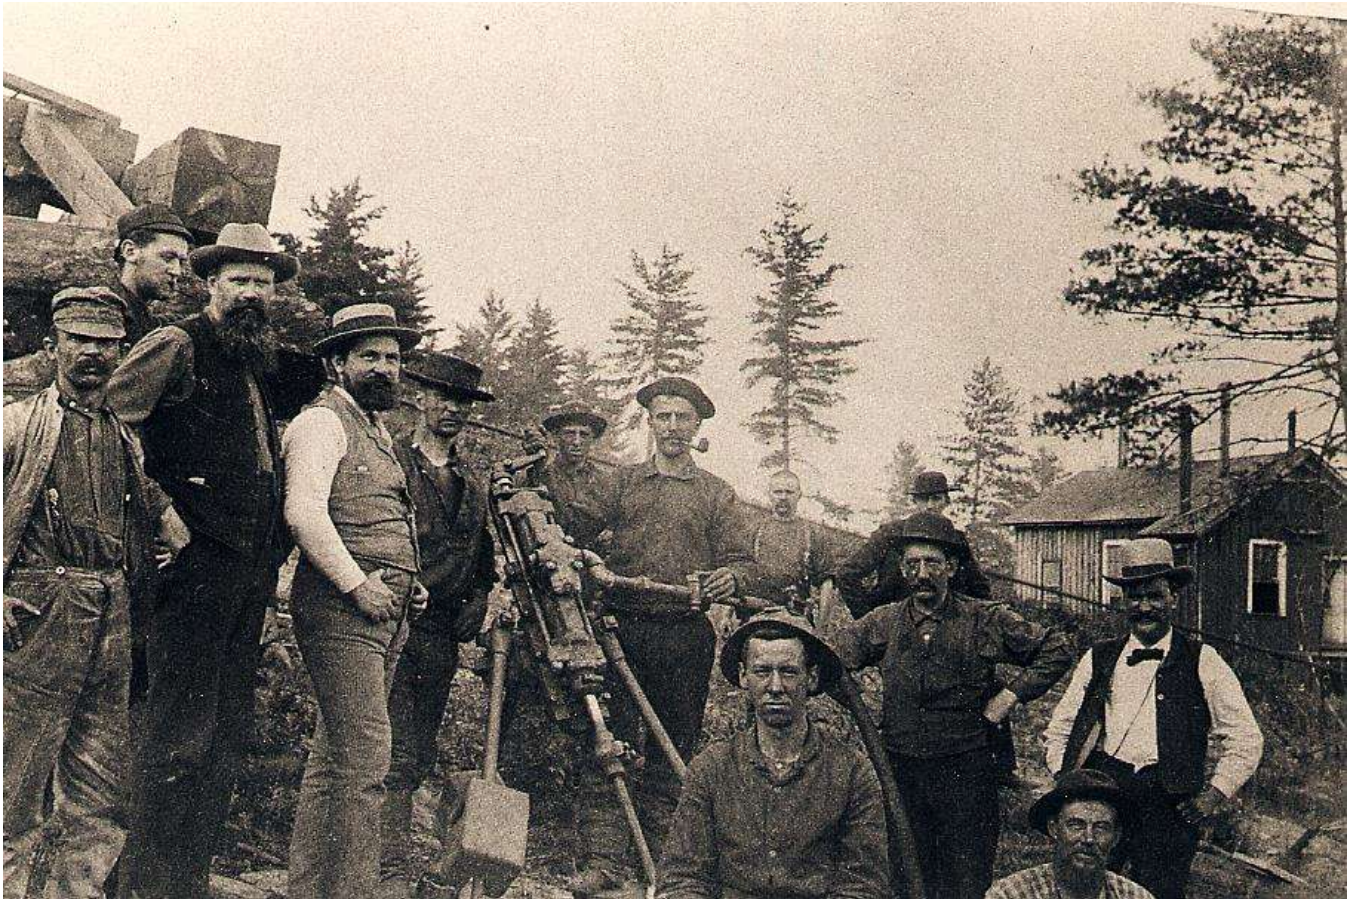
A group of Chapin and Ludington mining officials and surface workers posed informally around a Rand drill driven by compressed air at the Ludington Mine in 1886 or 1887. According to contemporary notations on the back of this dated photograph, the following men were among those pictured: Captain William Oliver, Chapin Mine; Per Larsson, mining engineer, Chapin Mine; Edward E. Brewster, chemist, Chapin Mine; Duff LaVictore, machinist; and Thomas Polkinghorn. Harry McDermott, the master mechanic at the Ludington Mine, appears in the lower right, wearing a checked shirt, black hat and sporting a moustache and beard. Edmund Kent, the master mechanic at the Chapin Mine and Iron Mountain's second mayor, has his thumbs hooked in the front pockets of his pants to the left of the Rand drill. The man standing at the far right with a moustache and wearing a light-colored hat and dark vest was A.D. Moore, superintendent of the Ludington Mine. [Menominee Range Historical Museum]

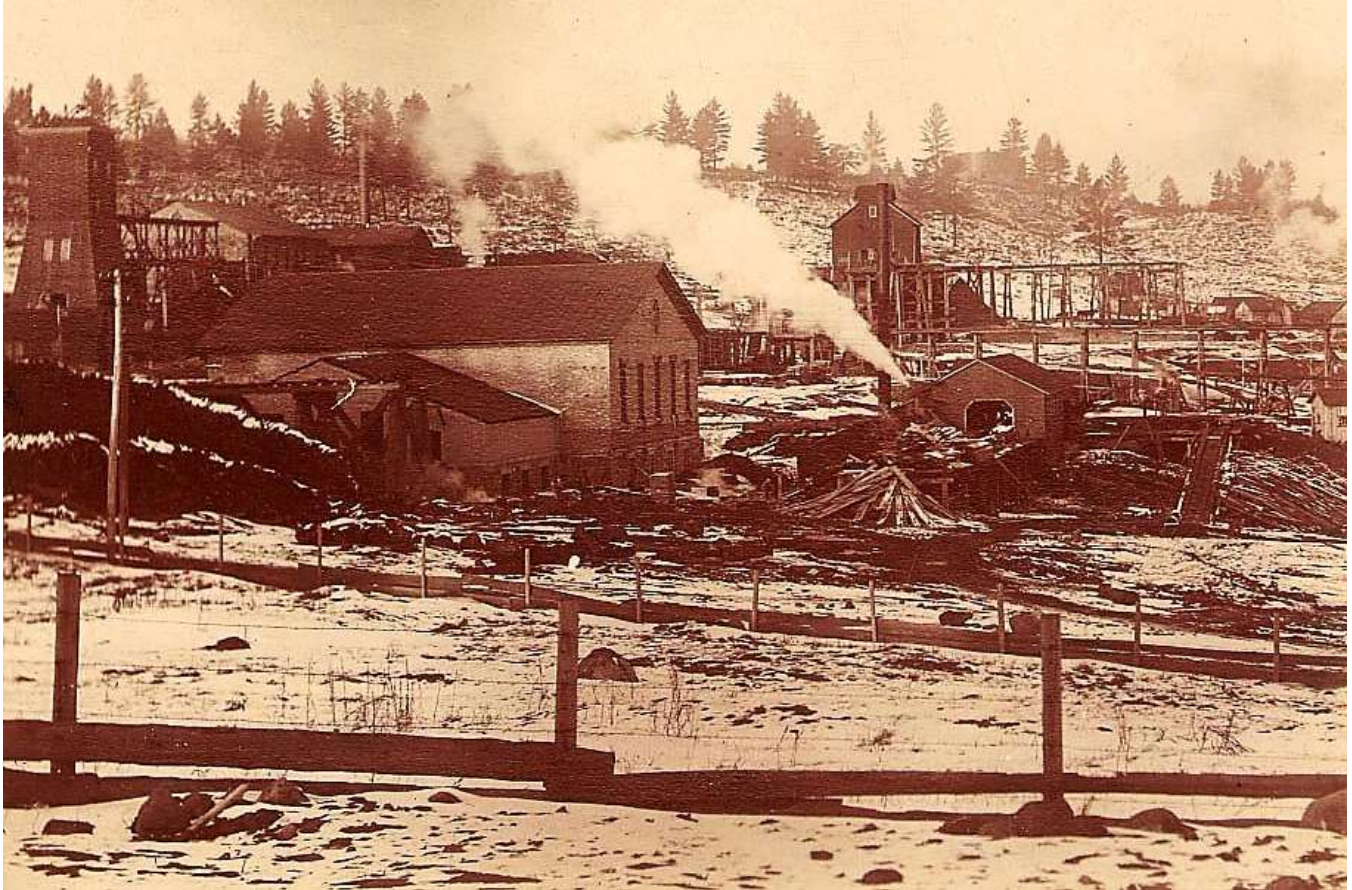
Taken by Iron Mountain photographer George S. Van Stone between 1893 and 1895, this view of the Ludington Mine shows a shaft house at the far left and another shaft house at the right, as well as a brick building, probably an engine house, to the left of center, and another brick or sandstone engine house to the right of the shaft house at the left. The building where steam is being emitted appears to have been a sawmill. *[Keen S. Scott]*

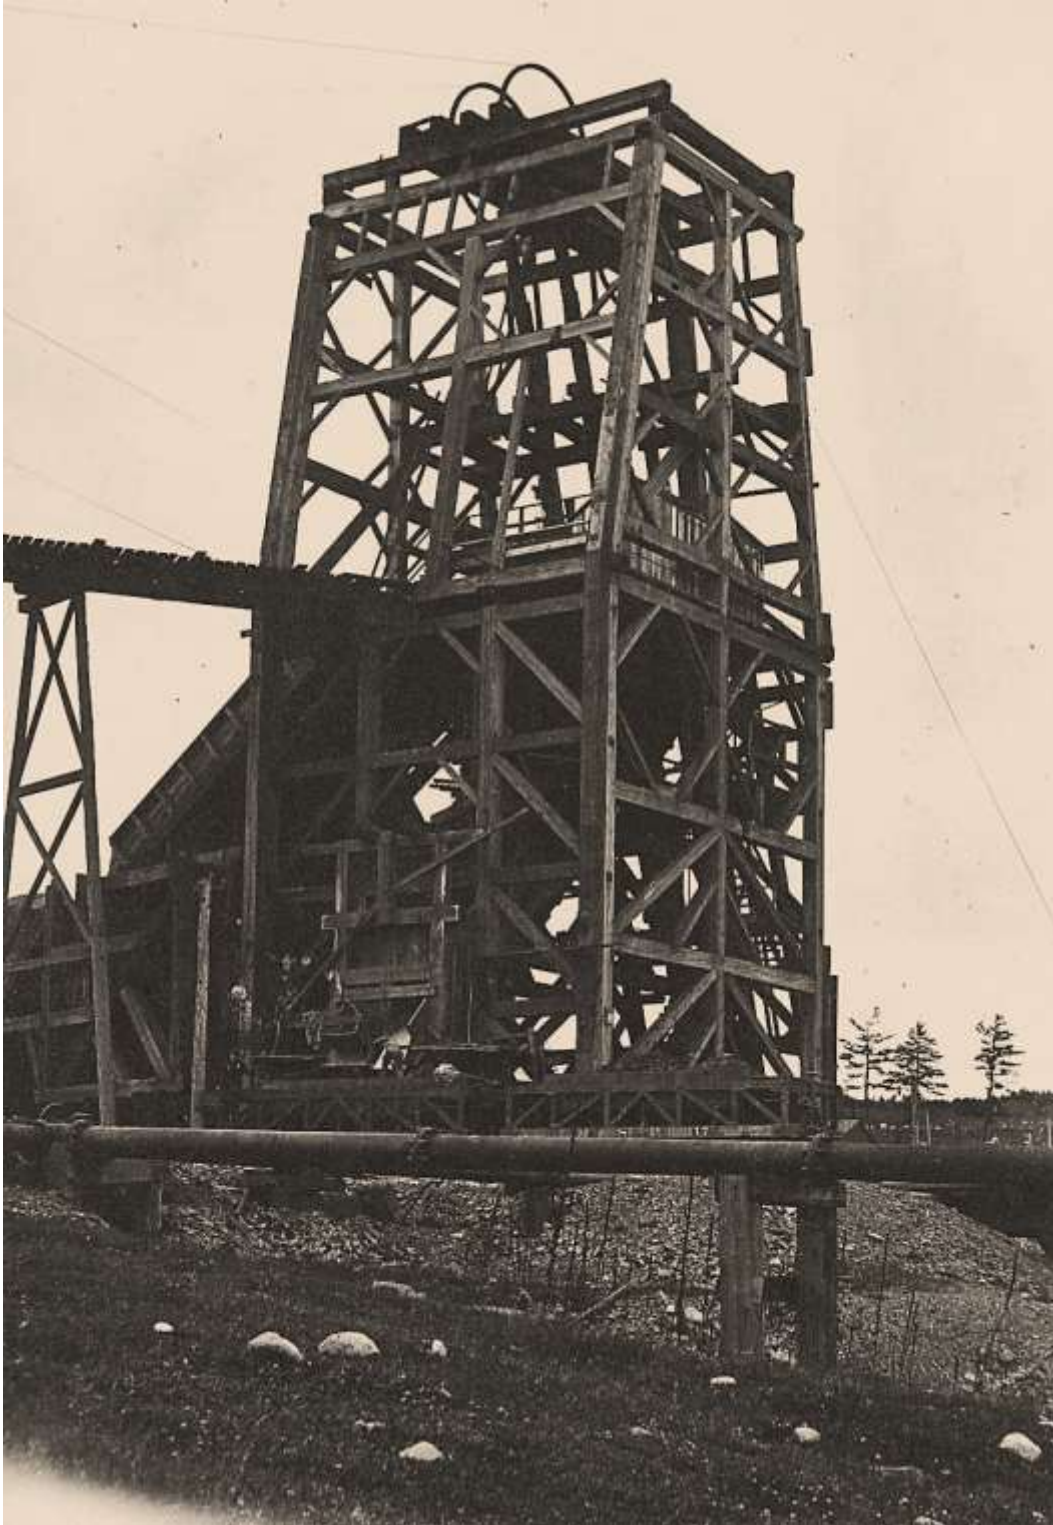
Jorgen J. Eskil, pioneer Menominee Range photographer, took this photograph of the No. 2 Shaft House of Iron Mountain's Ludington Mine in about 1890. Note the wooden timbering and the sheaves at the top for the cables used in hoisting ore and the skips in which the miners rode up and down the shaft. *[Menominee Range Historical Museum]*

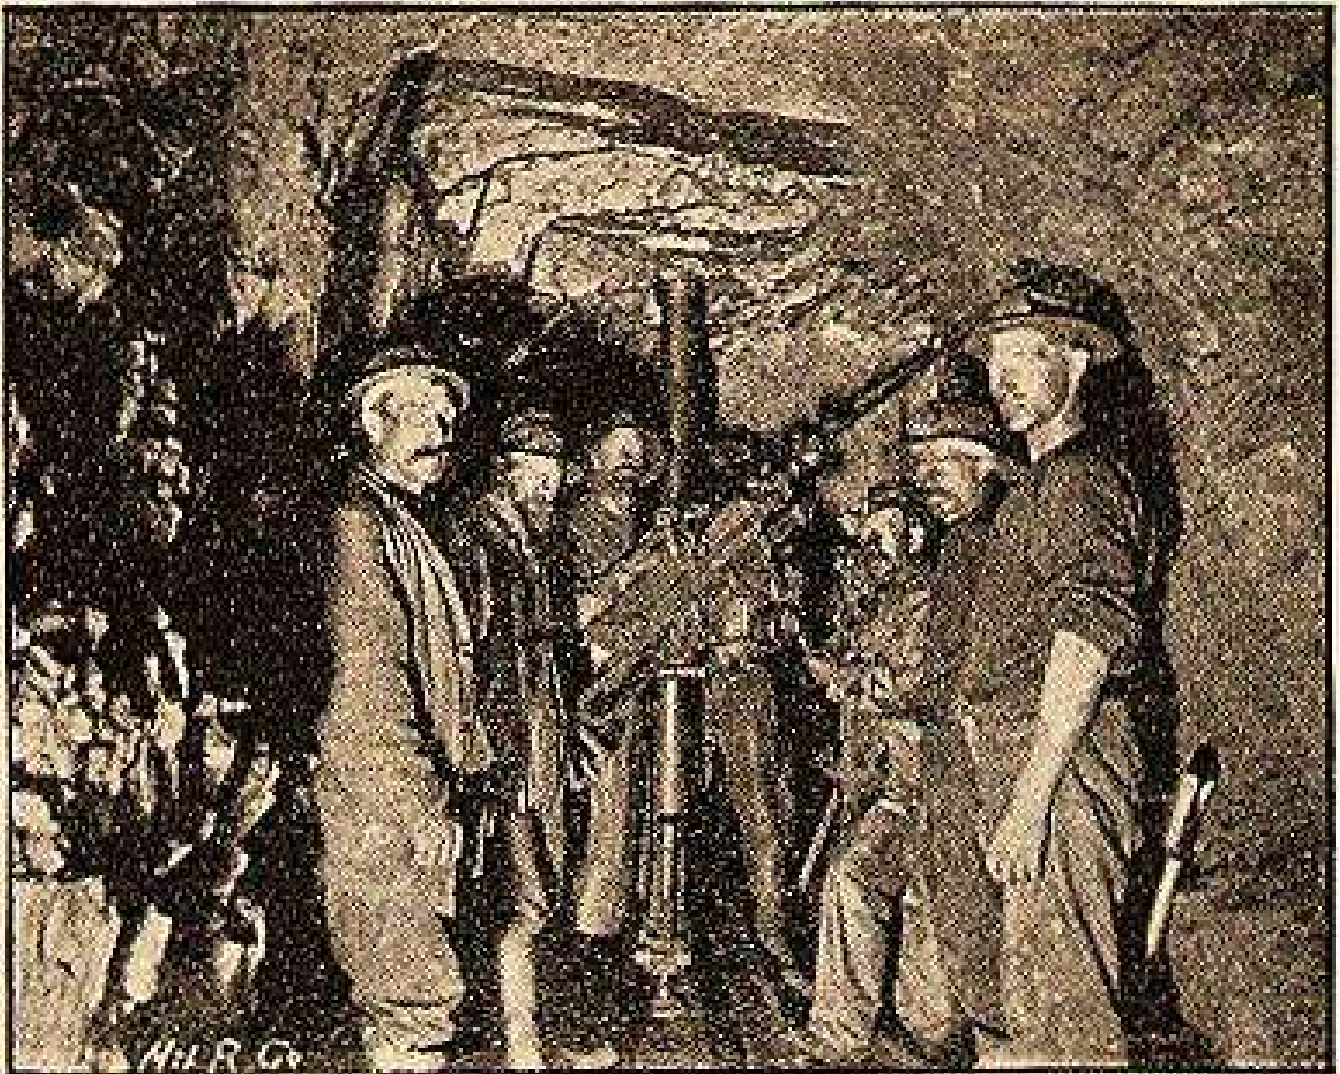
RAND DRILLS—4TH LEVEL LUDINGTON MINE.

This illustration appeared in Walter R. Nursey's book *The Menominee Iron Range*, published in 1891. [William J. Cummings]

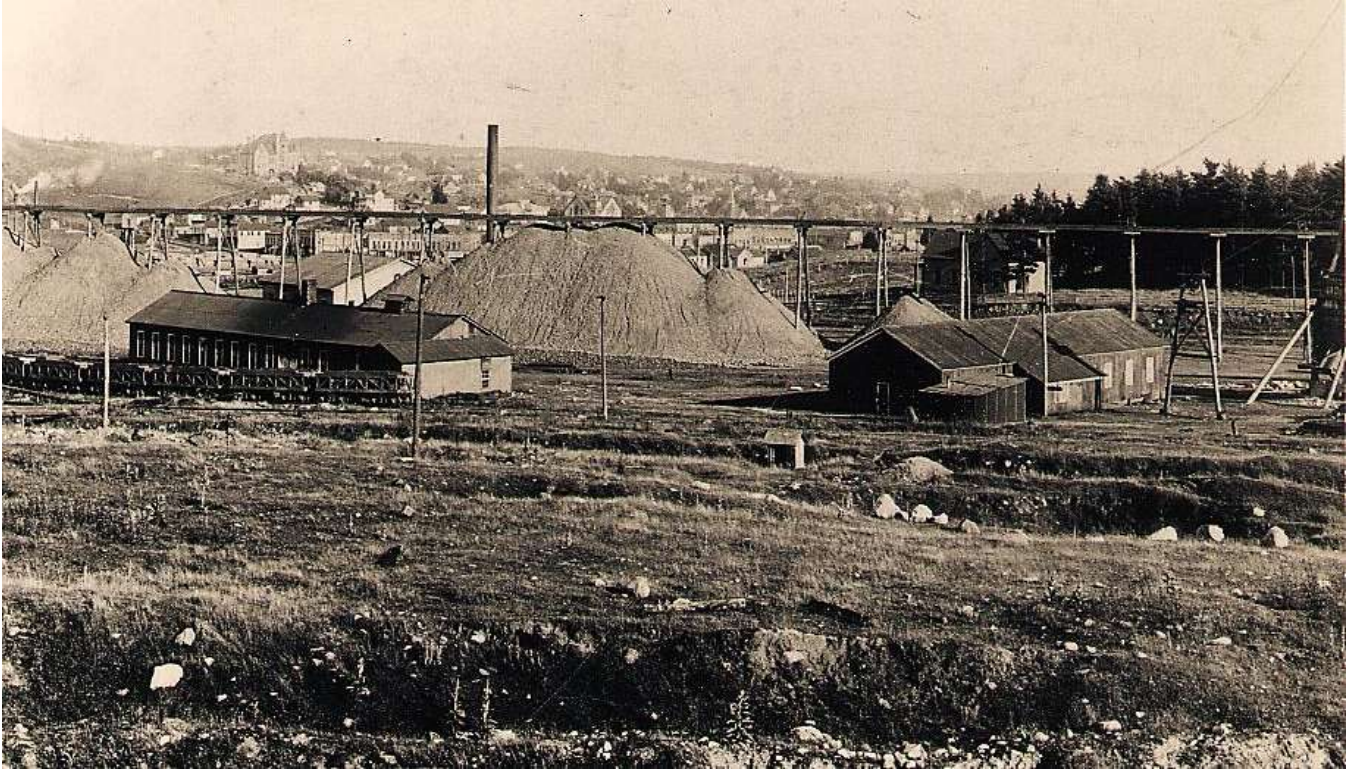
This detail of a panoramic view of the Hamilton and Ludington Shafts of the Chapin Mine was taken on July 21, 1904. Note the air pipe which supplied compressed air from Hydraulic Falls near Quinnesec. *[Menominee Range Historical Museum]*
