# PHOTOGRAPHS OF THE MENOMINEE IRON RANGE MINES

*[Compiled and Captioned by William John Cummings]*

## *The Cornish Pumping Engine at D Shaft of the Chapin Mine*

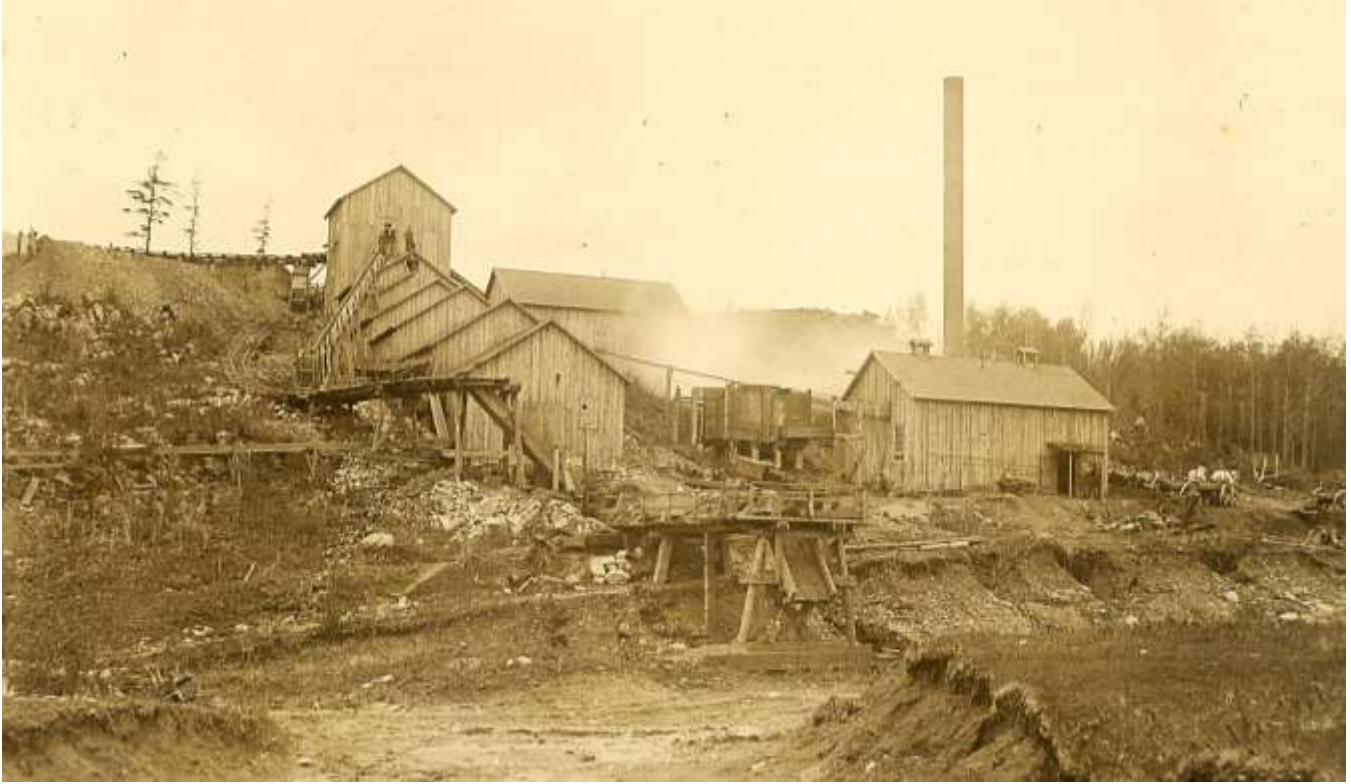
This view of the Pewabic Mine concentrating works was taken by Jorgen J. Eskil, pioneer Menominee Range photographer, between 1890 and 1900. *[Menominee Range Historical Museum]*

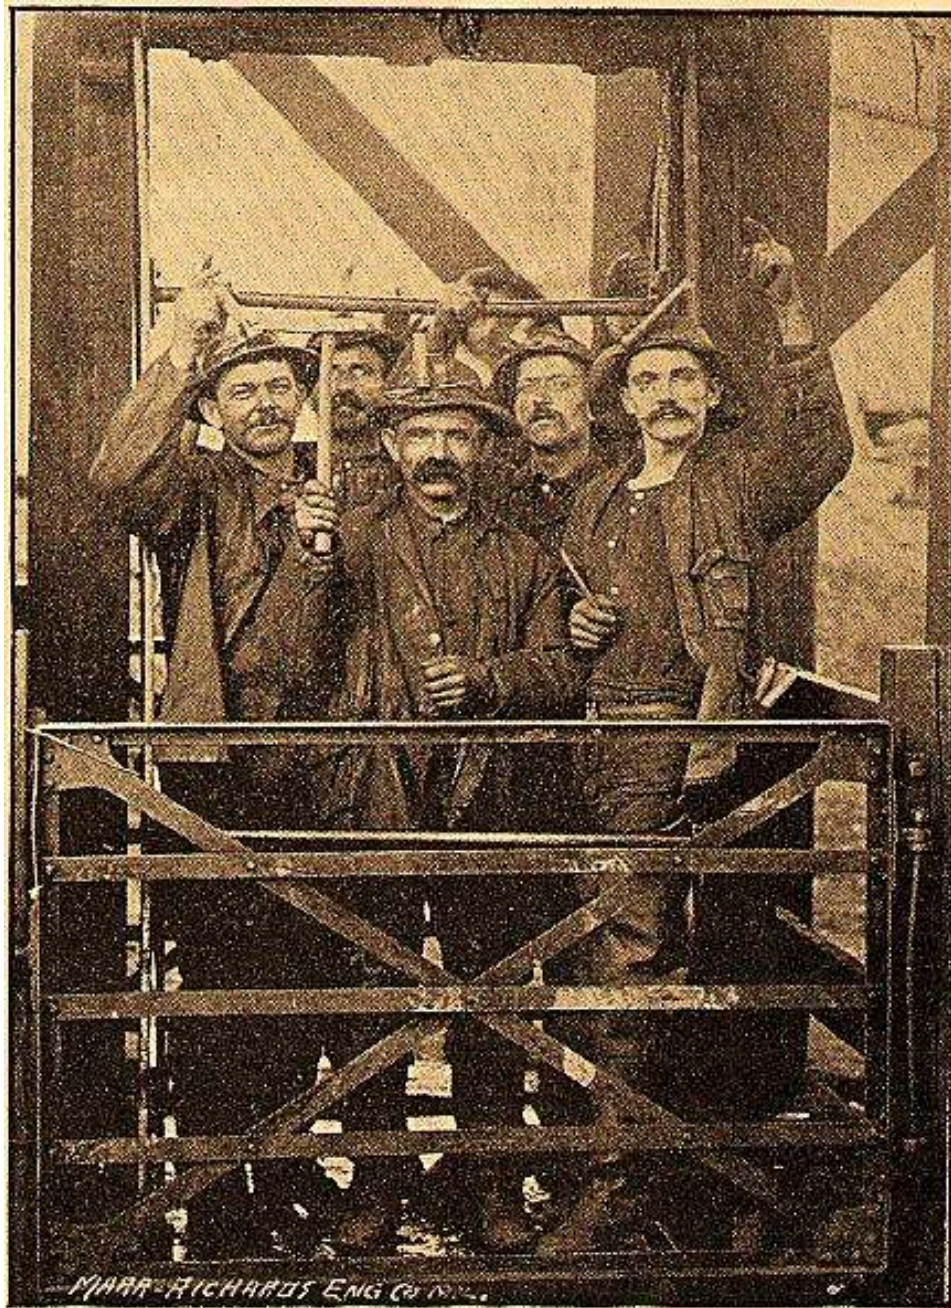
MINERS DESCENDING SHAFT, PEWABIC MINE.

This illustration appeared in Walter R. Nursey's book *The Menominee Iron Range*, published in 1891. [William J. Cummings]

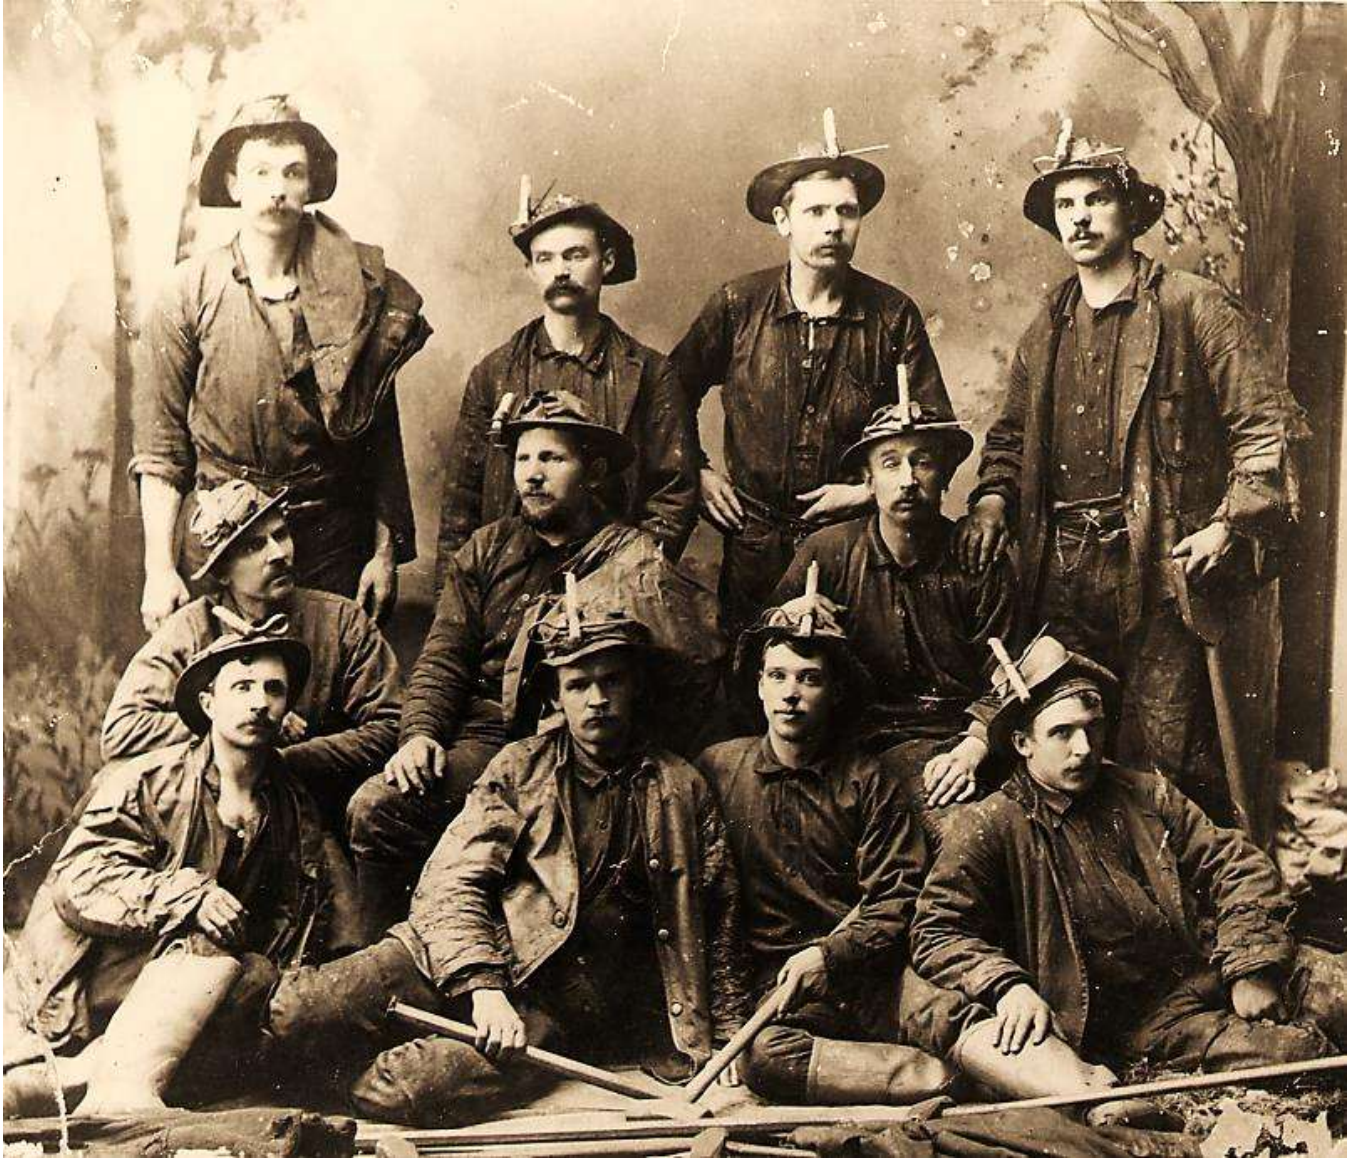
At 3 p.m. on Thursday, October 28, 1894, twelve miners in Iron Mountain's Pewabic Mine were entombed while at work on the fourth level when a room above them collapsed. One of the miners, Peter Gabardi, was caught and crushed to death under the falling mass. However, the eleven miners pictured above were finally rescued between 6 and 7 a.m. Saturday, having been entombed for over 40 hours. Only two men in the back row of this photograph have been positively identified. They are William Beard, at the extreme left, and Peter Hallberg, third from the left. The names of the remaining men are Stephen Allen, John Forrell, Samuel Husband, George Marcous, William Oliver, Thomas Penglase, George Rickard, John Thomas and George Wilcox. In the accounts of the accident in *The Range-Tribune* and *The Current* there was confusion with some of the names. Note the "oilers" worn due to wet mining conditions and also the miner's candlesticks on their hats which were used to light the individual miner's work area within the mine. [Gene Derwinski/Dick Ferris]

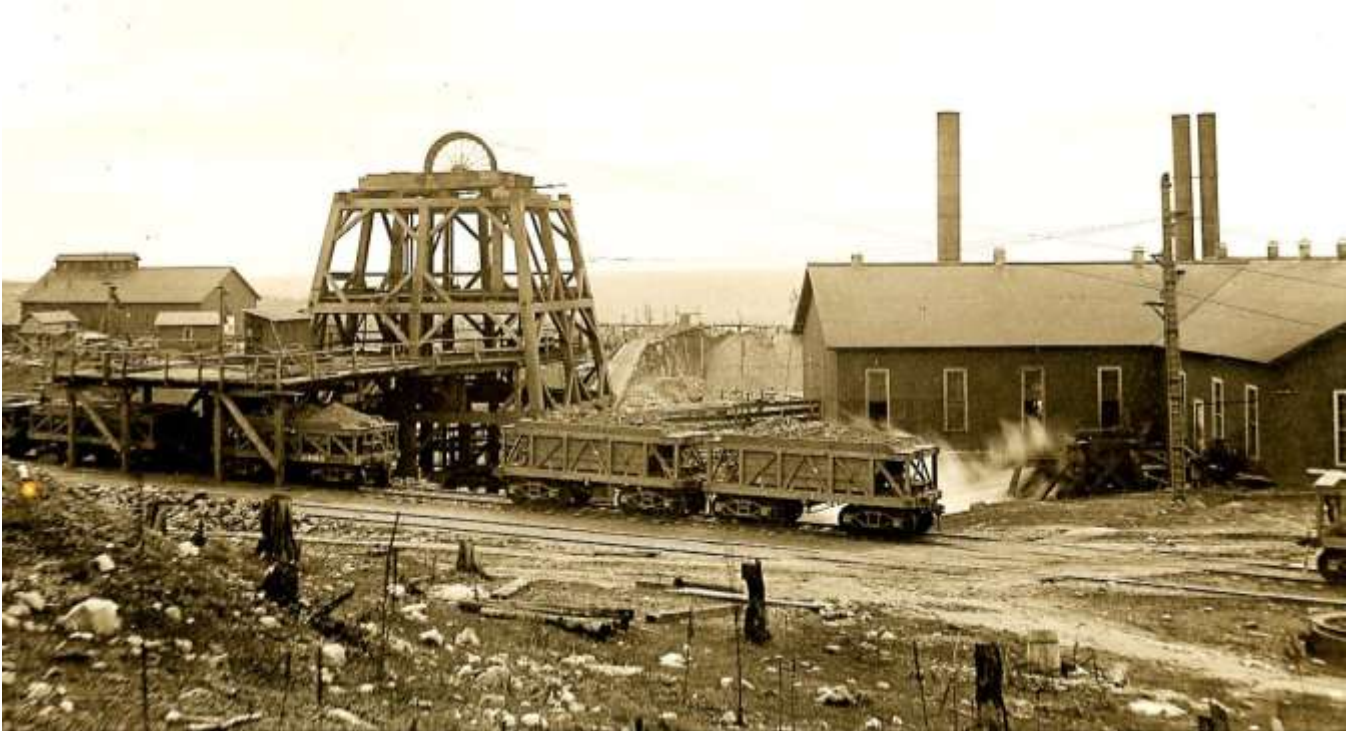
This view of the Pewabic Mine, showing the wooden shaft housing, was taken by Jorgen J. Eskil, pioneer Menominee Range photographer, in May, 1899. *[Menominee Range Historical Museum]*
