Silver Lake Head-Cutting Control Structure

Silver Lake Outlet Interim Stabilization Report

for
Upper Peninsula Power Company

October 7, 2003

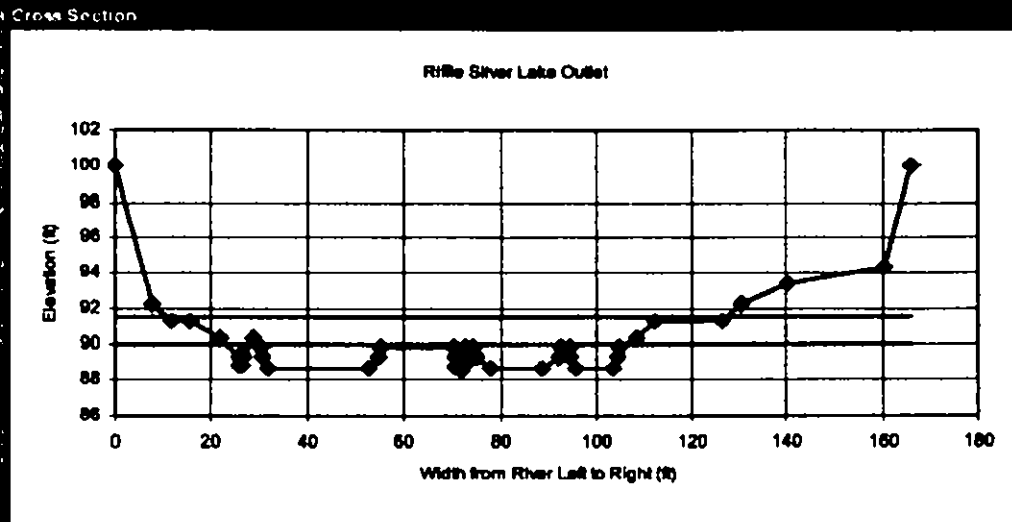
section:	Rifle
stream:	Silver Lake Outlet
location:	Rifle
description:	Sta: 25+57
height of instrument (ft):	100.00

FS bankfull	FS top of bank	W (ps (ft))	channel slope (%)	Manning's "n"
13	120	115.0	1.24	0.036

dimensions			
78.0	x-section area	1.0	d mean
81.8	width	87.0	wet P
1.5	d max	0.9	hyd radi
31.5	bank ht	85.8	w/d ratio
115.0	W flood prone area	1.4	ant ratio

hydraulics			
4.3	velocity (ft/sec)		
333.8	discharge rate, Q (cfs)		
0.89	shear stress ((lbf/ft sq)		
0.80	shear velocity (ft/sec)		
3.158	unit stream power (lbf/ft/sec)		
0.60	Froude number		
7.1	friction factor u/u*		
44.1	threshold grain size (mm)

exposed surface of the conglomerate individual rocks (predominantly gravel and small cobble) protrude from the surface. Figure 3 presents the X-section elevations and hydraulic geometry information for the interim stabilization site.

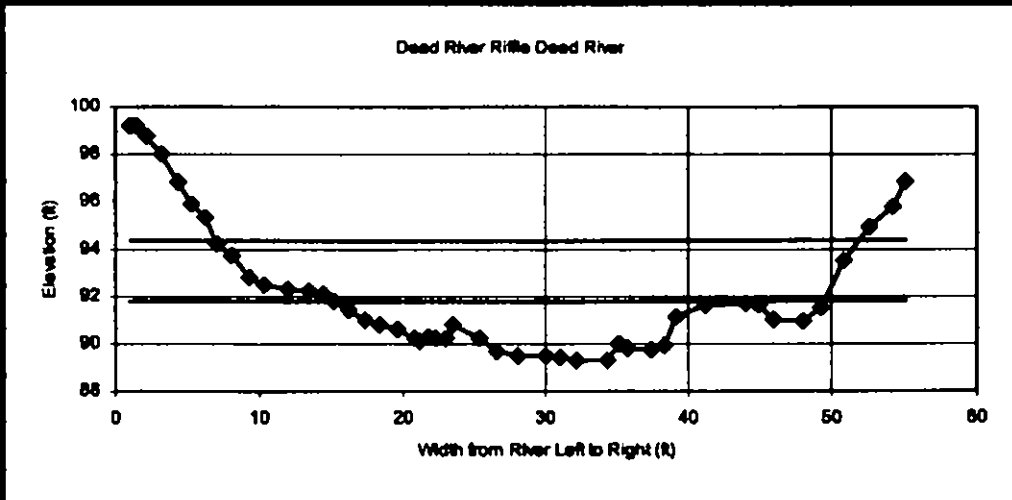
Cross Section

section: Dead River
 Riffle
 Dead River
 Dead River

FS bankfull	FS top of bank	W (ft)	channel slope (%)	Manning's "n"
91.81	90.8	15.5	2.861	0.046

dimensions			
37.8	x-section area	1.7	d mean
22.3	width	23.3	wet P
2.5	d max	1.8	hyd radi
10.3	bank ht	13.1	w/d ratio
45.5	W flood prone area	2.0	ent ratio

1994), was performed and the data is summarized in Figures 5 through 10 and Photos 8 and 9.

The reference reach drains approximately 9.6 SM and is a Rosgen B4 stream type. It is moderately entrenched, with a series of steps and irregularly spaced scour pools. The stream bed is gravel dominated with large cobble and medium boulders controlling the grade. The bankfull indicator was clearly defined on both channel banks using a variety of indicators including change in bank slope, vegetation change, and discoloration lines on large boulders. The stream was a series of small riffle features with consistent baseflow depth mixed with single and double pool systems. Channel slope for the reach was calculated at 2.8 percent.

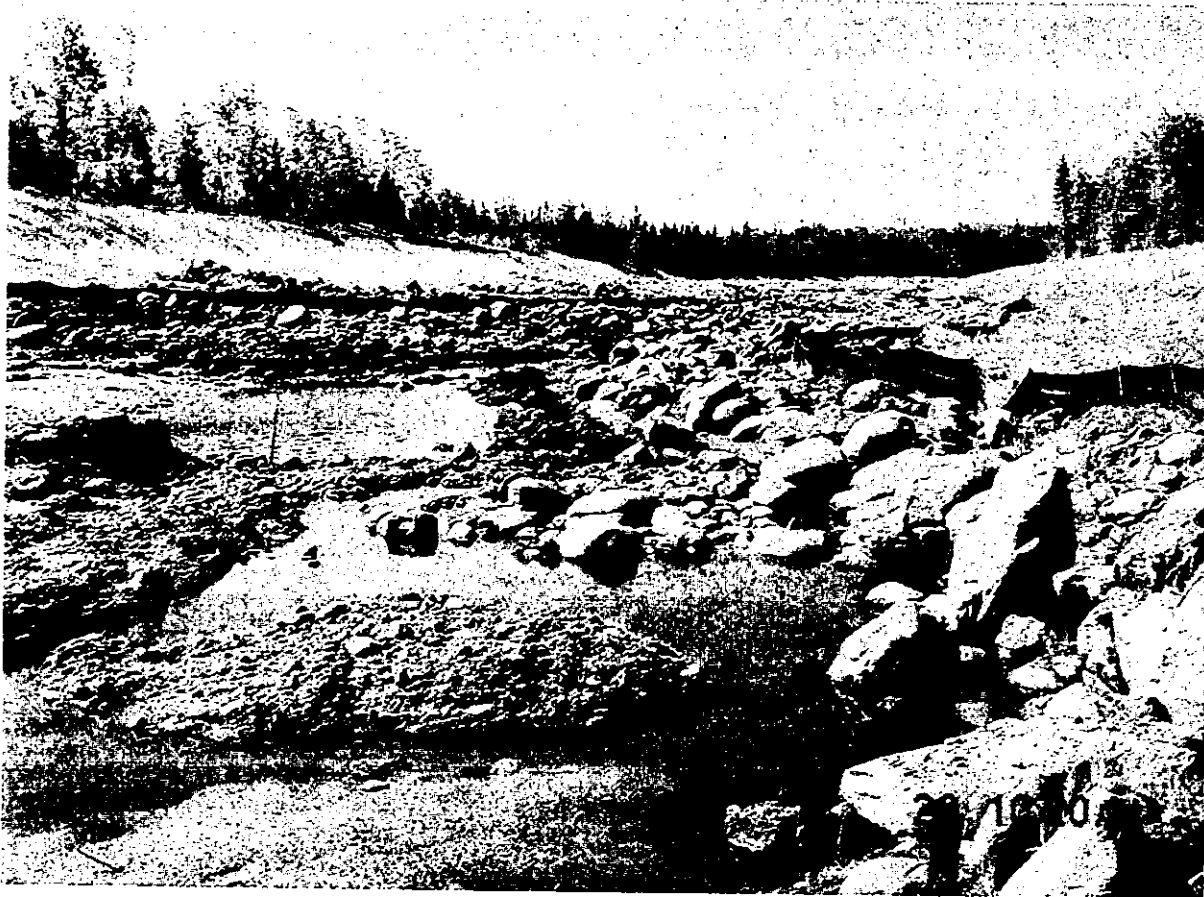
Photo 6: Exposed "Conglomerate" Area

The site has a dual classification of F1/F4 because the stream bed and bank material, below bankfull and within the limits of the flood prone area (FPA), are composed of a gravel, cobble, sand and silt matrix referred to as "conglomerate" (Photos 6 and 7). Along the

The exposed conglomerate extends for several hundred feet downstream of the initial lake/stream interface and extends from across the entire width of the channel to a point greater than bankfull. At an elevation close to two (2) times bankfull or commonly identified as the flood prone area the banks transition to steep slopes primarily comprised of unconsolidated material silt, sand, gravel, cobble, and large boulders which have been graded and seeded as part of the bank stabilization program performed post-event (Photo 6).

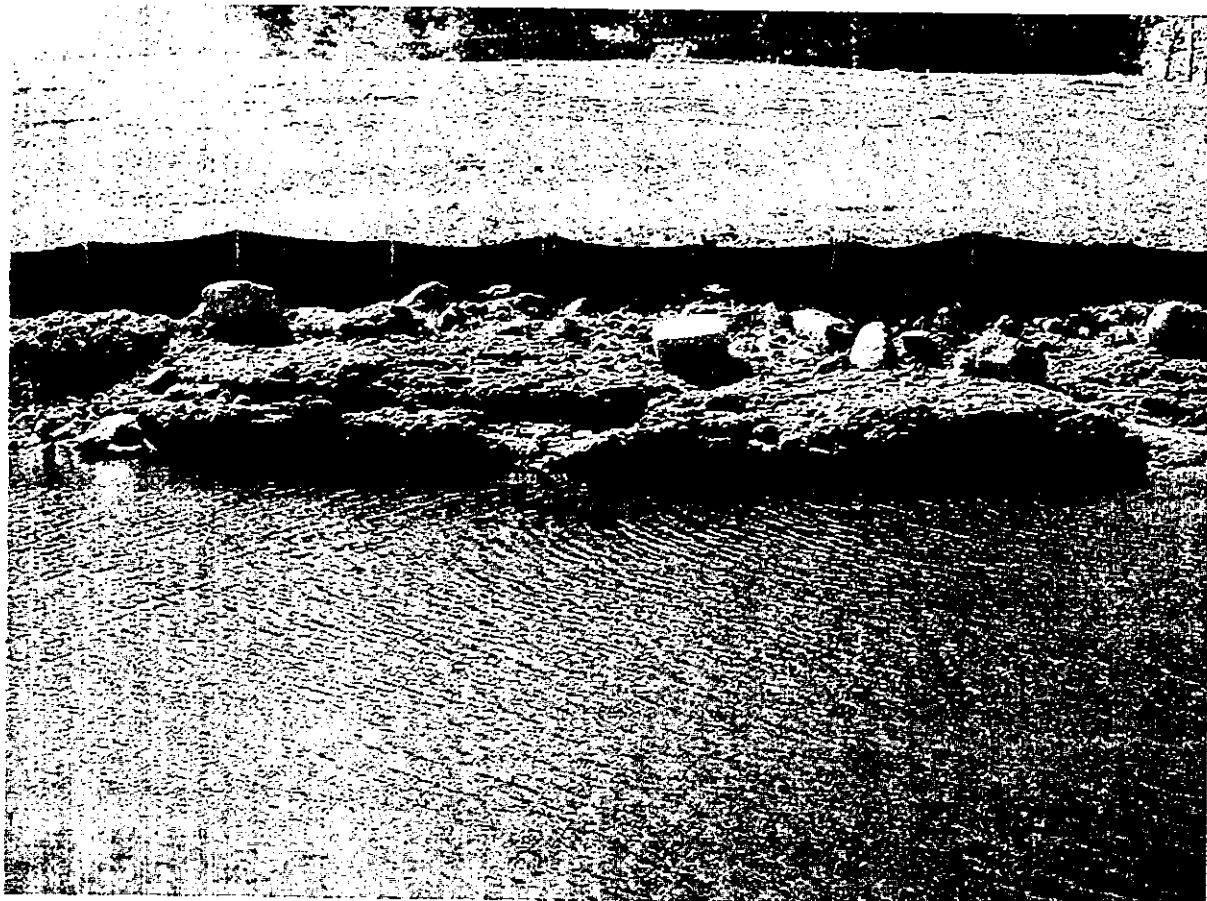
Photo 7: Close-up of "Conglomerate" Material
