In the Event of a Dam Failure...

**Silver Lake Levee Failure - Dead River Flood
May 2003**

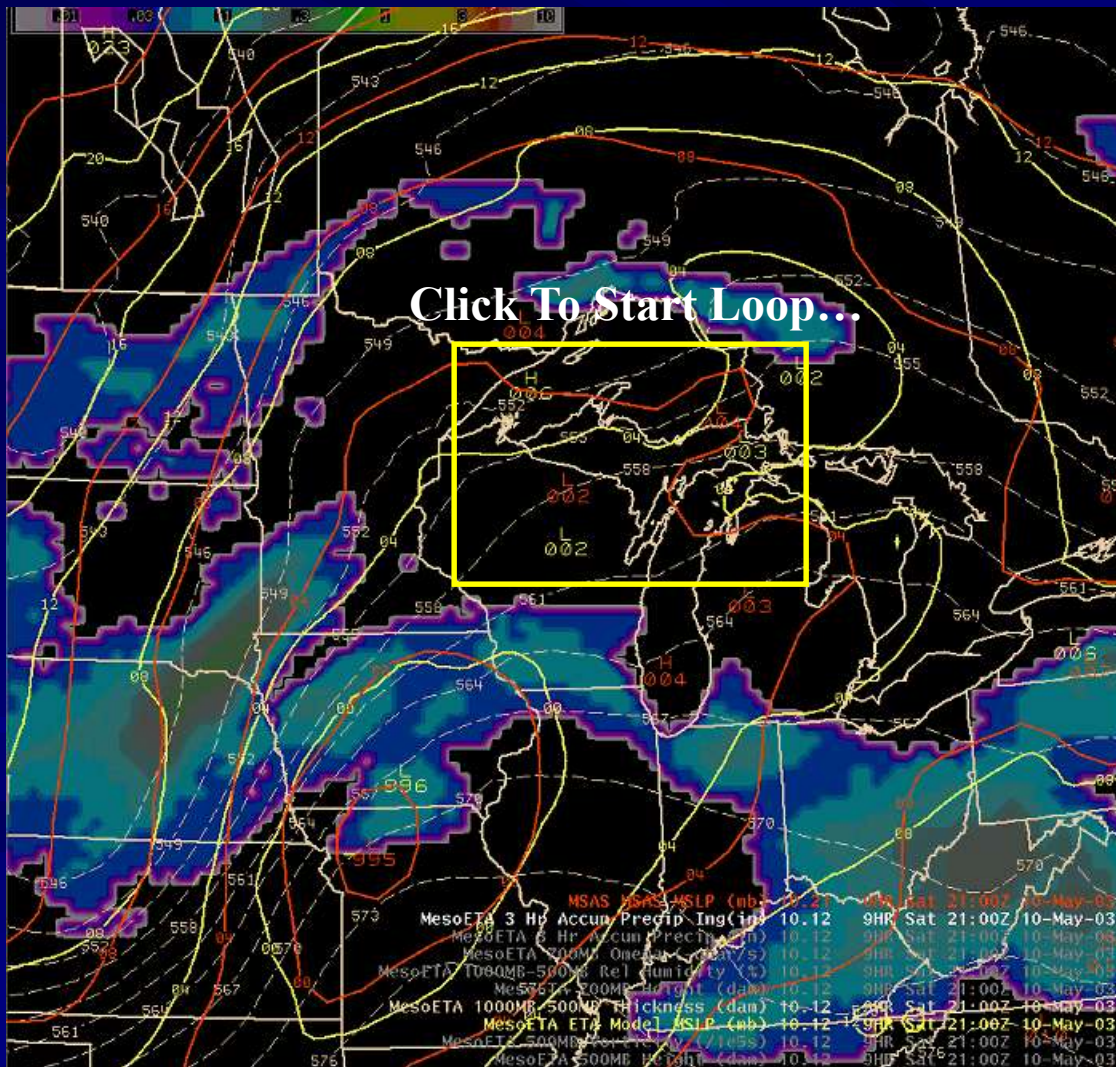
MSAS & ETA MSLP, and ETA 3hr Accumulated Precipitation...

The ETA MSLP and MSAS MSLP analysis are both plotted to show the ETA model had a fairly accurate depiction of the system.

Track of the low allowed for a nearly continuous upslope flow across the Huron Mountains and the headwaters of the Dead River Basin.

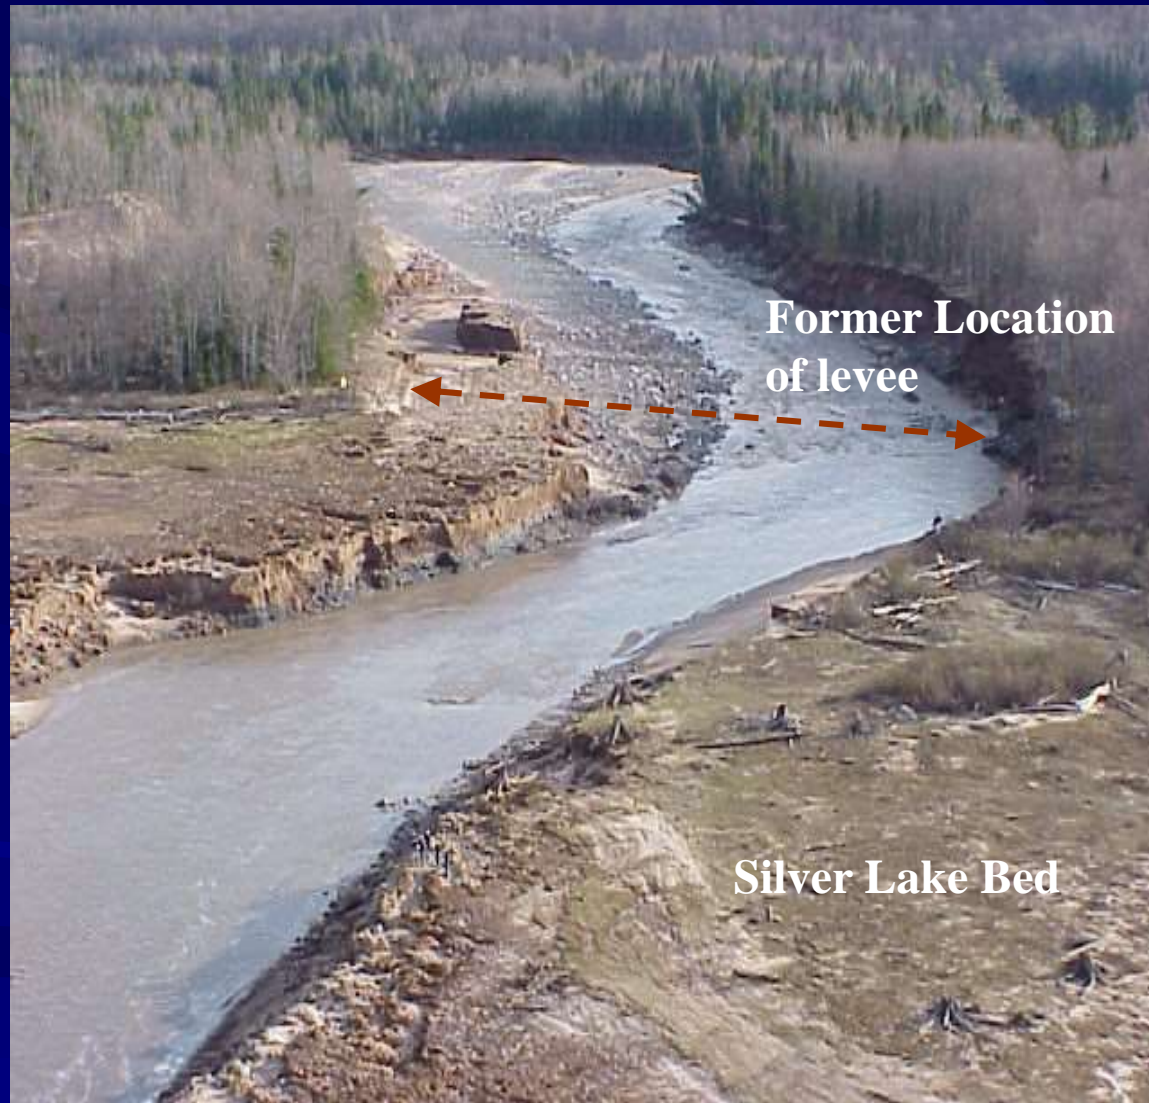
At the Breach...

- It is estimated 9.8 billion gallons (30,000 acre-feet) of water was released downriver. This created a new channel 100 yards wide and 25 feet deep, and rejoined the original channel a quarter mile downstream.
- A State of Emergency declared at 1:30 am EDT on May 15, 2003.

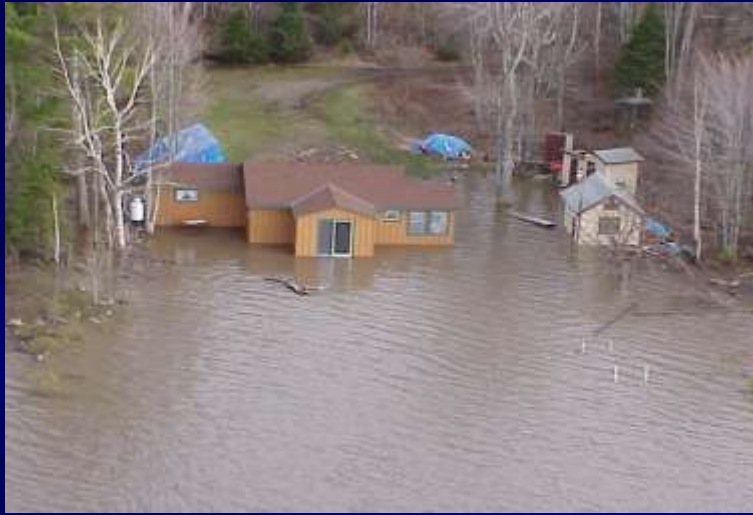
Dead River Flooding Continued...

- On May 15, 2003 homes and camps along the Dead River Storage Basin behind Hoist Dam were damaged by flood waters as the level rose about 10 feet above normal. Many residents did not realize they were in a flood plain.

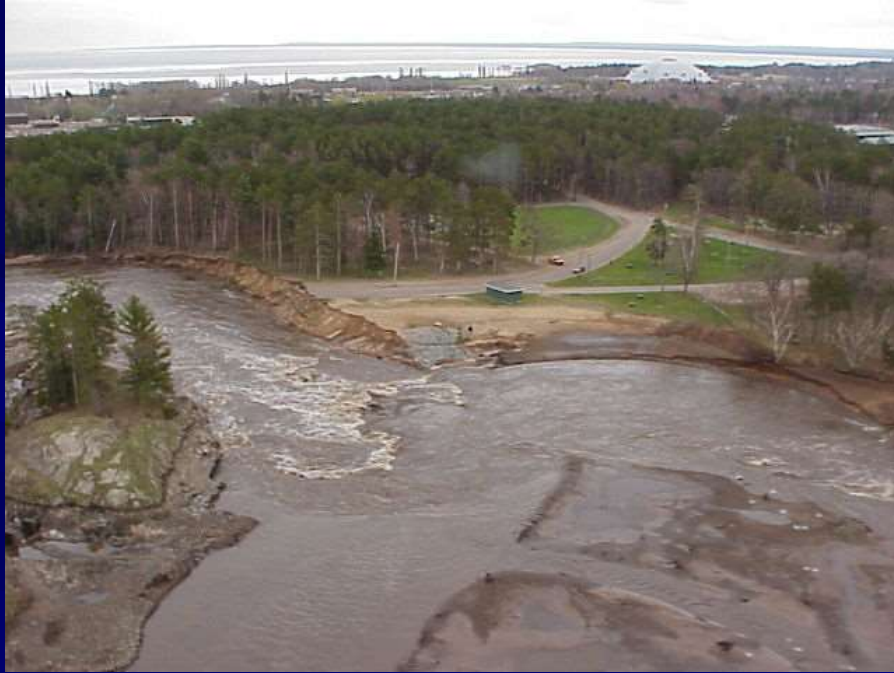
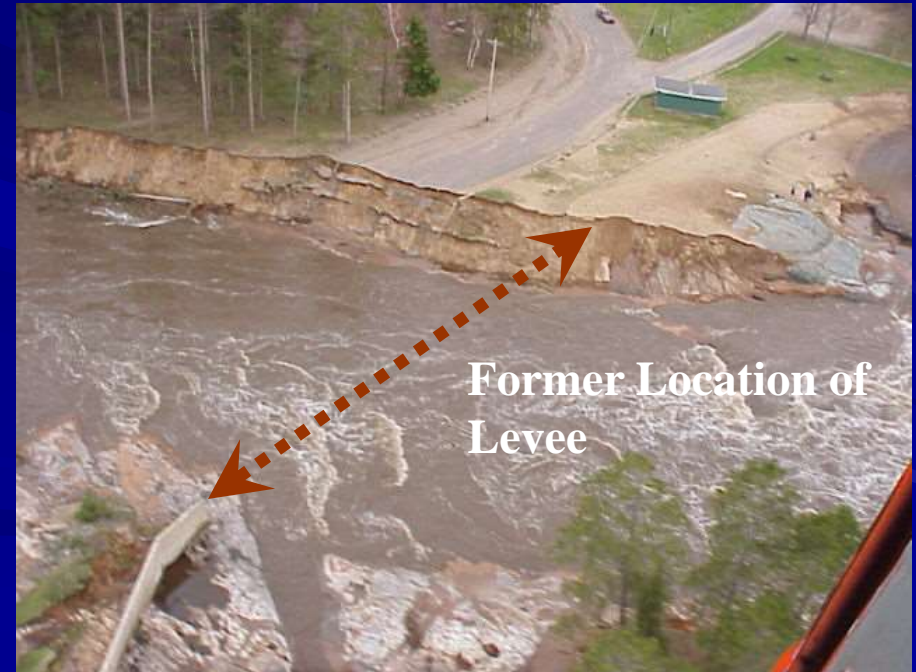
Tourist Park Flooding...

- Tourist Park is a recreation area located right in the city of Marquette, as seen in the background of the picture above.

- Despite being drawn down 5 feet, water levels eventually over-topped the Tourist Park Dam and eroded it away in a manner of hours.

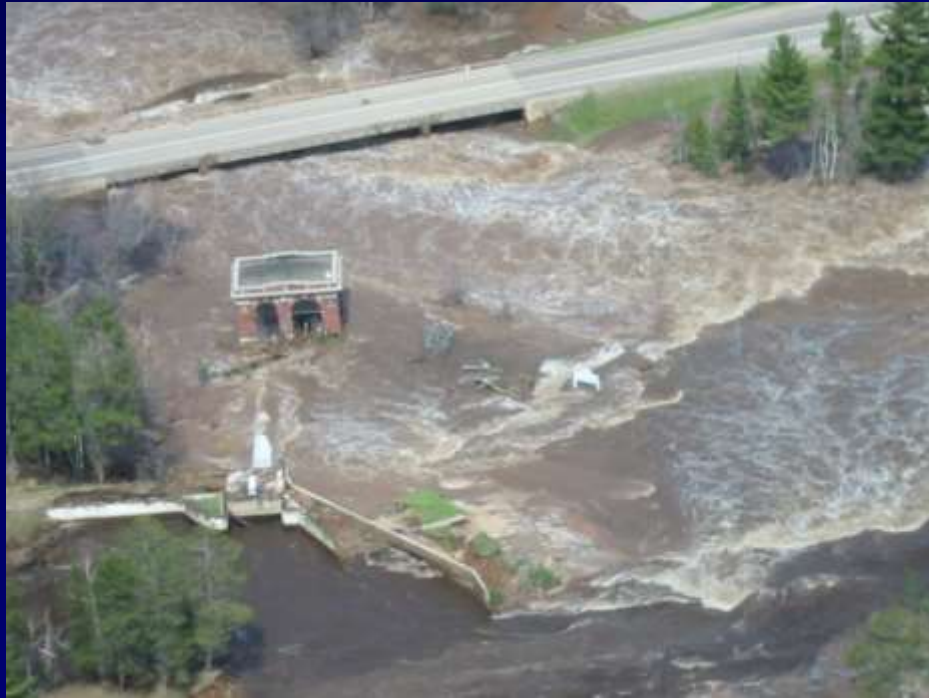
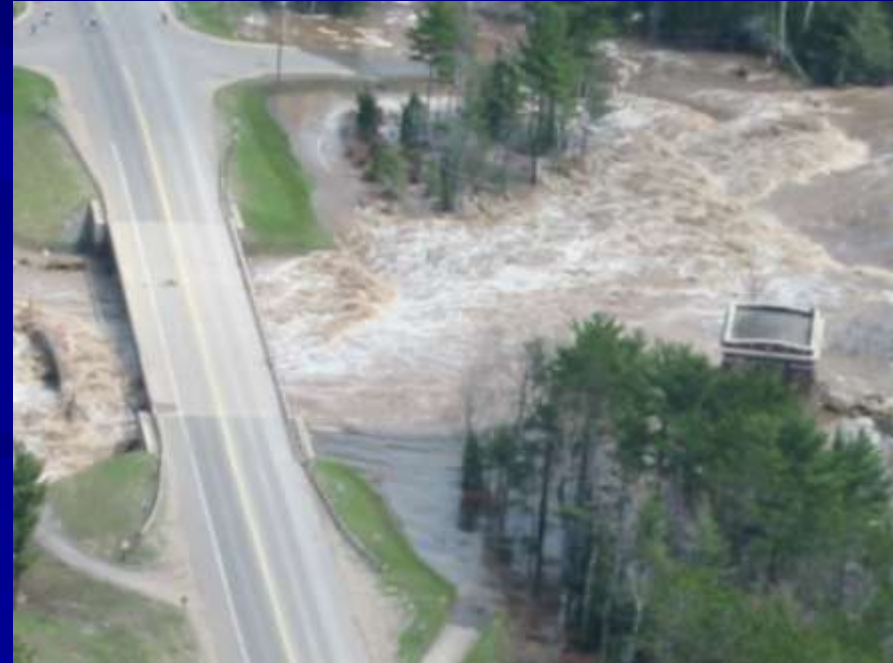
Tourist Park Flooding at Peak River Flow...

- Aerial photos show the widespread inundation at the Tourist Park Dam during peak flows.

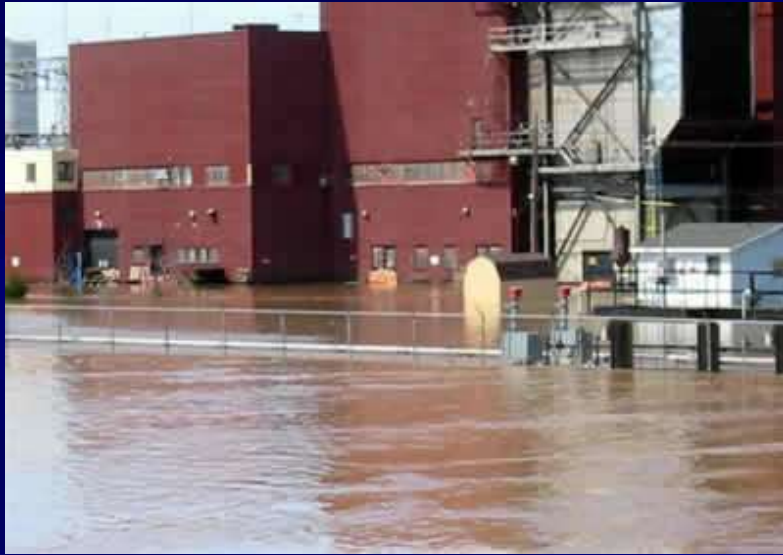
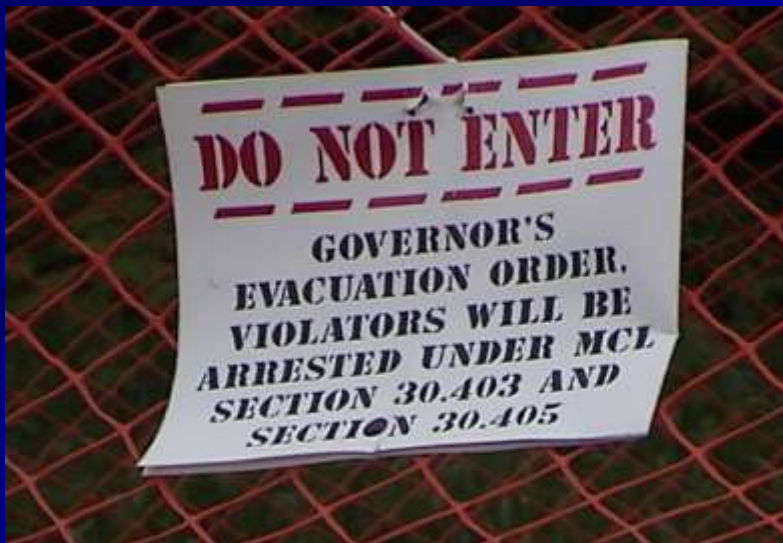
Flooding at the Presque Isle Power Plant...

- Considerable damage was done to the 620 Megawatt power plant, with the shutdown costing as much as \$1 million per day
- Nearby mines which relied on the power were forced to temporarily lay off 1100 workers, and voluntary power conservation was asked until the power plant was fully operational
- Access to the Dead River was restricted by an order from the Governor.
