Re: Report No. 2
FERC Independent Consultants Review Panel
Silver Lake Dam

REPORT NO. 2

SILVER LAKE DAM

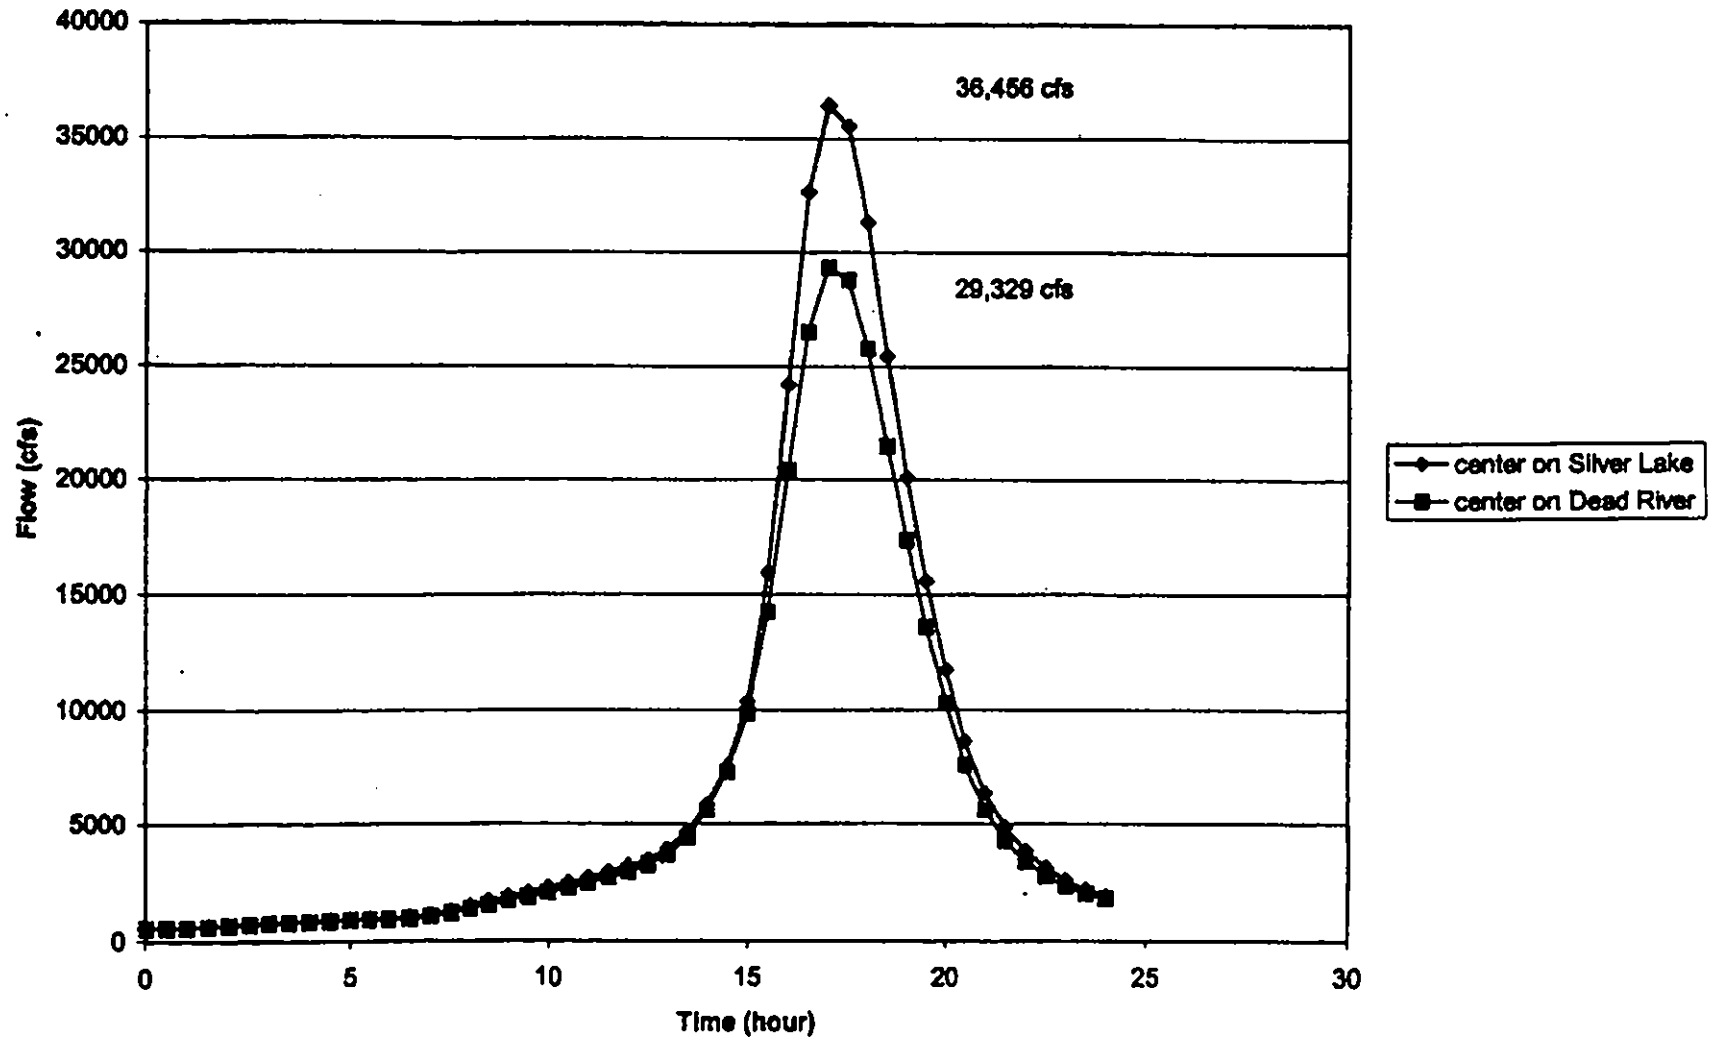
For this design, the PMF inflow shown in Figure 2.2-1, for a reservoir starting level of 1481.5, and the bottom outlet discharging 280 cfs (8 m³/s), results in an outflow of about 20,600 cfs (585 m³/s) for a maximum reservoir elevation of about 1488.45.

The Panel requested the Chicago FERC office to do a calculation for the PMF hydrograph inflow shown in Figure 2.2-1 routed through the Silver Lake reservoir for an initial reservoir elevation of 1481.5 and considering the low level outlet to operate at 280 cfs ($8 \text{ m}^3/\text{s}$) starting 20 hours into the inflow hydrograph. It was assumed that all bays in the concrete spillway, including the stop logs in the 4th bay, had an ogee elevation of 1486.25. It was found that the maximum reservoir level raised to 1490.5 ft [a freeboard of about 1.0 ft (.3 m)]. The hydrograph of the reservoir elevation and spillway discharge versus time is shown in Figure 2.3.2-5. It is noted that the reservoir elevation is shown to be above 1490 ft for about 8 hrs.

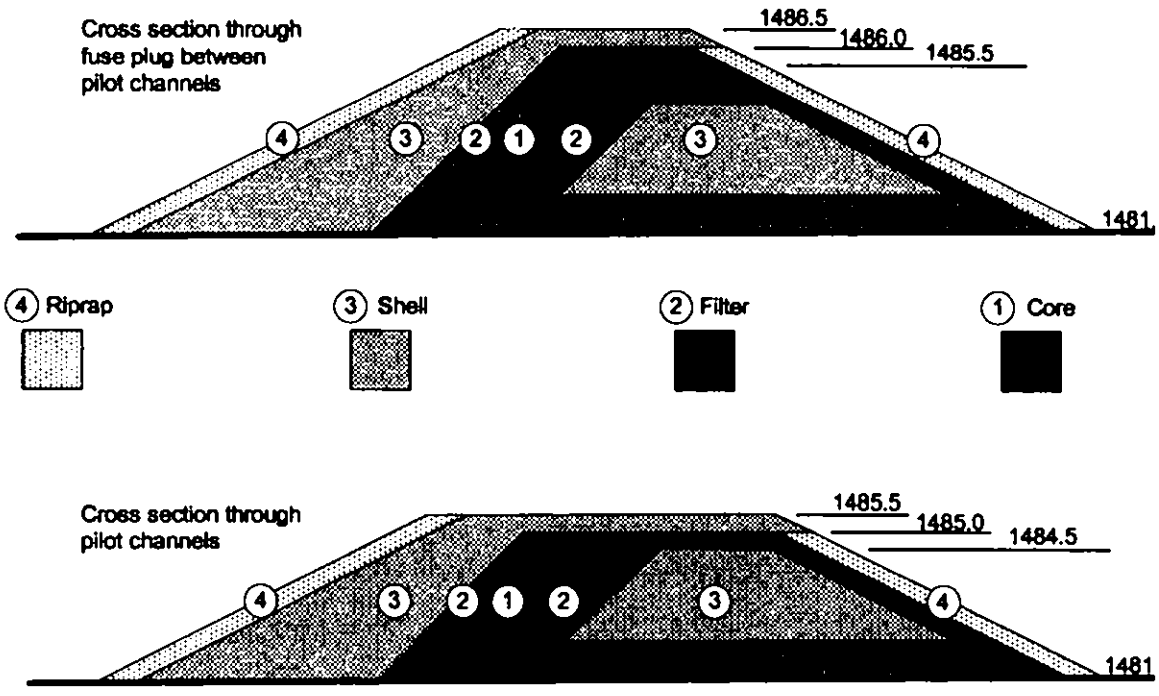
Figure 3.6.3-1 Cross sections through fuse plug embankment

The principal difference between the design intention and the failure that occurred is that the resulting erosion continued about 25 ft (7.6 m) below the base of the fuse plug embankment, and resulted in the loss of nearly the entire reservoir.

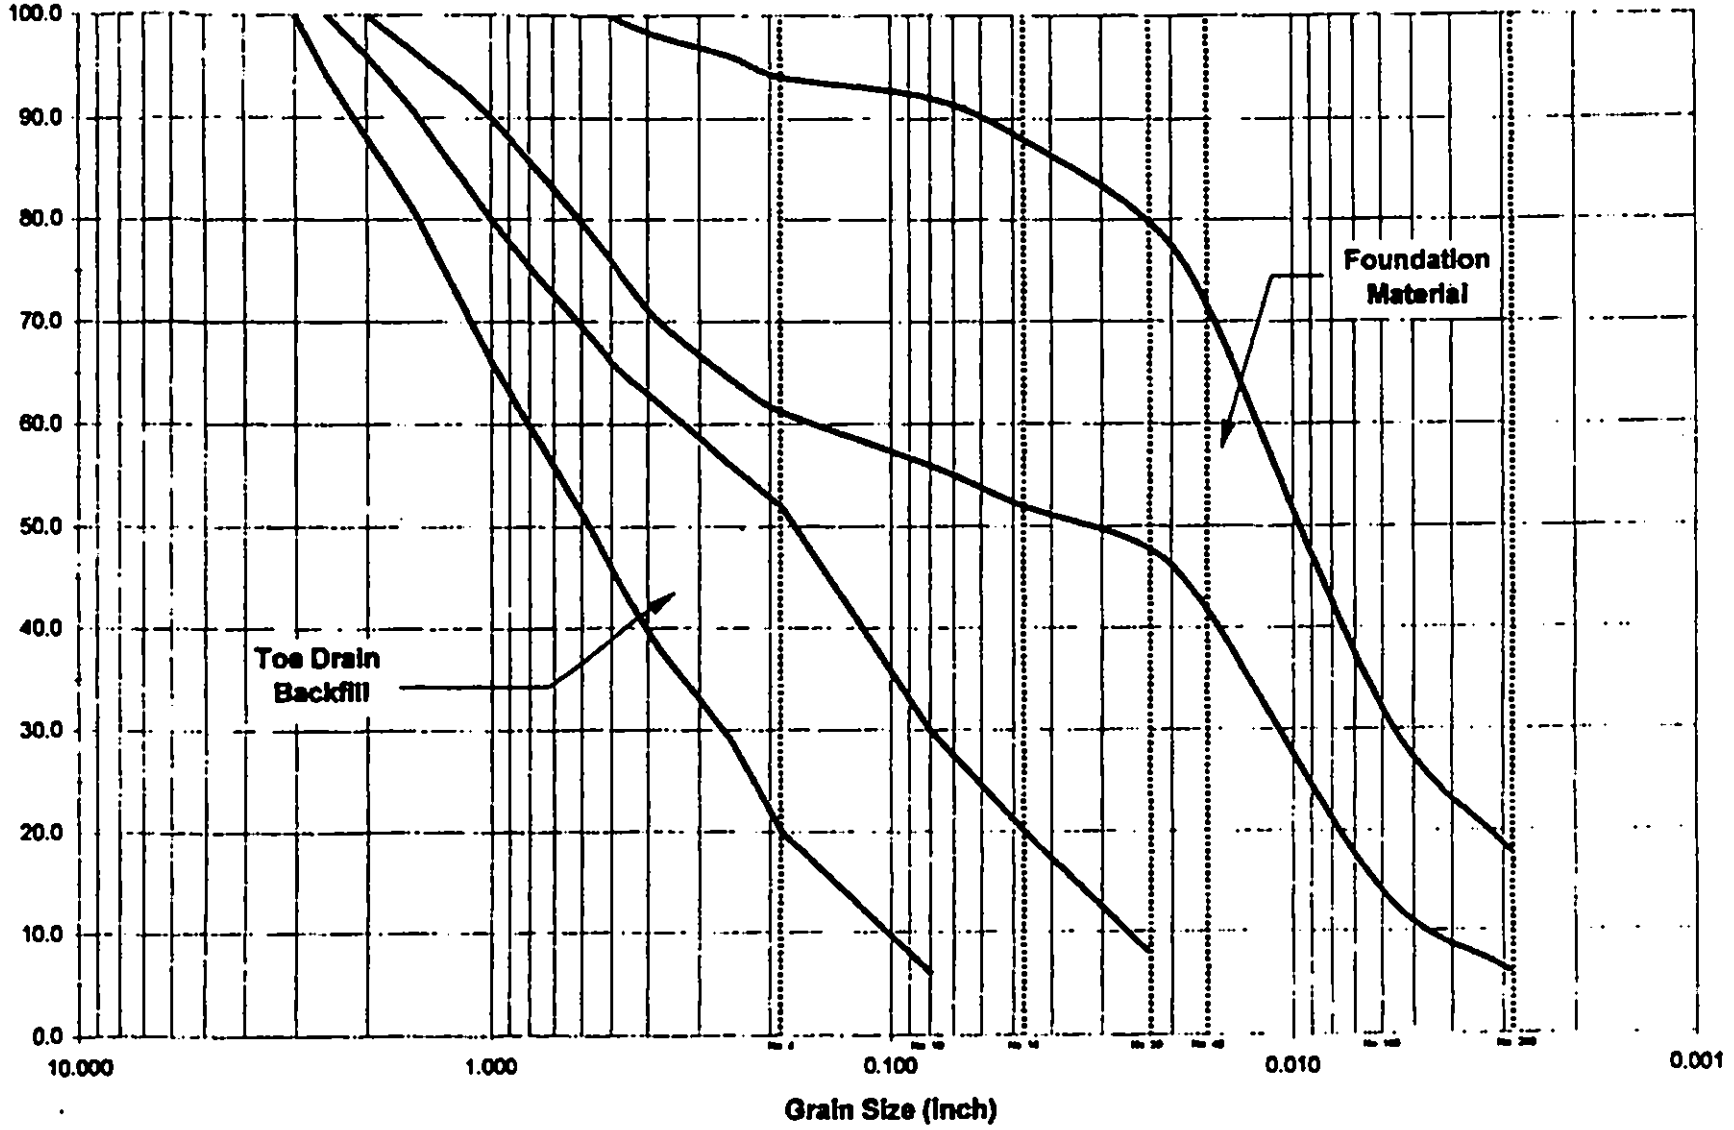
The natural foundation materials at the Silver Lake Dam-Fuse Plug are a complex series of glacial tills and glacial outwash materials. Although there were no known exploratory borings at the site of the fuse-plug during the design phase, Figure 9 of the MWH Design Report gives the designers' impression of the grain size distribution curve of the foundation materials. This curve is shown on Figure 4.4.1-1 in this report. It is noted that 61-74% passes the #4 sieve and that from 41-71% passes the #40 size. About 6-18% passes the #200 sieve. Thus the foundation materials would be classified as a sand in the Unified Soil Classification System. The classification could be SP, SW, SW-SM, SP-SM, or SM, assuming that the fines were non-plastic.

During construction of the fuse plug, one grain size analysis was performed on material identified as "foundation soil". The sample was identified as Sample 10 in the MWH final construction report. The grain size distribution of this sample is given in Figure 1 of the FERC Investigation Report and is shown as Figure 4.4.1-2 of this report. This sample has 92% passing the #4 sieve, 80% passing the #40 sieve, and 7% passing the #200 sieve. With non-plastic fines this material would classify as an SP-SM material in the Unified Soil Classification system.

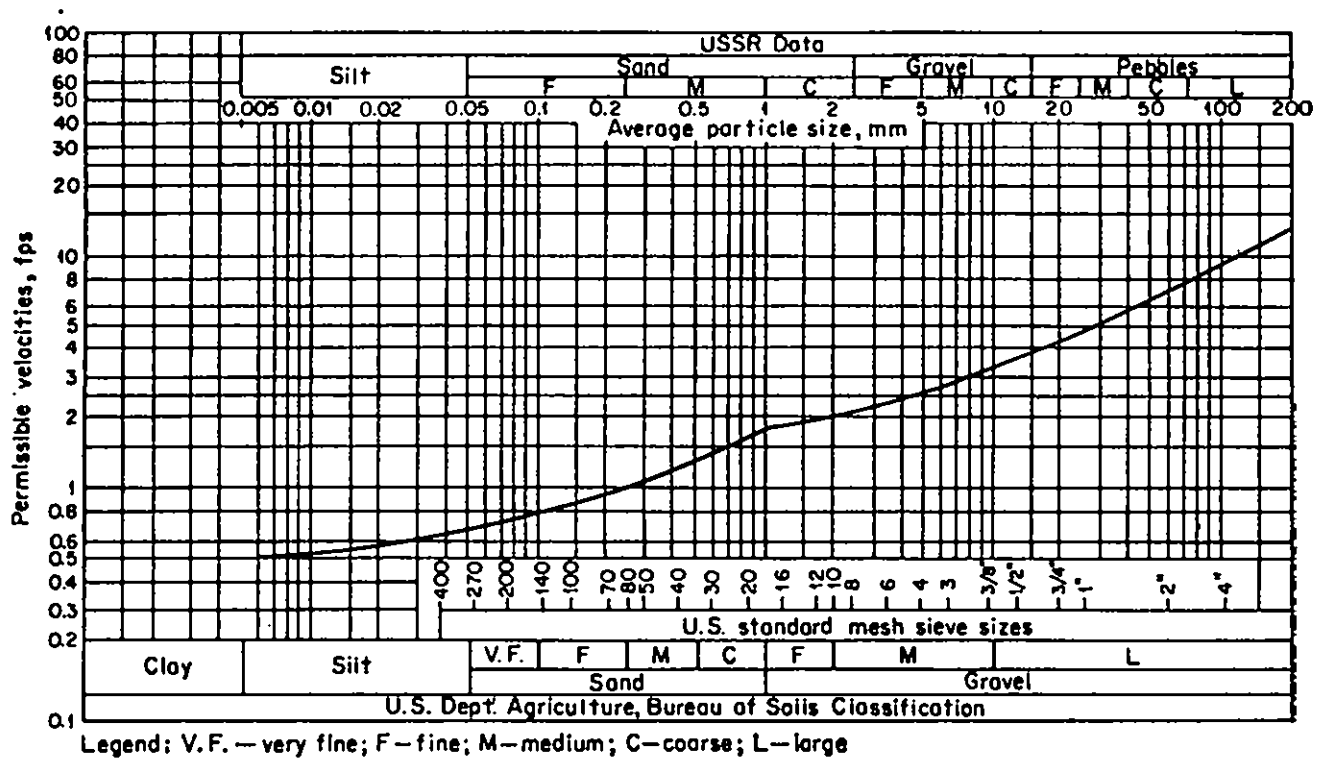
FIG. 7-3. U.S. and U.S.S.R. data on permissible velocities for noncohesive soils.

In 1936, Russian data was presented regarding permissible velocities for various sizes of cohesionless soils. This data is presented in Figure 7-3 of Chow and in Figure 4.4.2-3 of this report. As shown in Figure 4.4.2-3, the permissible velocity for fine sand is 0.75 fps (0.23 m/s) and for the material retained on the #4 sieve is 2.5 fps (0.76 m/s). Thus for coarse sand or fine gravel the limit of 2.5 fps (0.76 m/s) is the same as given in Figures 4.4.2-1 and 4.4.2-2.

In section 4.3 of this report it is shown that the channel velocities could have ranged between 8.5 fps (2.6 m/s) and 10 fps (3.0 m/s) for the May 14, 2003 event. It is clear that these velocities exceeded the 2.5 fps (0.76 m/s) permissible velocities for no grass cover for a channel composed of cohesionless sands. This is the root technical cause for the most significant aspect of the behavior of the fuse plug, which was the fact that erosion did not stop at the base of the fuse plug at El. 1481 ft. The erosion proceeded downward through the
