Initial Report of Findings

FERC Investigation of Activation of Fuse Plug Spillway  
May 14, 2003

Silver Lake Basin  
Dead River Project No. 10855  
Marquette County, MI  
Upper Peninsula Power Company

Draft: July 24, 2003

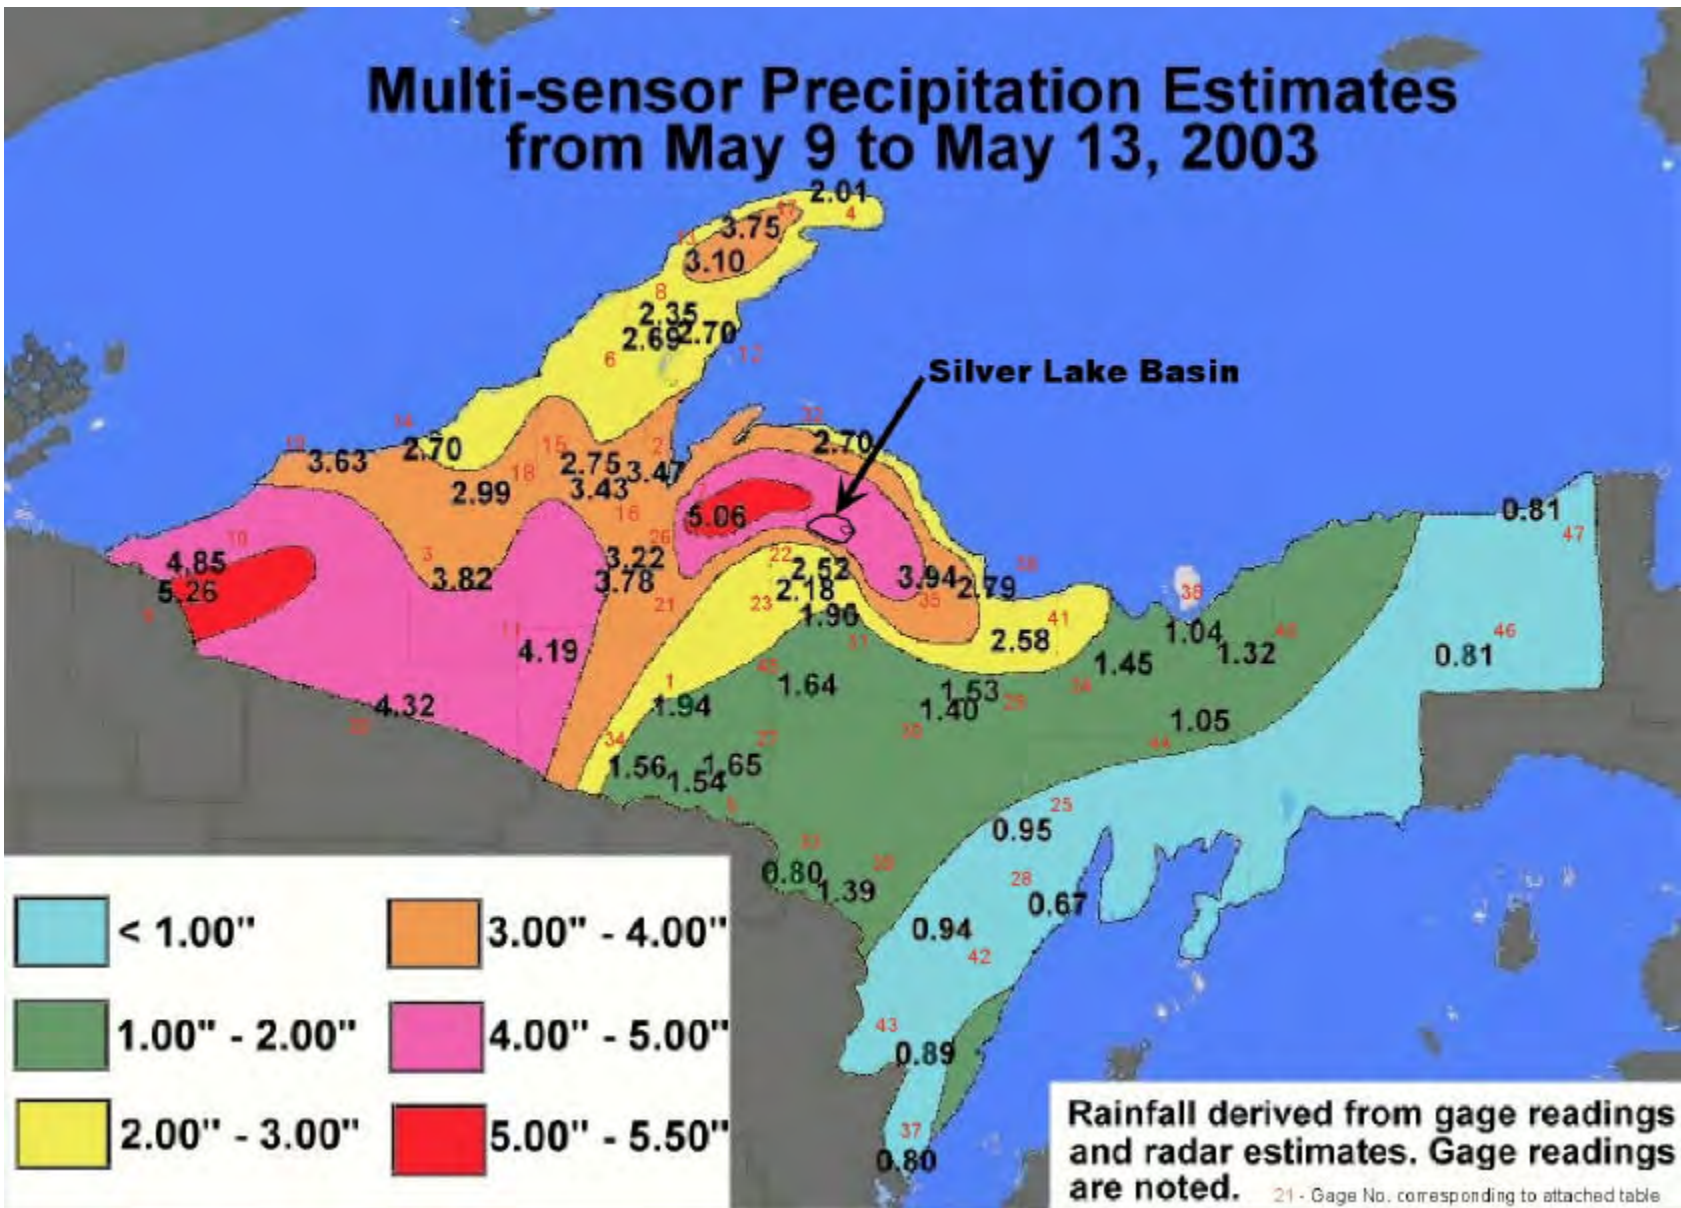
Prior to the breach of the fuseplug spillway at Silver Lake, a significant rainfall event occurred in the Silver Lake Basin during the period from May 9 to May 13, 2003. We contacted Mr. Edward Fenelon, Chief Meteorologist, National Weather Service (NWS), Marquette, Michigan, to obtain information on this rainfall event. He provided us with a map showing the estimated rainfall in the Upper Peninsula of Michigan based on gage readings and radar estimates. The precipitation gages are located across the Upper Peninsula and are cooperatively maintained and read by local residents who report the 24-hour total rainfall as of 8 a.m. each day. Figure 1 and Table 1, attached, show the map and the 24-hour totals at all

Figure 1. May 9-13, 2003 Rainfall Estimates and Precipitation Gage Totals
