VIII. Fuse Plug Design, Construction and Activation

A. Fuse Plug Design.

B. Fuse Plug Construction.

a) Surficial Geology along the Silver Lake Fuse Plug (Dike No.2) Channel

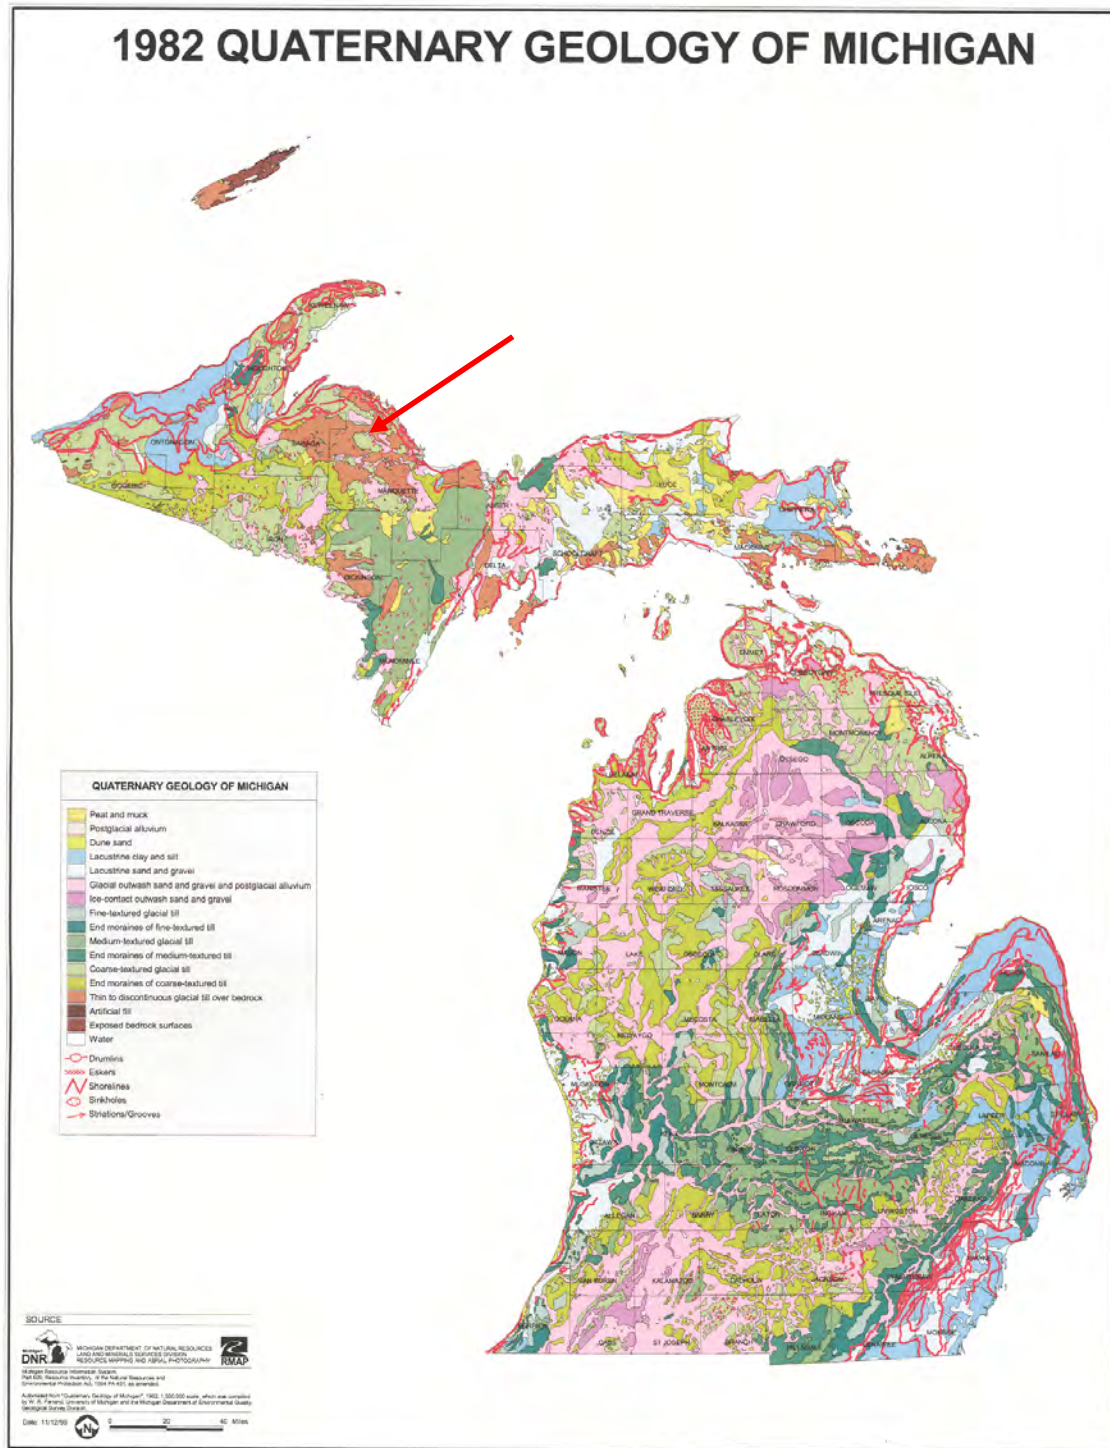
As indicated by the brief glacial history cited above, the surficial deposits in the channel area have a complex and varied origin. Figure 1 is a glacial map of Michigan from the Michigan Department of Natural Resources. As shown in Figure 1, the glacial deposits in Marquette County (red arrow) are predominantly "thin to discontinuous glacial till over bedrock" (light brown unit). Aligned from the northwest to the southeast are glacial deposits indicated as "glacial outwash sand and gravel and postglacial alluvium" (pink) and "coarse-textured glacial till" (olive green). The Silver Lake Reservoir lies immediately to the NNW of a deposit of this "coarse-textured glacial till" (red arrow point of Figure 1). This deposit forms the channel outlet along the Fuse Plug spillway channel. These coarse deposits may likely be associated with the Au Train-Whitefish Channel that drained proto Lake Superior to proto Lake Michigan, as discussed above. As such, these deposits likely constitute a higher-energy depositional environment than that of a typical glacial till. Three glacial units were observed along the channel area during the authors' reconnaissance and are described below from youngest to oldest.

Figure 1 Glacial Map of Michigan. Red arrow points to "Coarse-textured glacial till" (olive-green oval deposit). Silver Lake lies immediately to the N-NW of this unit (at point of arrow).
