P-10855

Re: Report No. 2
FERC Independent Consultants Review Panel
Silver Lake Dam

REPORT NO. 2
FERC INDEPENDENT CONSULTANTS REVIEW PANEL
SILVER LAKE DAM

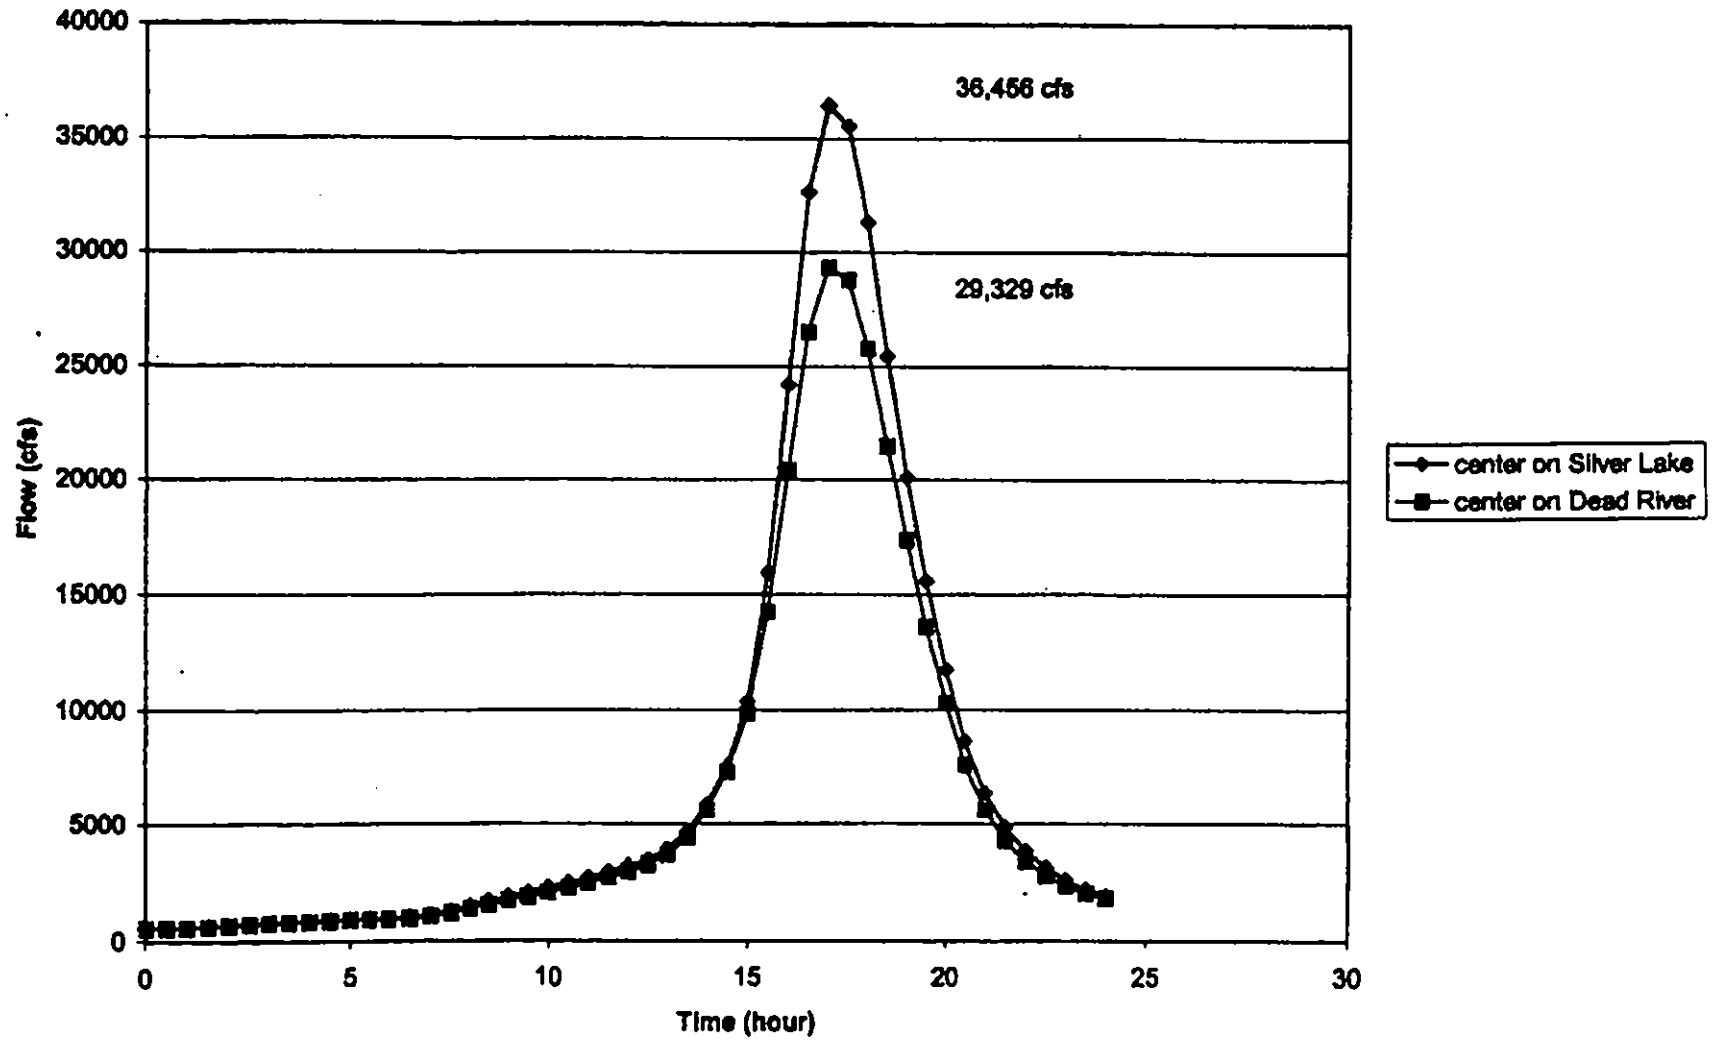
Figure 2.2-1

In May 1999, a Periodic Inspection Report No. 2 – Hoist Hydroelectric Development, Dead River Project FERC No. 10855 for UPPCO, by Stone and Webster, Michigan, Inc. confirms the 1995 recommendations for modifications as adequate to meet FERC dam safety guidelines, and appropriate for upgrading Silver Lake dam to accommodate the PMF flood. At that time the inflow PMF, as approved by FERC, had a peak of 40,700 cfs (1156 m³/s). Further studies by Harza Engineering Co. in 2001, reviewed by FERC, finally arrived at a peak inflow PMF of 36,500 cfs (1037 m³/s), and was agreed upon in March 2001. This PMF hydrograph is shown in Figure 2.2-1. The volume of inflow associated with this hydrograph is 16,248 acre-ft (20.0 hm³).

For this design, the PMF inflow shown in Figure 2.2-1, for a reservoir starting level of 1481.5, and the bottom outlet discharging 280 cfs (8 m³/s), results in an outflow of about 20,600 cfs (585 m³/s) for a maximum reservoir elevation of about 1488.45.

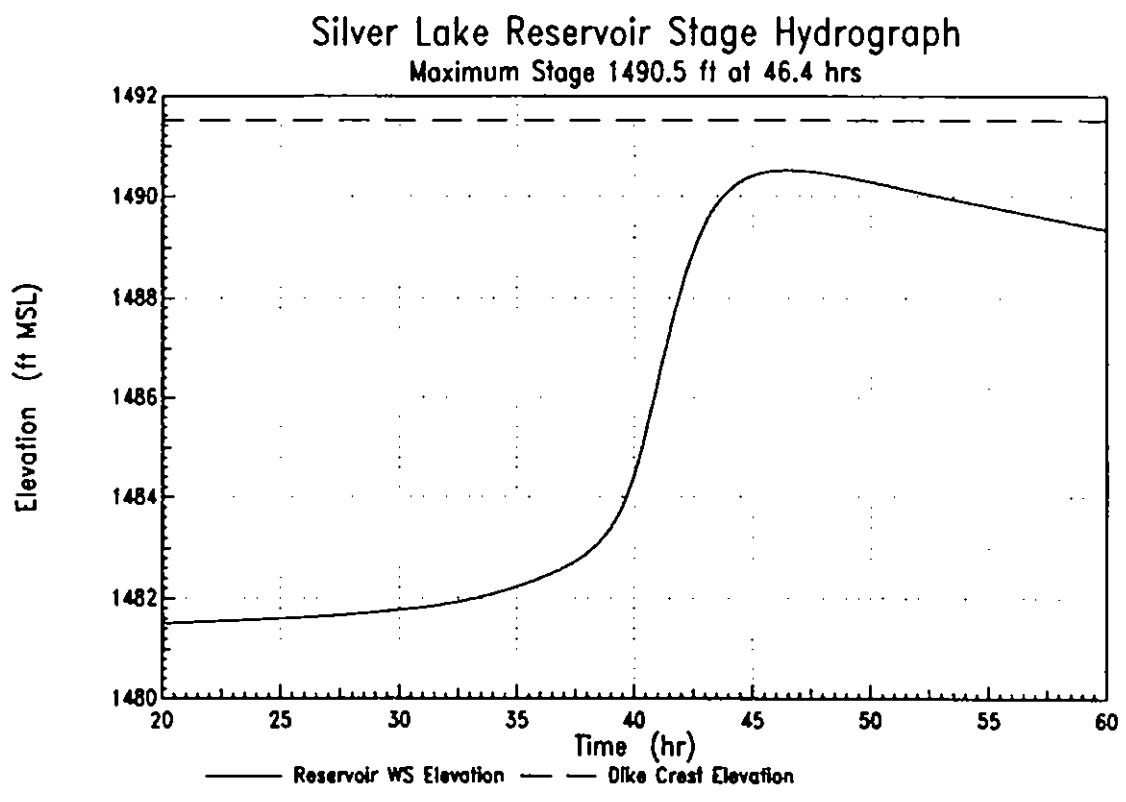
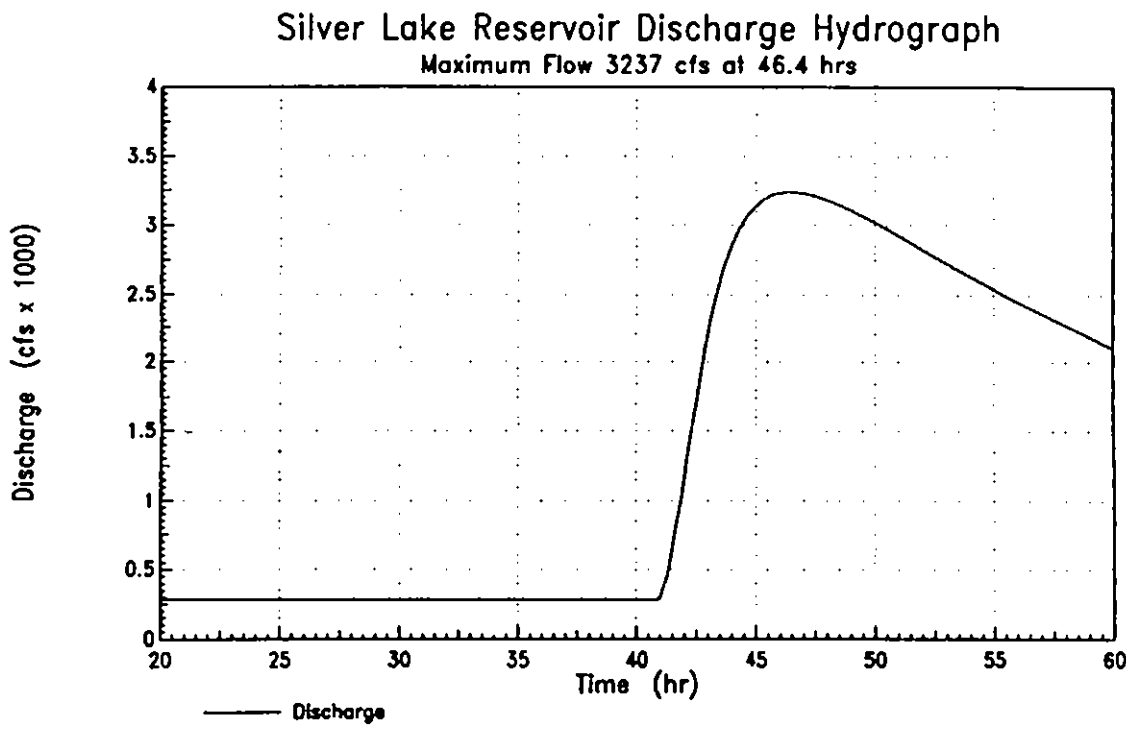
Figure 2.3.2-5

The Panel requested the Chicago FERC office to do a calculation for the PMF hydrograph inflow shown in Figure 2.2-1 routed through the Silver Lake reservoir for an initial reservoir elevation of 1481.5 and considering the low level outlet to operate at 280 cfs (8 m³/s) starting 20 hours into the inflow hydrograph. It was assumed that all bays in the concrete spillway, including the stop logs in the 4th bay, had an ogee elevation of 1486.25. It was found that the maximum reservoir level raised to 1490.5 ft [a freeboard of about 1.0 ft (.3 m)]. The hydrograph of the reservoir elevation and spillway discharge versus time is shown in Figure 2.3.2-5. It is noted that the reservoir elevation is shown to be above 1490 ft for about 8 hrs.

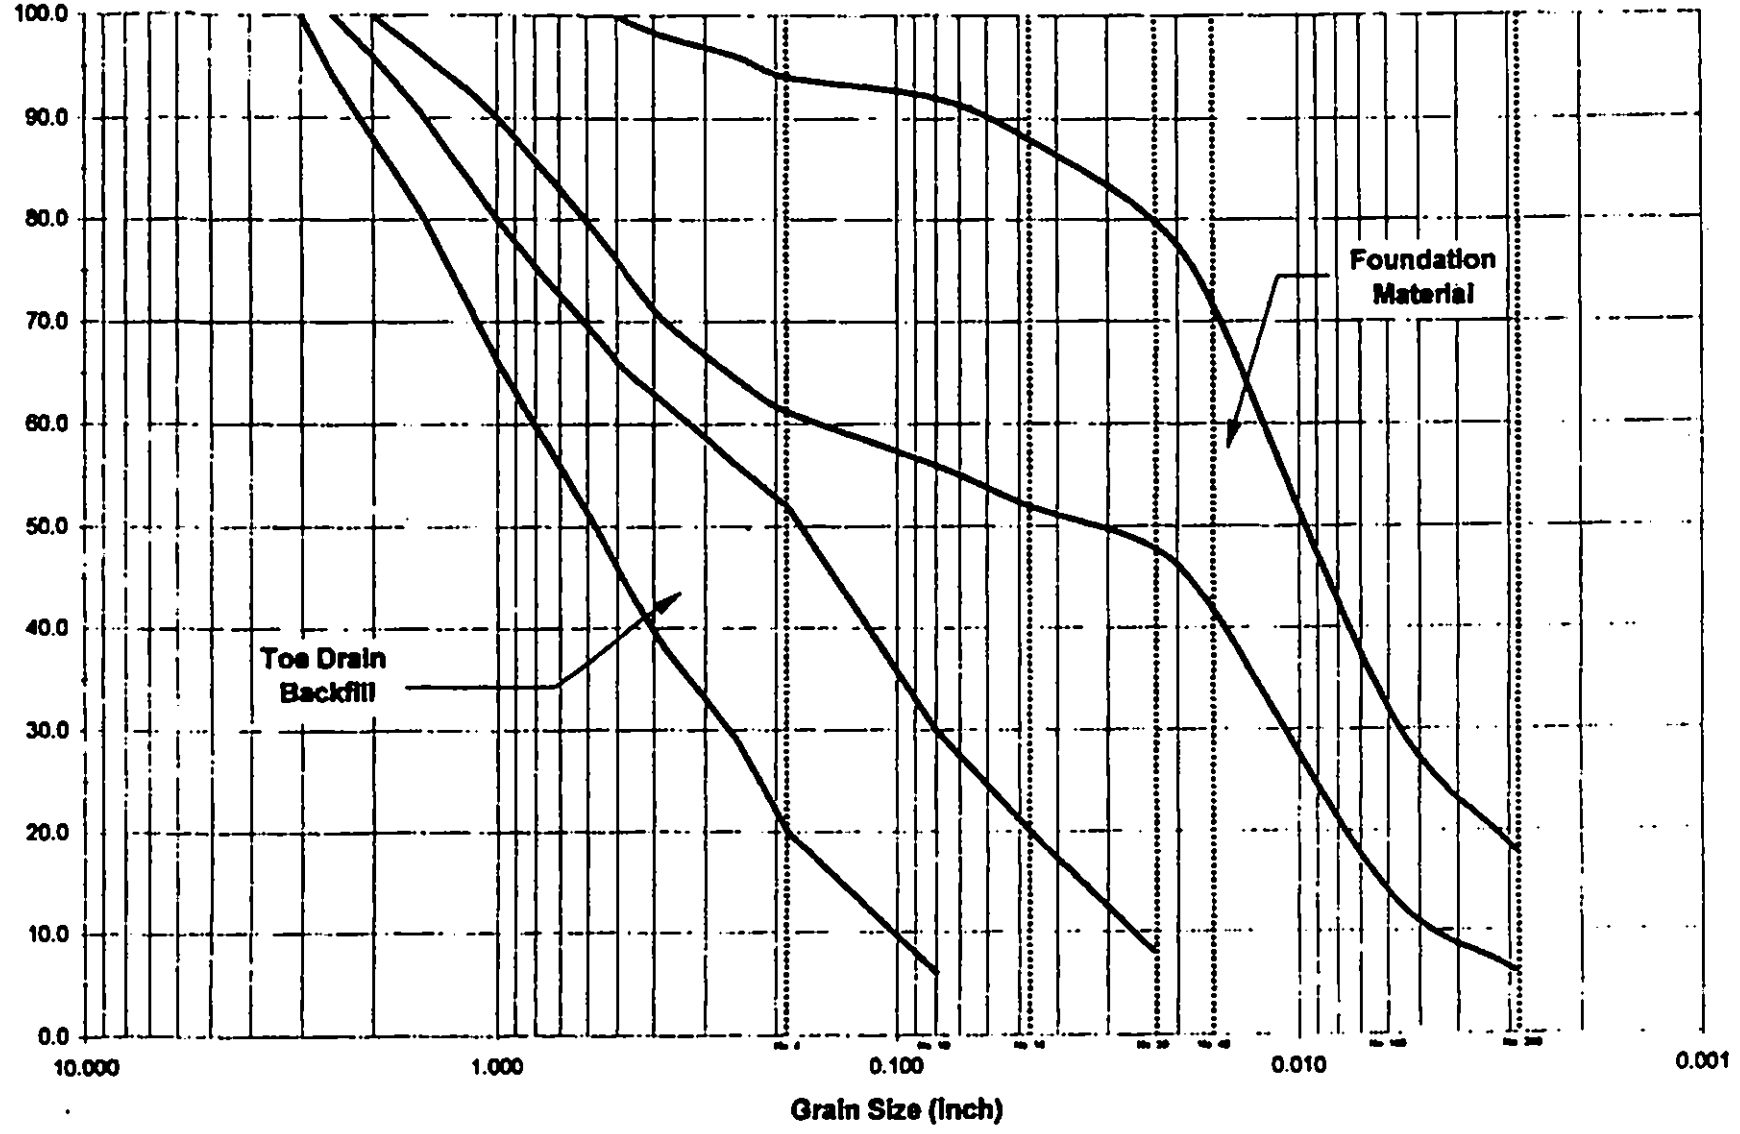
The natural foundation materials at the Silver Lake Dam-Fuse Plug are a complex series of glacial tills and glacial outwash materials. Although there were no known exploratory borings at the site of the fuse-plug during the design phase, Figure 9 of the MWH Design Report gives the designers' impression of the grain size distribution curve of the foundation materials. This curve is shown on Figure 4.4.1-1 in this report. It is noted that 61-74% passes the #4 sieve and that from 41-71% passes the #40 size. About 6-18% passes the #200 sieve. Thus the foundation materials would be classified as a sand in the Unified Soil Classification System. The classification could be SP, SW, SW-SM, SP-SM, or SM, assuming that the fines were non-plastic.

During construction of the fuse plug, one grain size analysis was performed on material identified as "foundation soil". The sample was identified as Sample 10 in the MWH final construction report. The grain size distribution of this sample is given in Figure 1 of the FERC Investigation Report and is shown as Figure 4.4.1-2 of this report. This sample has 92% passing the #4 sieve, 80% passing the #40 sieve, and 7% passing the #200 sieve. With non-plastic fines this material would classify as an SP-SM material in the Unified Soil Classification system.

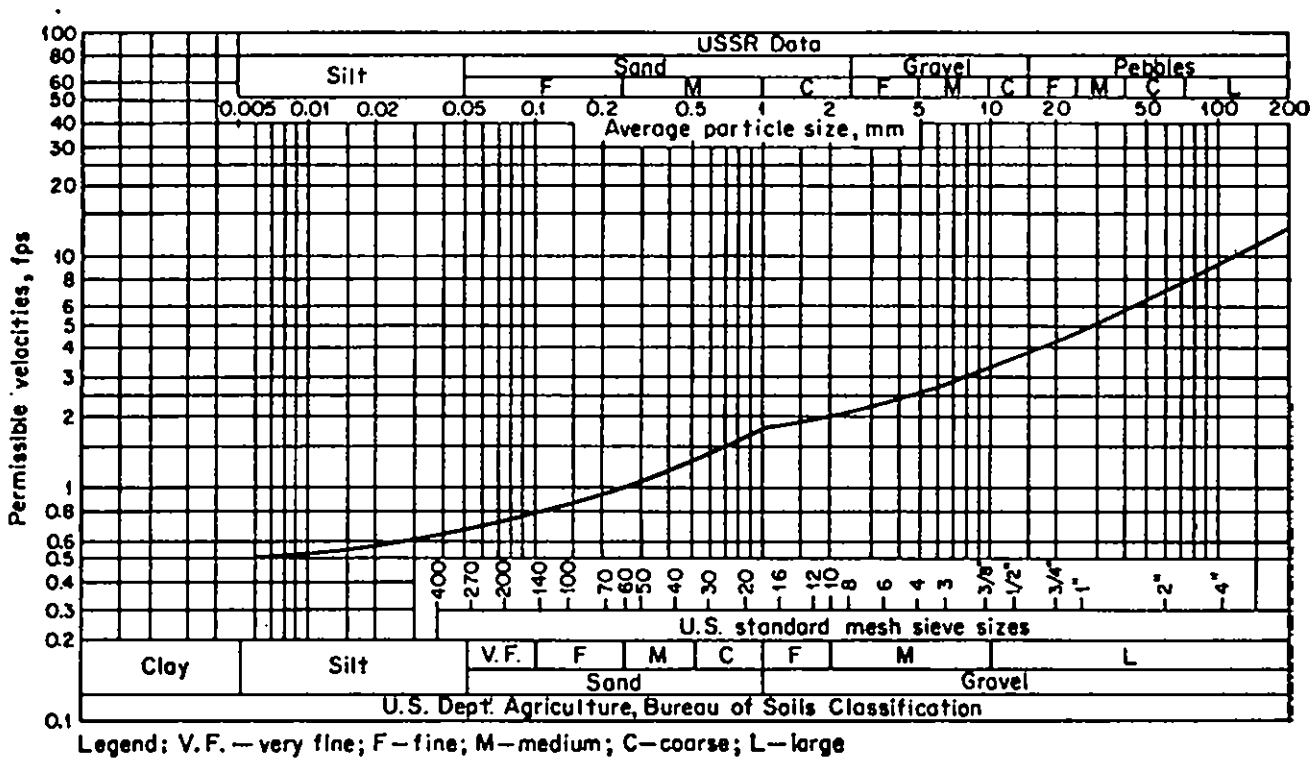
FIG. 7-3. U.S. and U.S.S.R. data on permissible velocities for noncohesive soils.

In 1936, Russian data was presented regarding permissible velocities for various sizes of cohesionless soils. This data is presented in Figure 7-3 of Chow and in Figure 4.4.2-3 of this report. As shown in Figure 4.4.2-3, the permissible velocity for fine sand is 0.75 fps (0.23 m/s) and for the material retained on the #4 sieve is 2.5 fps (0.76 m/s). Thus for coarse sand or fine gravel the limit of 2.5 fps (0.76 m/s) is the same as given in Figures 4.4.2-1 and 4.4.2-2.

In section 4.3 of this report it is shown that the channel velocities could have ranged between 8.5 fps (2.6 m/s) and 10 fps (3.0 m/s) for the May 14, 2003 event. It is clear that these velocities exceeded the 2.5 fps (0.76 m/s) permissible velocities for no grass cover for a channel composed of cohesionless sands. This is the root technical cause for the most significant aspect of the behavior of the fuse plug, which was the fact that erosion did not stop at the base of the fuse plug at El. 1481 ft. The erosion proceeded downward through the
