Upper Peninsula Power Company

McClure Penstock Revegetation Report: The McClure Penstock Replacement Project as part of the Dead River Hydroelectric Project (FERC Project No. 10855)

**UPPCO – McClure Penstock Replacement
Revegetation Monitoring
Photo Log**

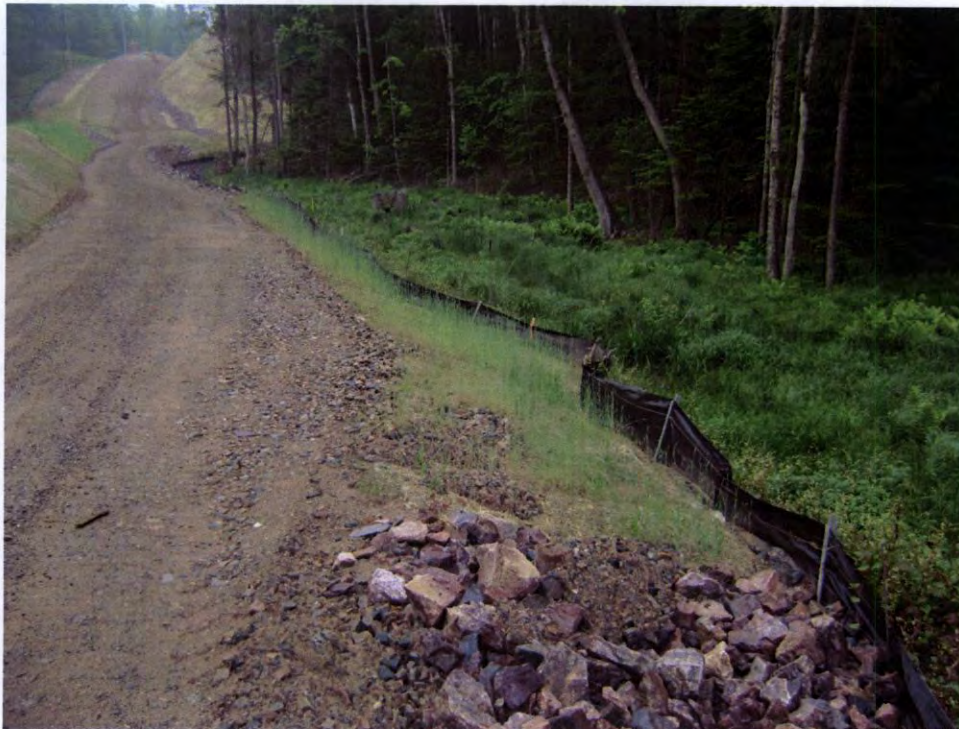
RM-7 looking northeast (South side of corridor)

Percent Cover	Vegetative	Bare Soil	Mulched (Straw & Hydro)	Percent Cover	Vegetative	Bare Soil	Mulched (Blanket or Hydro)
	20%	0%	100%		60%	0%	100%
Condition of Erosion Control	Excellent – Hydromulch and straw			Condition of Erosion Control	Excellent – Mulch Blanket and Silt Fence		
Description of Erosion (if any)	None			Description of Erosion (if any)	None

Other Observations
Drought conditions exist on site. National Weather Service website shows <1.0" of rain has fallen since the last monitoring date of June 16, 2011.

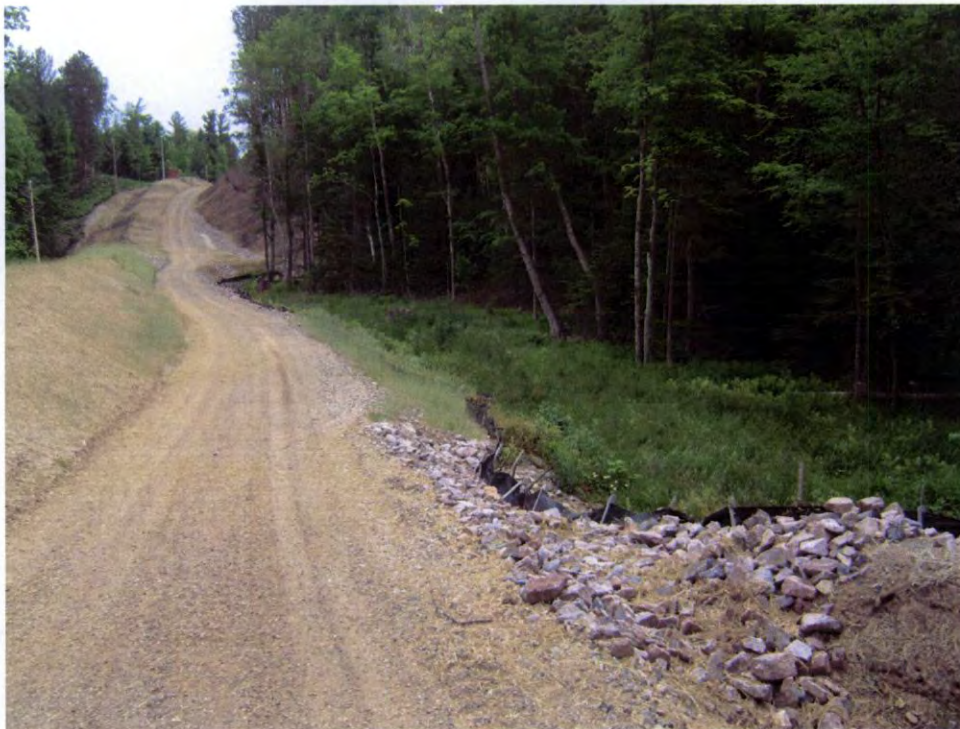
RM-7 looking northeast (South side of corridor)

Percent Cover	Vegetative	Bare Soil	Mulched (Straw & Hydro)	Percent Cover	Vegetative	Bare Soil	Mulched (Blanket or Hydro)
	30%	0%	100%		70%	0%	100%
Condition of Erosion Control	Excellent – Hydromulch and straw			Condition of Erosion Control	Excellent – Mulch Blanket and Silt Fence		
Description of Erosion (if any)	None			Description of Erosion (if any)	None

Other Observations
Drought conditions exist on site. National Weather Service website shows <0.75" of rain has fallen since the last monitoring date of July 15, 2011.

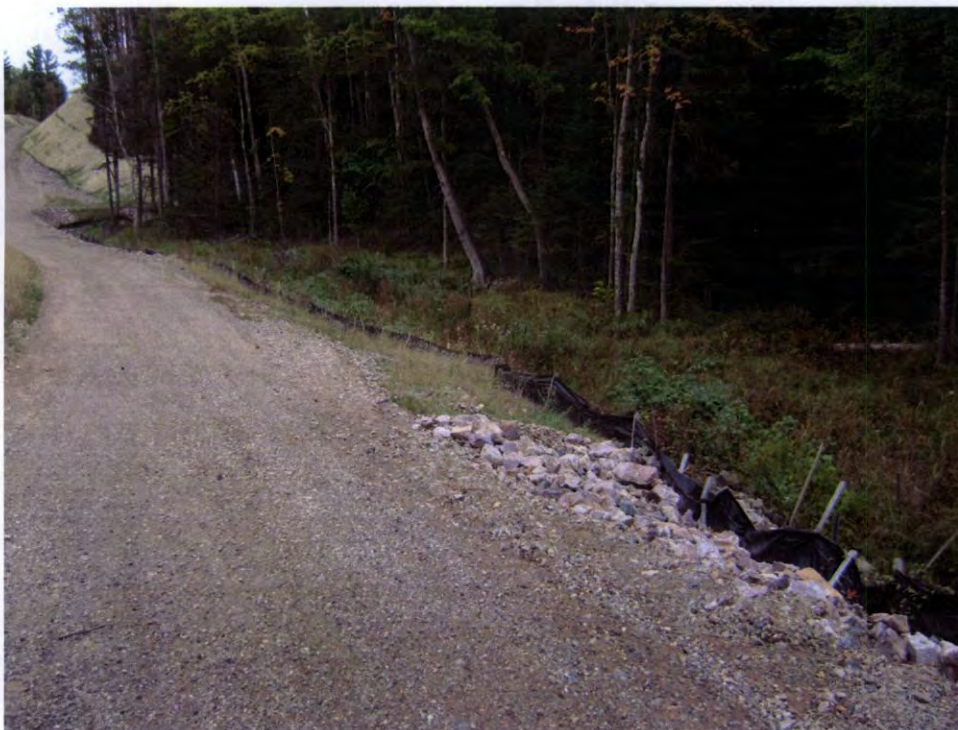
RM-7 looking northeast (South side of corridor)

Percent Cover	Vegetative	Bare Soil	Mulched (Straw & Hydro)	Percent Cover	Vegetative	Bare Soil	Mulched (Blanket or Hydro)
	45%	0%	100%		70%	0%	100%
Condition of Erosion Control	Excellent – Hydromulch and straw			Condition of Erosion Control	Excellent – Mulch Blanket		
Description of Erosion (if any)	None			Description of Erosion (if any)	None

Other Observations
Slight drought conditions still exist on site. National Weather Service website shows approx. 5.5" of rain has fallen since the last monitoring date of September 20, 2011.

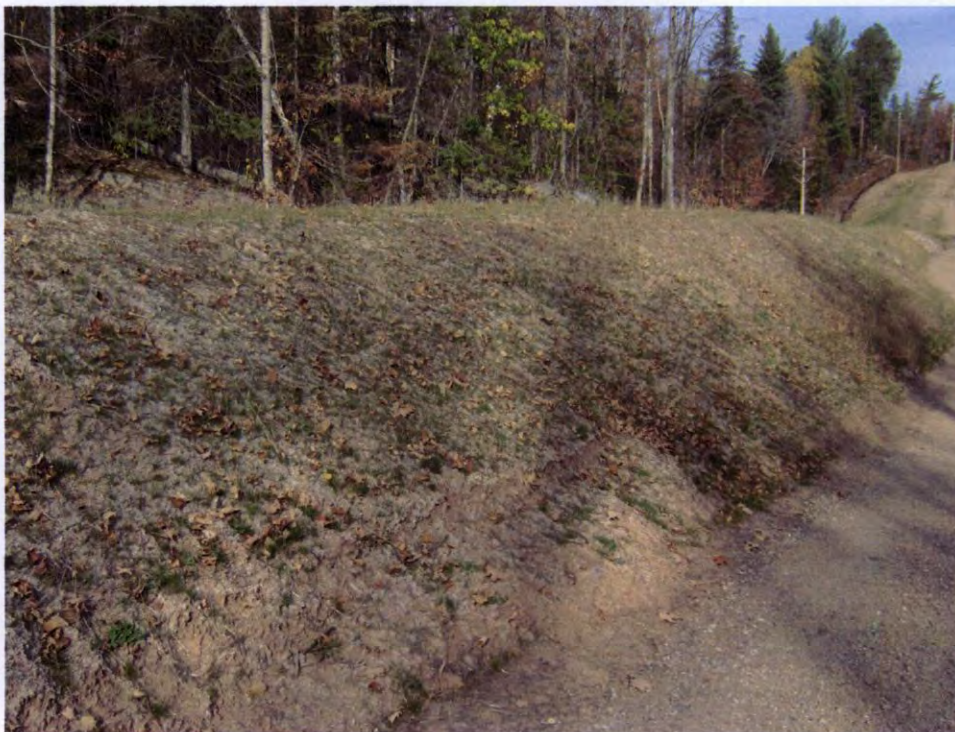
RM-7 looking north northeast (North side of corridor)

Percent Cover	Vegetative	Bare Soil	Mulched (Blanket or Hydro)	Percent Cover	Vegetative	Bare Soil	Mulched (Blanket or Hydro)
	0%	10%	90%		0%	100%	0%
Condition of Erosion Control	Excellent - Hydromulch			Condition of Erosion Control	Excellent – Silt Fence		
Description of Erosion (if any)	None			Description of Erosion (if any)	None

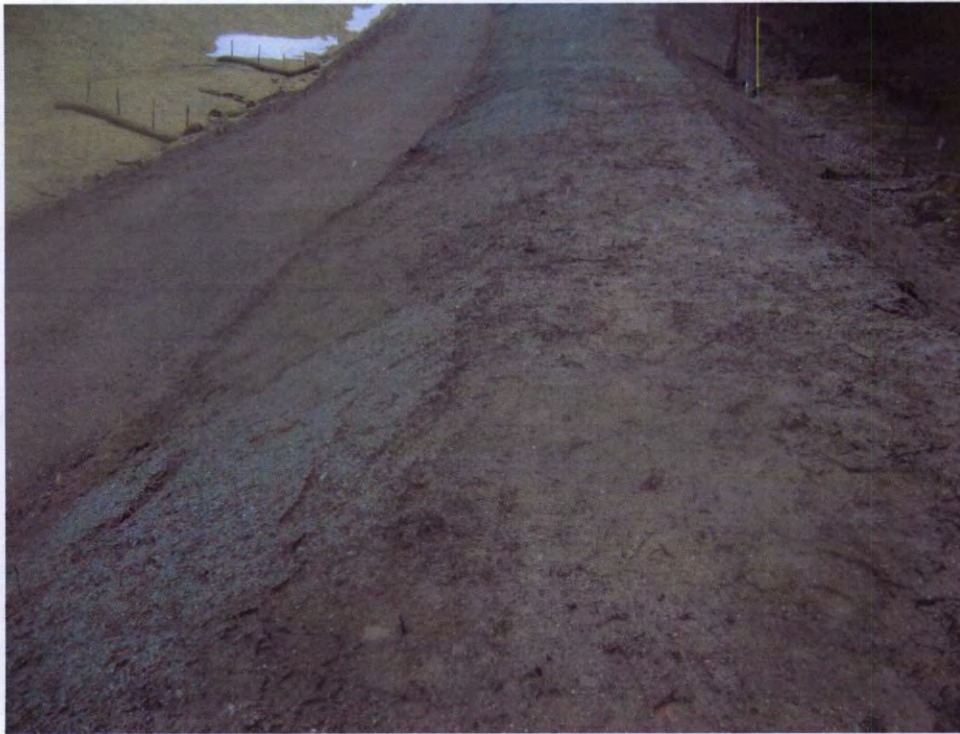
RM-8 looking west southwest (North side of corridor)

Percent Cover	Vegetative	Bare Soil	Mulched (Blanket or Hydro)	Percent Cover	Vegetative	Bare Soil	Mulched (Blanket or Hydro)
	20%	10%	90%		20%	0%	100%
Condition of Erosion Control	Excellent - Hydromulch			Condition of Erosion Control	Excellent – Mulch Blanket and Silt Fence		
Description of Erosion (if any)	None			Description of Erosion (if any)	None

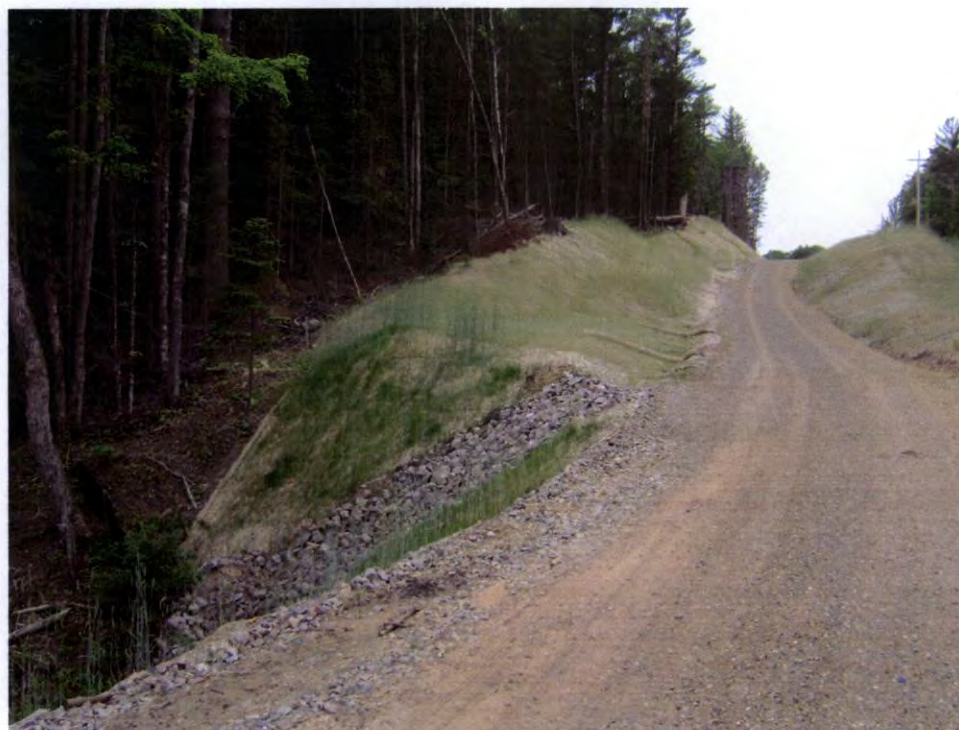
RM-8 looking southwest (South side of corridor)

Percent Cover	Vegetative	Bare Soil	Mulched (Straw & Hydro)	Percent Cover	Vegetative	Bare Soil	Mulched (Blanket or Hydro)
	40%	10%	90%		70%	0%	100%
Condition of Erosion Control	Excellent – Hydromulch and straw			Condition of Erosion Control	Excellent – Mulch Blanket and Silt Fence		
Description of Erosion (if any)	None			Description of Erosion (if any)	None

Other Observations
Drought conditions exist on site. National Weather Service website shows <0.75" of rain has fallen since the last monitoring date of July 15, 2011.

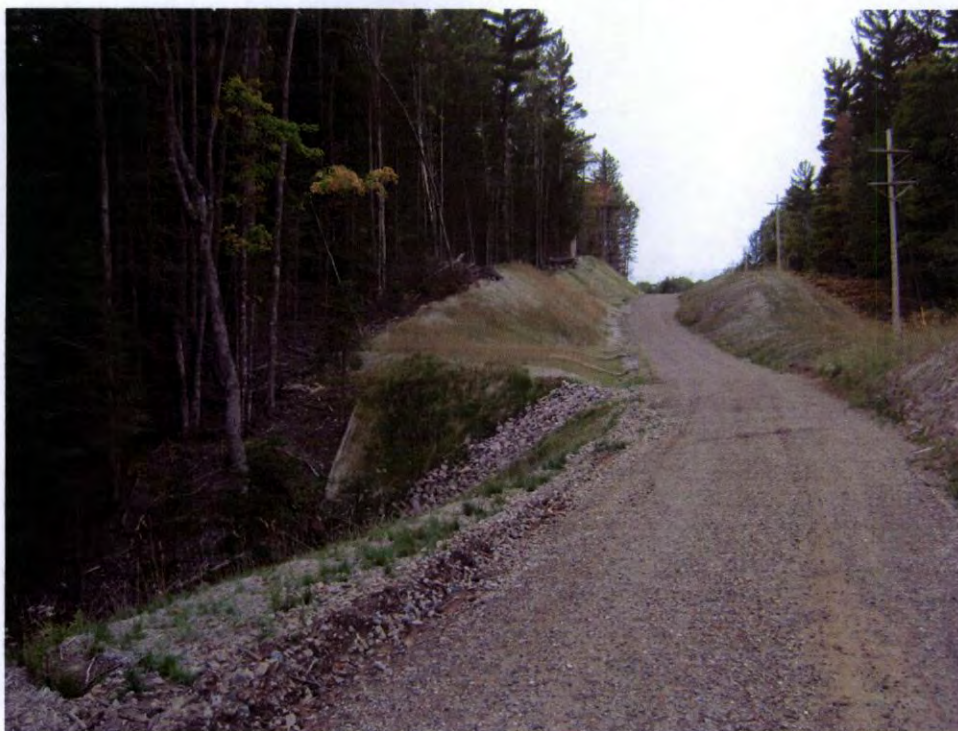
RM-8 looking southwest (South side of corridor)

Other Observations
Slight drought conditions still exist on site. National Weather Service website shows approx. 5.5" of rain has fallen since the last monitoring date of September 20, 2011.

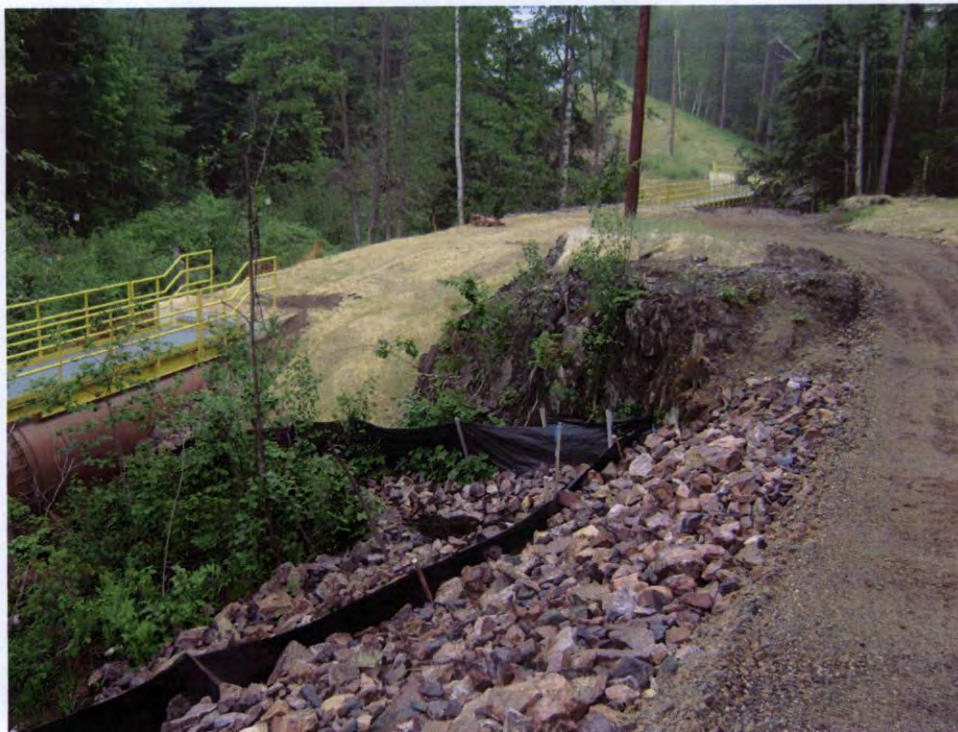
RM-9 looking northeast (South side of corridor)

Other Observations
Drought conditions exist on site. National Weather Service website shows <1.0" of rain has fallen since the last monitoring date of June 16, 2011.

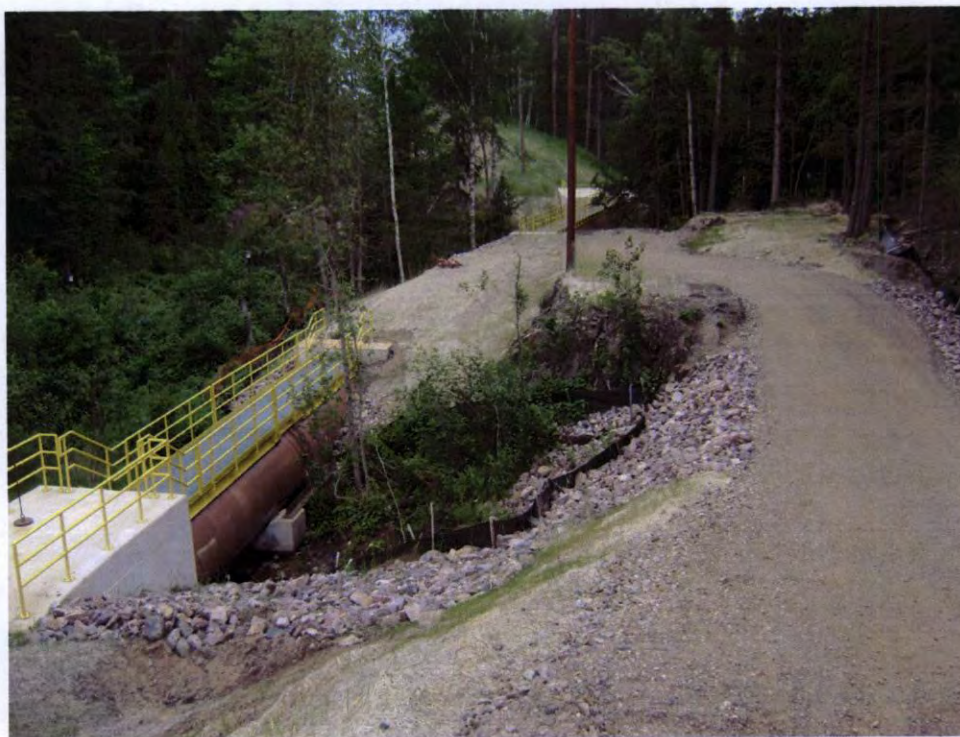
RM-9 looking northeast (South side of corridor)

Other Observations
Drought conditions exist on site. National Weather Service website shows <0.75" of rain has fallen since the last monitoring date of July 15, 2011.

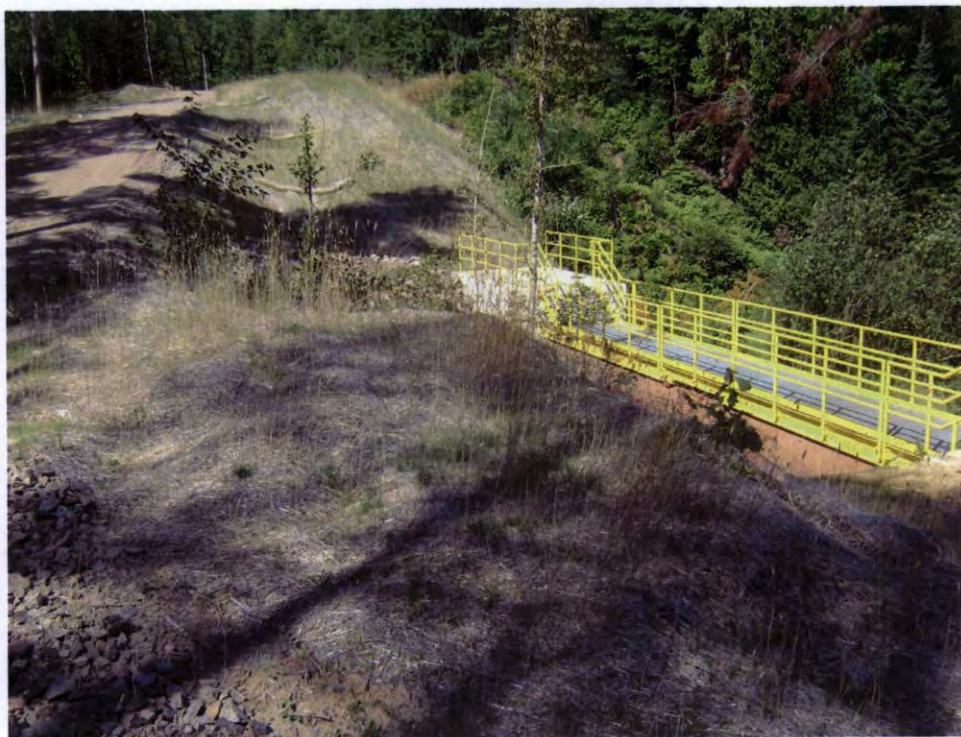
RM-9 looking northwest (South side of corridor)

Other Observations
Drought conditions exist on site. National Weather Service website shows <1.75" of rain has fallen since the last monitoring date of August 17, 2011.

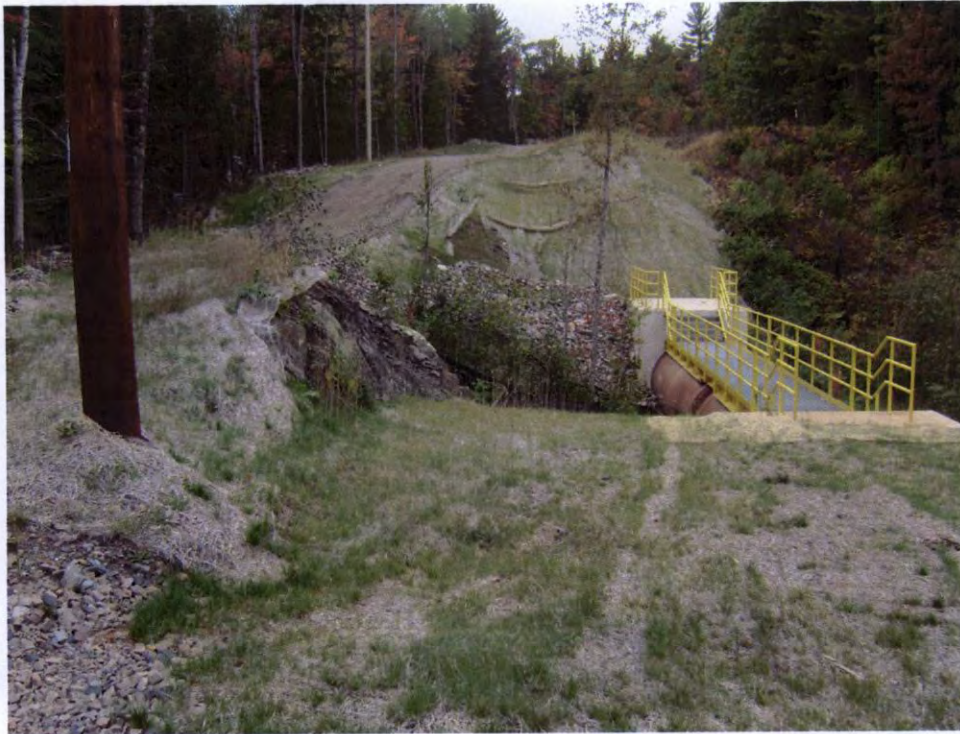
RM-9 looking west (South side of corridor)

Other Observations
Slight drought conditions still exist on site. National Weather Service website shows approx. 5.5" of rain has fallen since the last monitoring date of September 20, 2011.

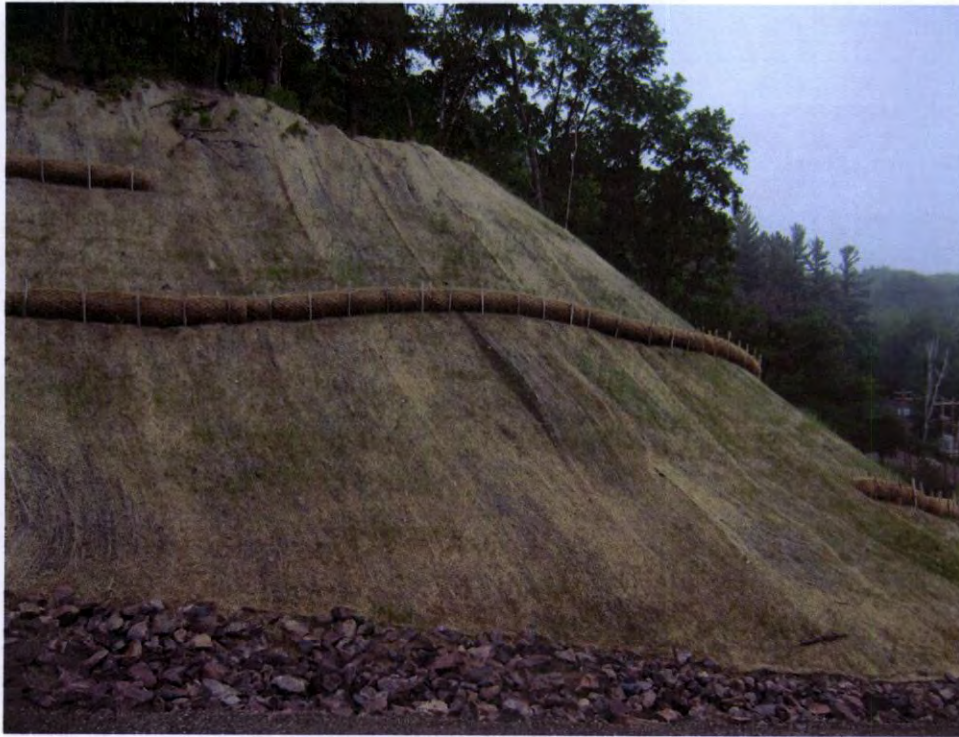
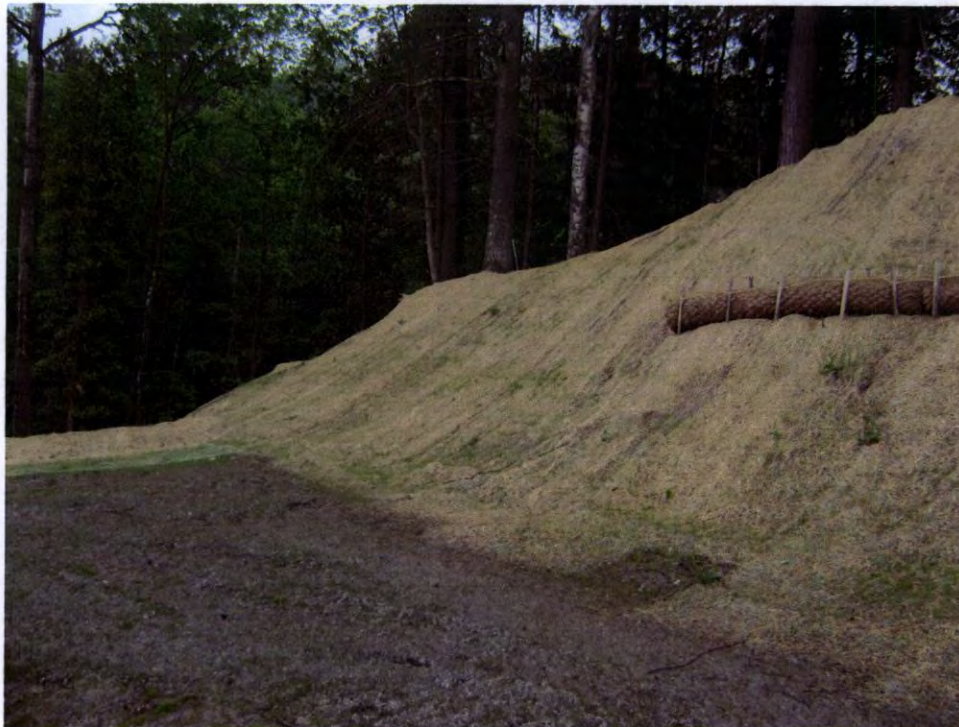
Drought conditions exist on site. National Weather Service website shows <1.0" of rain has fallen since the last monitoring date of June 16, 2011.

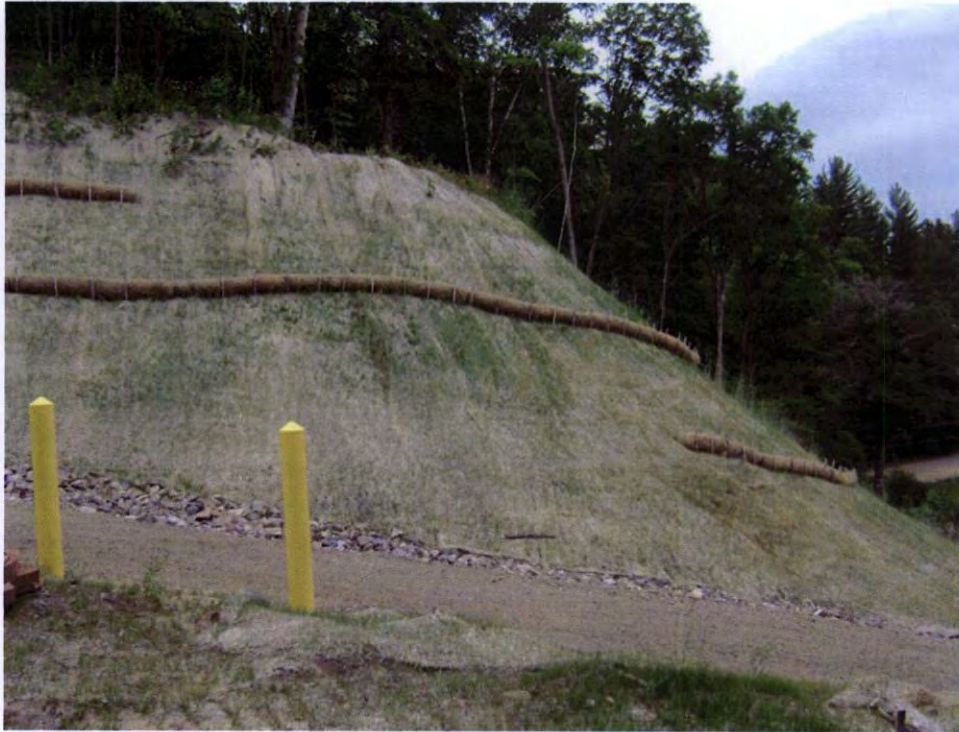
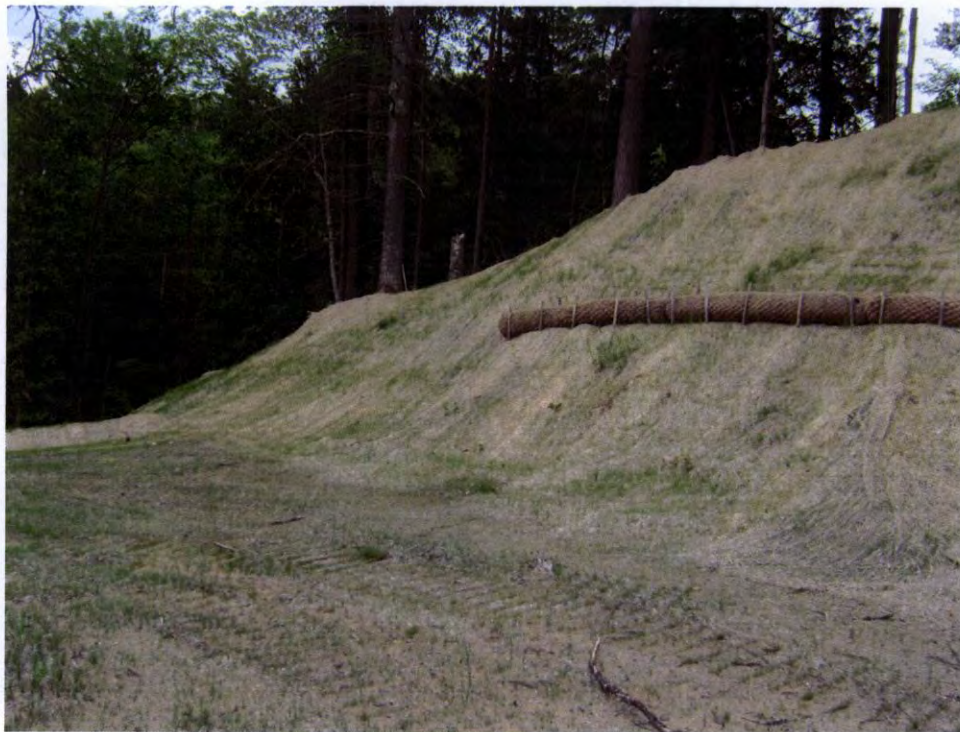
Other Observations
Drought conditions exist on site. National Weather Service website shows <0.75" of rain has fallen since the last monitoring date of July 15, 2011.

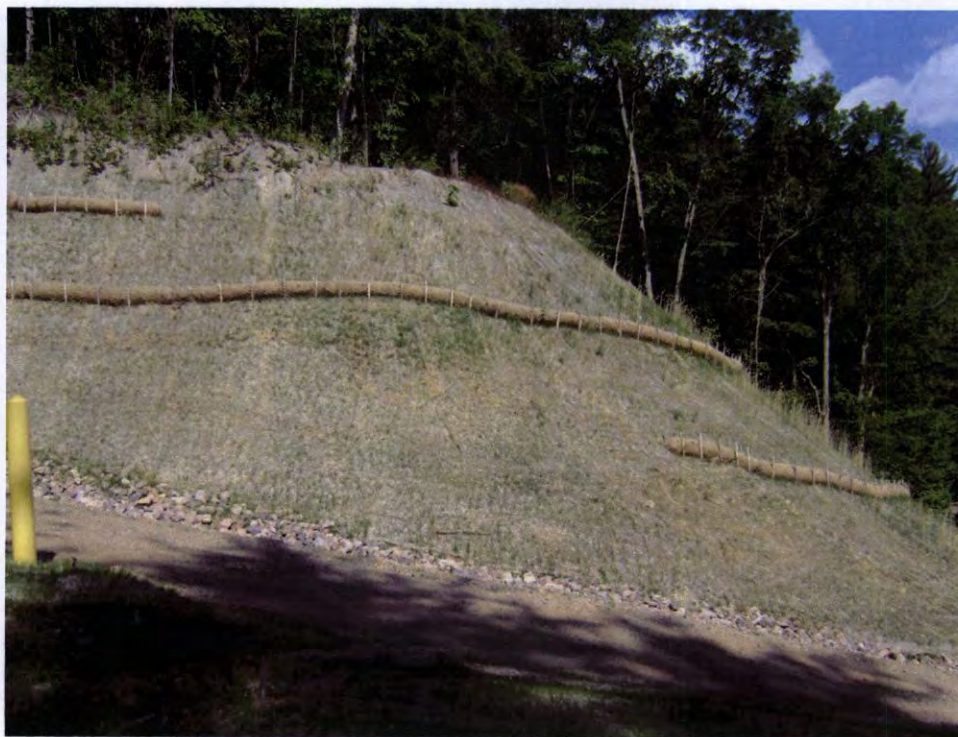
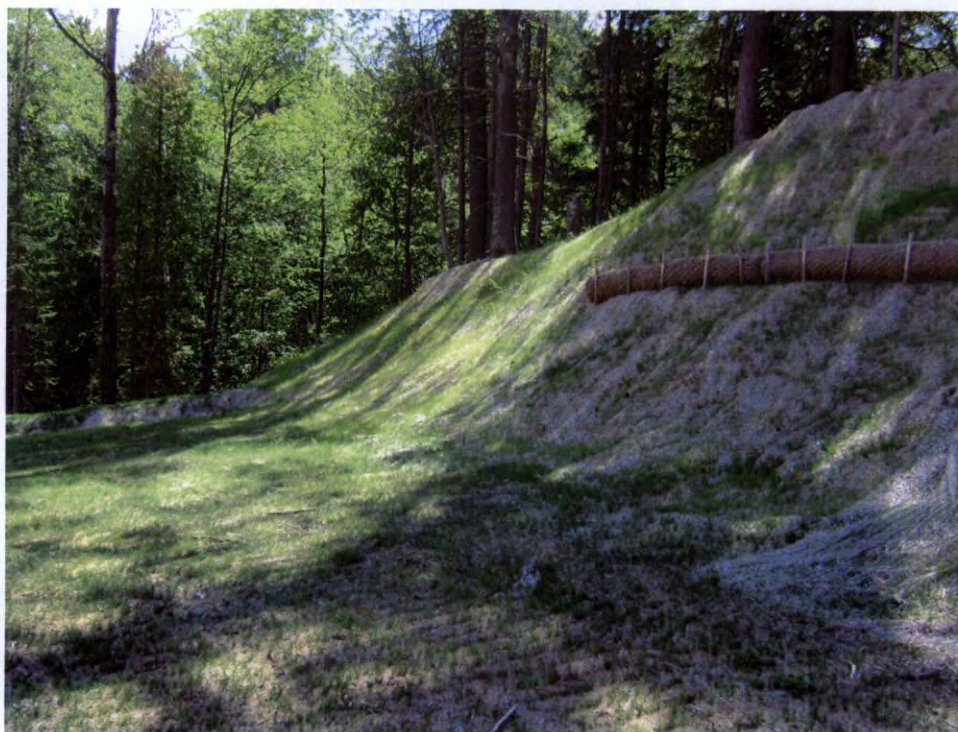
Other Observations
Drought conditions exist on site. National Weather Service website shows <1.75" of rain has fallen since the last monitoring date of August 17, 2011.

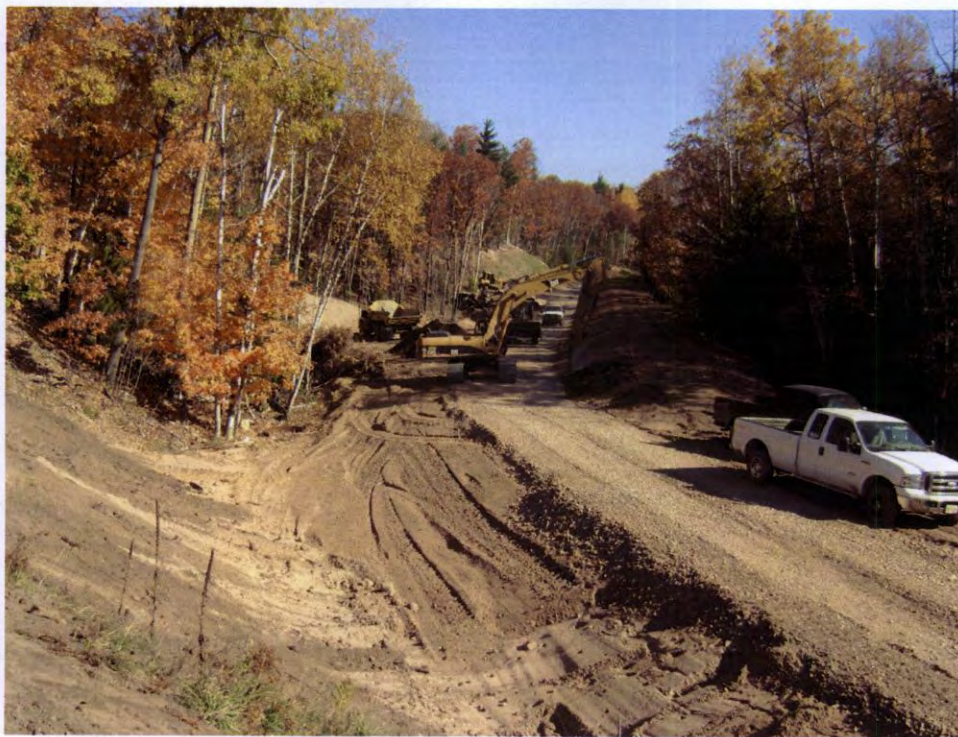
Beginning of topsoil placement near dam embankment

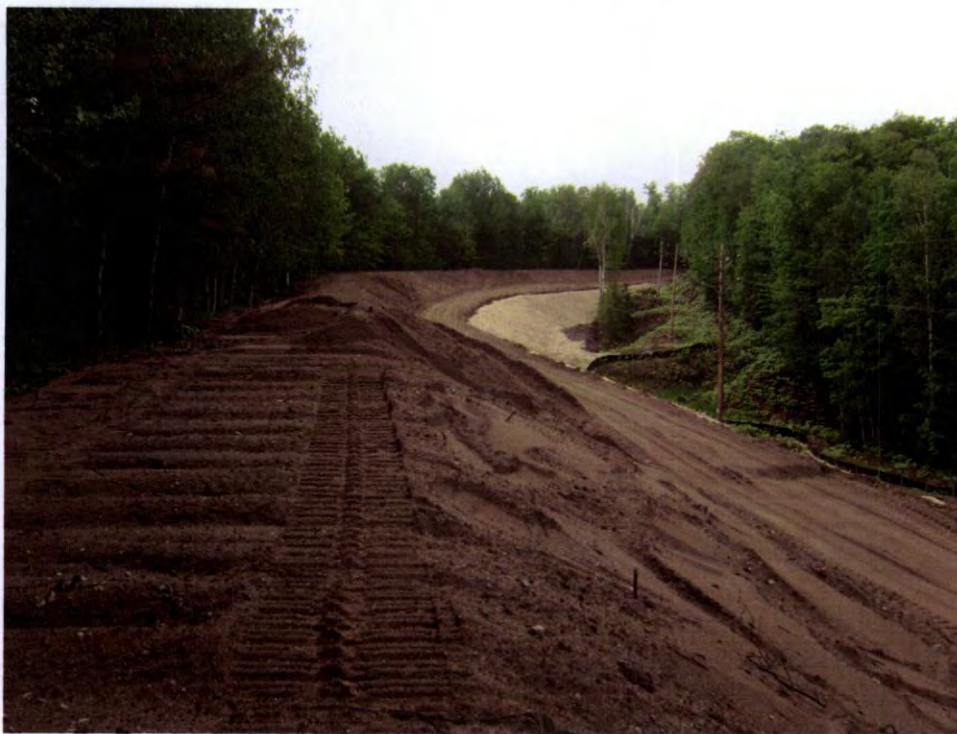
Rough grade near RM-2

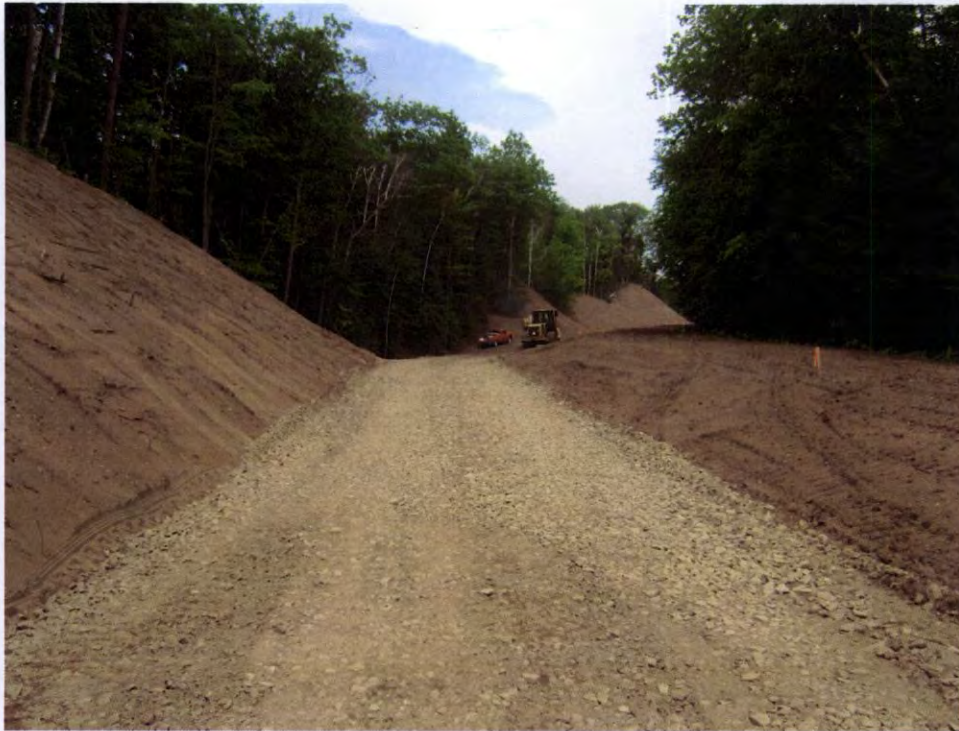
Final grade/topsoil placed between DRM-1 and RM-1
