**Boney Falls Dam
Spillway Expansion
(FERC No. 2506)**

**SUPPORTING
DESIGN REPORT**

**April 1989
Harza Engineering Company**

**BONEY FALLS DAM SPILLWAY EXPANSION
Escanaba River
Escanaba, Michigan**

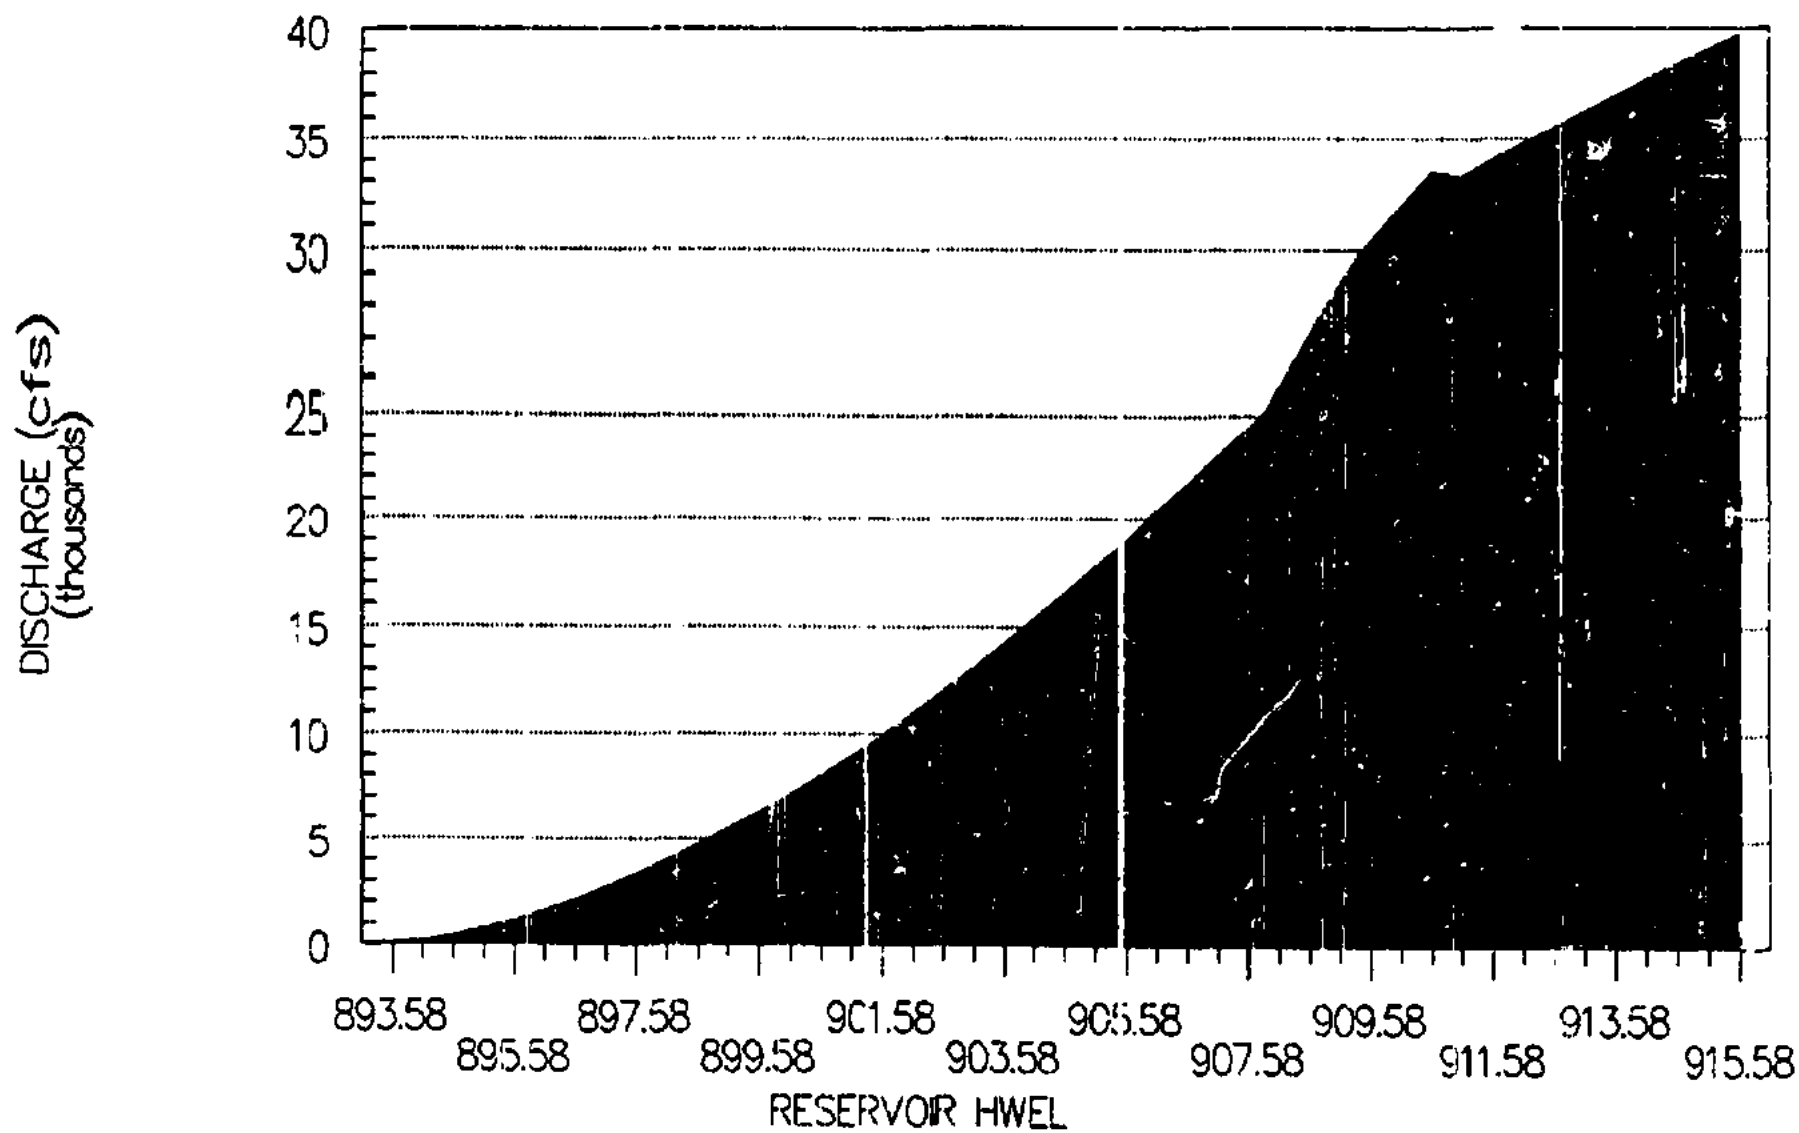
Gated Spillway Rating Curve

SUBJECT: Tainter Gated Spillway Discharge Rating Curve (Free Overfall Conditions)		PROJECT: Boney Falls NUMBER: 1979L DATE: 25-Apr-89 PAGE: _____ of _____				
COMPUTED: M.F. Rogers						
RESERVOIR MEL (ft,msl)	BAYS:		CONTRACTIONS:		DESIGN:	
	Crest EL:	893.58	K(pier):	0.00	No =	14.2
	Width =	20	K(abut):	0.05	EGLo =	907.78

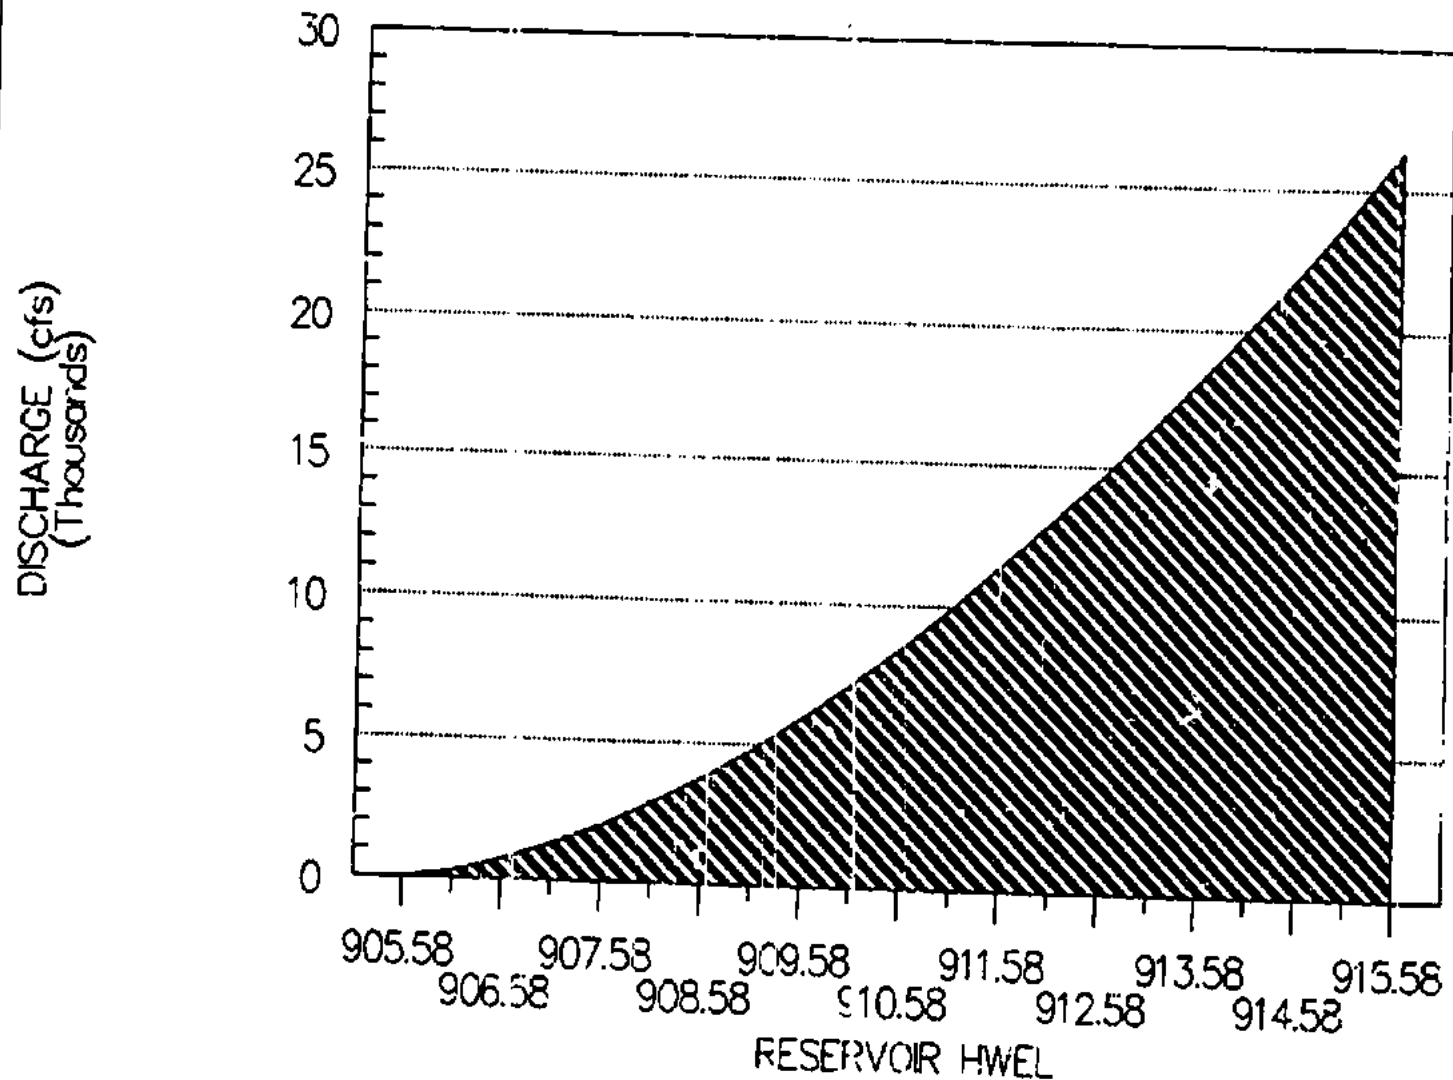
Ungated Spillway Rating Curve

SUBJECT: Ungate Spillway Discharge Rating Curve (Free Overfall Conditions)		PROJECT: Boney Falls				
COMPUTED: M.F. Rogers		NUMBER: 1979L	DATE: 25-Apr-89	PAGE ___ of ___		
BAYS:		CONTRACTIONS:		DESIGN:		
Crest EL 905.58		K(PIER)= 0.00	No = 6.70			
Width = 200		K(BUT)= 0.05	CG = 912.28

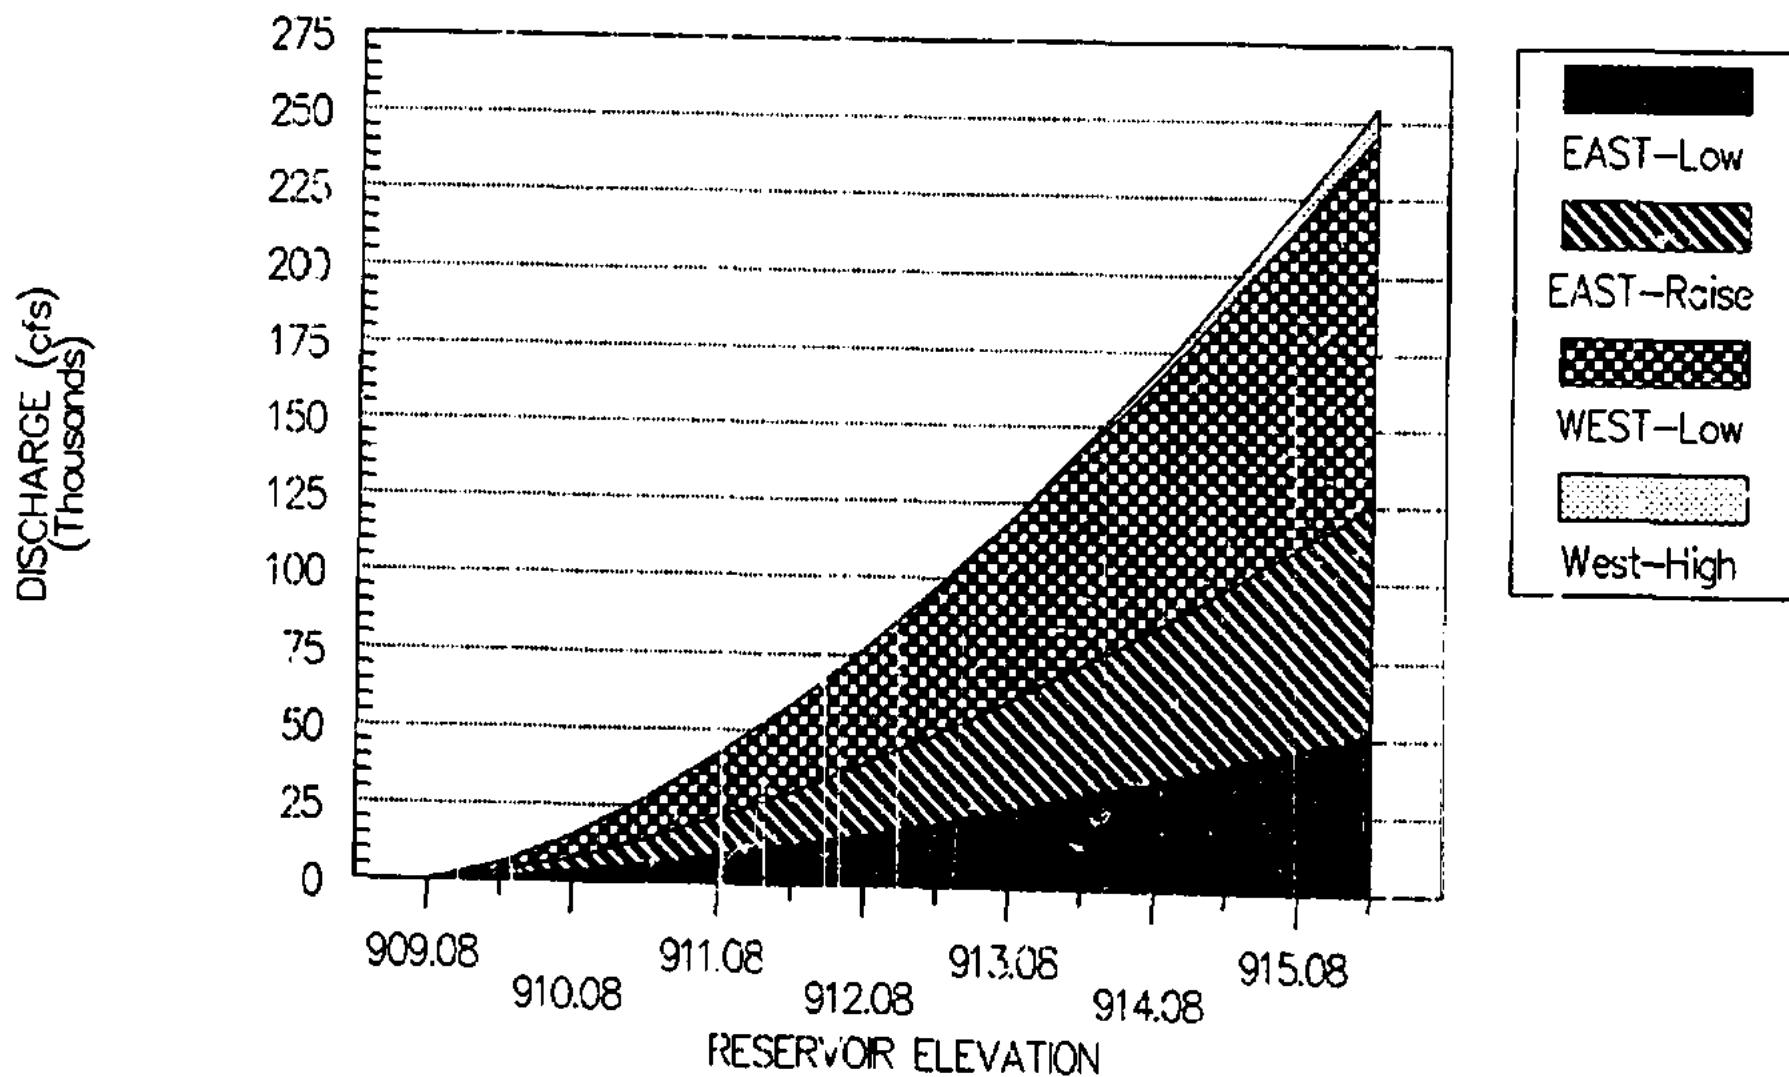
Flow Over Embankment-EXISTING

SUBJECT: Embankment Overtopping Flow
 Discharge Rating Curve
 EXISTING CONDITIONS
 COMPLETED: M.F. Rogers

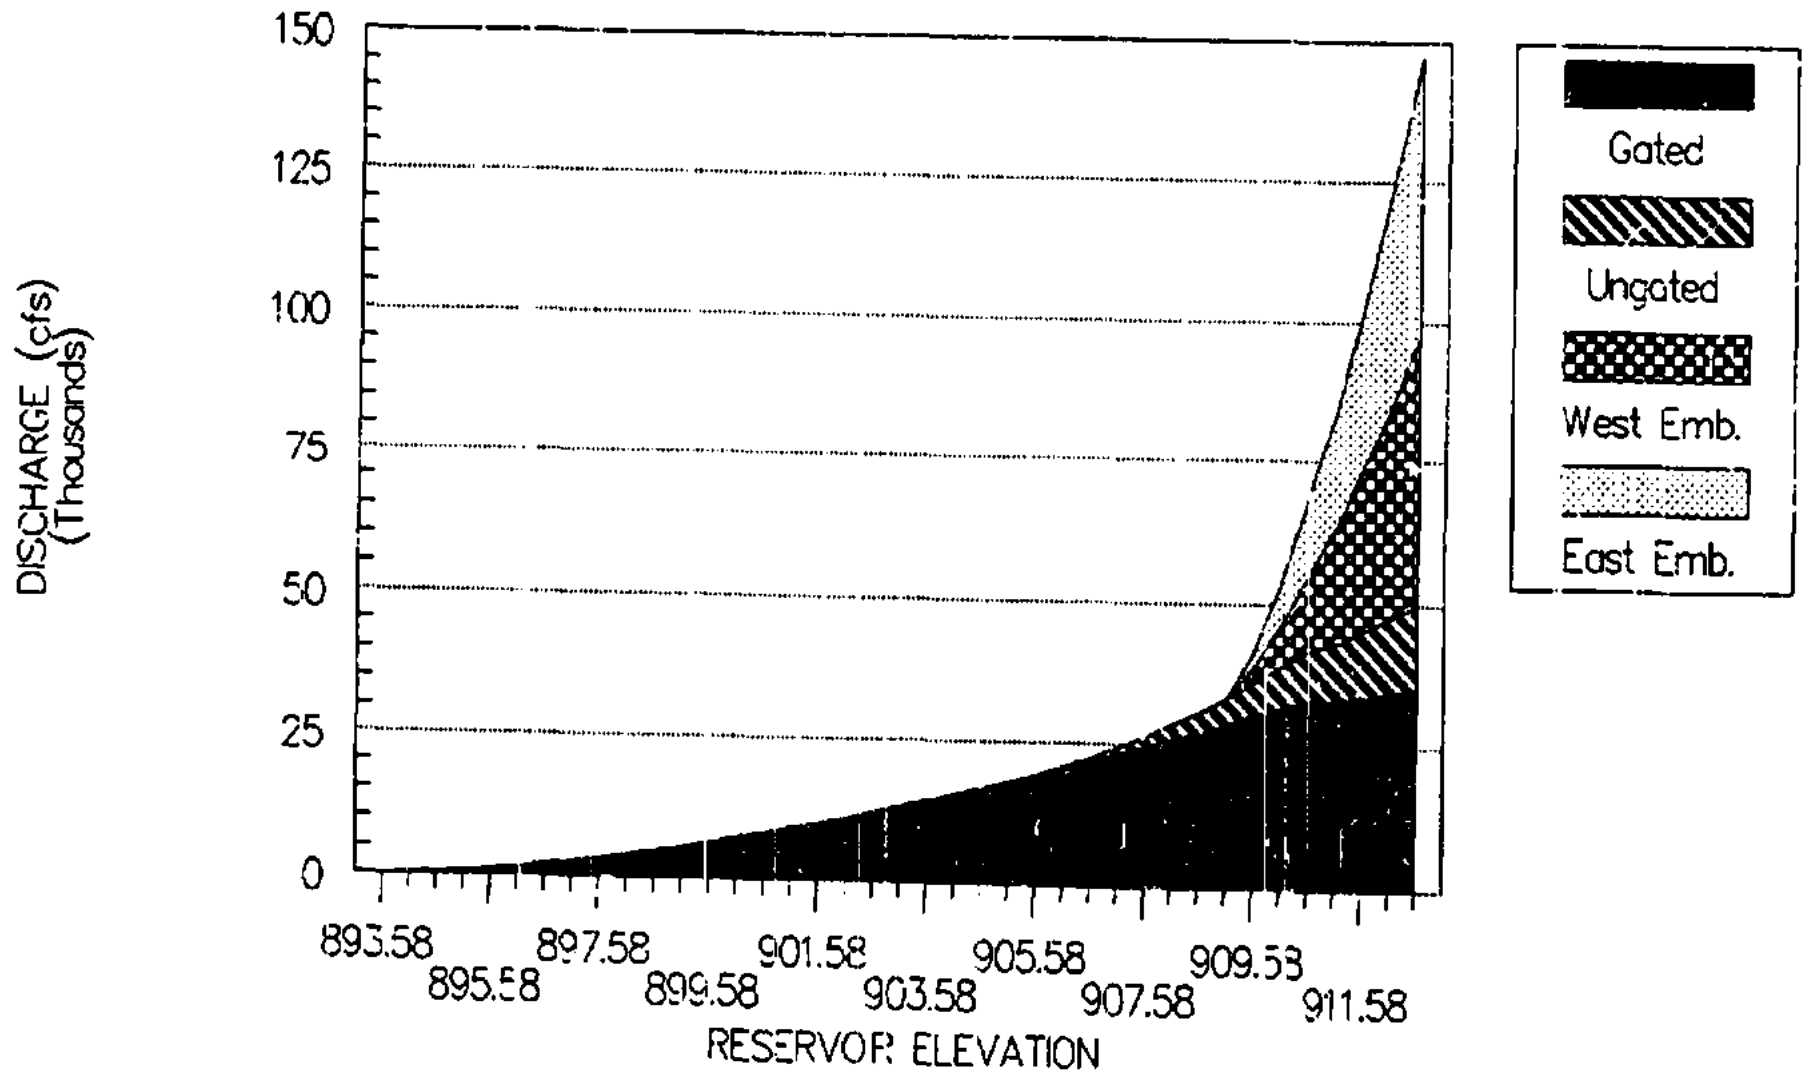
EXISTING Project Discharge Rating Curve

SUBJECT: Project Discharge Capacity Headwater vs. Discharge Rating Curve EXISTING CONDITIONS COMPUTED: M.F. Rogers						PROJECT: Boney Falls NUMBER: 1970L DATE: 01-May-89 PAGE ___ of ___	
RESERVOIR WUEL (ft.,=sl)	GATED SPILLWAY		UNGATED	WEST EMBANKMENT	EAST EMBANKMENT	EXISTING PROJECT DISCHARGE (cfs)	RESERVOIR WUEL (ft.,=sl)
	Flow Control	Discharge (cfs)	Discharge (cfs)	Discharge (cfs)	Discharge (cfs)

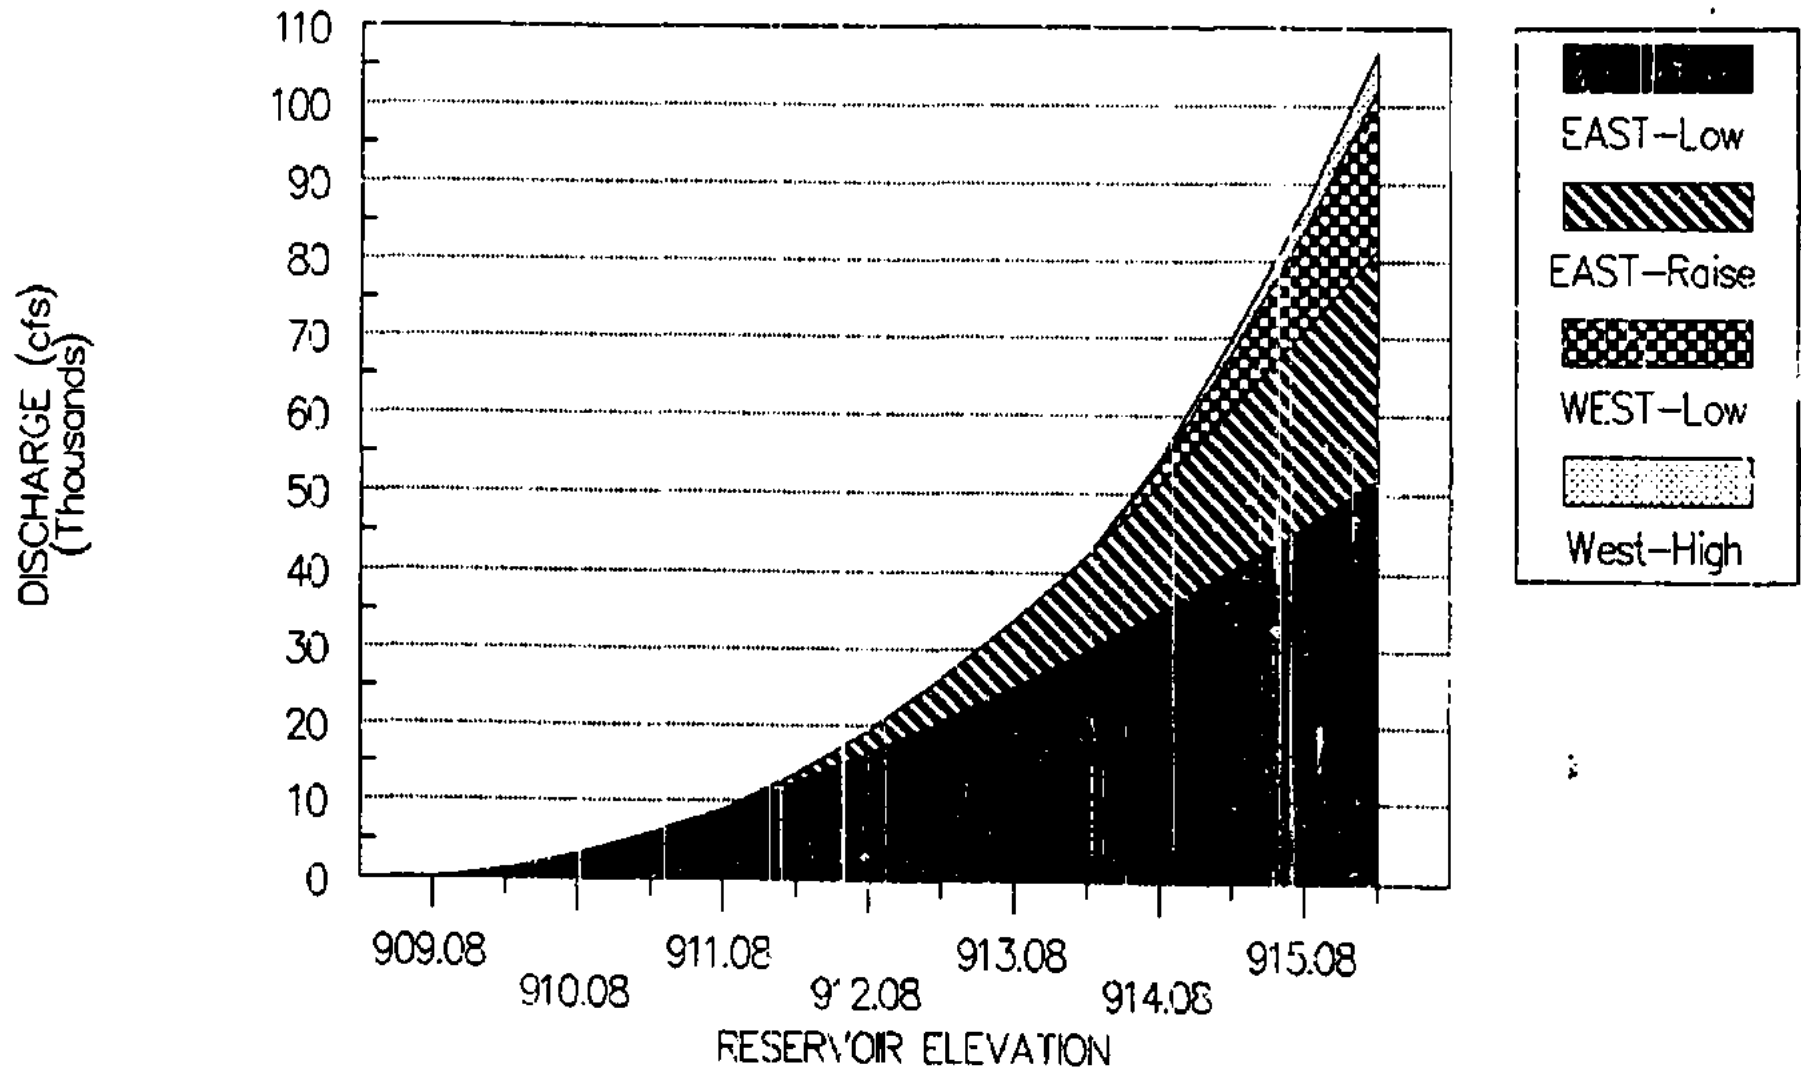
Flow Over Embankments after Raising

SUBJECT: Embankment Overlapping Flow
Discharge Rating Curve
AFTER SPILLWAY EXPANSION
COMPUTED: M.F. Rogers

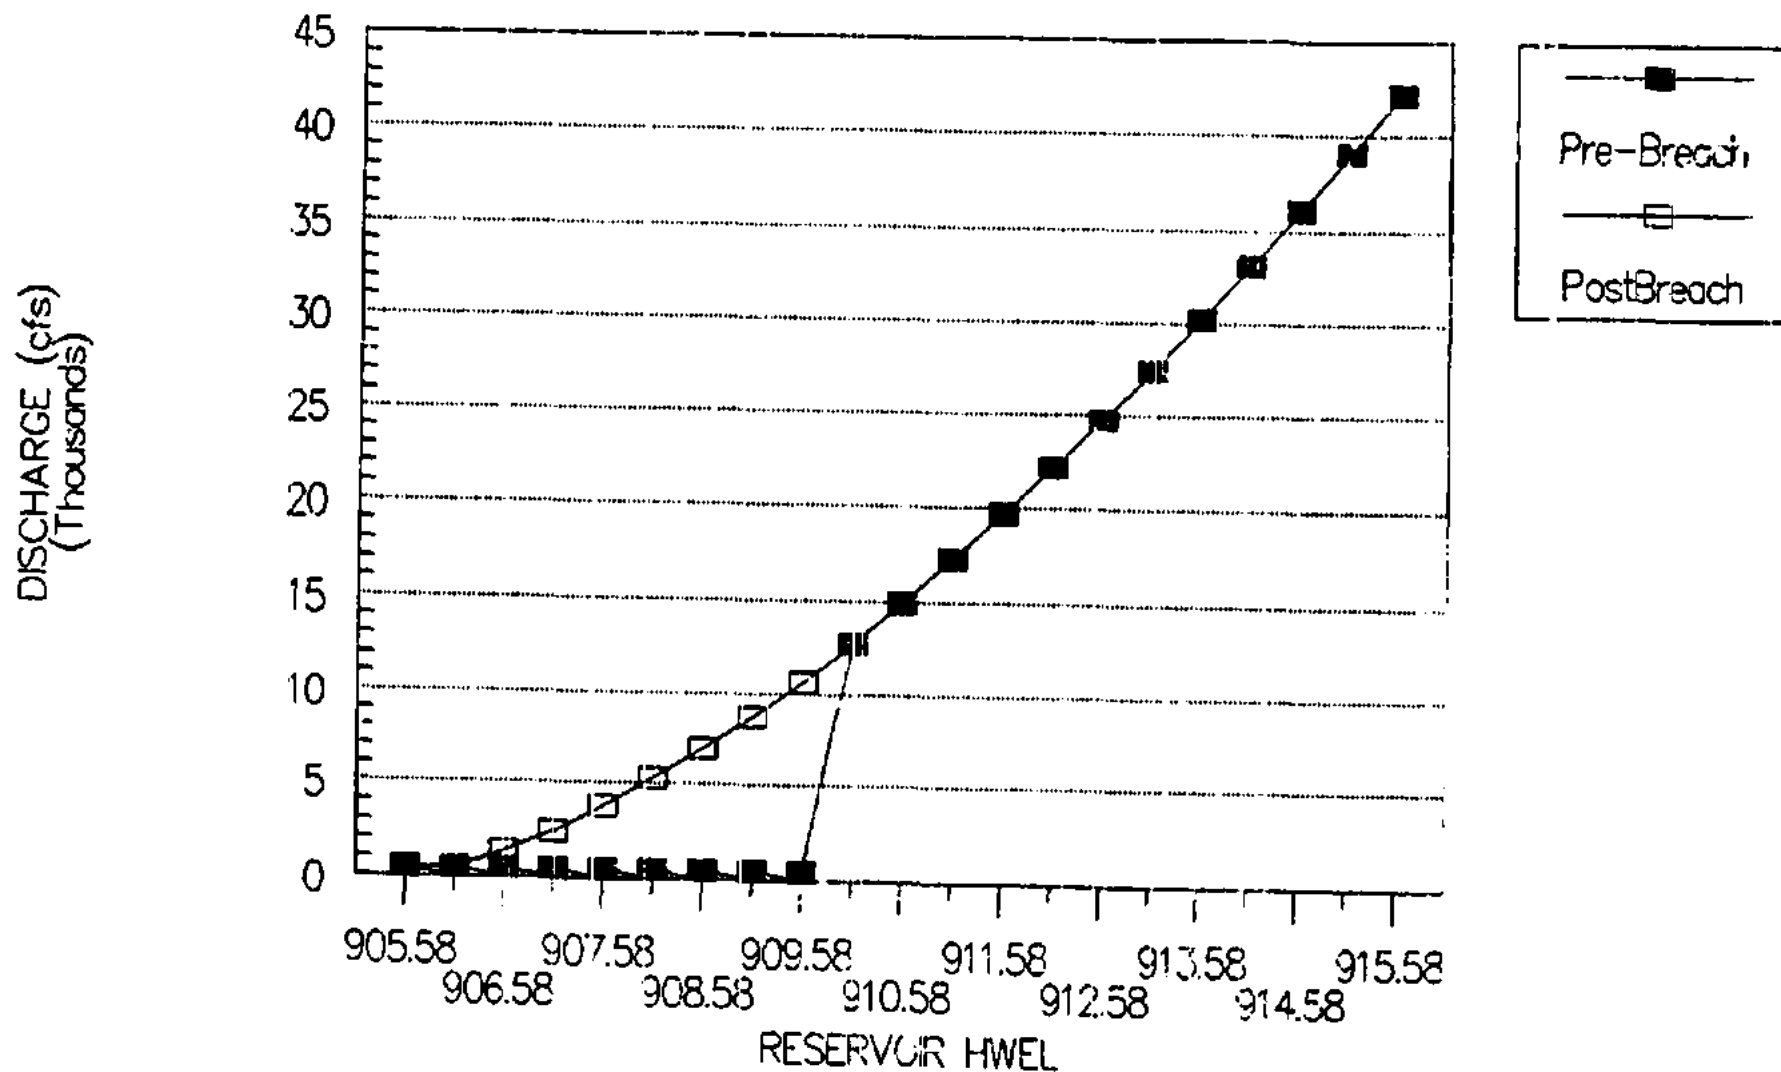
New RCC Spillway Rating Curve

SUBJECT: Roller Compacted Concrete PROJECT: Honey Falls Emergency Spillway NUMBER: 1979L Discharge Rating Curve DATE: 01-Jan-89		COMPUTED: M.F. Rogers PAGE ___ of ___		
EAST EMBANKMENT DAM Sta. 0+00 to 5+00 Top of Dam: 910.06 Crest EL: 905.58 Length 500 Cd = 2.67				
RESERVOIR HWEL (ft, MSL)	Head (ft)	Cd	DISCHARGE (cfs)	
			Prior to Breach	After Breach

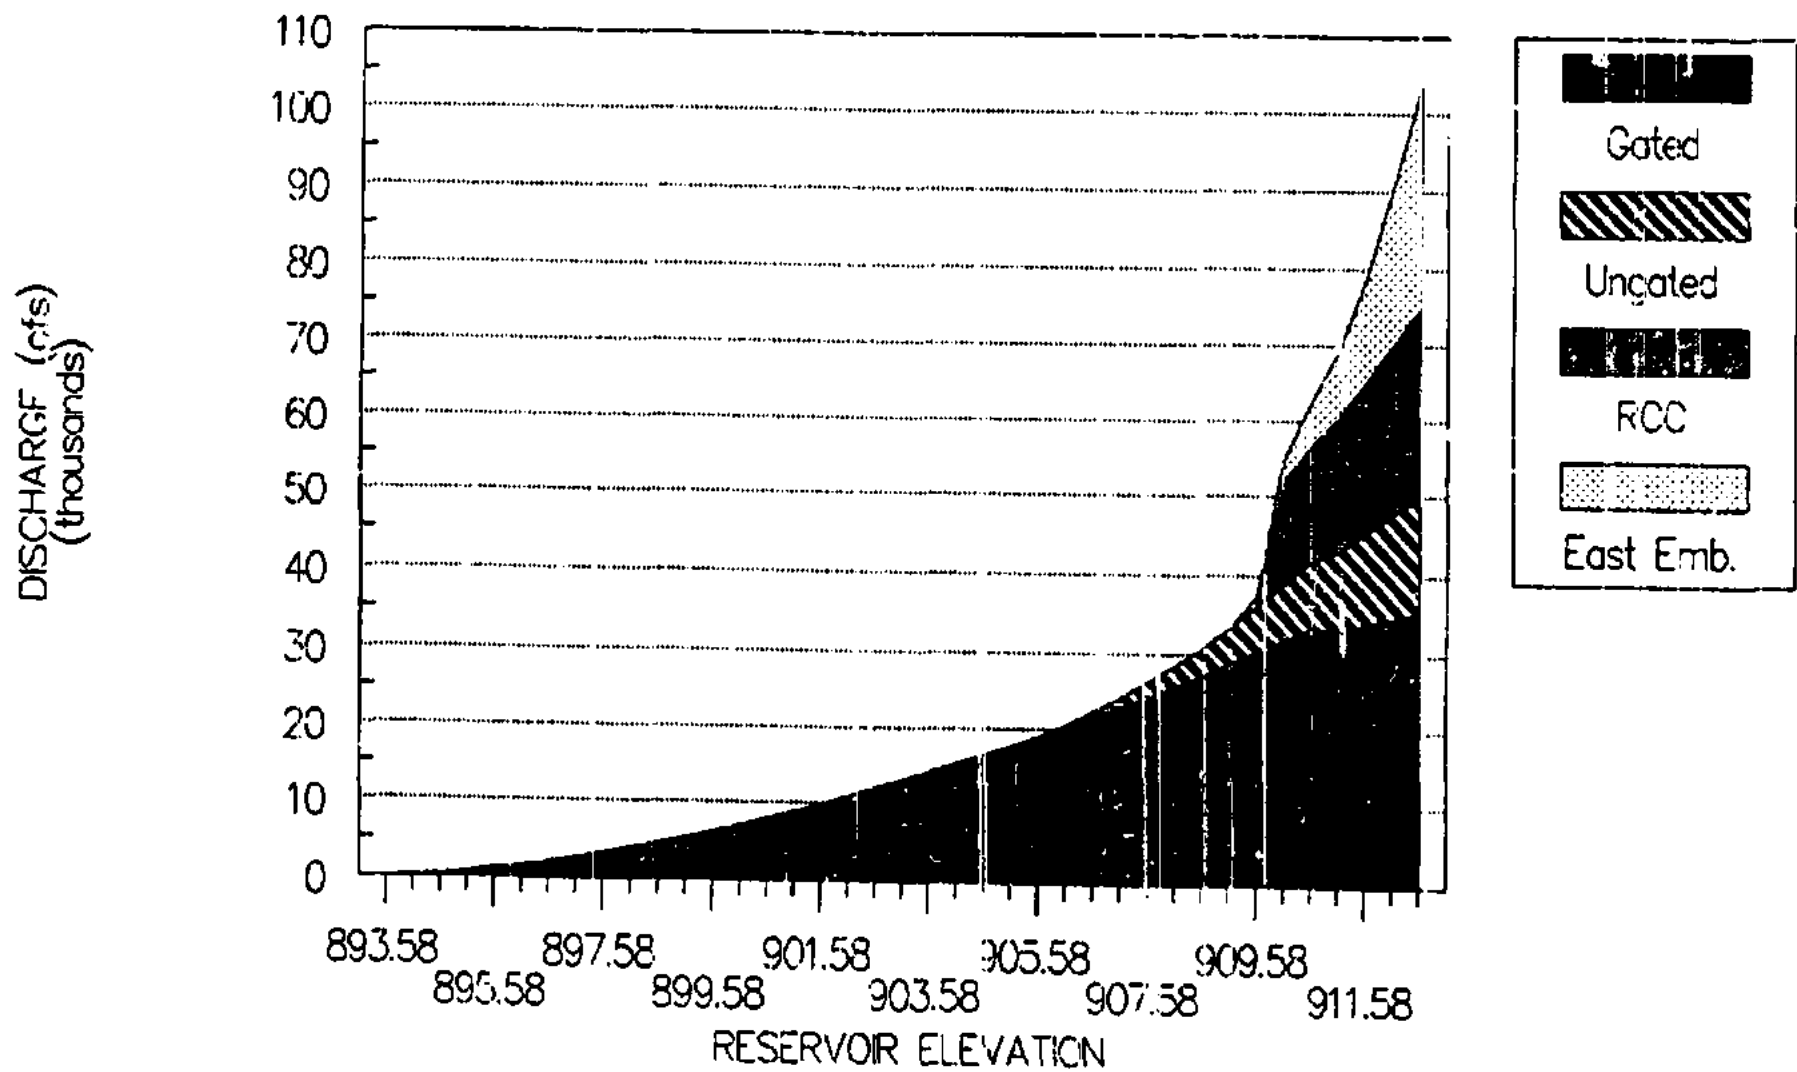
New Project Discharge Rating Curve

SUBJECT: Project Discharge Capacity
 Headwater vs. Discharge Rating Curve
 AFTER SPILLWAY EXPANSION
 COMPUTED: M.F. Rogers

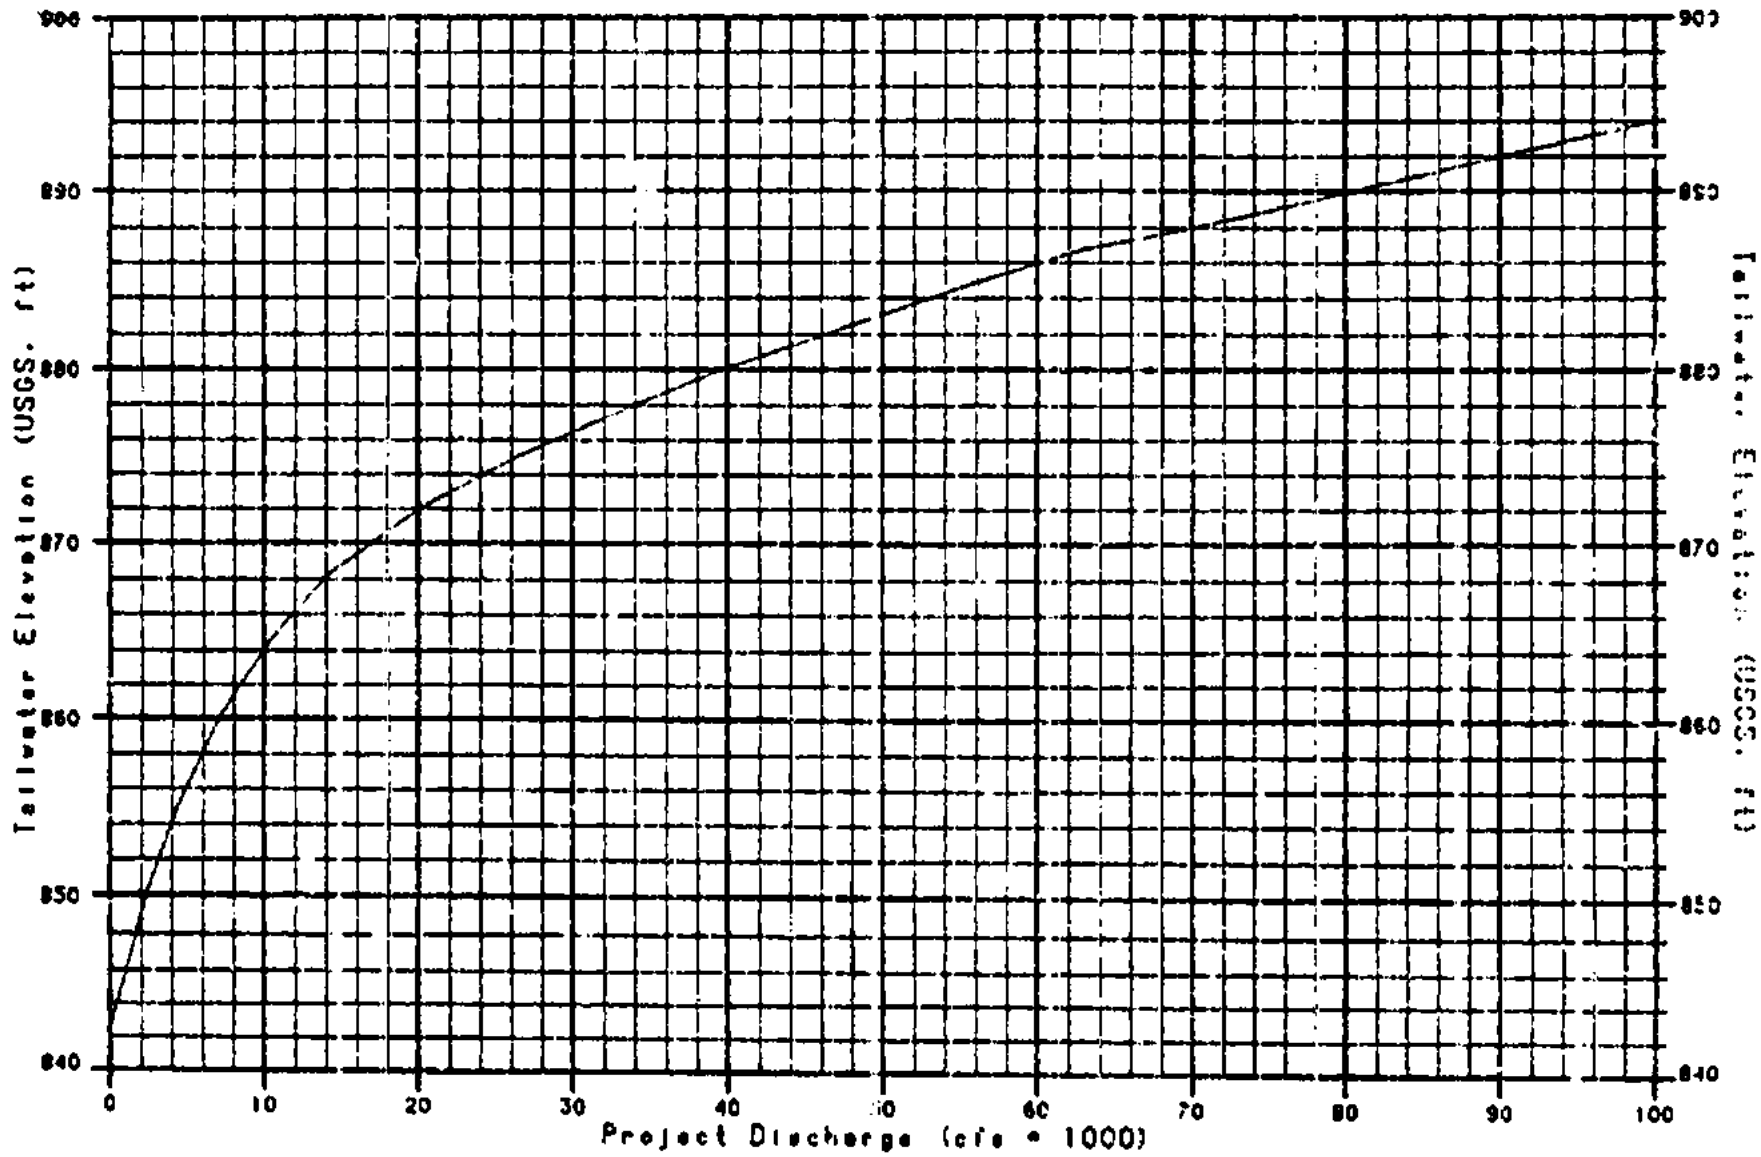
Source : Barr Engineering Co.

MEAD CORPORATION PUBLISHING PAPER DIVISION	
RCC SPILLWAY	BONEY FALLS DAM
TAILWATER RATING CURVE	
MARZA ENGINEERING COMPANY	
CHICAGO, ILLINOIS	APR 22 1968

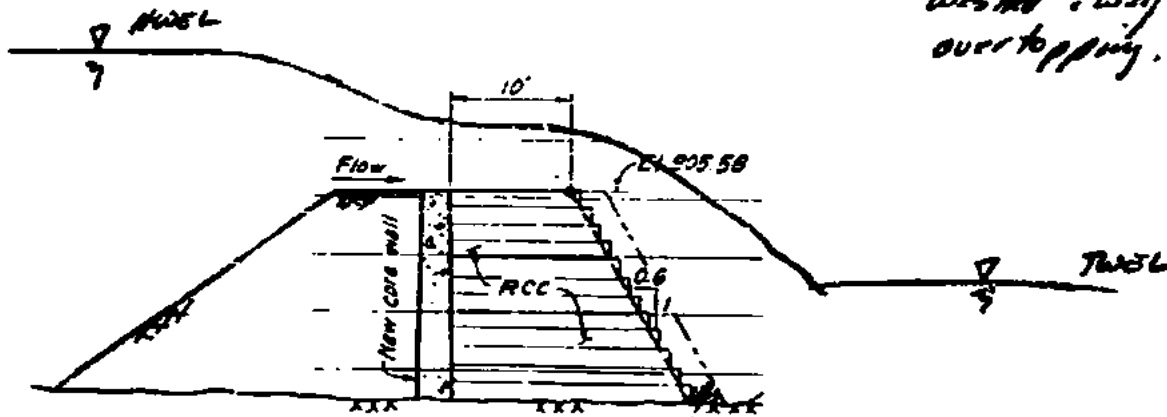
TYPICAL SECTION (after breach)

- Carving material washed away due to overtopping.

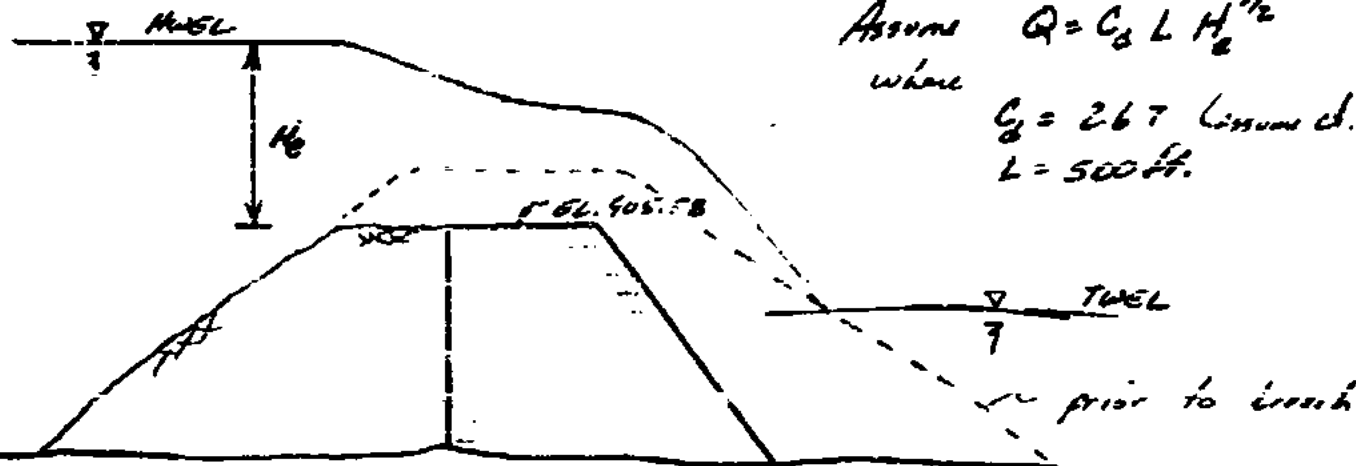
VII. RCC Spillway Rating Curves

RESERVOIR MWEL (ft, msl)	EAST EMBANKMENT DAM Sta. 0+00 to 5+00 Crest EL: 905.58 Length 500 Cd = 2.67		DISCHARGE (cfs)	
	Head (ft)	Cd	Prior to Breach	After Breach
