CR AAO Bridge

Dead River Flood & Natural Channel Design

Mitch Koetje
Water Resources
Division
UP District

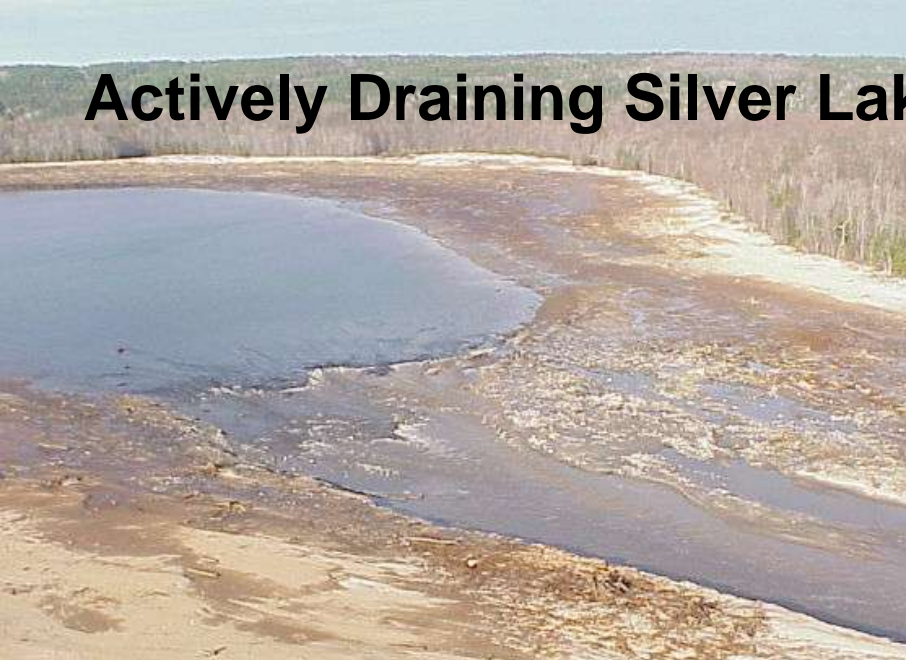
**Look Downstream
From Silver Lake
Through Fuse Plug**

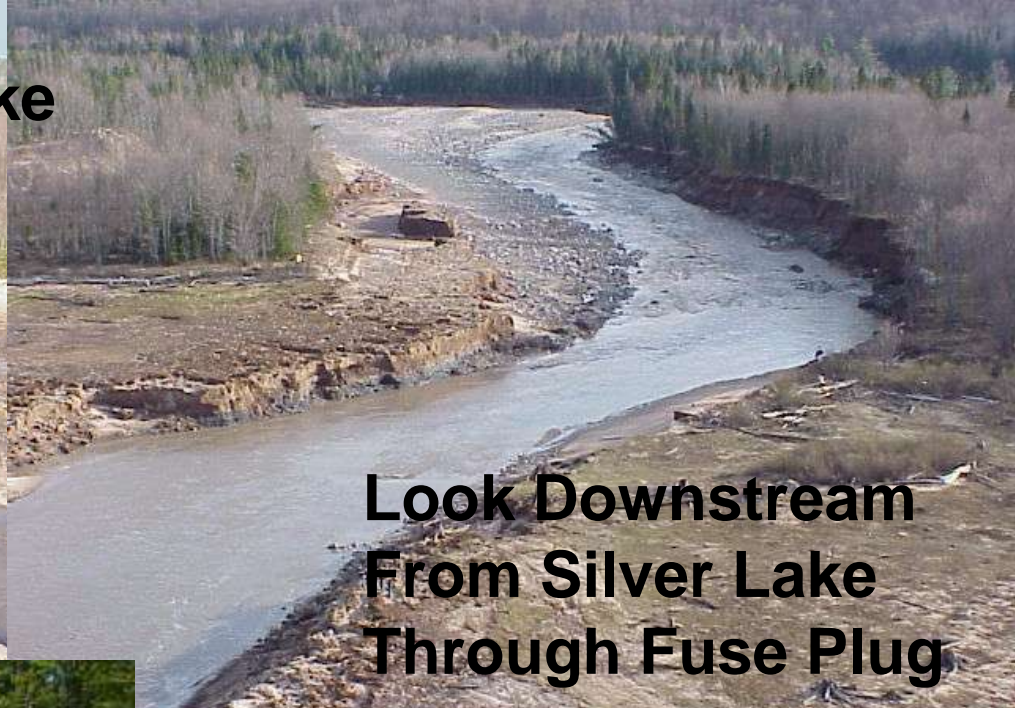
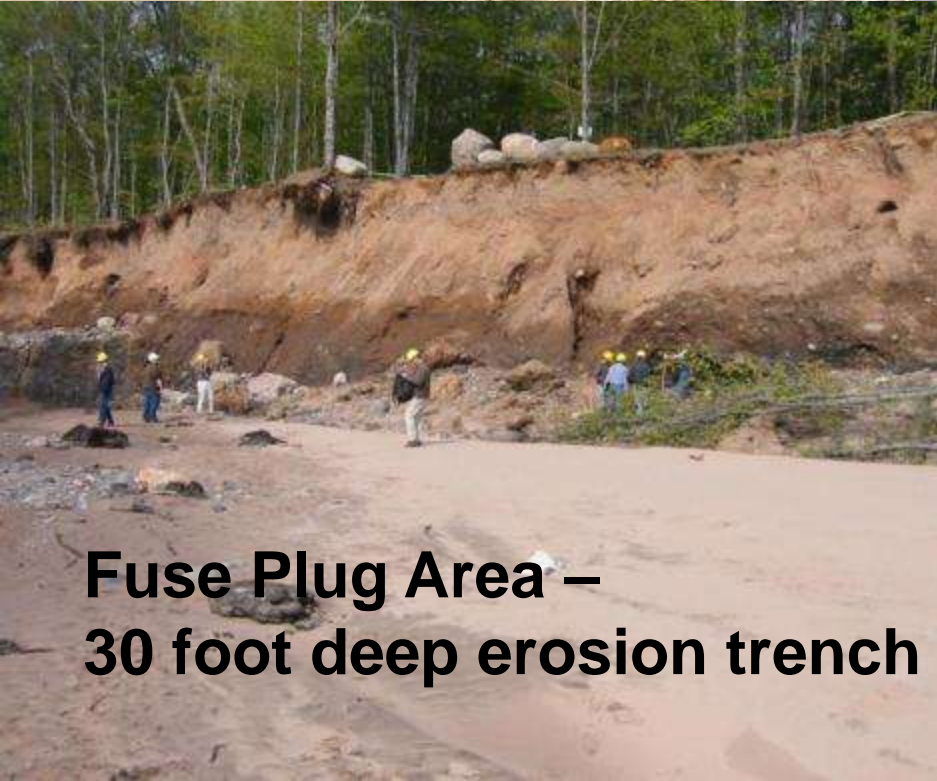
**Fuse Plug Area –
30 foot deep erosion trench**

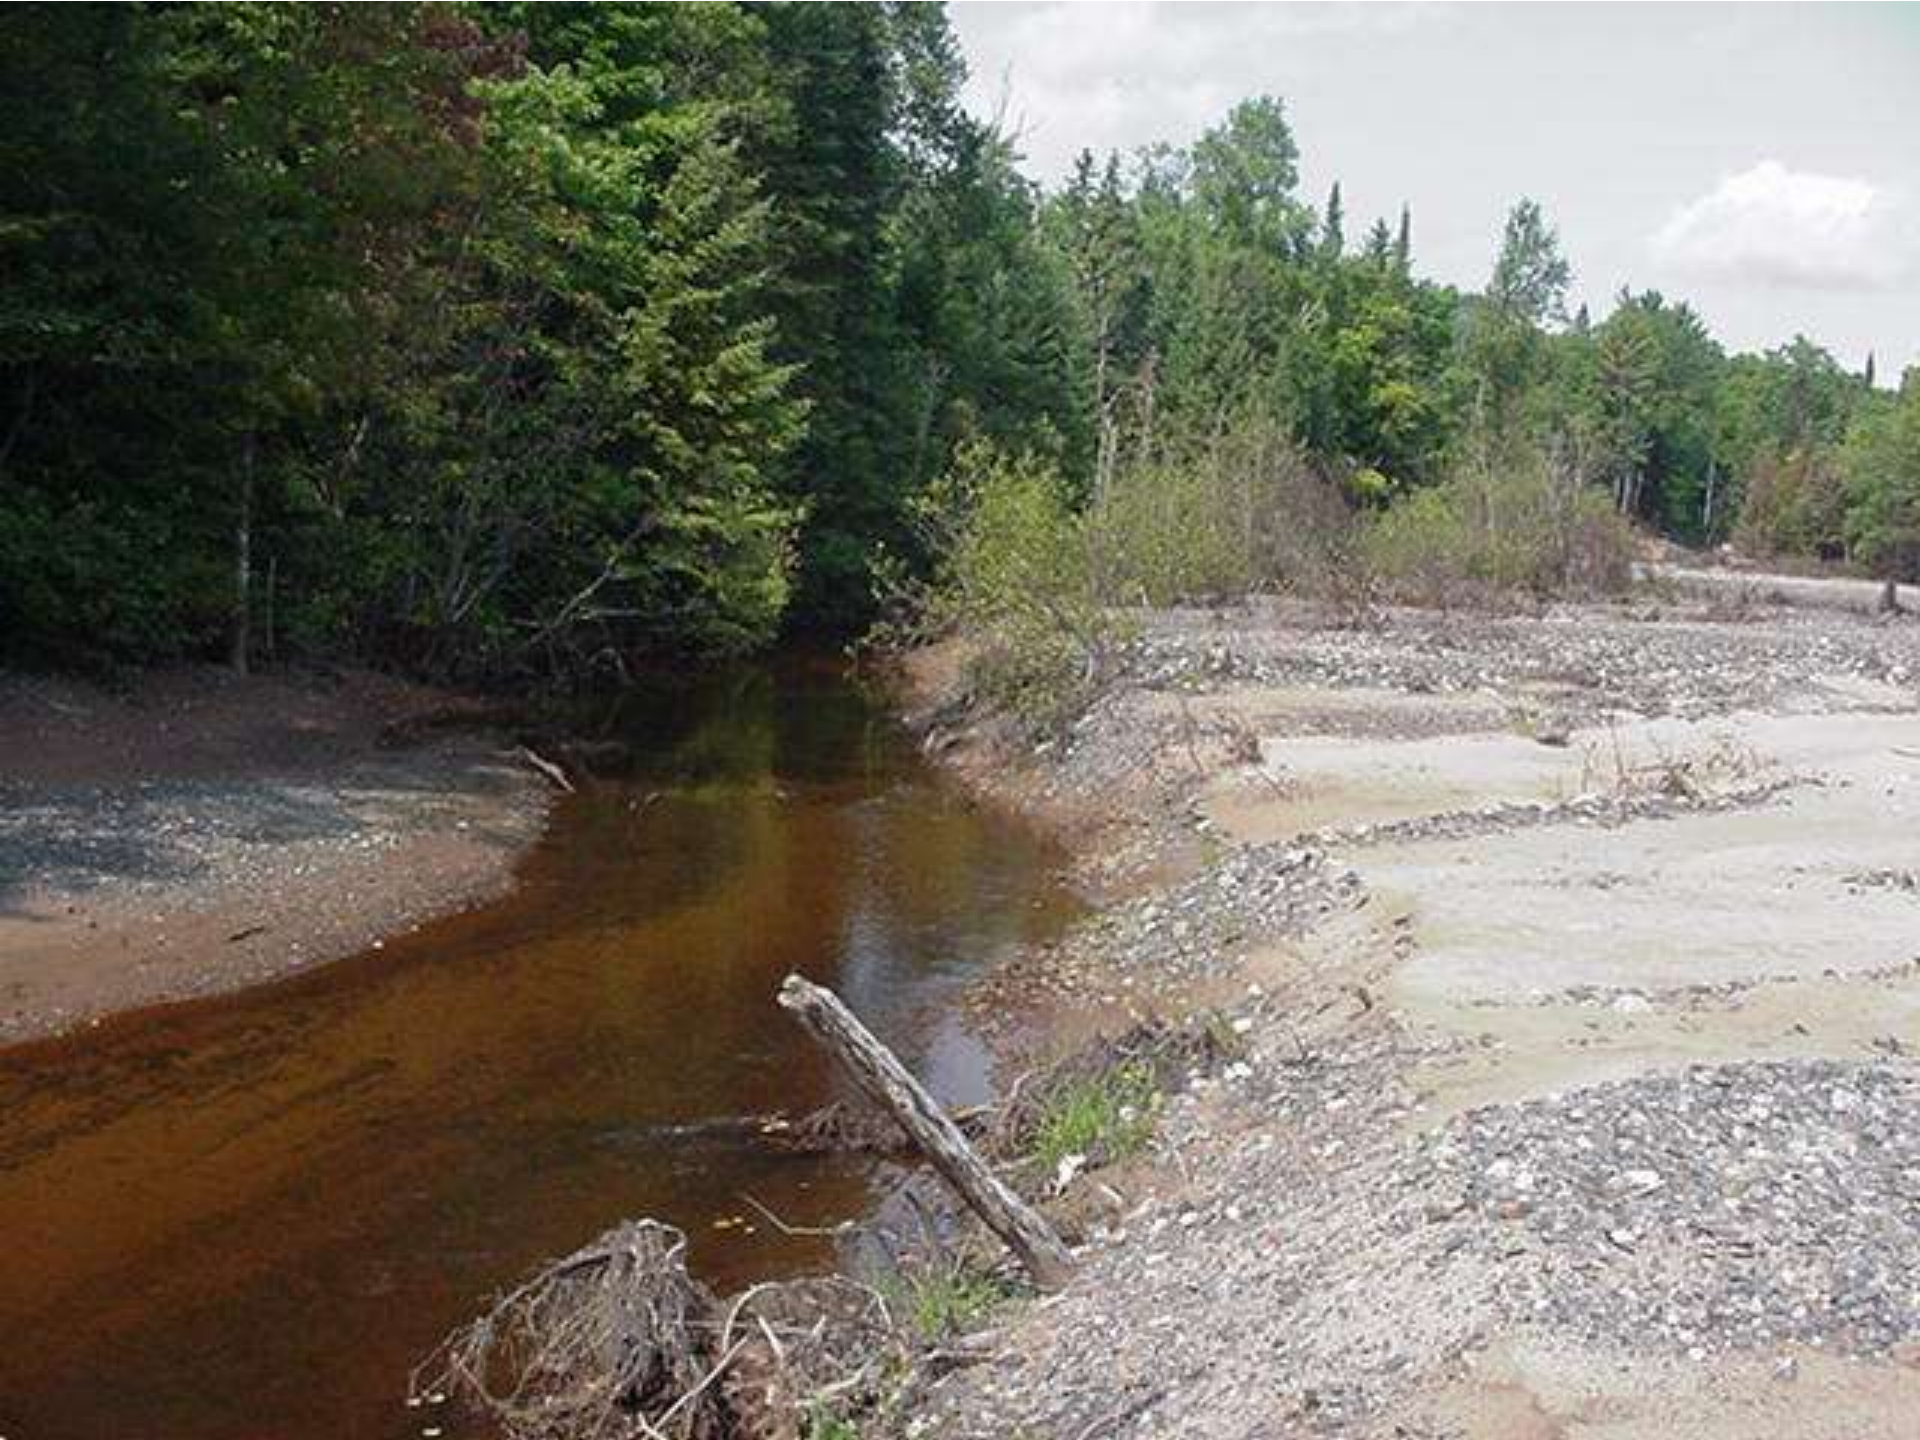
Dead River Basin Sand Delta in May 2004

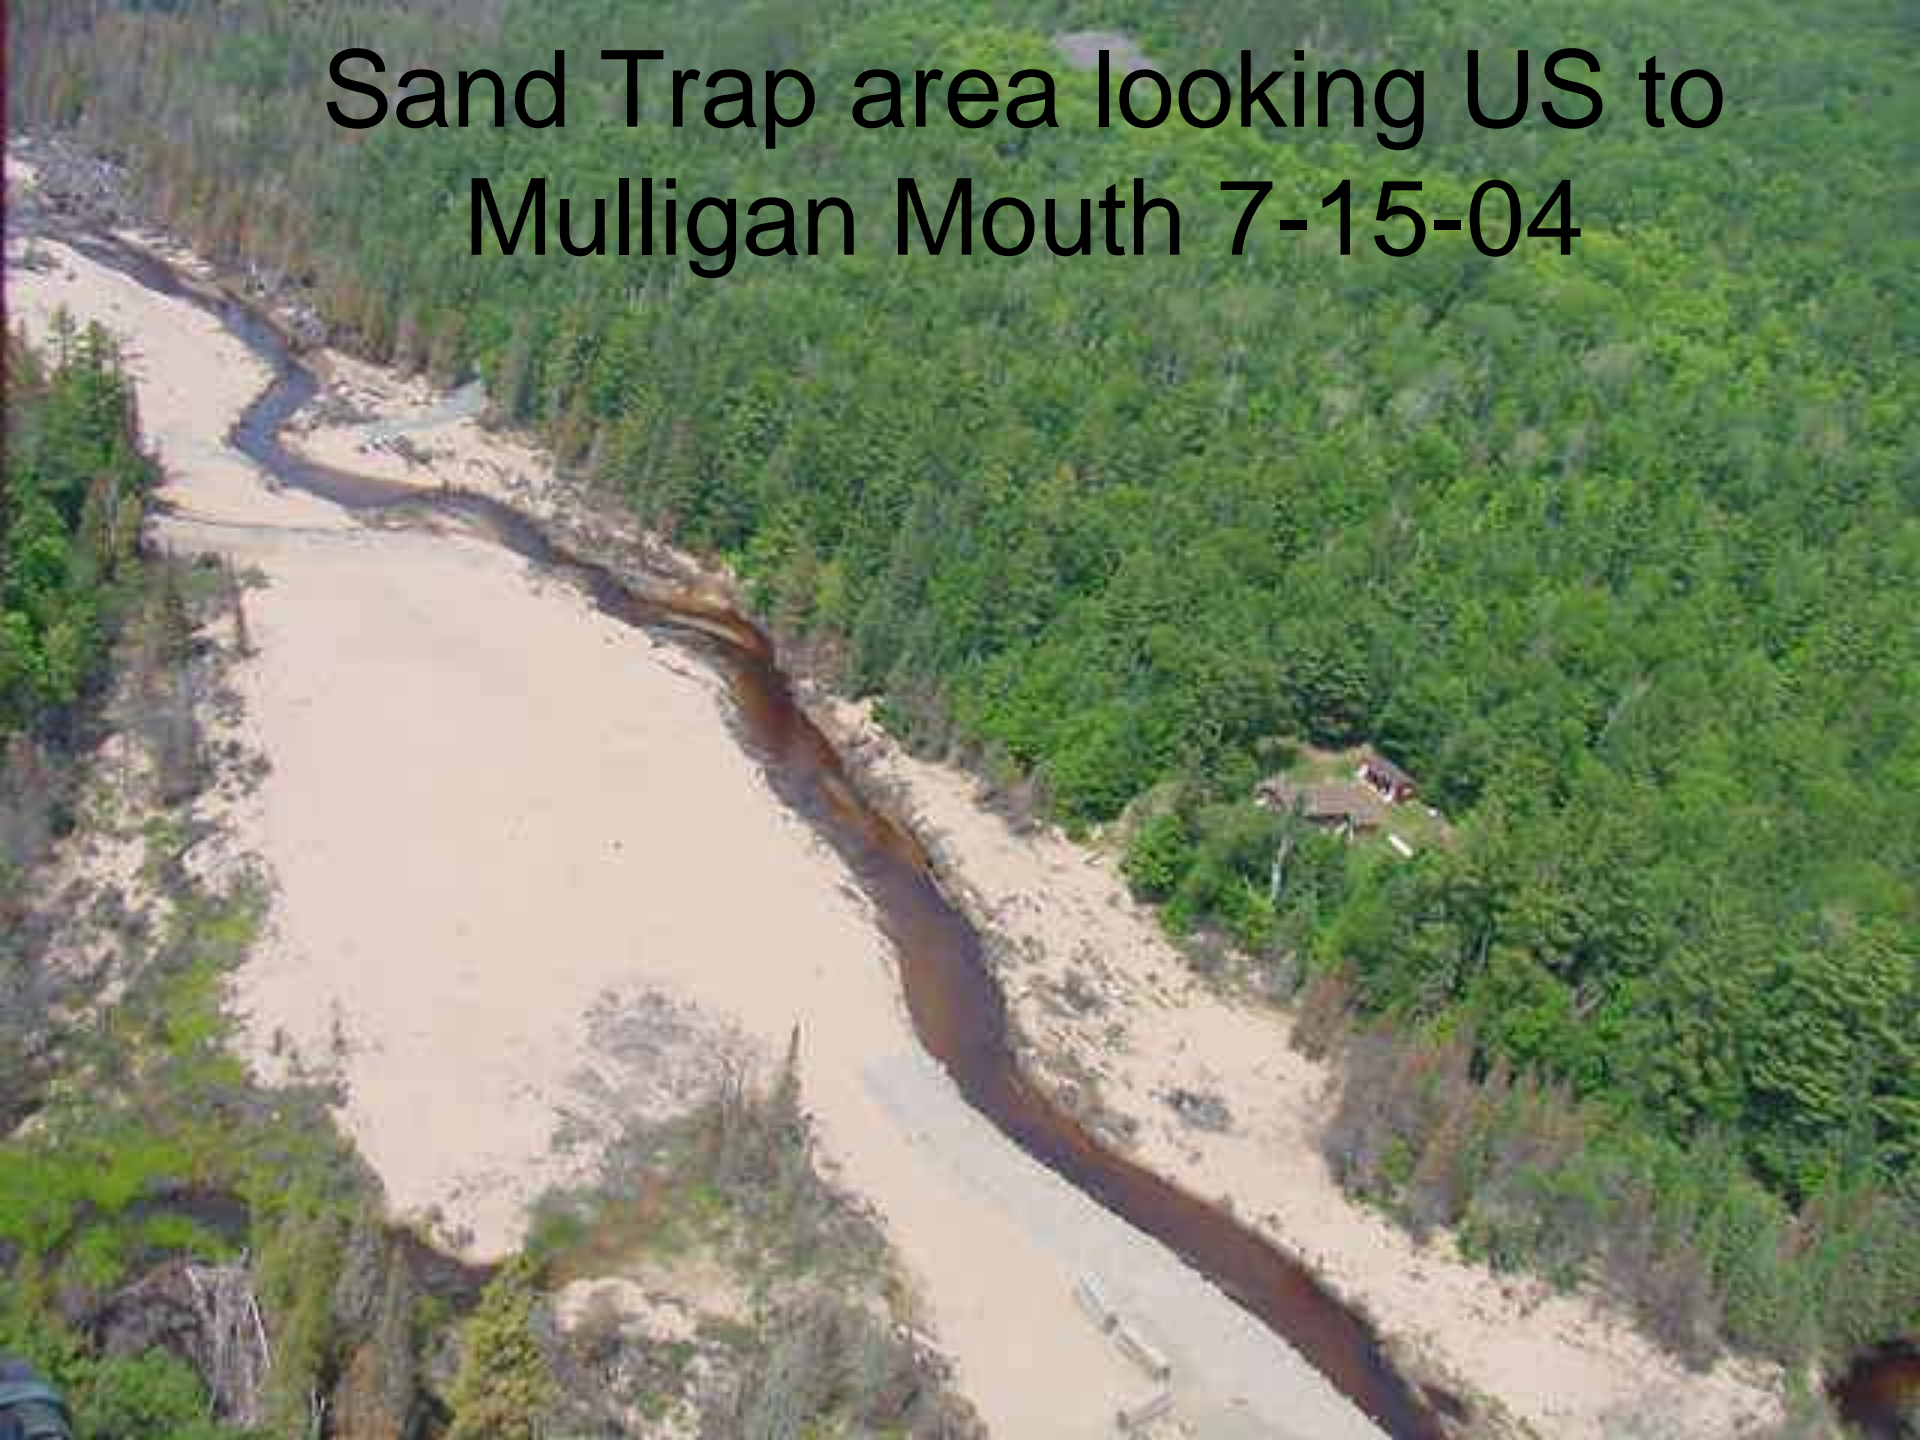
4/23/04 – Mulligan Creek Confluence

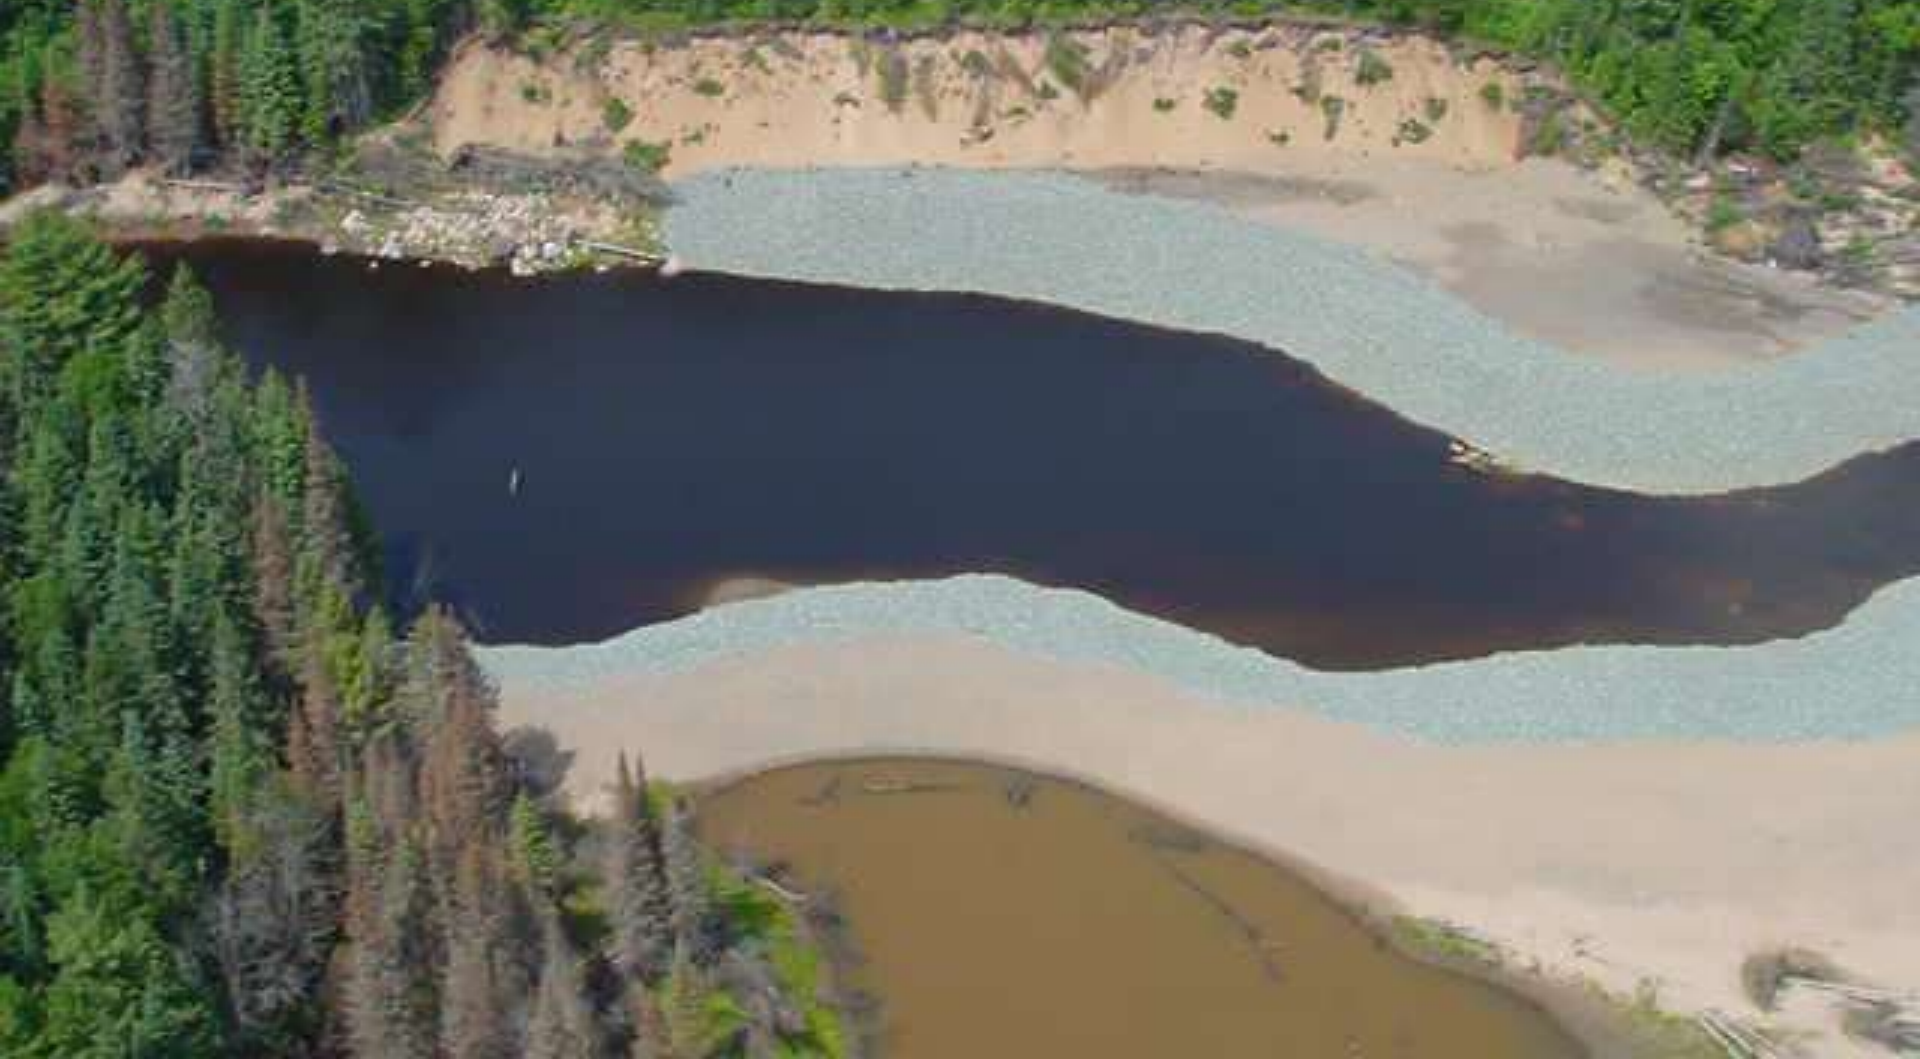
5-4-05

Riprap Bank

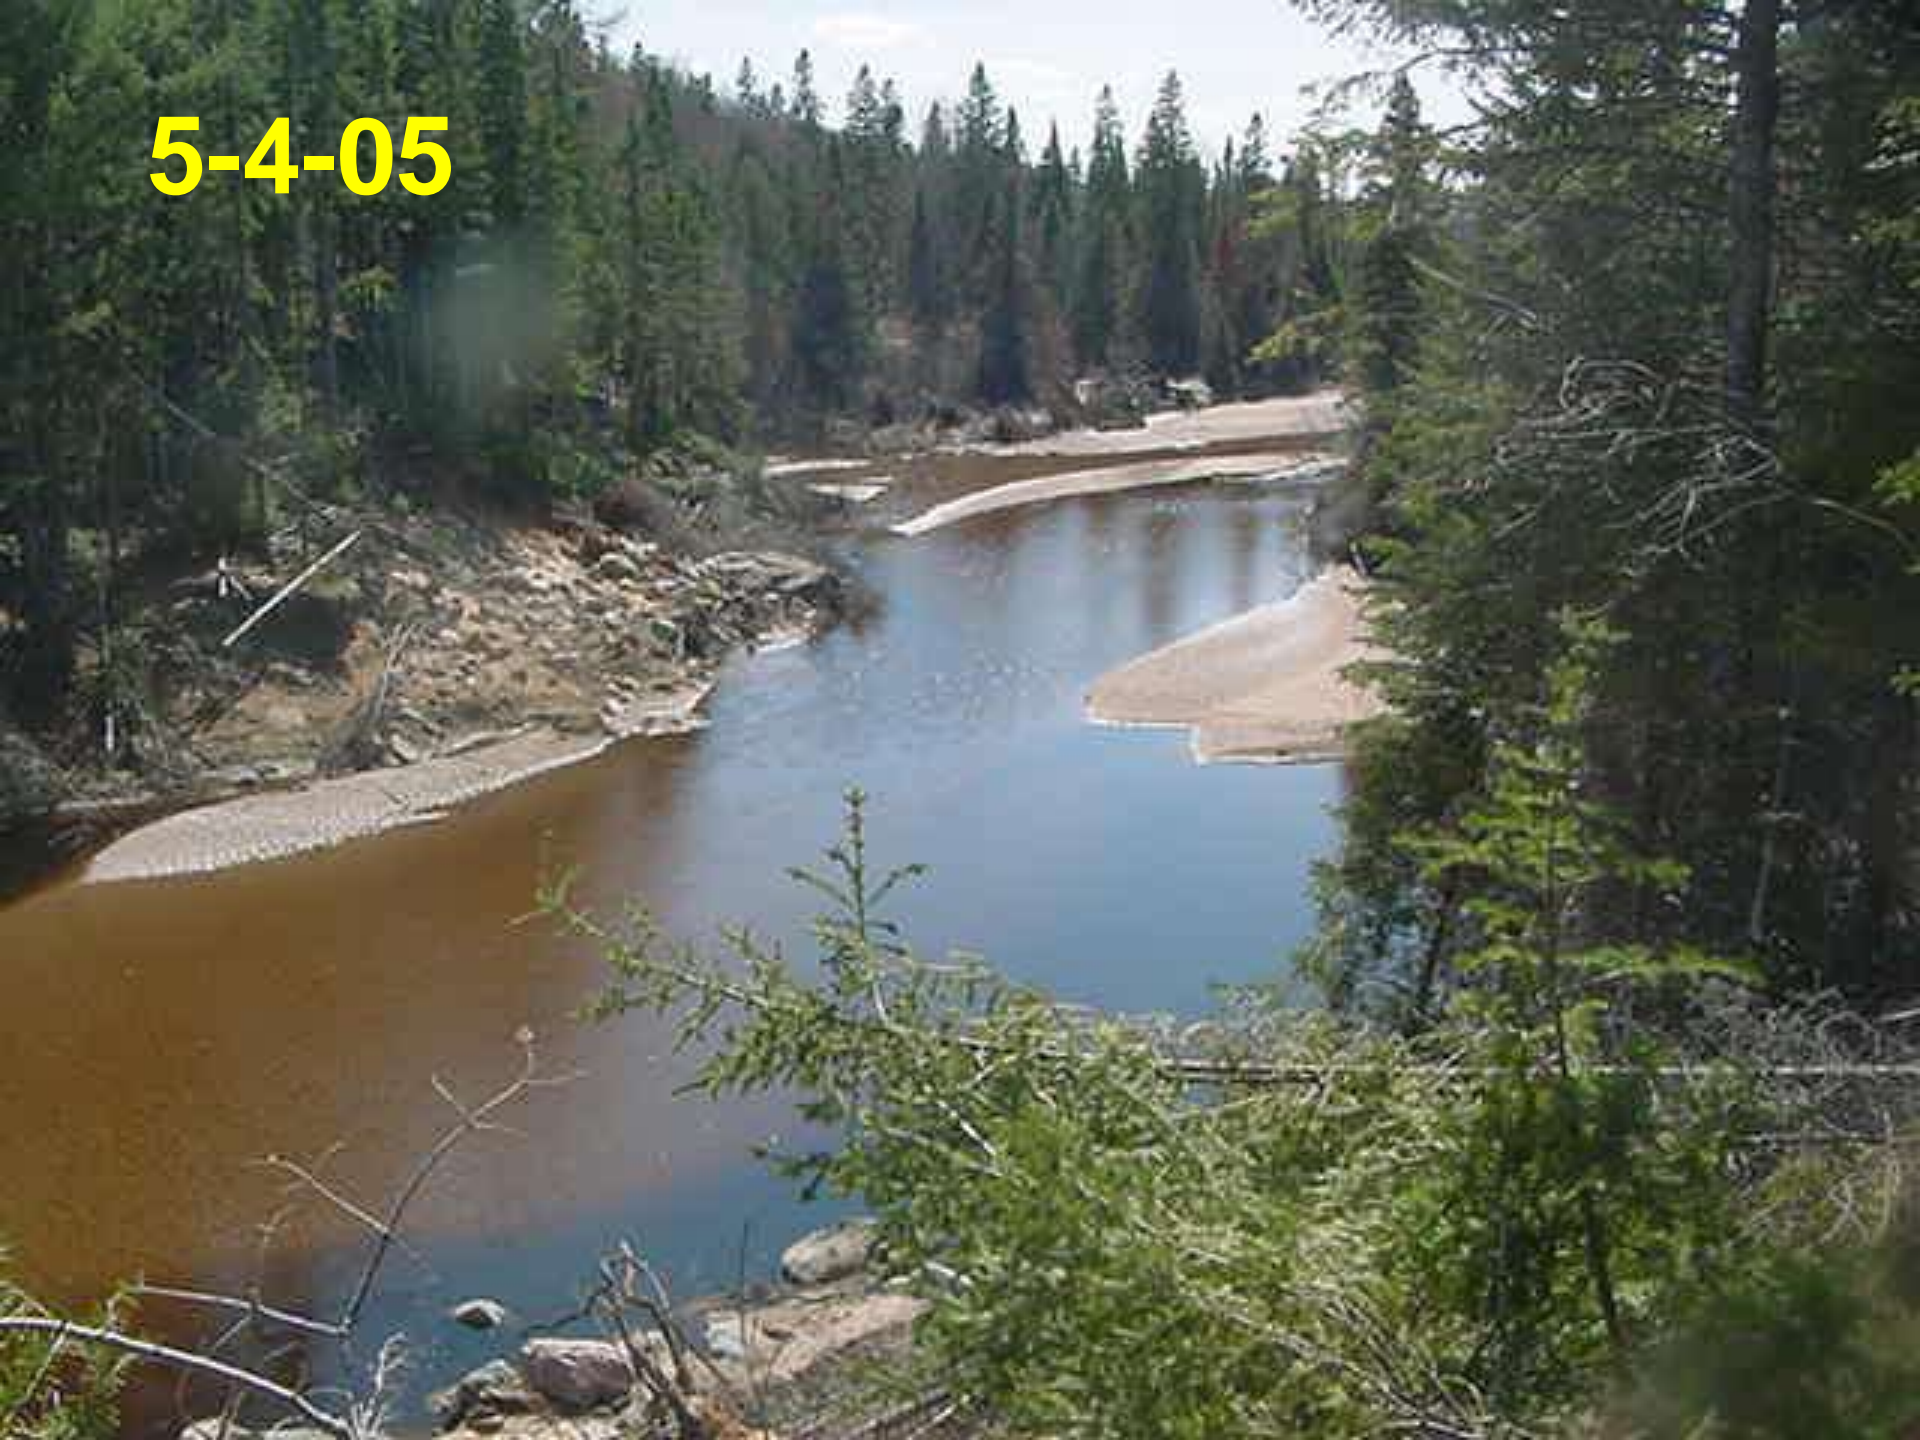
Same spot 6/3/10
4 years post construction

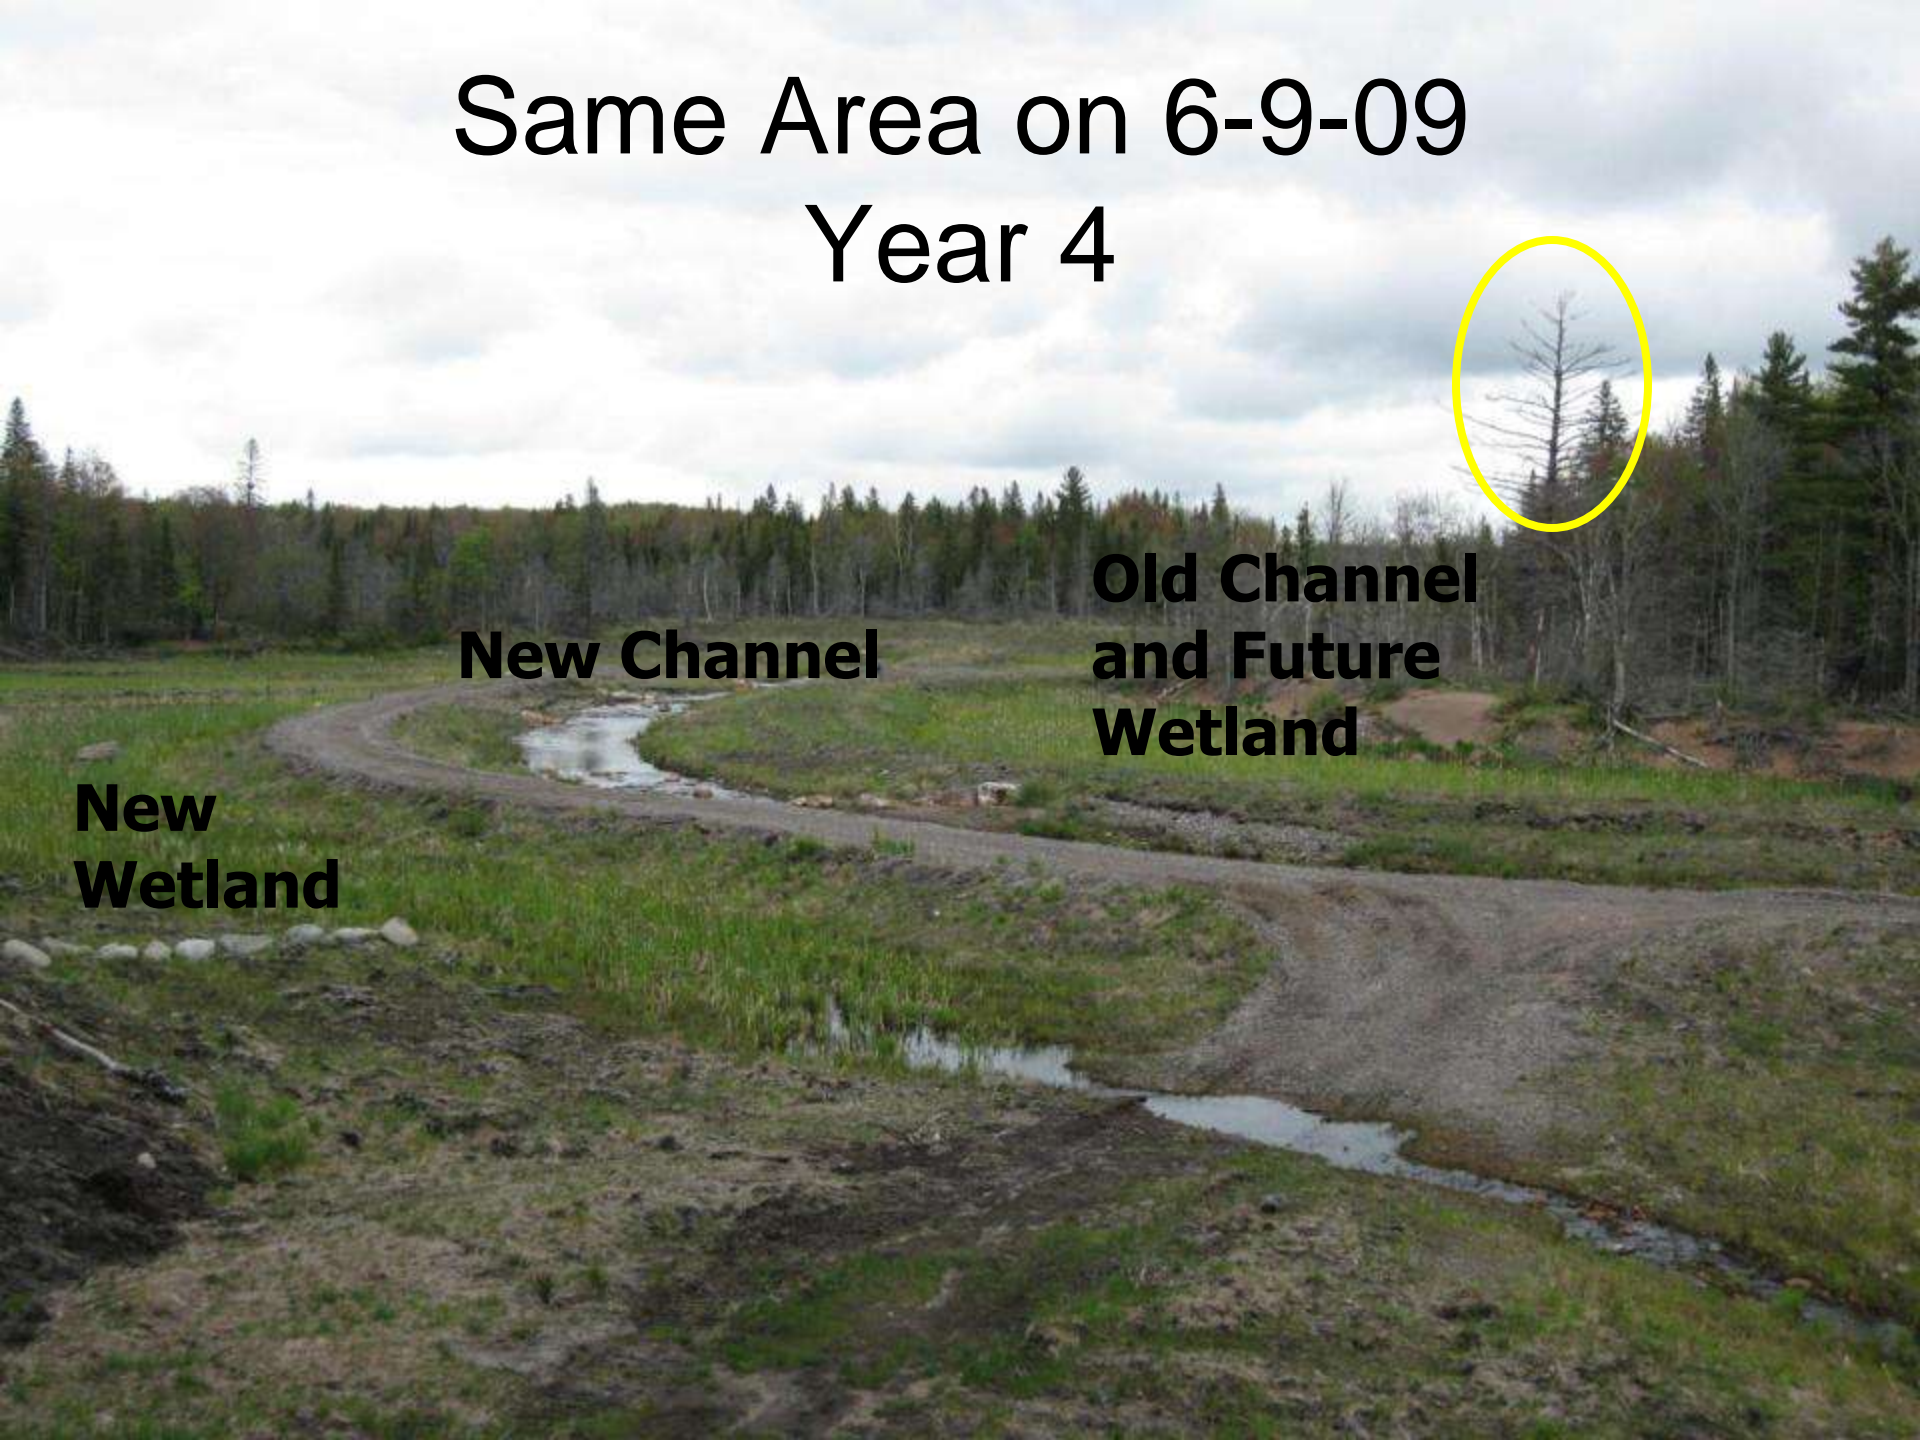
Same Area on 6-9-09 Year 4

New Channel

**Old Channel
and Future
Wetland**

**New
Wetland**

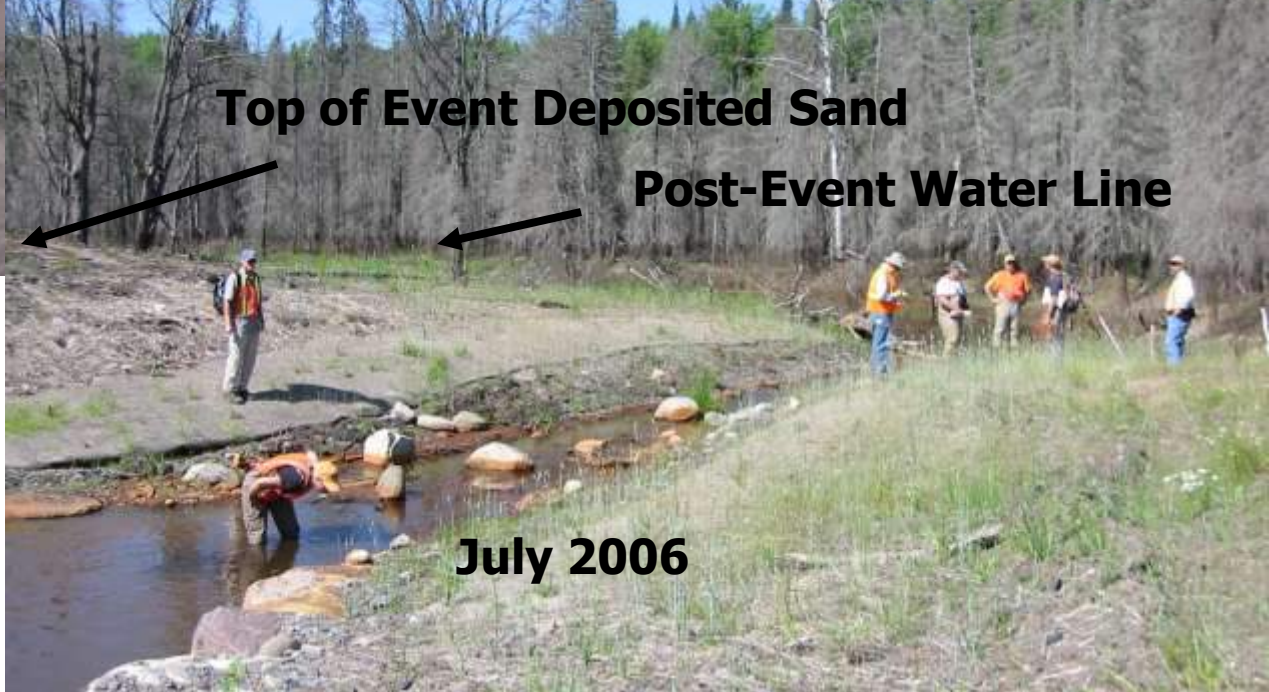
**Post-Event Water Line
and "white" tree**

**Top of Pre-
Reach A**

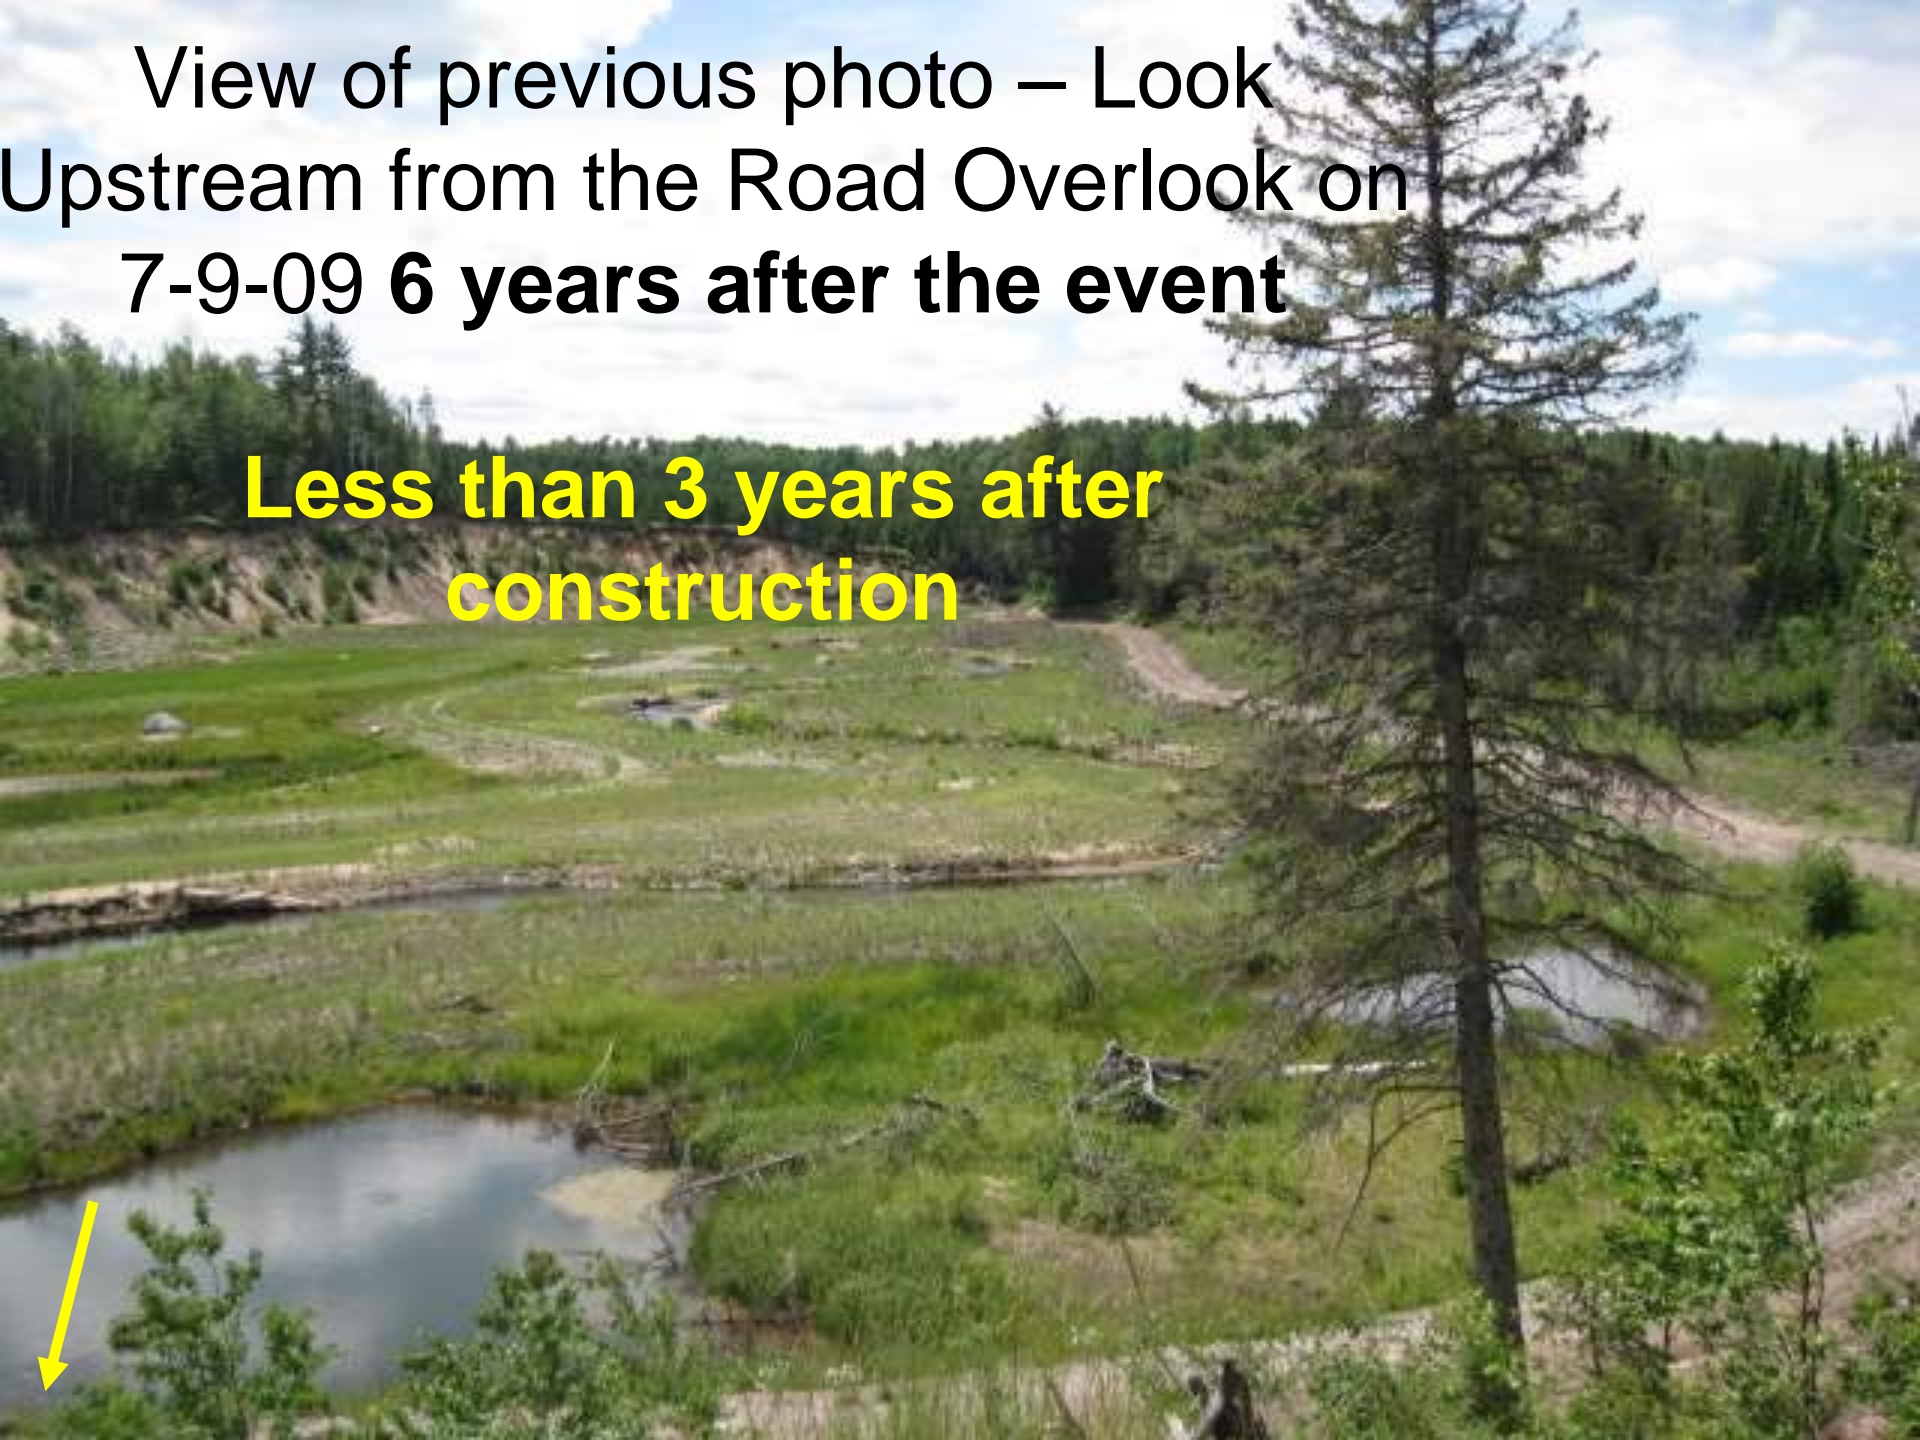
View of previous photo – Look
Upstream from the Road Overlook on
7-9-09 **6 years after the event**

**Less than 3 years after
construction**
